## Heritage, Design and Access Statement

Stable Block at The Clock Face, Derby  
Street, Prescott, L34 3LL

Daniel Thwaites Plc

JANUARY 2025

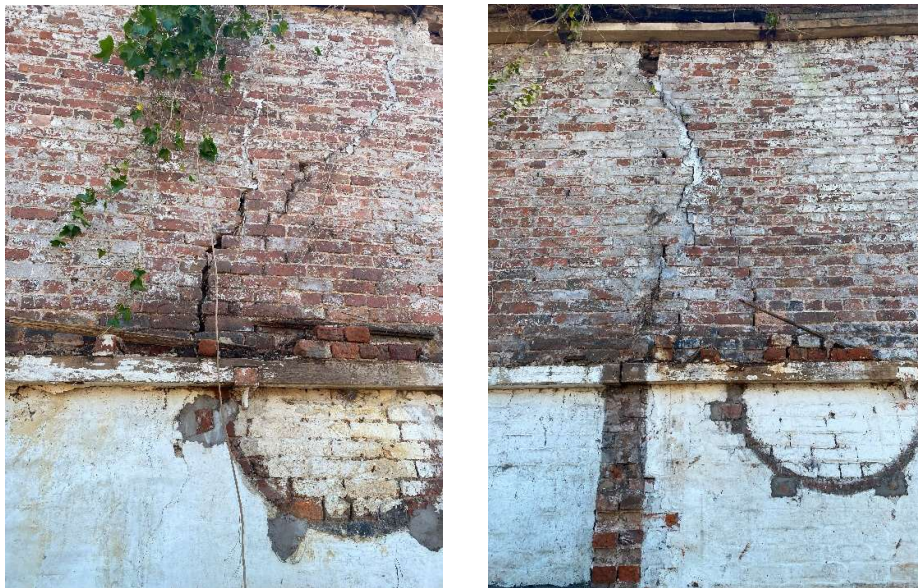
- 3.1 Following demolition of the lean-to structure 2no diagonal cracks to the external face of the brickwork were exposed at first floor level. The cracks extended from two joist holes and travelling vertically the elevation towards timber beam inserted to support the first floor joists. No cracking is visible to the internal faces of the building.
- 3.2 To remedy 2no. cracks identified following the removal of the lean-to it is proposed to that the sections of the elevations surrounding the cracks are rebuilt in line with the specification presented within Thwaites specification of works.

*Plates 1 and 2 - Vertical cracking exposed to the first floor of the north elevation.*

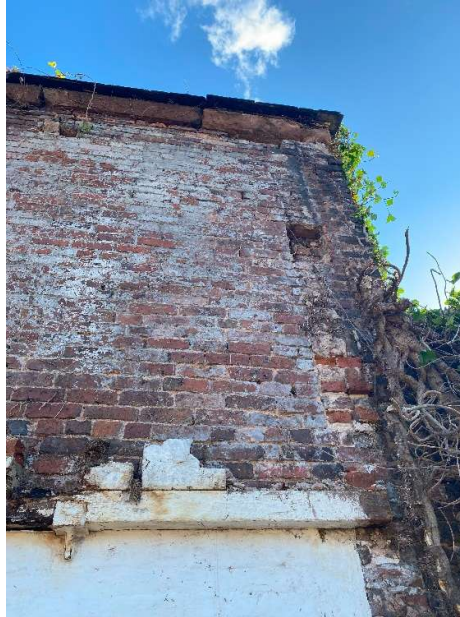
- 3.7 Damaged bricks are present where the lean-to structure was previously tied into the northwest elevation of the stable block. These areas are limited to the northeast and southwest ends of the elevation where the end walls of the lean-to were intermittently tied in at high level only and to where former joists were bedded into the elevation.
- 3.8 The damaged, rough edge bricks are to be carefully cut out by hand or mechanically, using a small handheld grinder and a vacuum attachment to cut down the amount of dust from becoming airborne. Replacement bricks salvaged from the lean-to structure during the demolition are to be instated. These bricks match the colour, texture and size of the bricks

*Plate 3 – Typical example of damaged bricks where brickwork replacement is proposed*

- 3.9 The replacement bricks are to be bed and pointed in a lime and sand mortar in accordance with the methodology set out above.

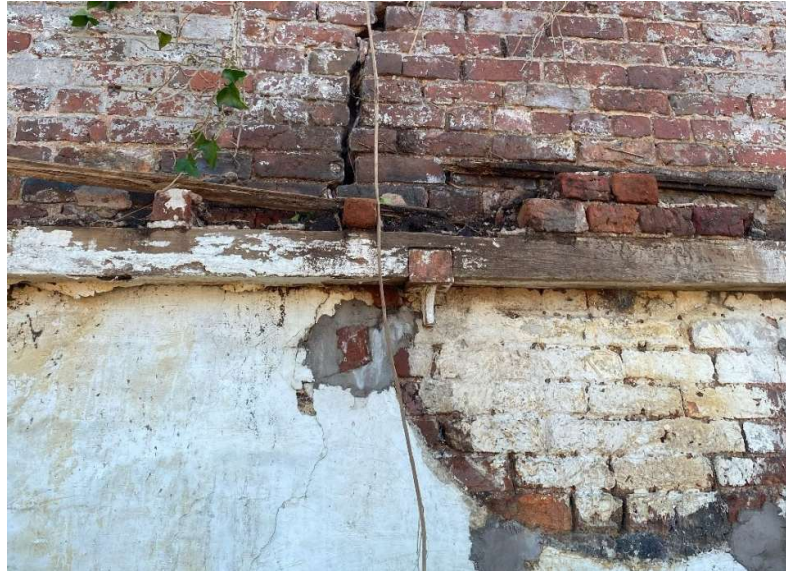
- 3.10 Isolated timbers, brackets, slates and lead flashings remain fixed to the northwest elevation. These features were associated the roof and internal structure of the lean-to.
- 3.11 The remaining timbers appear to set against the brickwork the northwest elevation and carried on metal brackets.
- 3.12 Open mortar joints exposed by the removal of flashings, slates and brackets are to be pointed in accordance with the methodology presented above.
- 3.13 Where insertion of the metal hanger brackets and timbers has caused damage to the brickwork, the brickwork will be careful cut out and replaced with bricks salvaged from the lean-to structure during the demolition.

*Plate 4 – Remaining timber and metal bracket to be removed.*

Where fixings leave holes in brickwork, the resulting hole shall be cleaned with water to remove dust & debris prior to being infilled with lime mortar ensuring it has been well compacted, and the mortar is colour toned to match the brickwork as best as possible.

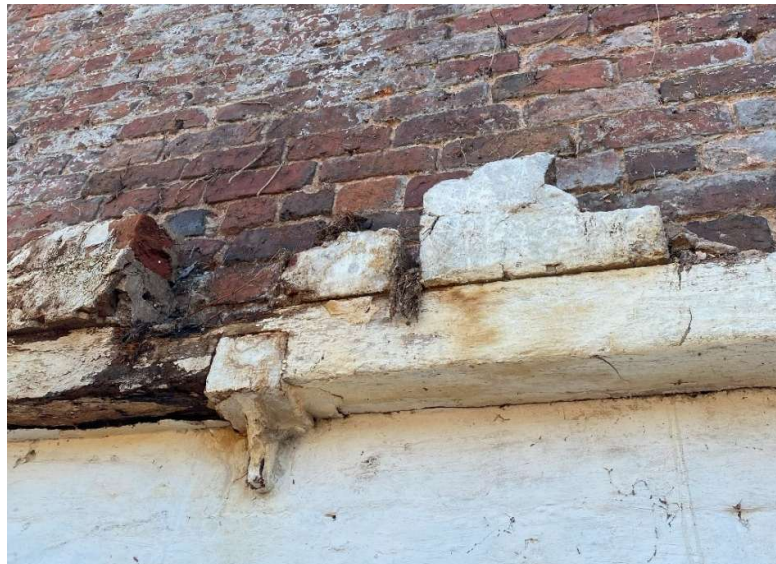
*Plate 5 – Remaining timber and metal bracket to be removed.*

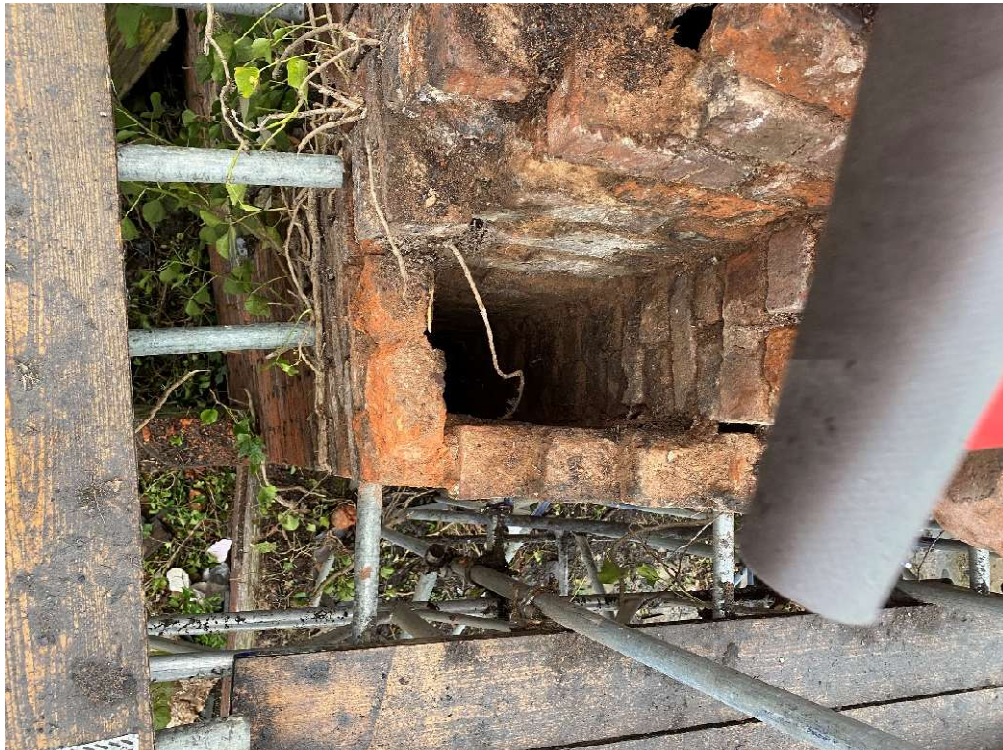
*Plate 6 – Internal stack to the northeast corner of the northwest elevation.*

- 3.17 To the northeast corner, it is proposed that the top courses of a brick stack visible to the interior of the building is raised in height by approximately two courses so that stack terminates level with the eaves. The flue of the stack is to be battened over and re-slatted with a vented slate. The external element of the stack has been removed previously with the slate roof simply extended over the flue.

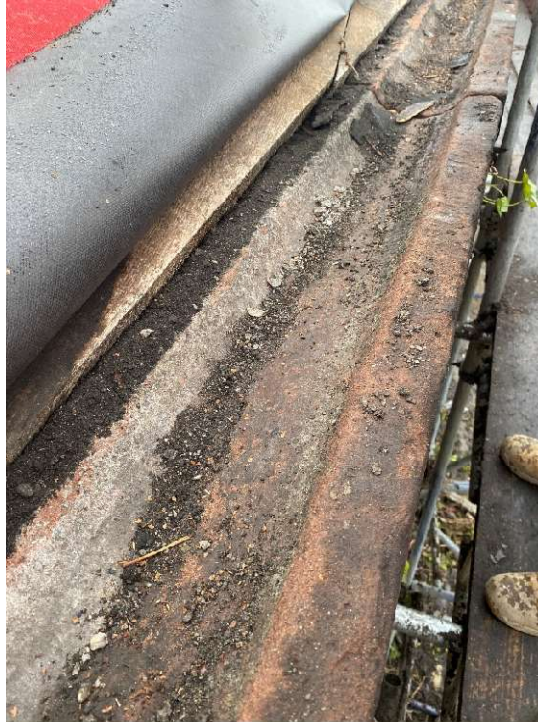
3.20 The drainage channel within the blocks is very shallow. It is a concern that the channel, due to the shallow depth is unlikely to be able to manage the flow of the rainwater off the roof covering particularly during extreme heavy downpours of rain which are becoming more common due to the effects of climate change. In these events, the rainwater would overflow the gutter and run down the face of the gutter block and the brickwork of the building. This could lead to accelerated deterioration of the stonework block, which is naturally softer and deterioration of the red brickwork. Furthermore, the gutter blocks have been previously removed from the southeast, courtyard elevation of the building with the upper courses of brickwork to this elevation being different in colour and texture to the original brickwork. Rainwater on this elevation is collected by traditional, cast iron guttering, carried on brackets and discharged into cast iron downpipes. To the northeast elevation, whilst the stone gutter blocks remain, they were not in use with the roof altered to allow the slate tiles to extend the blocks. These previous interventions offer evidence that indicates the gutter blocks may not have been effective.

*Plate 7 – Drainage channel to stone gutter blocks to the northwest roof slope.*

3.21 It is proposed that half round cast iron gutting to match the existing is to be installed to the northwest elevation to match that to the southeast courtyard elevation. Three downpipes and simple, cast iron hopper are to be installed, one at either end of the elevation and one

centrally to discharge of the rainwater collected. Inclusion of traditionally detailed hoppers provides opportunity to manage rainwater collection during heavy downpours. The guttering shall be carried on brackets to match the existing arrangement. The guttering to the southeast courtyard elevation is to be repaired with any cracks and splits sealed. Sections beyond repair will be replaced on a like for like basis.

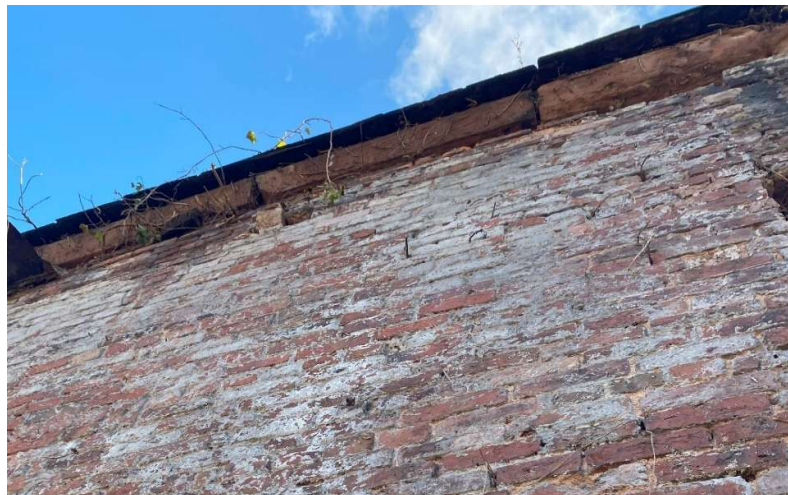
*Plate 8 – Red stone blocks to be re-bed to the northwest rear elevation.*

3.19 Whilst the roof is stripped, the red sandstone gutter blocks are to be re-bed and pointed using the agreed mortar.
