# **ARBORICULTURAL REPORT & Impact Assessment to BS 5837:2012 at:**

***Kirkby Substation  
(cable area route):  
Land at Cut Lane,  
Knowsley  
L33 7TT***

Prepared for: *Envams*

Reference: *AWA6835*

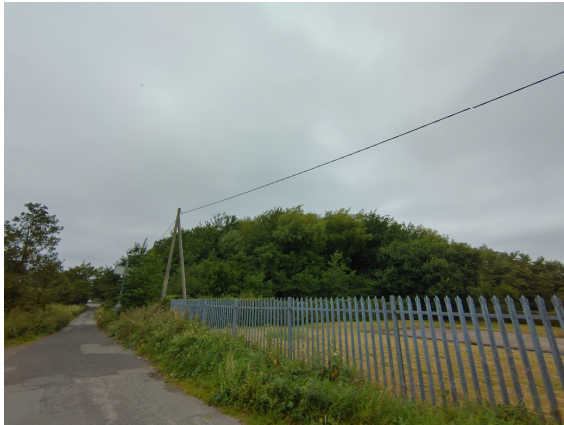
- 3.2.10 G1 is a semi-mature mixed species group of predominantly Cherry, Alder, Willow and Oak. These were likely planted for screening purposes, and

some trees still have tree ties attached. Unofficial footpaths through the group have compacted the soil and utilities infrastructure has likely damaged some roots. The northeastern edge of this group is predominantly young, likely self-set specimens, with semi- and early-mature likely planted trees extending up banking to the southwest beyond the survey area. This group offers good screening and is retention category C. Within this group larger individual trees were also plotted.

Photo 1: G1 from northeast

- 4.2.5 6 tree groups require partial removal to facilitate the development. G1, G13, G20, G21, G23 and G22 require a strip of trees removing to allow space for the development. With the exception of G13, these are all low value retention category C groups with little arboricultural value. Most of these groups will remain intact, lessening the visual and arboricultural impact of the removal of a limited number of trees within them.

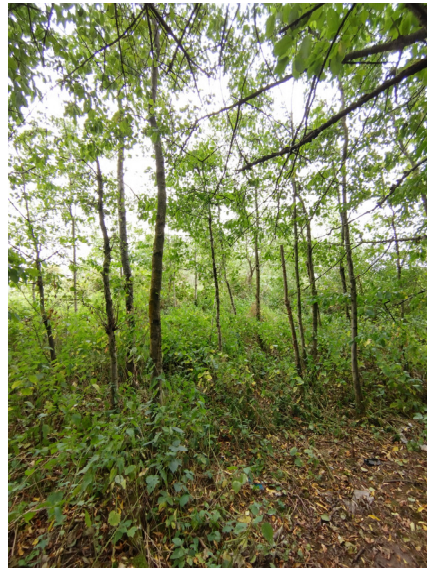
Photo 2: G1 young trees on northeastern edge of group.

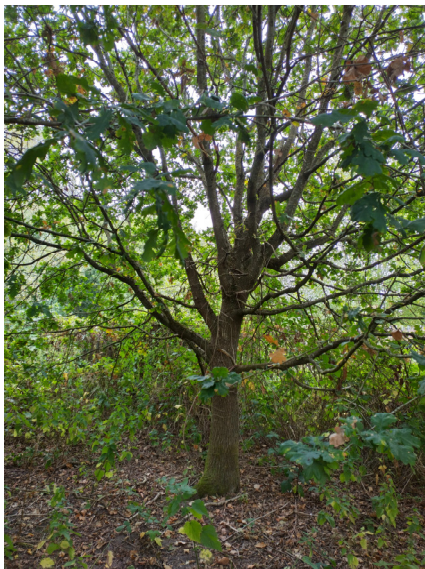
- 3.2.9 G13 is a group of young Oak, likely planted when the site was established. Dense brambles around the base made many of these trees inaccessible, and some of the stems were plotted approximately. These Oaks appear to be in good physiological and good structural health and are likely to have good prospects. Collectively they are retention category B, with many individually also category B.

Photo 3: Oak with G13

- 4.2.6 G13 is collectively of moderate arboricultural value. The removal of approximately half of this group will have a moderate arboricultural impact. However, these are generally young Oaks and will be replaceable in a relatively short time frame, and their loss can be mitigated by replacement planting in other areas of the site.

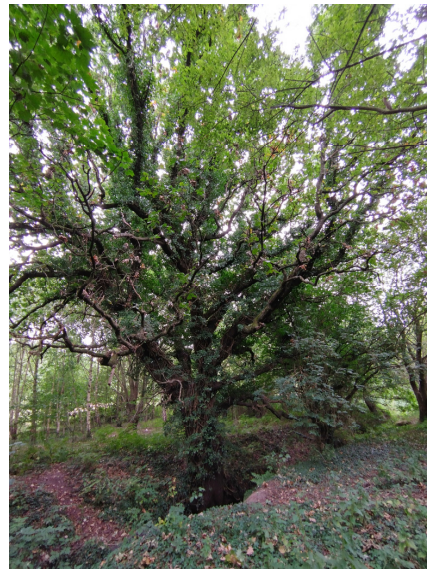
Photo 4: T25 from north

- 4.3.4 The encroachment into the RPA of T25 is more significant. However, the encroachment is likely to be relatively minor given the width of the easement, and it is likely that T25 will tolerate these works. It is recommended to review the health of this tree once works are completed.

- 4.2.7 2 trees require pruning works to facilitate the development. T25 and T28 require the crowns lifting and cutting back to give 3m clearance from the proposed works.

| <b>Tree/Group Ref</b> | <b>Value</b> | <b>Impact Type</b> | <b>Description of Impact</b> | <b>Impact Level</b> | <b>Mitigation / Solution</b> |
|---|---|---|---|---|---|
| T25 | B (Moderate) | Indirect - RPA Incursion | Encroachment into RPA | Minor | Carry out risk assessment within 3 years of completion of works |

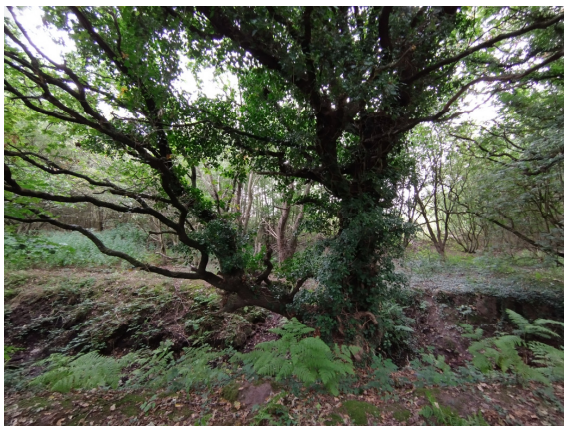
Photo 5: T27 from south

- 4.2.4 Oak T27 is a category B tree with good long term prospects, although it has some structural defects. The removal of this tree will have a moderate negative arboricultural impact. Replacement planting within the site will go some way towards mitigating the loss of this tree.

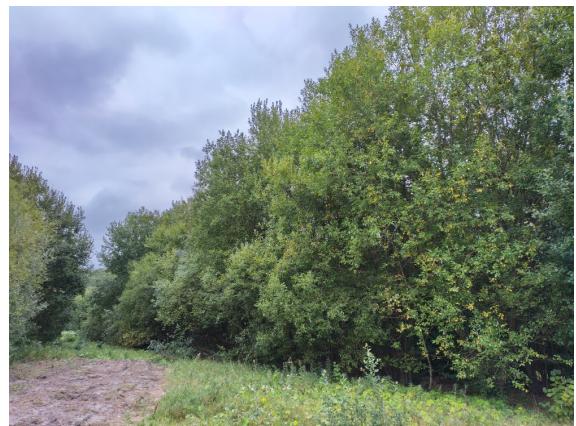
Photo 6: G22 and G23 from west
