Tree Survey, Arboricultural Impact Assessment, and Arboricultural Method Statement

BS5837:2012 (Trees in Relation to Design, Demolition and Construction) Format

School Lane, Prescot L34 9EN

Produced For:	B. Maguire
Produced By:	Robert Rainford Bsc. (Hons.) MArborA
Survey Date	26/06/2024
Report Date	11/07/2024
Reference:	RA.BS5837.005

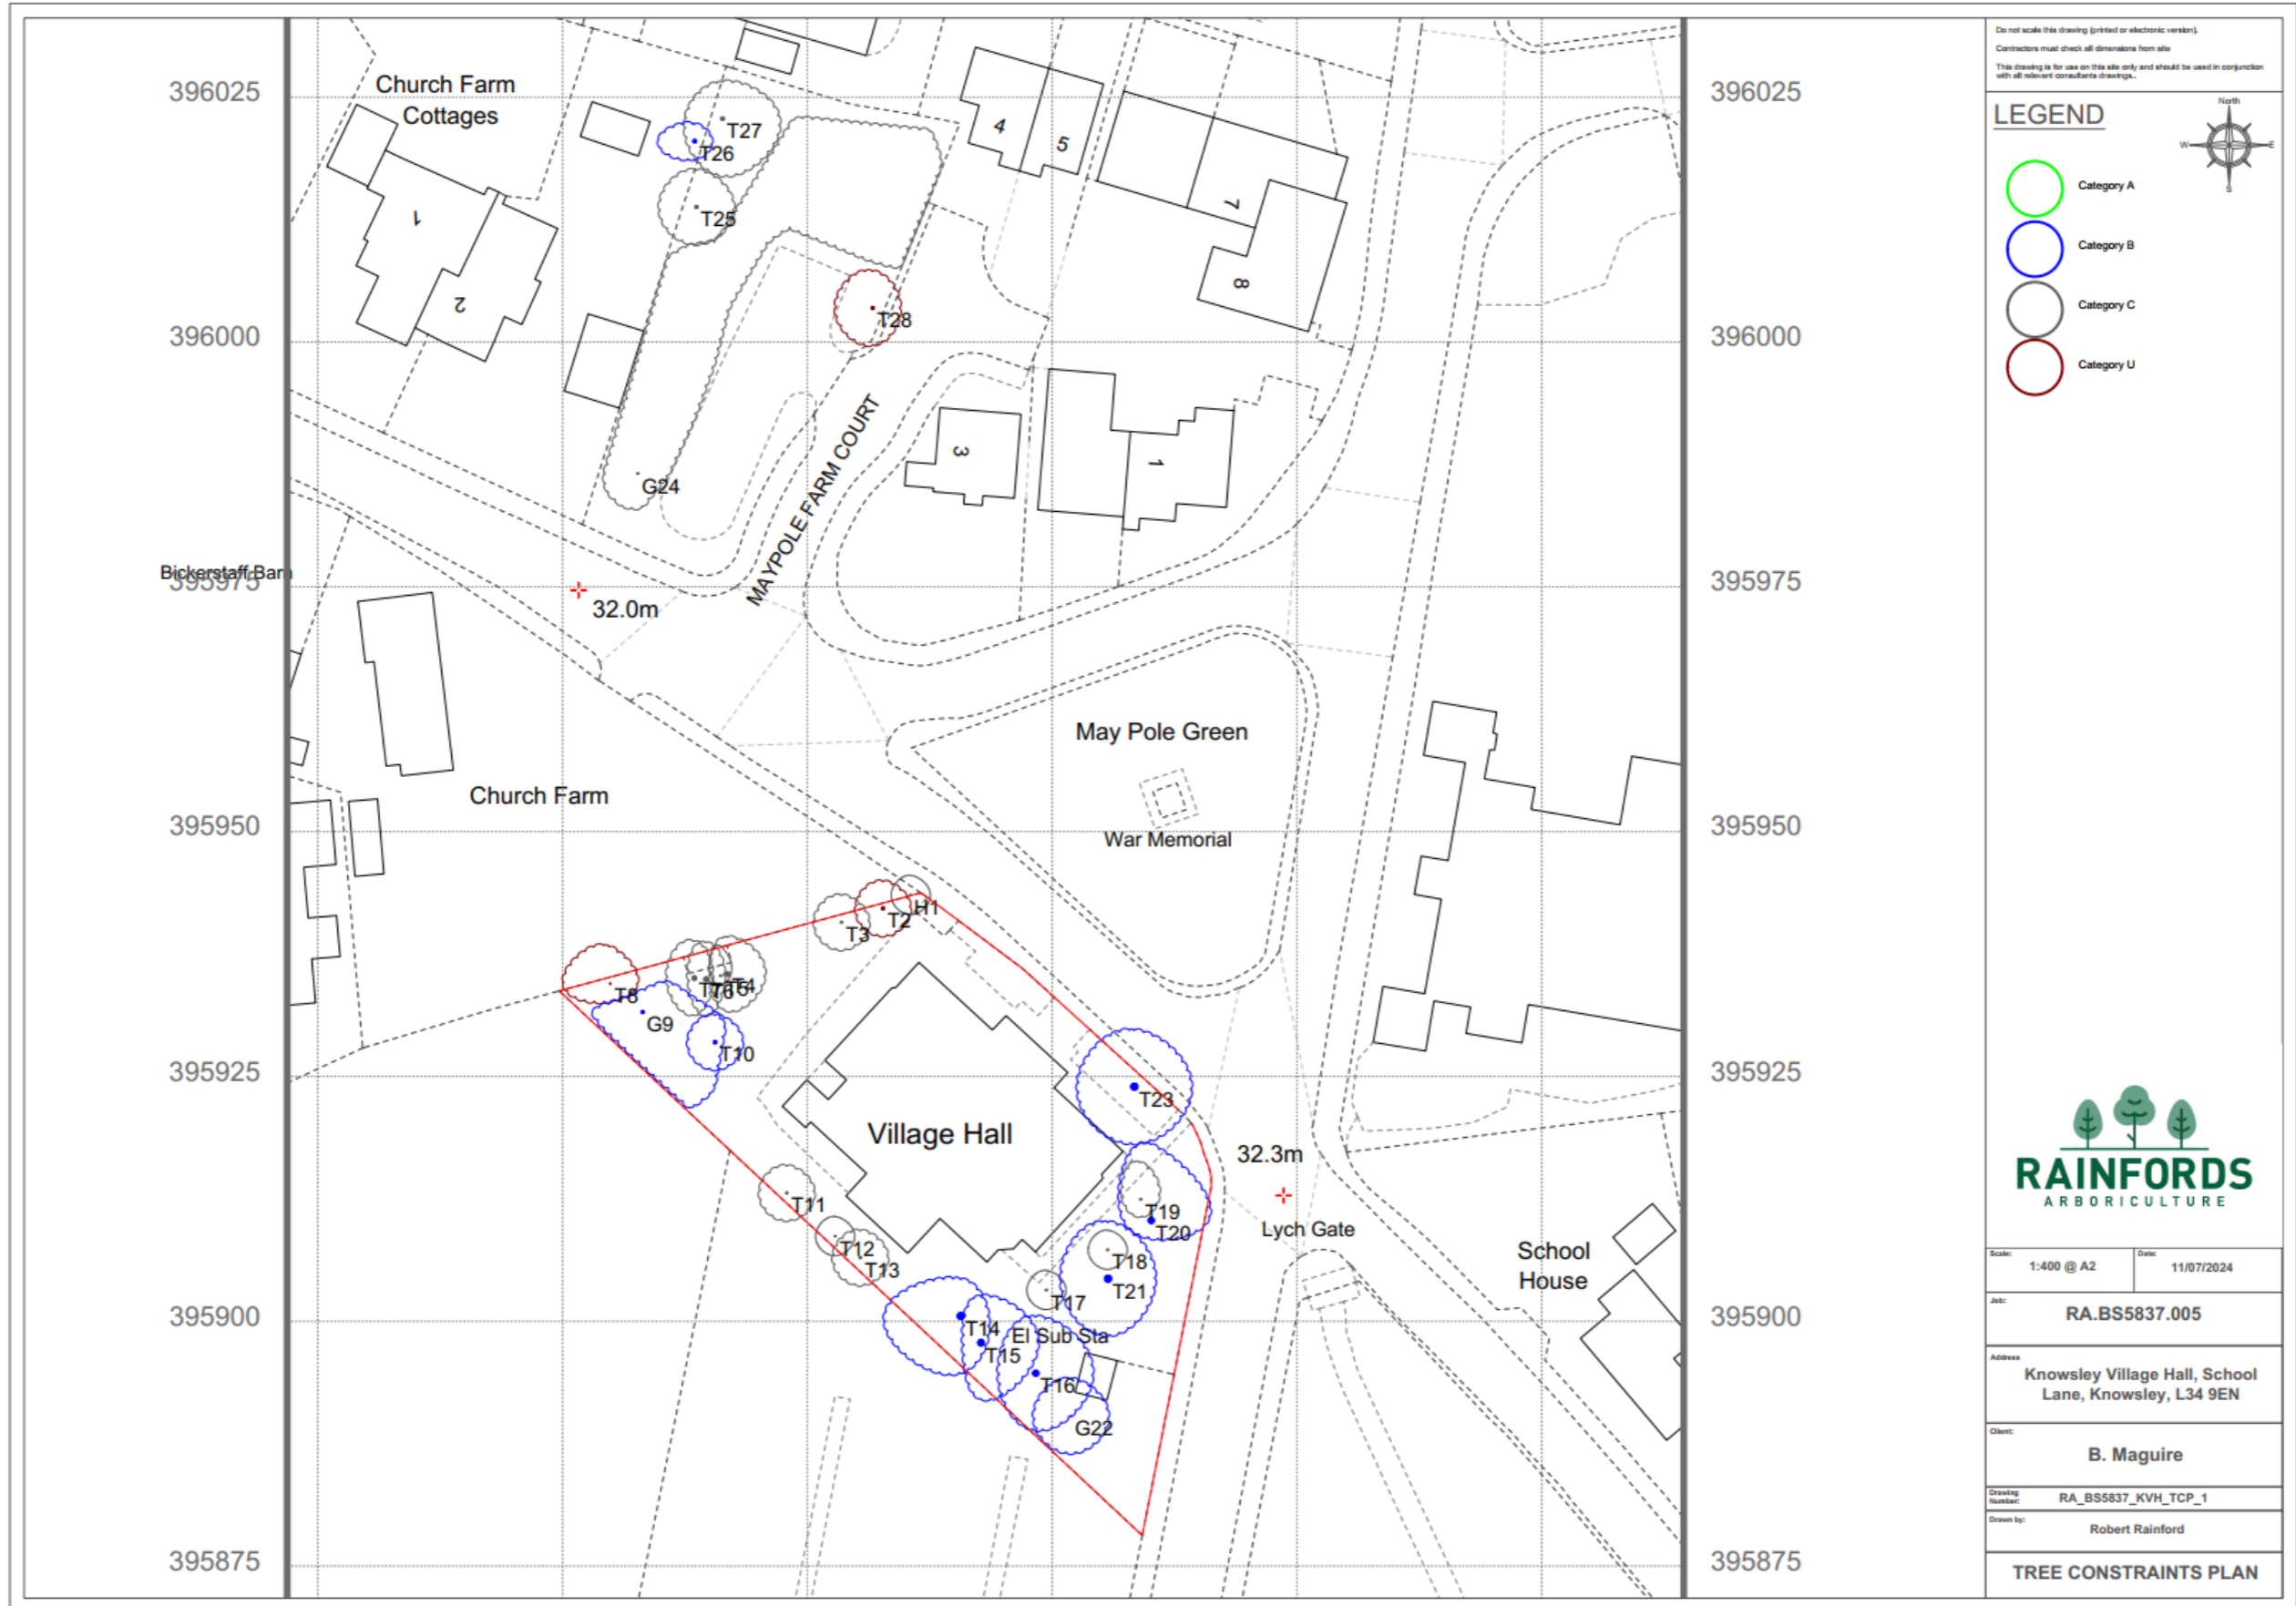
9 APPENDIX B - Tree Constraints Plan

T2 has suffered a limb failure into adjacent property, coupled with the Ganoderma DDB on the lower stem, this is a low quality tree.

T3 Holly has a stem pushing against the coping stones on the top of the boundary wall.

T8 Willow has also suffered limb failures into the site, it is against the boundary wall and more failures are likely from the base of the tree, some of these stems will fail into neighbouring property.

T11, T12 and T13 along the south boundary were all showing a considerable covering of Ivy, this has been severed and the ivy has died however the large number of stems of the ivy limited crown visibility into these smaller trees.

T28 Willow has been displacing the boundary fence, footpath and external streetlight with its incremental growth, this is creating a risk of the light falling over into the highway.

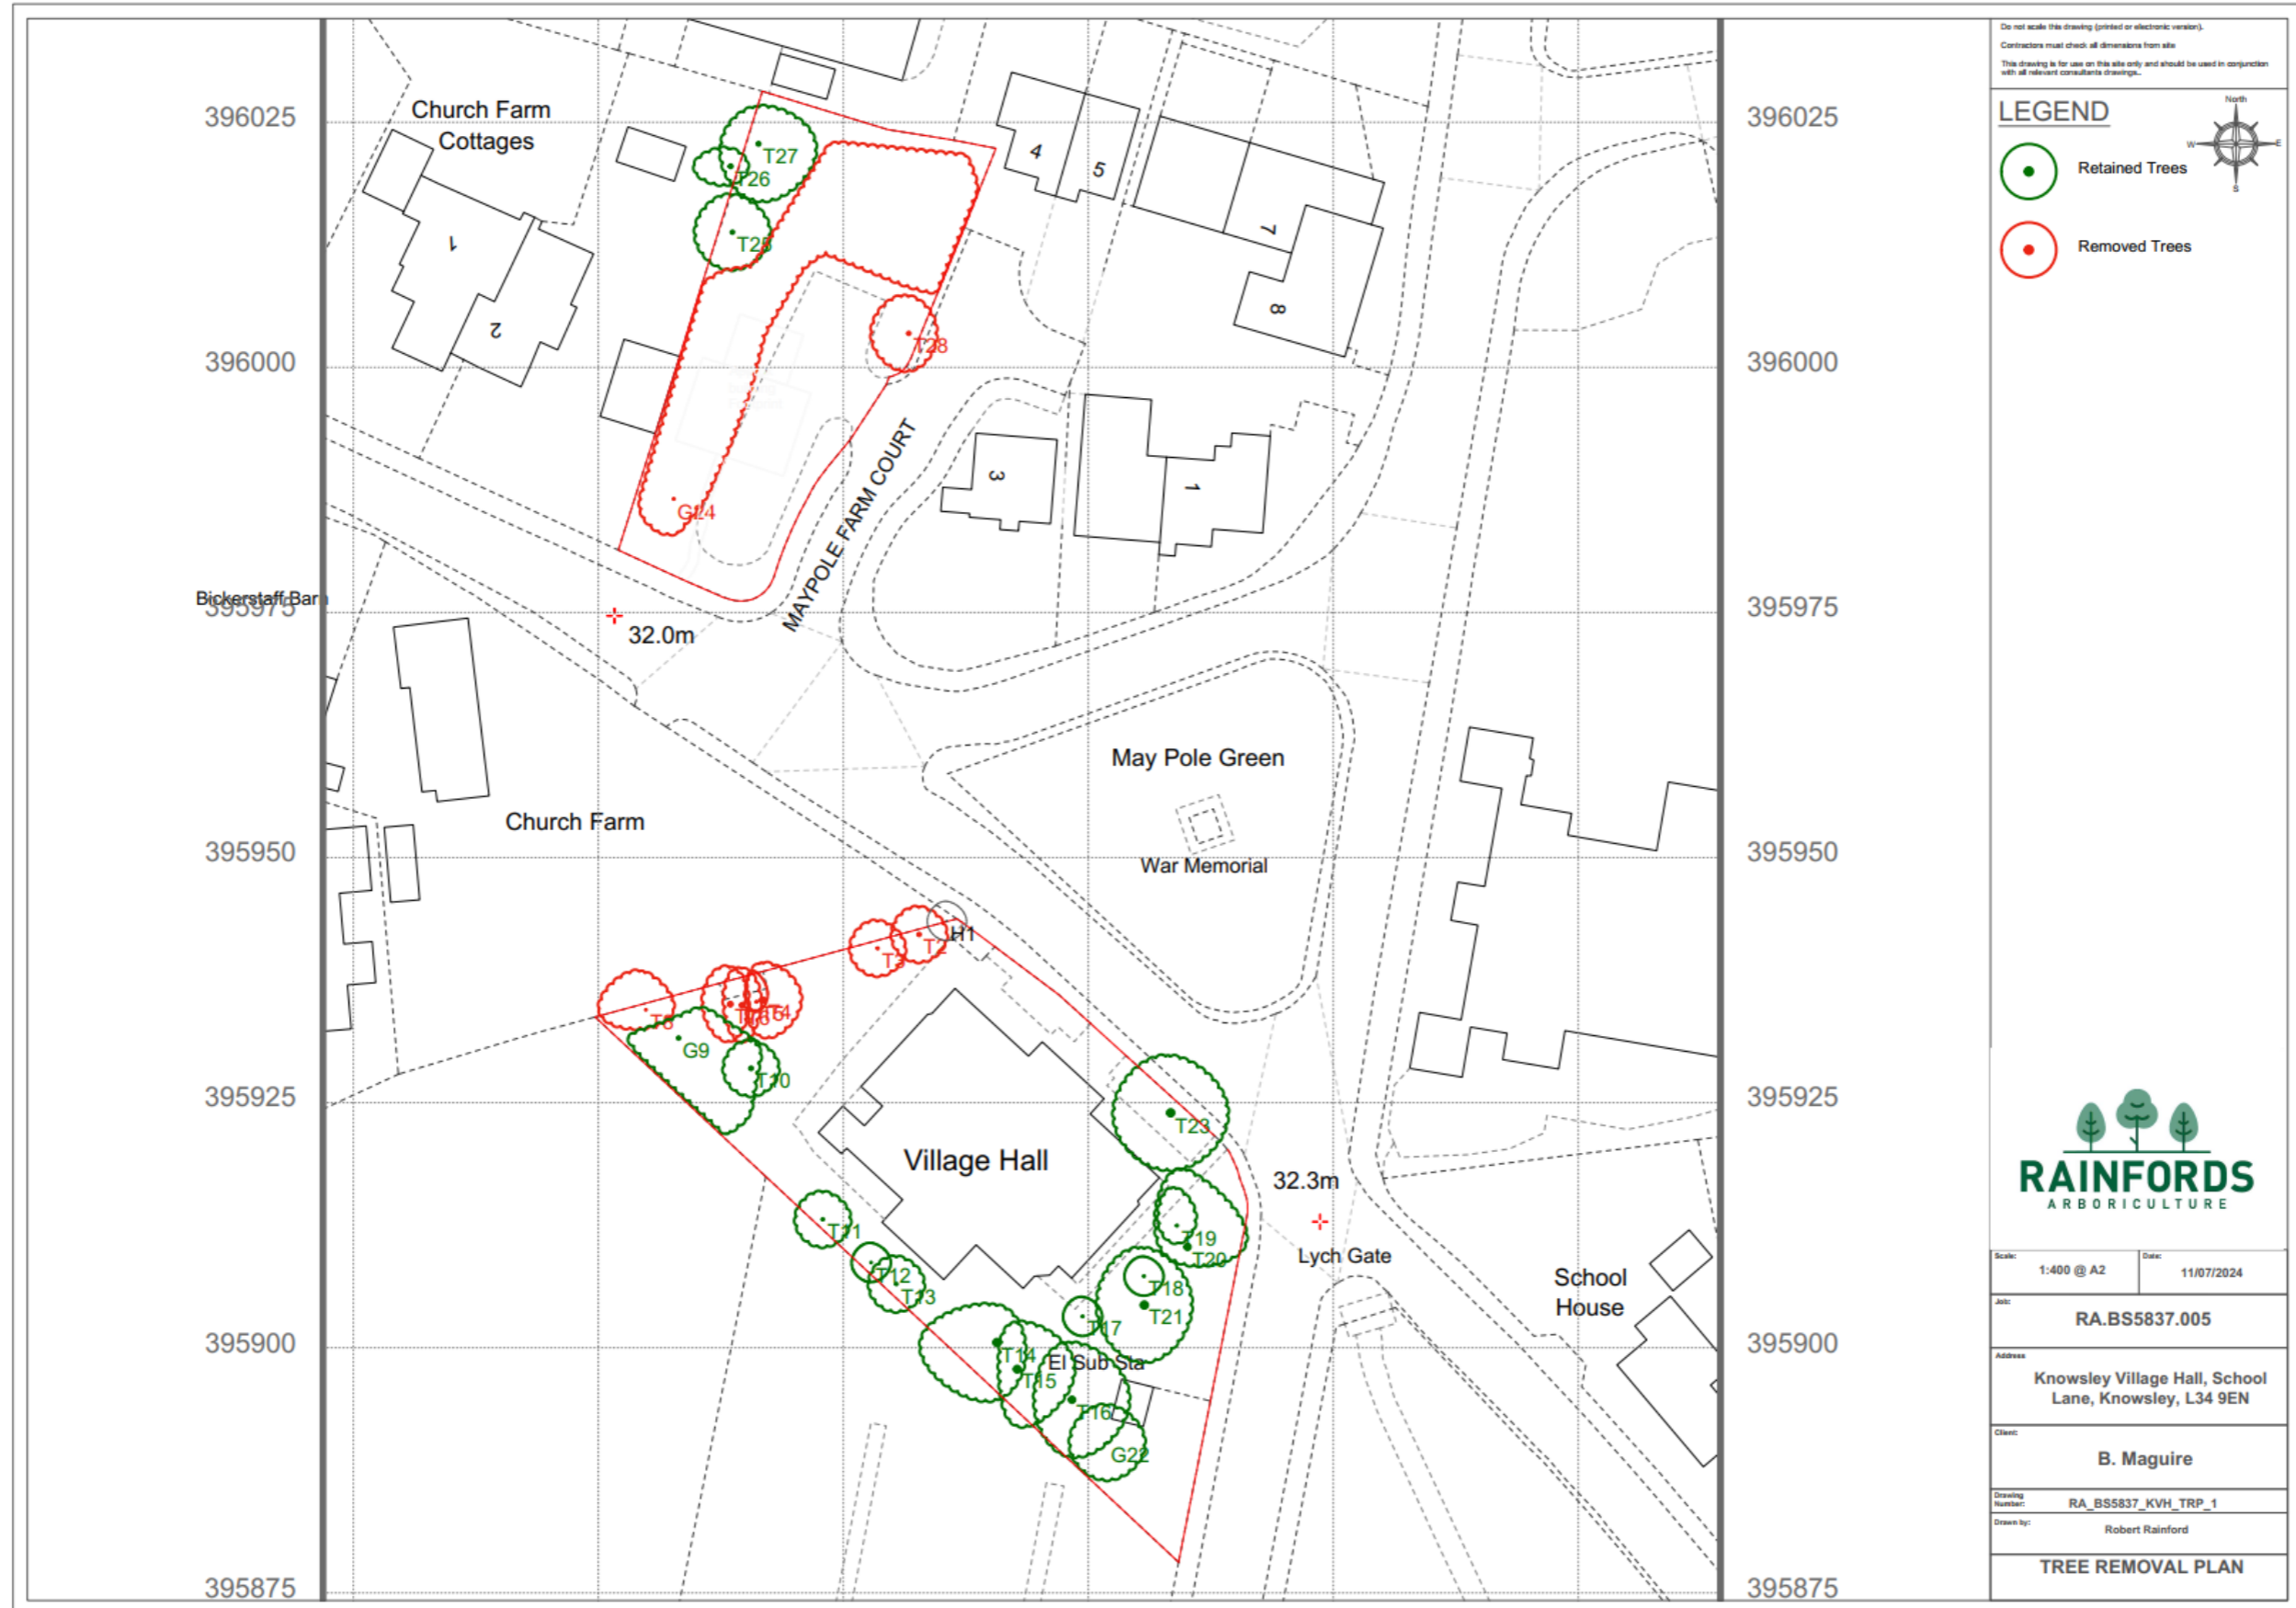
11 APPENDIX D – Tree Removal Plan

A Group	8	1	150	N	4	2	Y	A: 10.2	Good	C: Good	Fell :: Unspecified Fell to allow development. Group of young willow, alder, sycamore around site and against fenceline. Trees against fenceline not suitable long term and should be replaced on site in better positions.	C >40 yrs
--				E	4	2		R: 1.8		S: Good		
				S	4	2				B: Good		
				W	4	2						
H1												
A Hedgerow	4	1	80	N	2	2	M	A: 2.9	Good	C: Fair	No action :: Unspecified Neighbouring hedge. Hawthorn and sycamore with heavy ivy covering	C 20 to 40 yrs
