# Preliminary Bat Roost Assessment

Former Ambulance and Fire Station, Huyton Lane, Huyton, Liverpool, Merseyside

A Report To: McCarthy & Stone  
Report Number: RT-MME-158942-02 Rev A  
Date: October 2022  
Revised: January 2023

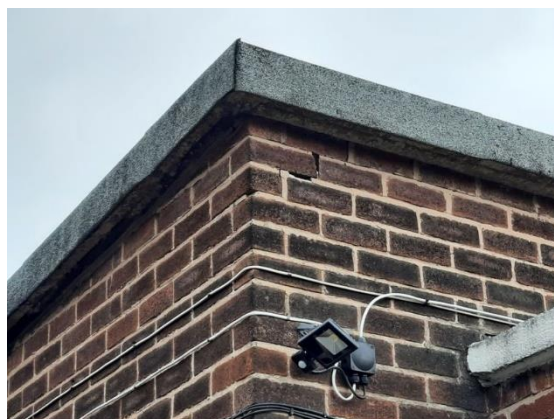
The building had cavity brick walls with wooden doors and uPVC windows which were all in good condition. Some of the windows also had metal security bars over them. The brickwork was generally in good condition, but missing mortar was noted between some of the bricks in a small number of locations. Most of the brickwork gaps noted appeared to be superficial (i.e. towards the western-corner and on the west edge of the tower structure), but a cobwebbed gap on the southern elevation was inspected and found to extend into the wall (Plate 4.2).

**Plate 4.2: Cobwebbed Brickwork Gap on the Southern Elevation of Building B1, which Extended into the Wall.**

Building B1 has been assessed as having moderate bat roosting potential due to the presence of small amounts of missing mortar around brickwork and the presence of several weep holes immediately above the porch feature in the east of the building on the south side. It was not possible to fully inspect all of these features due to being inaccessible or extending too far for full inspection.

- R1 Building B1 (Ambulance Station):** Building B1 has been identified as having moderate potential to support roosting bats. Bat Surveys: Good Practice Guidelines published by the Bat Conservation Trust (Collins, 2016)<sup>2</sup> recommends that for structures with moderate bat roosting potential two separate survey visits (consisting of one dusk emergence and a separate dawn re-entry survey) be undertaken during the bat emergence/re-entry survey season to determine the presence/absence of roosting bats within the structure. The bat emergence/re-entry survey season extends from May to September. At least one of the surveys should be undertaken during the peak season for emergence/re-entry surveys between May and August. Should this survey confirm the presence of roosting bats, it will be necessary to undertake additional surveys in order to inform a Natural England licence application. In addition, should the survey identify the presence of significant levels of bat activity at the site, it may be necessary to undertake further survey visits to comprehensively assess the value of the site to bats.

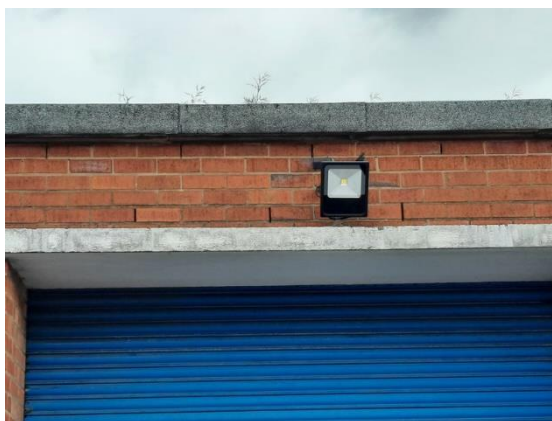
Several metal roller doors were present towards the southern end of the south-west elevation, which is where the ambulance vehicles were kept. At the south-east end, the brickwork type changed from brown to red brick, with the red brick area appearing to be of newer construction than the remainder of the building. A concrete porch was present on the south-west elevation of this area, and approximately 10 - 30 cm above this, a small number of weep holes were staggered

within the brickwork (Plate 4.3). A security light was also present towards the centre of this area. Due to their aspect, these features could not be fully inspected.

**Plate 4.3: Weep Holes and Security Light Above Concrete Porch at South End of South-west Elevation of Building B1.**

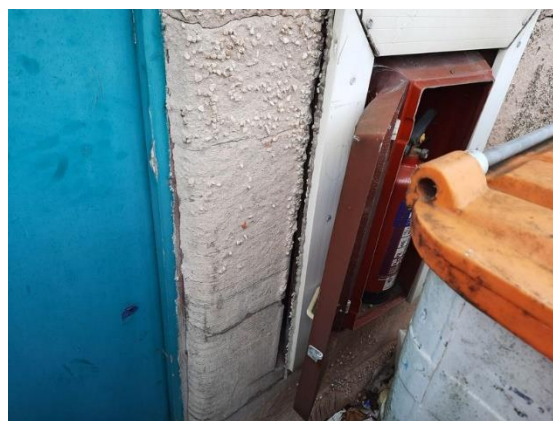
**Plate 4.7: Lifted uPVC Framework Around Fire Extinguisher to North-west of Building B2.**

Building B2 has been assessed as having low bat roosting potential due to the presence of a gap around an area of uPVC framework and a gap around the fascia boarding on the north-west elevation. The gap around the uPVC framework was partially obscured by two large bins.

- R2 Building B2:** Building B2 has been identified as having low potential to support roosting bats. Bat Surveys: Good Practice Guidelines, published by the Bat Conservation Trust (Collins, 2016)<sup>2</sup>, recommends for structures with low bat roosting potential that at least one survey (consisting of either a dusk emergence survey or a dawn re-entry survey) be undertaken during the peak season for emergence/re-entry surveys (May to August) to determine the presence/absence of roosting bats within the structure. Should this survey confirm the presence of roosting bats, it will be necessary to undertake additional surveys in order to inform a Natural England licence application. In addition, should the survey identify the presence of significant levels of bat activity at the site, it may be necessary to undertake further survey visits to comprehensively assess the value of the site to bats.

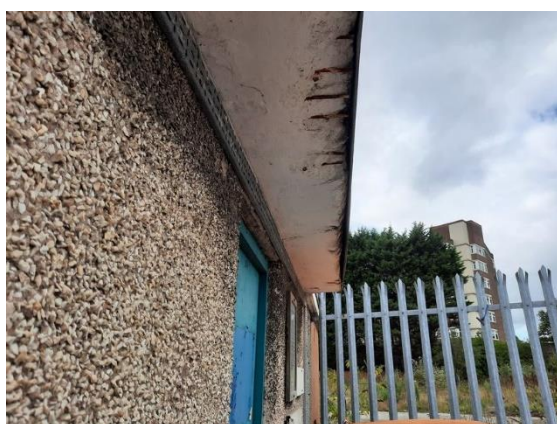
The building had a concrete roof which overhung the eaves to the north-west. The concrete was degraded here, exposing some of the metal supports within (Plate 4.8). A metal fascia board was present to the north-west, which was positioned in front of the concrete overhang. This was slightly lifted from the concrete frontage, providing a reasonably wide gap which extended up for approximately 7 cm. This feature did not, however, appear to extend the entire length of the fascia board or into the building itself. The remaining elevations had a lead-flashing overhang over the concrete roof, which did not form any suitable bat roost features.

**Plate 4.8: Degraded Concrete and Gap Around Fascia to North-west of Building B2.**

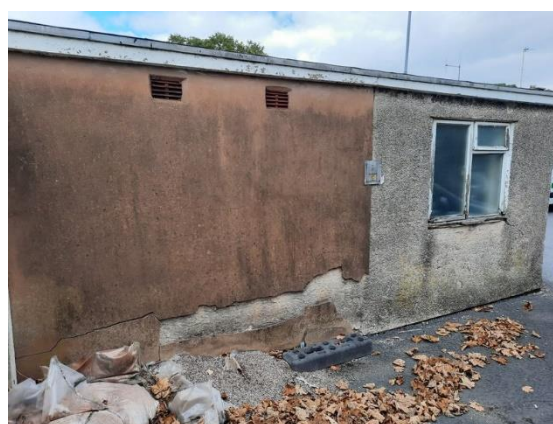
On the south-east elevation, peeling wall render and a rotten window frame were noted (Plate 4.9). However, no suitable bat roost opportunities associated with these features were identified.

**Plate 4.9: Peeling Render and Rotten Window Frame to South-east of Building B2.**
