## BOW17.1593- Wilson Road, Water Vole Ecological Advice Note

| Document Title: BOW17.1593 - Wilson Road, Water Vole Ecological Advice Note | Author: Melissa Quigley, <i>Aquatic Ecologist</i> | Version: V1 | Date: 07.04.2026 |

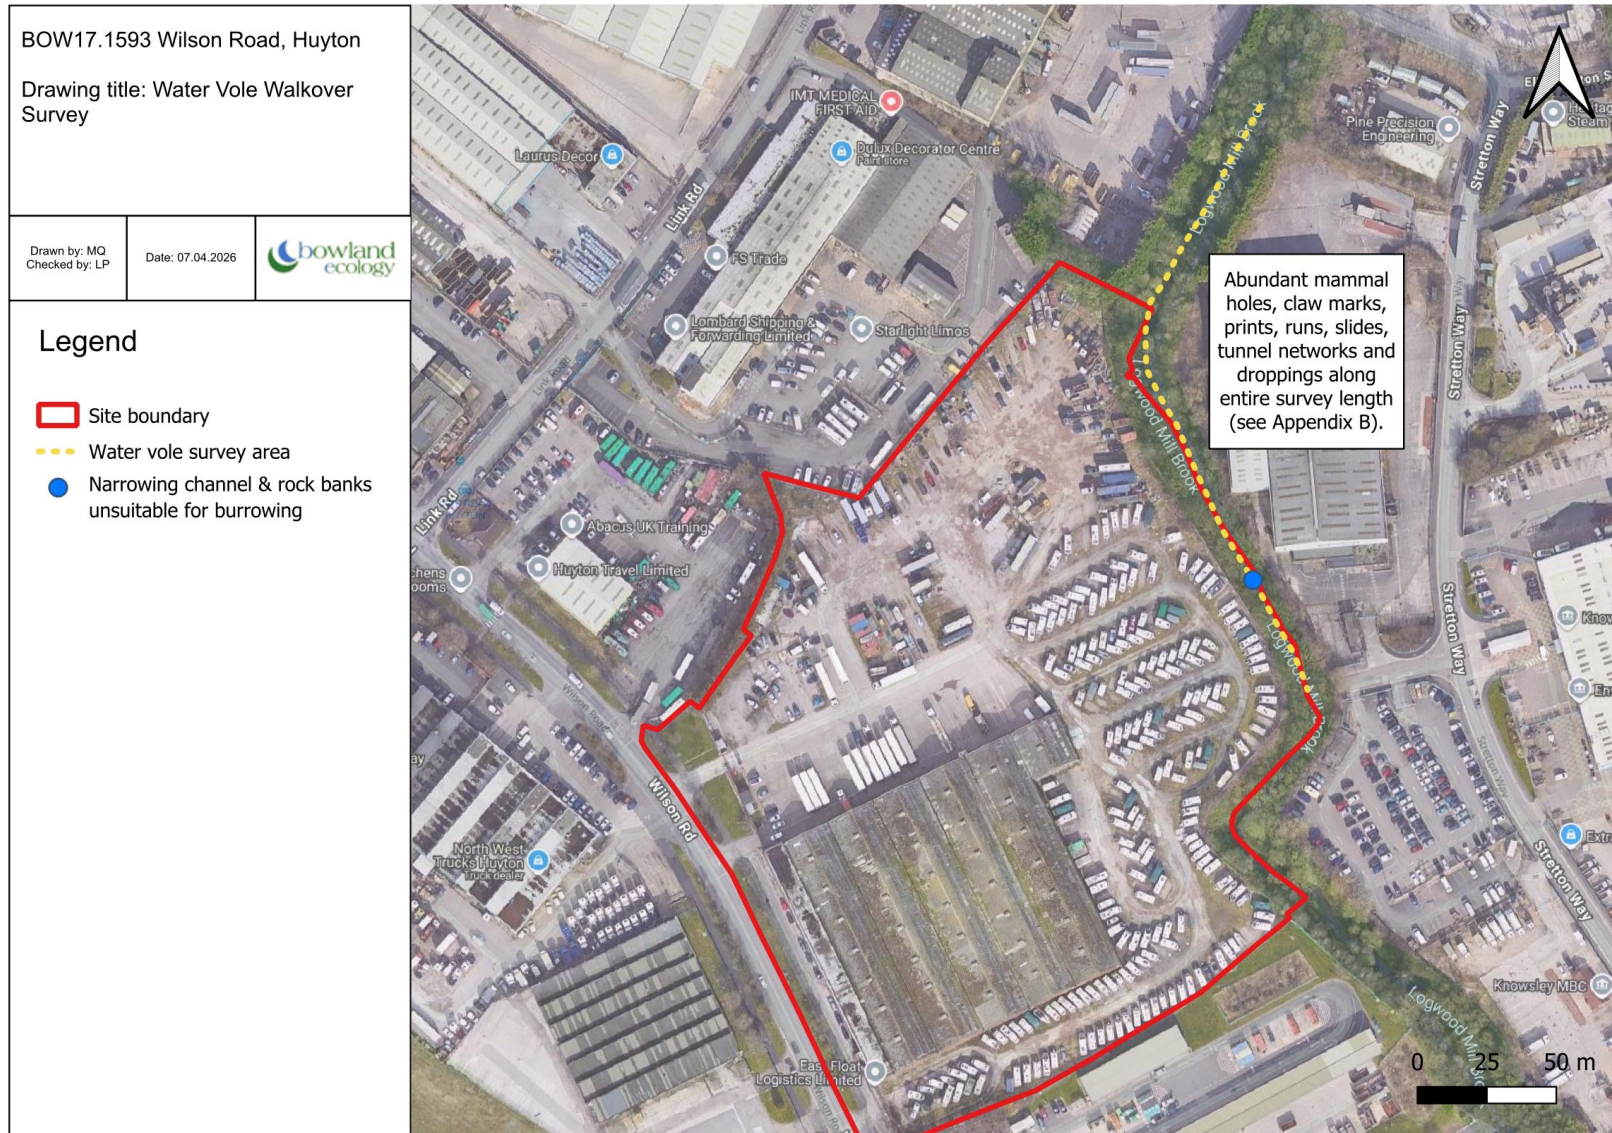
## Appendix A – Water Vole Walkover Survey Plan and Results

The survey for water vole covered almost the entire length of Logwood Mill Brook along the site boundary (see Limitations) and extended approximately 80 m north of the red boundary line along the brook, surveying both the eastern and western margins and associated banks of the watercourse whilst wading in safe areas of the channel for maximum visibility (see Appendix A).

The furthest downstream extent of the survey area was not easily accessible due to water depths exceeding waist height (see blue marker in Appendix A). In addition, the presence of narrow, steep, rock-dominated banks rendered the habitat unsuitable for burrowing water vole whilst also posing a safety risk to surveyors.

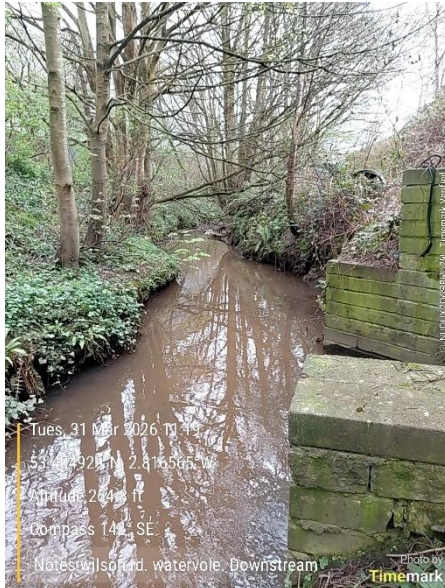
Photo 1: Downstream with outflow (SJ 45810 90100)

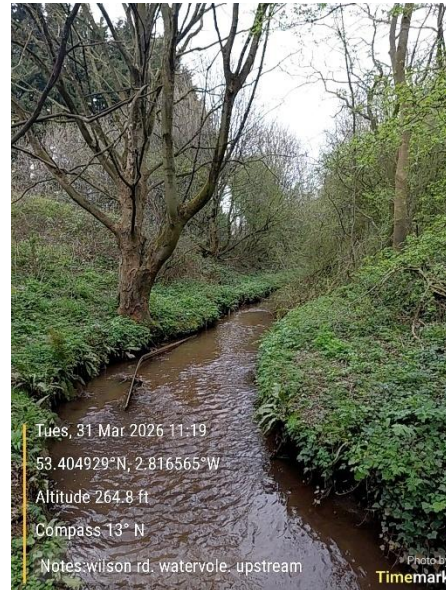
Photo 2: Upstream (SJ 45810 90100)

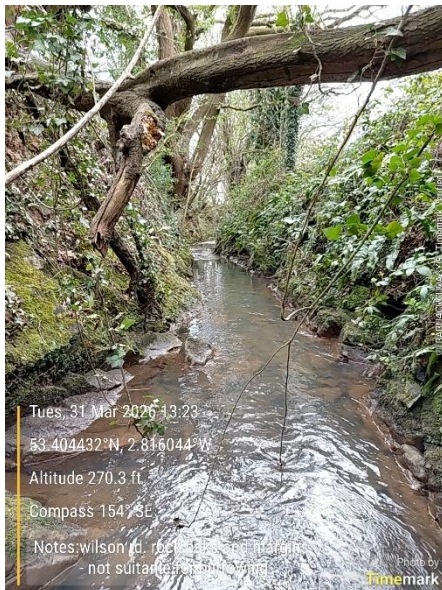
Photo 3: Downstream rock banks and margins, unsuitable for burrowing (SJ 45844 90045)

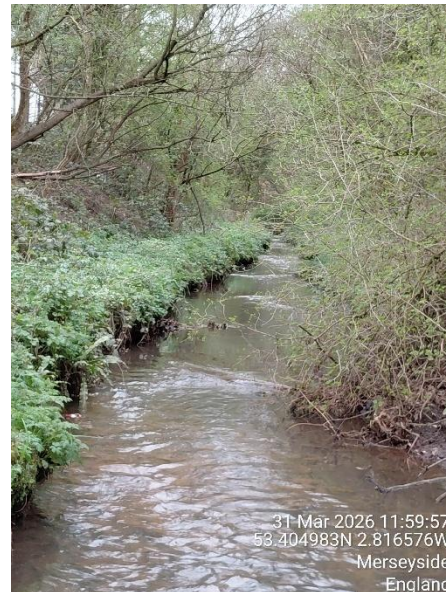
Photo 4: Upstream, alternating riffles and pools (SJ 45810 90107)

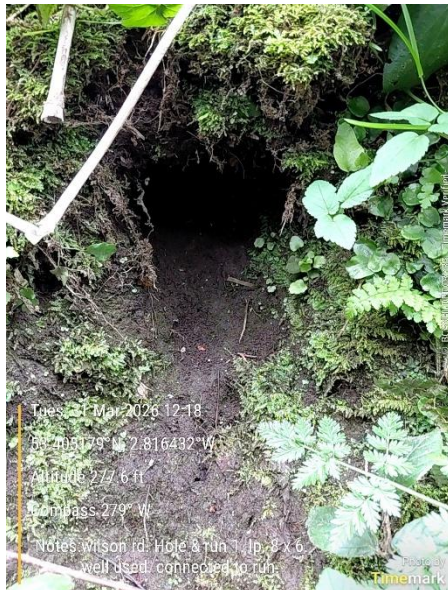
Photo 5: Mammal hole (8 x 6 cm) and run, both well used (SJ 45820 90128)

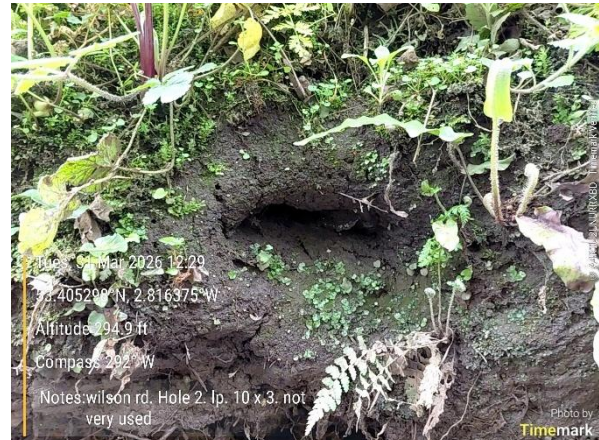
Photo 6: Mammal hole (10 x 3 cm), less used (SJ 45824 90142)

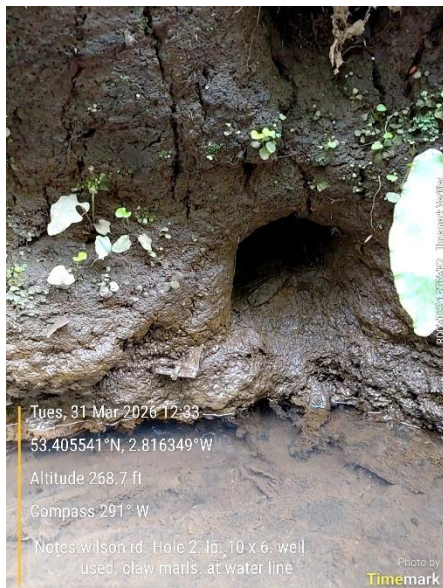
Photo 7: Mammal hole (10 x 6 cm), well used with claw marks at the water line (SJ 45826 90169)

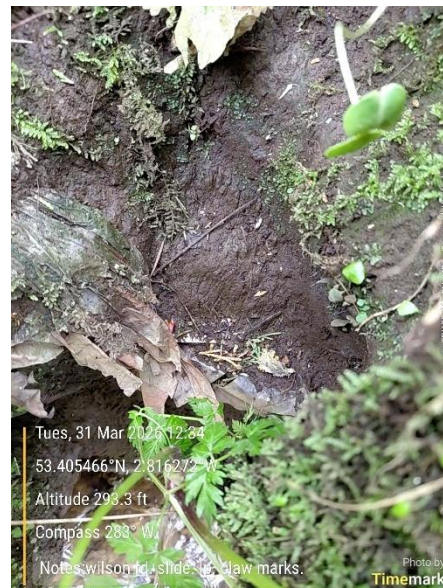
Photo 8: Slide with claw marks (SJ 45831 90160)

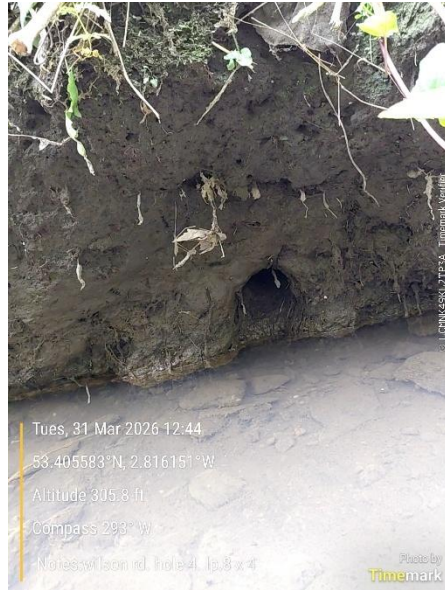
Photo 9: Mammal hole (8 x 4 cm) at water line (SJ 45839 90173)

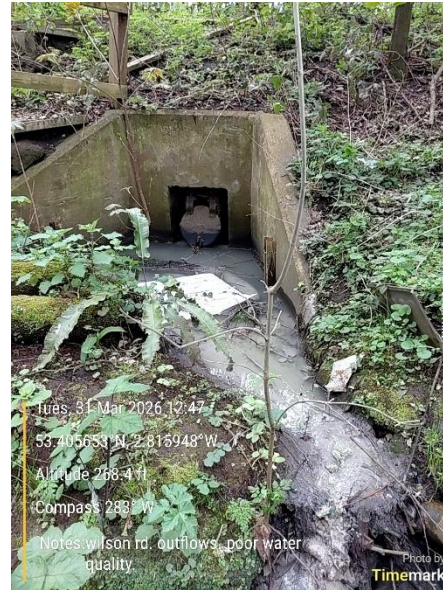
There are a total of four permitted sewage discharge points along Logwood Mill Brook. The Whiston Park combined sewer overflow (within the survey area) spilled 25 times for a total of 113.8 hours, discharging into Logwood Mill Brook in 2025 and the Link Road combined sewer overflow (also within the survey area) spilled three times for a total of 0.9 hours.

Photo 10: Sewage outflow, very poor water quality (SJ 45852 90181)

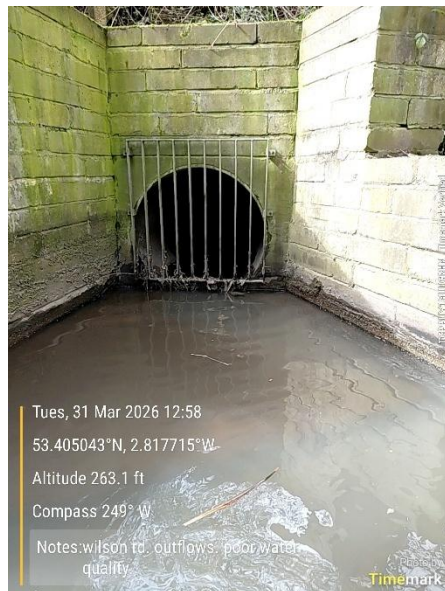
Photo 11: Outflow, poor water quality (SJ 45734 90114)

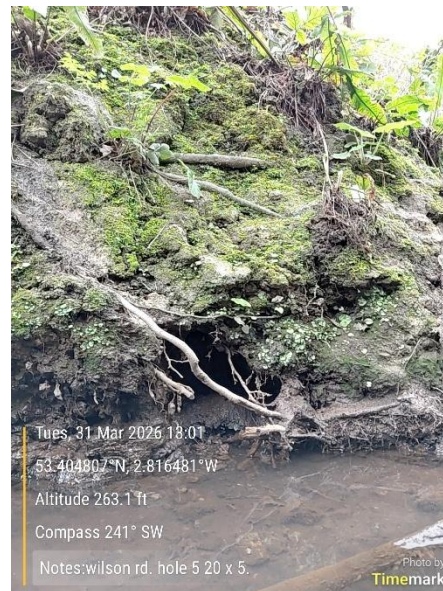
Photo 12: Mammal hole (20 x 5 cm) (SJ 4816 90087)

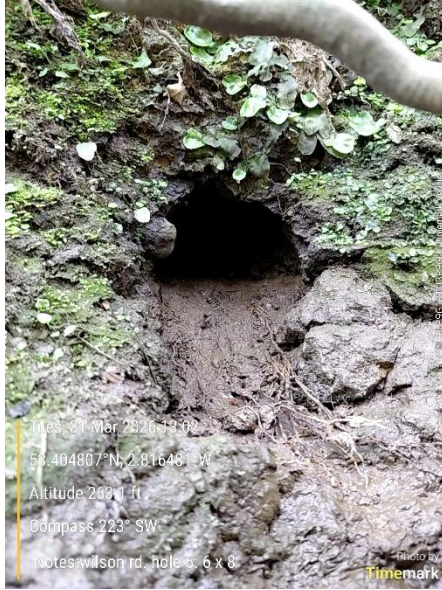
Photo 13: Mammal hole (6 x 8 cm)  
(SJ 45816 90087)

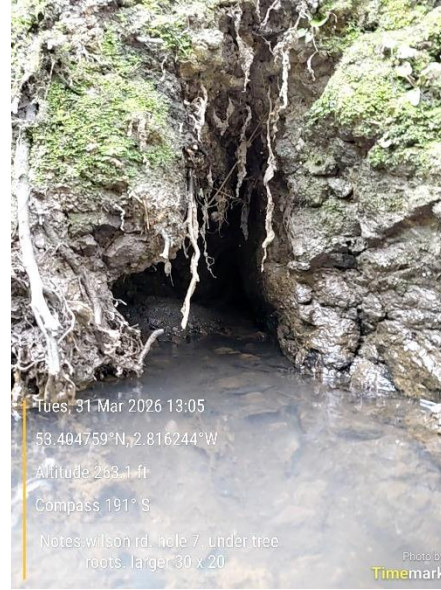
Photo 14: Large hole beneath tree roots (30 x 20 cm)  
(SJ 45832 90082)

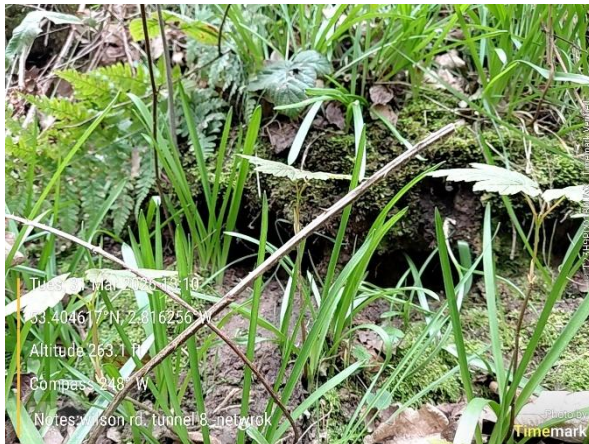
Photo 15: Tunnel network (SJ 45831 90066)

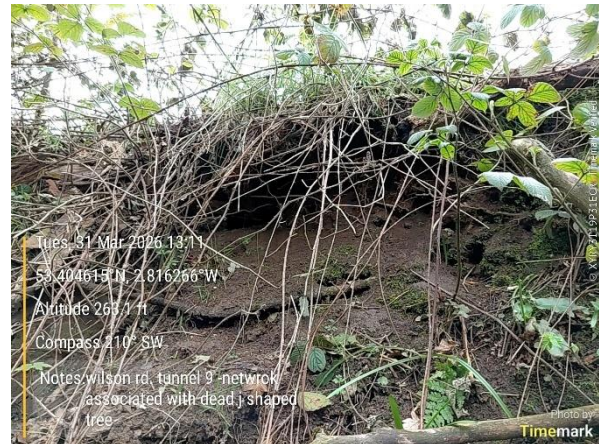
Photo 16: Tunnel network associated with dead J-shaped tree  
(SJ 45830 90066)

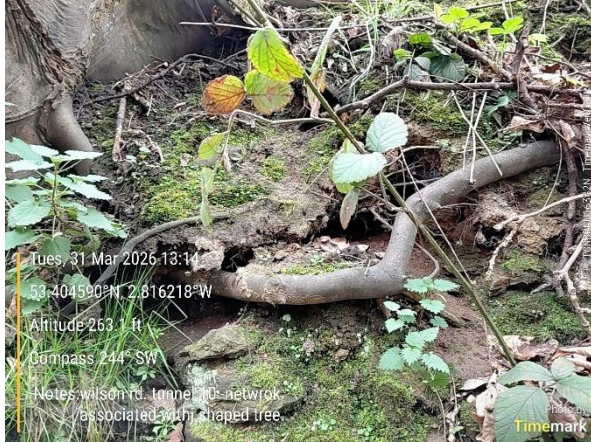
Photo 17: Tunnel network associated with j-shaped tree (SJ 45833 90063)

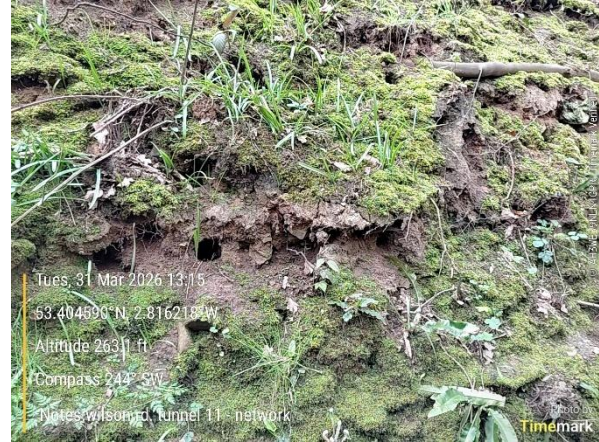
Photo 18: Tunnel network (SJ 45833 90063)

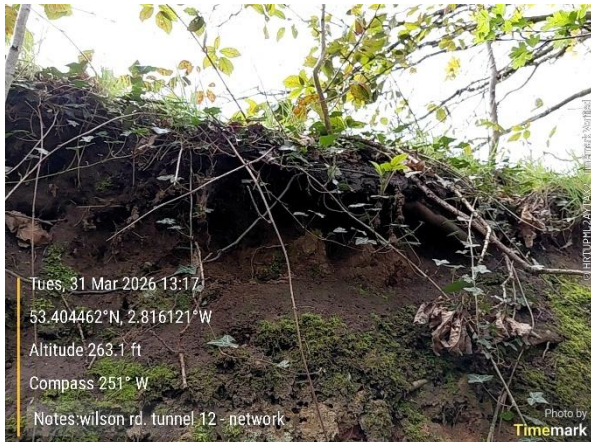
Photo 19: Tunnel network (SJ 45839 90048)

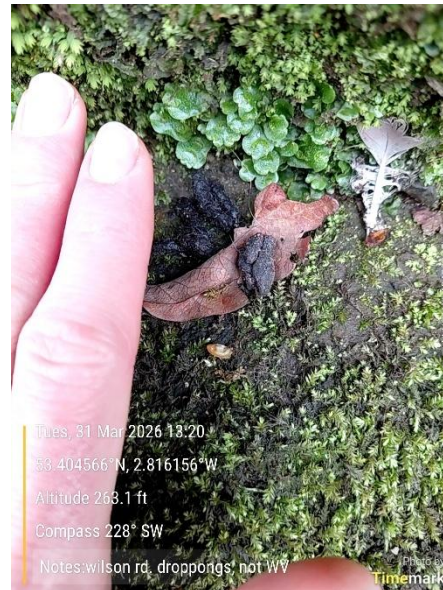
Photo 20: Droppings (not water vole) (SJ 45837 90060)

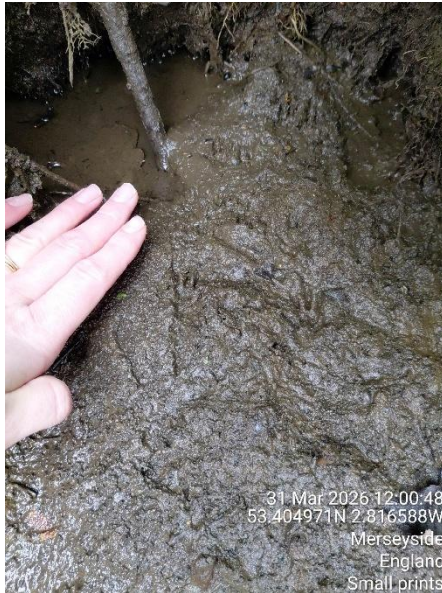
Photo 21: Small mammal prints. Definite ID cannot be confirmed. (SJ 45809 90105)

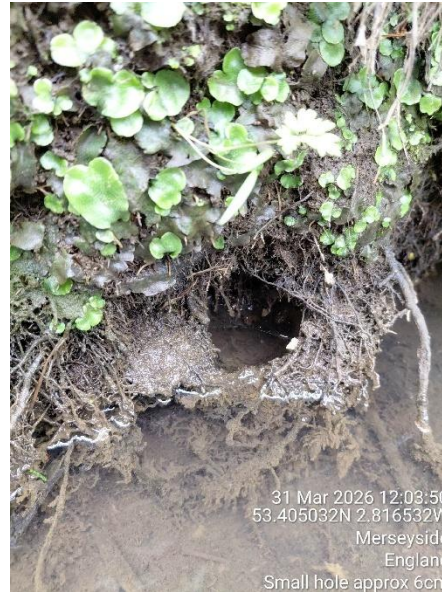
Photo 22: Small hole (6 x 6 cm)  
(SJ 45813 90112)

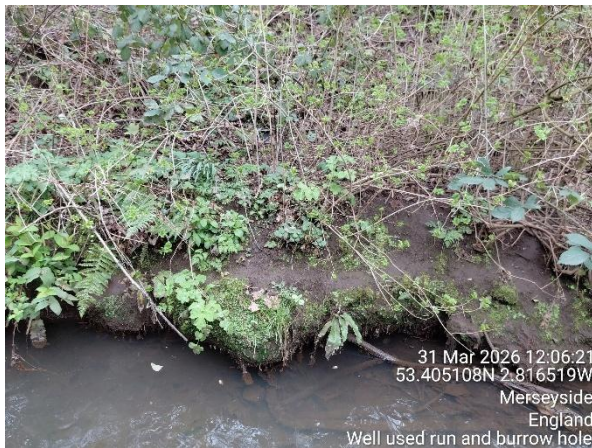
Photo 23: Well used run and mammal hole (13 x 6 cm)  
(SJ 45814 90121)

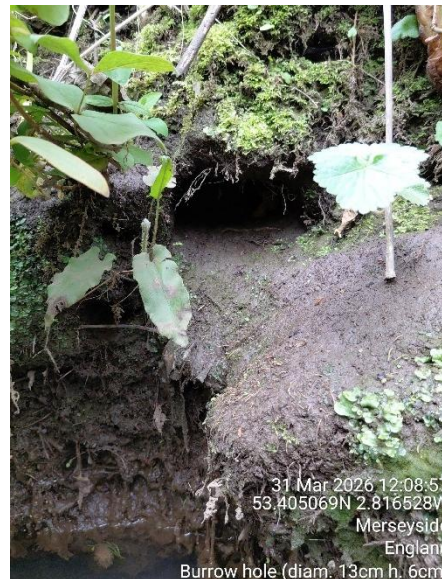
Photo 24: Mammal hole along well used run  
(SJ 45813 90116)

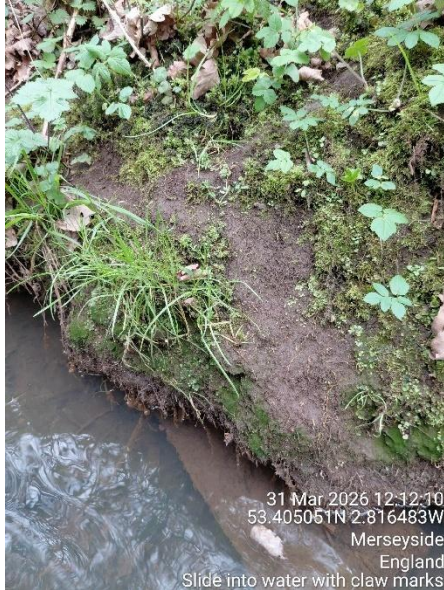
Photo 25: Slide into water with claw marks (SJ 45816 90114)

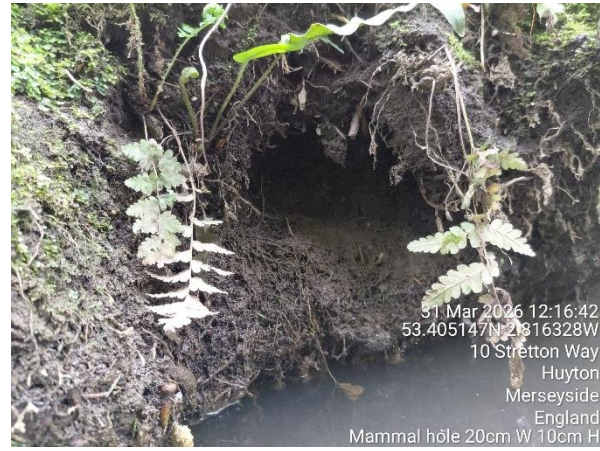
Photo 26: Mammal hole (20 x 10 cm) (SJ 45826 90125)

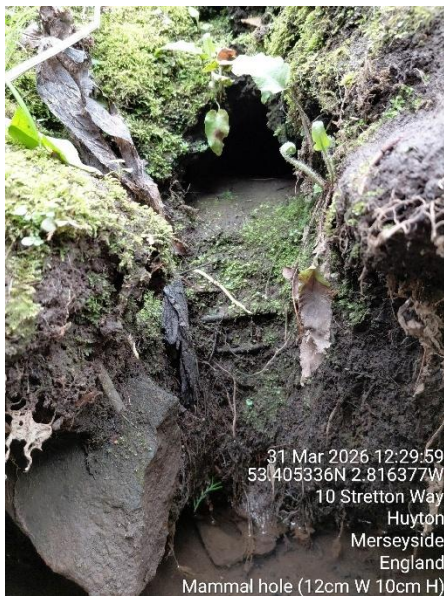
Photo 27: Mammal hole (12 x 10 cm) (SJ 45823 90146)

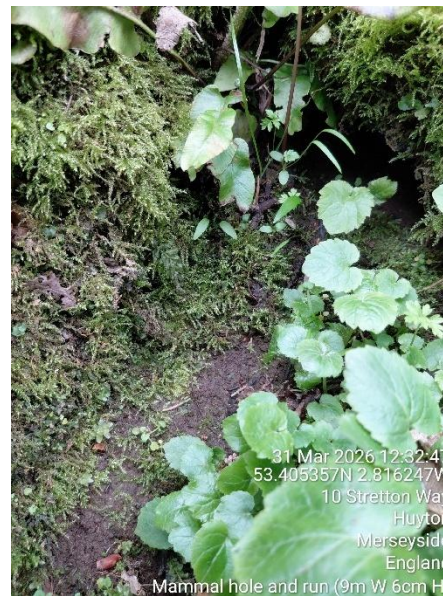
Photo 28: Mammal hole (9 x 6 cm) and well used run (SJ 45832 90148)

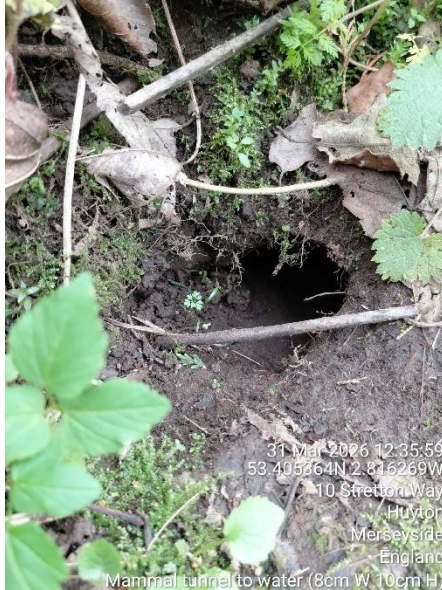
Photo 29: Mammal tunnel (8 x 10 cm), leading directly to water channel (SJ 45831 90149)

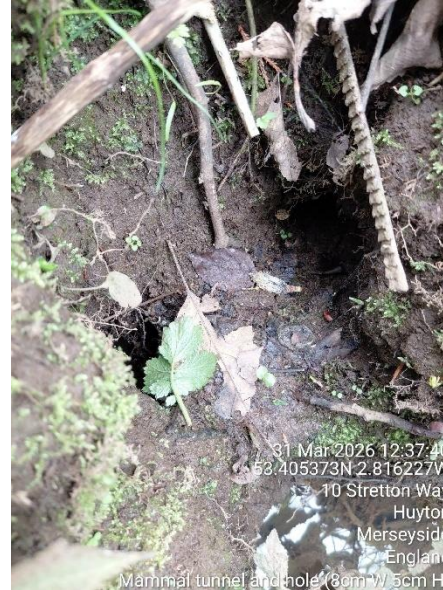
Photo 30: Mammal tunnel and hole (8 x 5cm) (SJ 45833 90150)

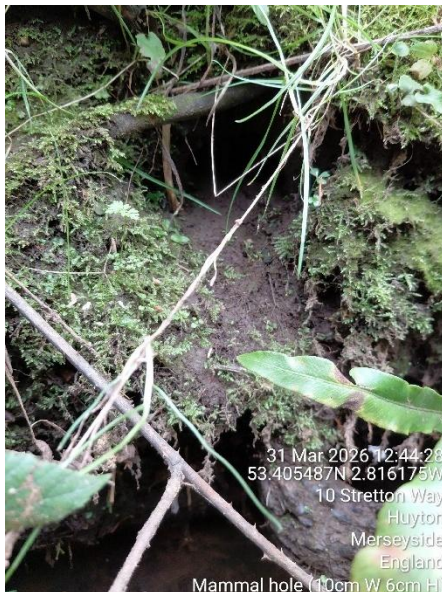
Photo 31: Mammal hole (10 x 6cm) (SJ 45837 90163)

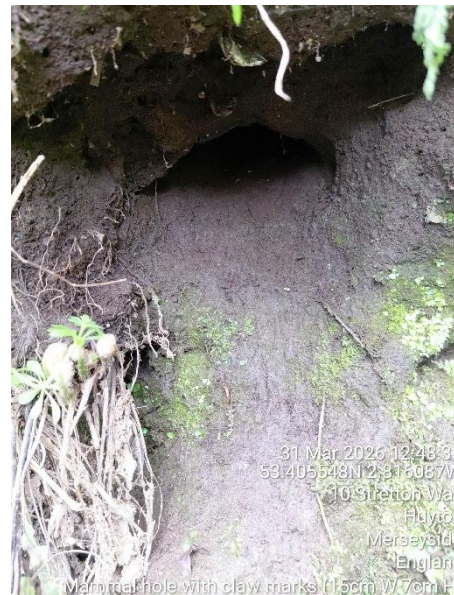
Photo 32: Mammal hole (15 x 7cm), slide and claw marks (SJ 45843 90169)

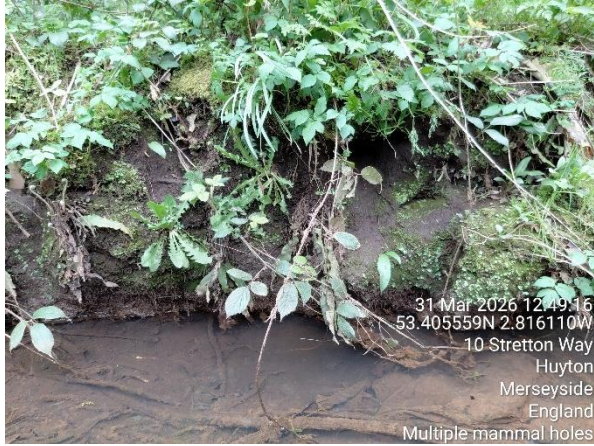
Photo 33: Multiple mammal holes condensed in one area (SJ 45841 90170)

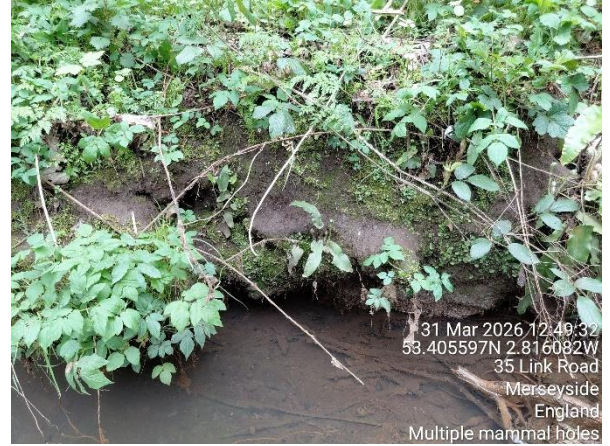
Photo 34: Multiple mammal holes (SJ 45843 90175)

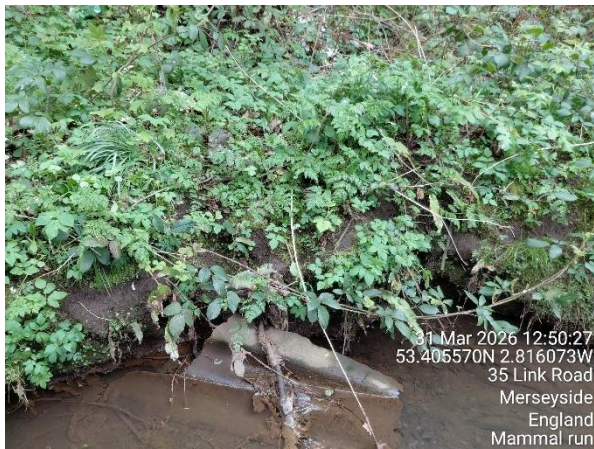
Photo 35: Mammal run (SJ 45844 90172)

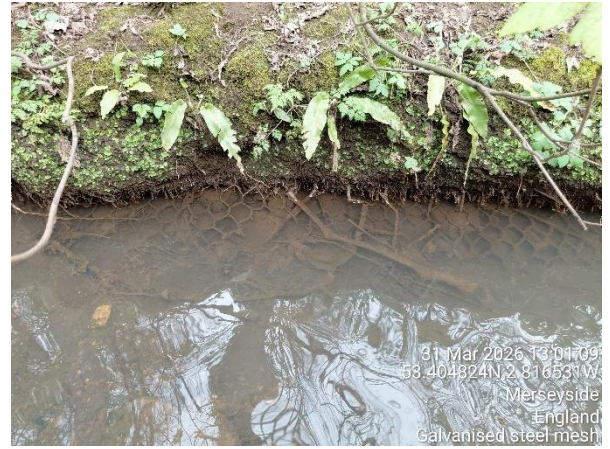
Photo 36: Galvanised steel mesh in water channel, attached to bank (SJ 45813 90089)

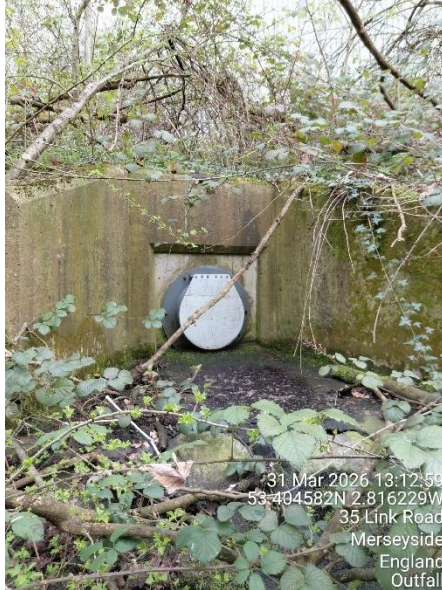
Photo 37: Outfall discharge (SJ 45832 90062)

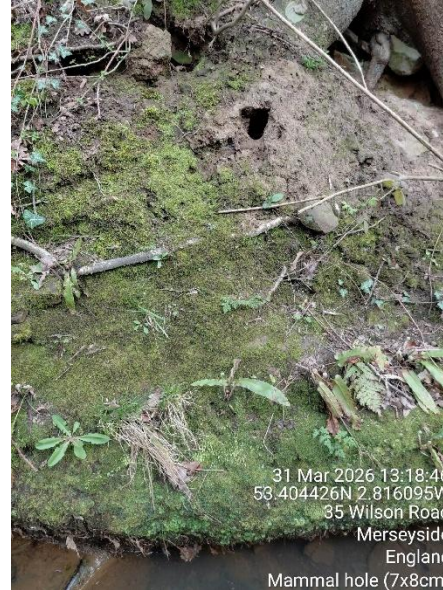
Photo 38: Mammal hole (7 x 8 cm) higher up bank (SJ 45841 90044)

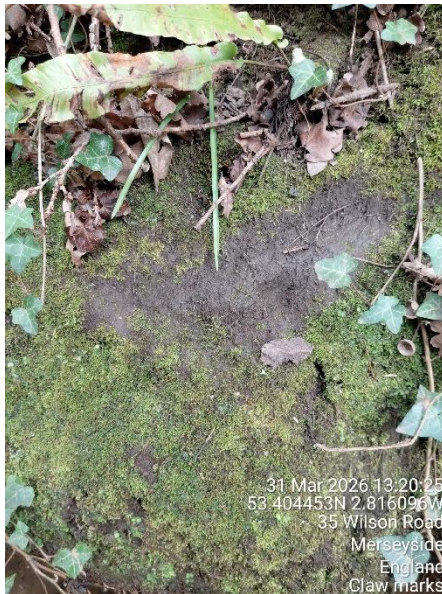
Photo 39: Claw marks in mud (SJ 45841 90047)

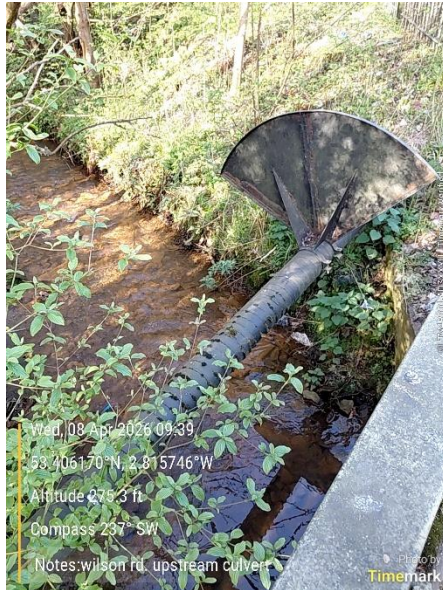
Photo 40: Upstream culvert ( SJ 45866 90238)

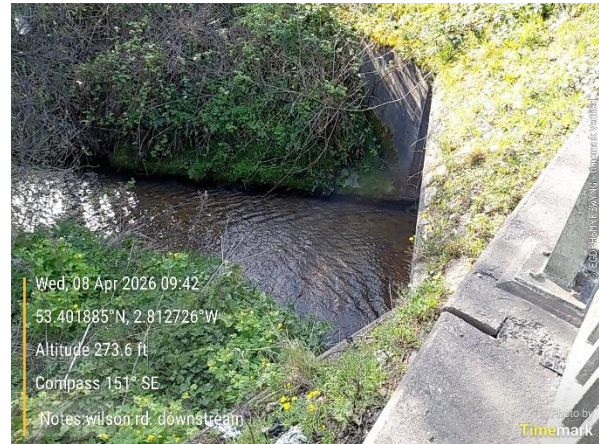
Photo 41: Downstream culvert (SJ 46062 89759)
