# Headbolt Lane Station

## Riparian Mammal Habitat Suitability and Survey Report

**Project No:** 2593 – Headbolt Lane

**Title:** Headbolt Lane Station; Riparian Mammal Habitat Suitability and Survey Report

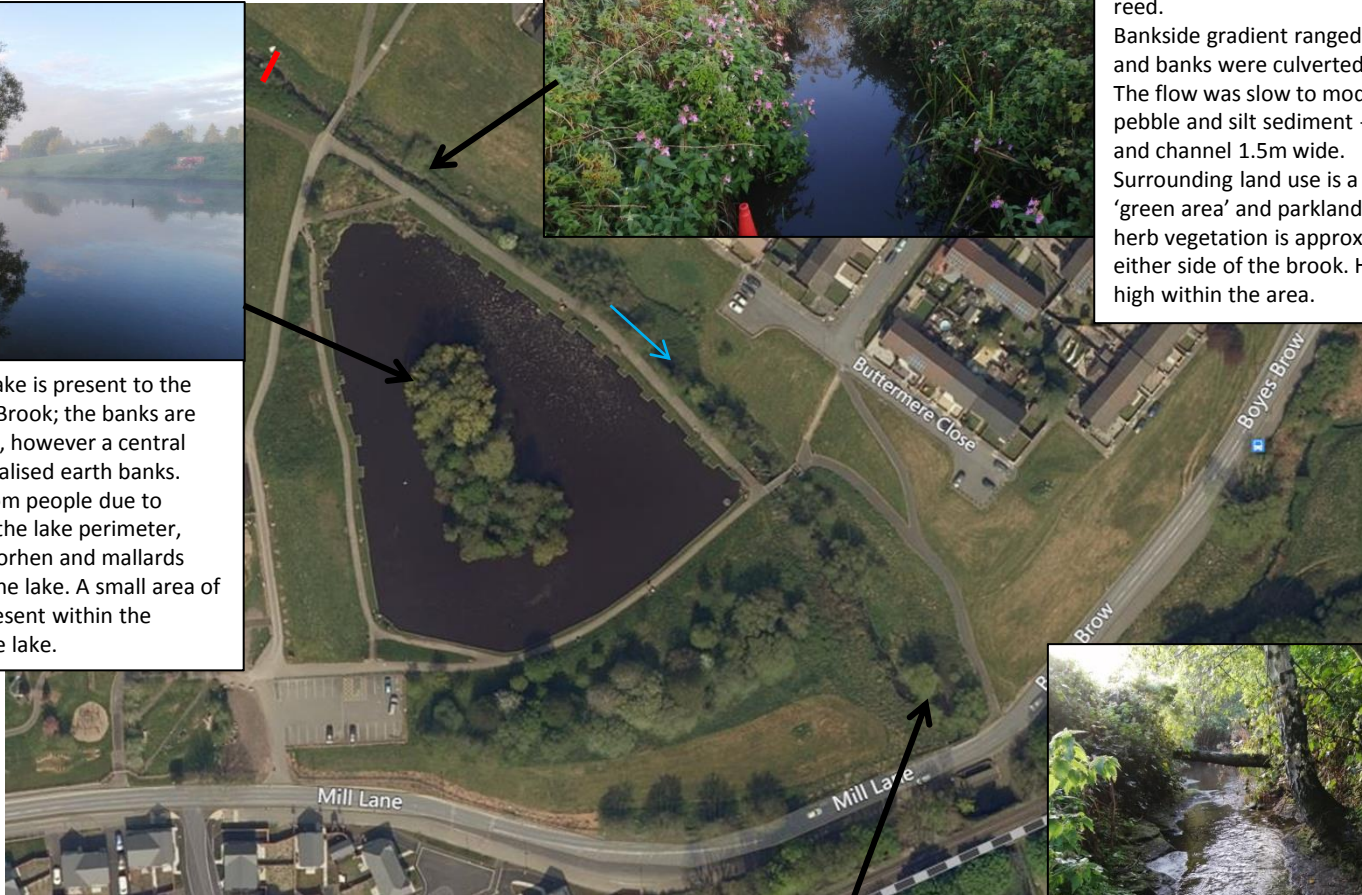
The northern section of Simonswood Brook; embankments were dominated by ruderal and herb species including Himalayan balsam (d), common nettle (a), bramble (f), willowherb (f) and reed canary grass (o). Occasional in-channel vegetation included reed canary grass and bur reed.

Bankside gradient ranged from 60° to undercut and banks were culverted with large stone slabs. The flow was slow to moderate with a rock, pebble and silt sediment - water depth 0.1 – 0.3m and channel 1.5m wide.

Surrounding land use is a publicly accessible 'green area' and parkland - the scrub, ruderal and herb vegetation is approximately 5m wide on either side of the brook. Human disturbance is high within the area.

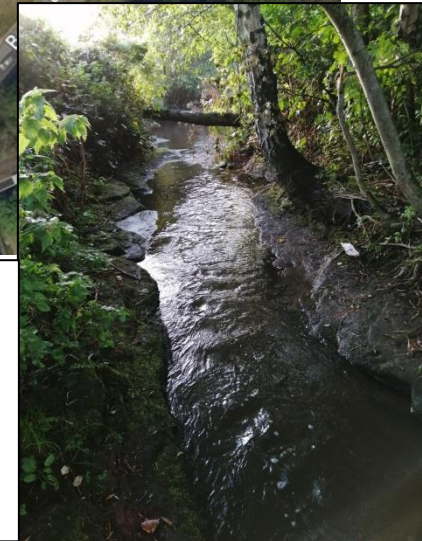
Trees become more dominant on the bankside to the south of the section of Simonswood Brook, The bank profile remains similar, however notable sections of the channel are fairly flat rock (see photograph). Channel is relatively shaded and bankside vegetation is sparse in wooded areas. Himalayan balsam, common nettle and bramble dominate the vegetation on the banks in locations where trees are not present.

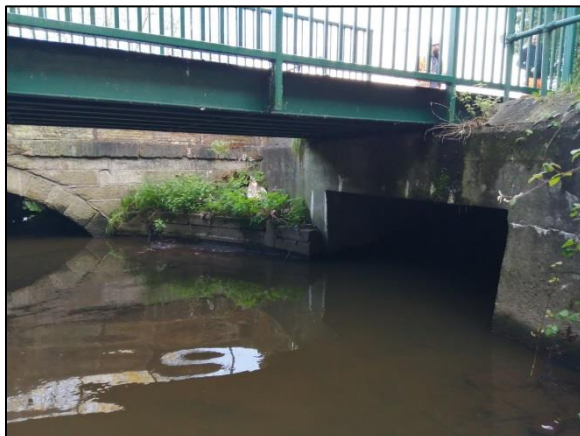
View under road and pedestrian bridge at confluence of Simonswood Brook and unnamed tributary – no suitable ledges for riparian mammal use.

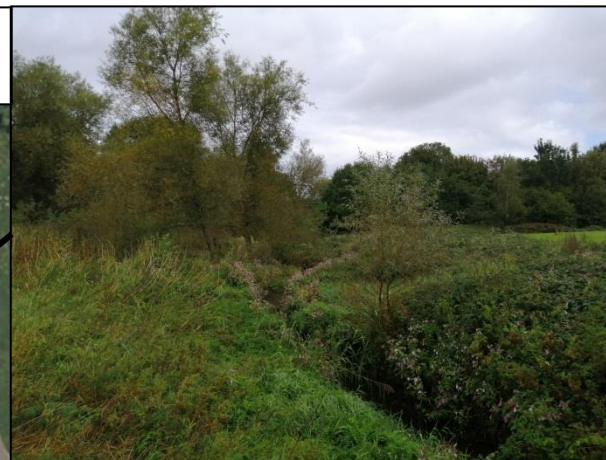
View facing north of the brook profile; banksides dominated by ruderal vegetation and scrub with occasional willow trees. Himalayan balsam dominant / abundant throughout. Banks are steep 60 - 90° with signs of culverting - large slabs in place. Sediment is sandy silt with some clay and pebble. Flow is slow to moderate, water depth 0.1 – 0.3m and channel 1.5m wide.

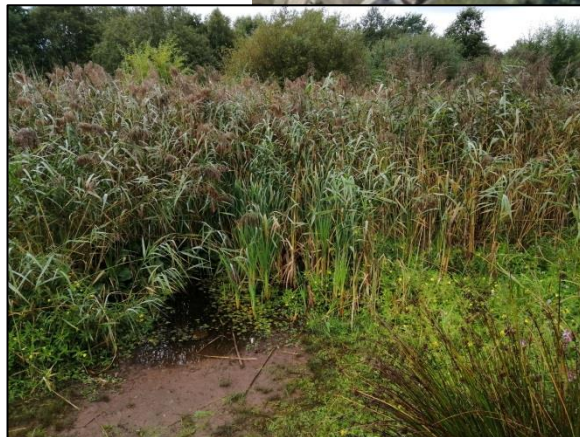
Common reed-dominated swamp area with soft rush, willow scrub and bulrush present. The area of swamp was very dense and inaccessible, and embankments were not suitable for burrows, however water vole nests could be present within dense common reed vegetation.

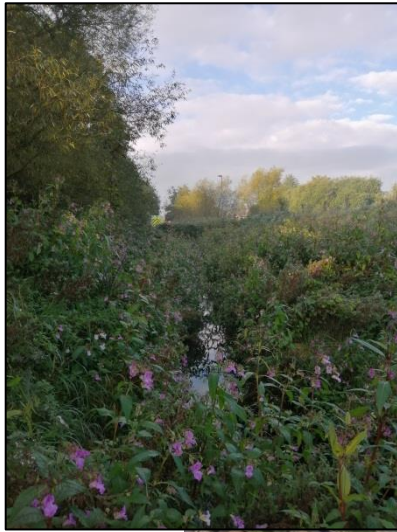
Stream is approximately 0.75 – 1.25m wide throughout and relatively shallow; 0.05 – 0.15m depth with a slow current. Sediment was rock and pebble with steep earth banks ( $\sim 75^\circ$ ). Banks were between 0.5 – 1.5m in height and densely vegetated with rank grasses, Himalayan balsam, common nettle and bramble. Rat droppings were observed in multiple locations along the length of the watercourse.

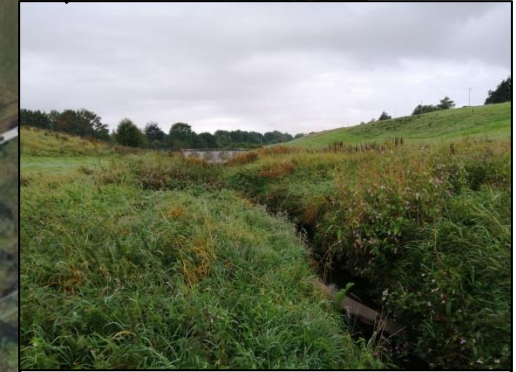
North east of the section of the stream; bank height is maximum of 0.5m, sediment is pebble and stone, with more visible undercutting of banks. Himalayan balsam less prevalent, with coarse grasses dominating the bankside including reed canary grass, cock's-foot and false oat-grass.

Habitat surrounding the stream is an urban greenway of semi-improved grassland which is managed through mowing. A margin of vegetation approximately 5-10m in width has been set aside along the stream embankments.
