15<sup>th</sup> September 2023

**RE: Water Vole Survey Knowsley Village Stables**

Water Vole Survey

P.1889.23.E02

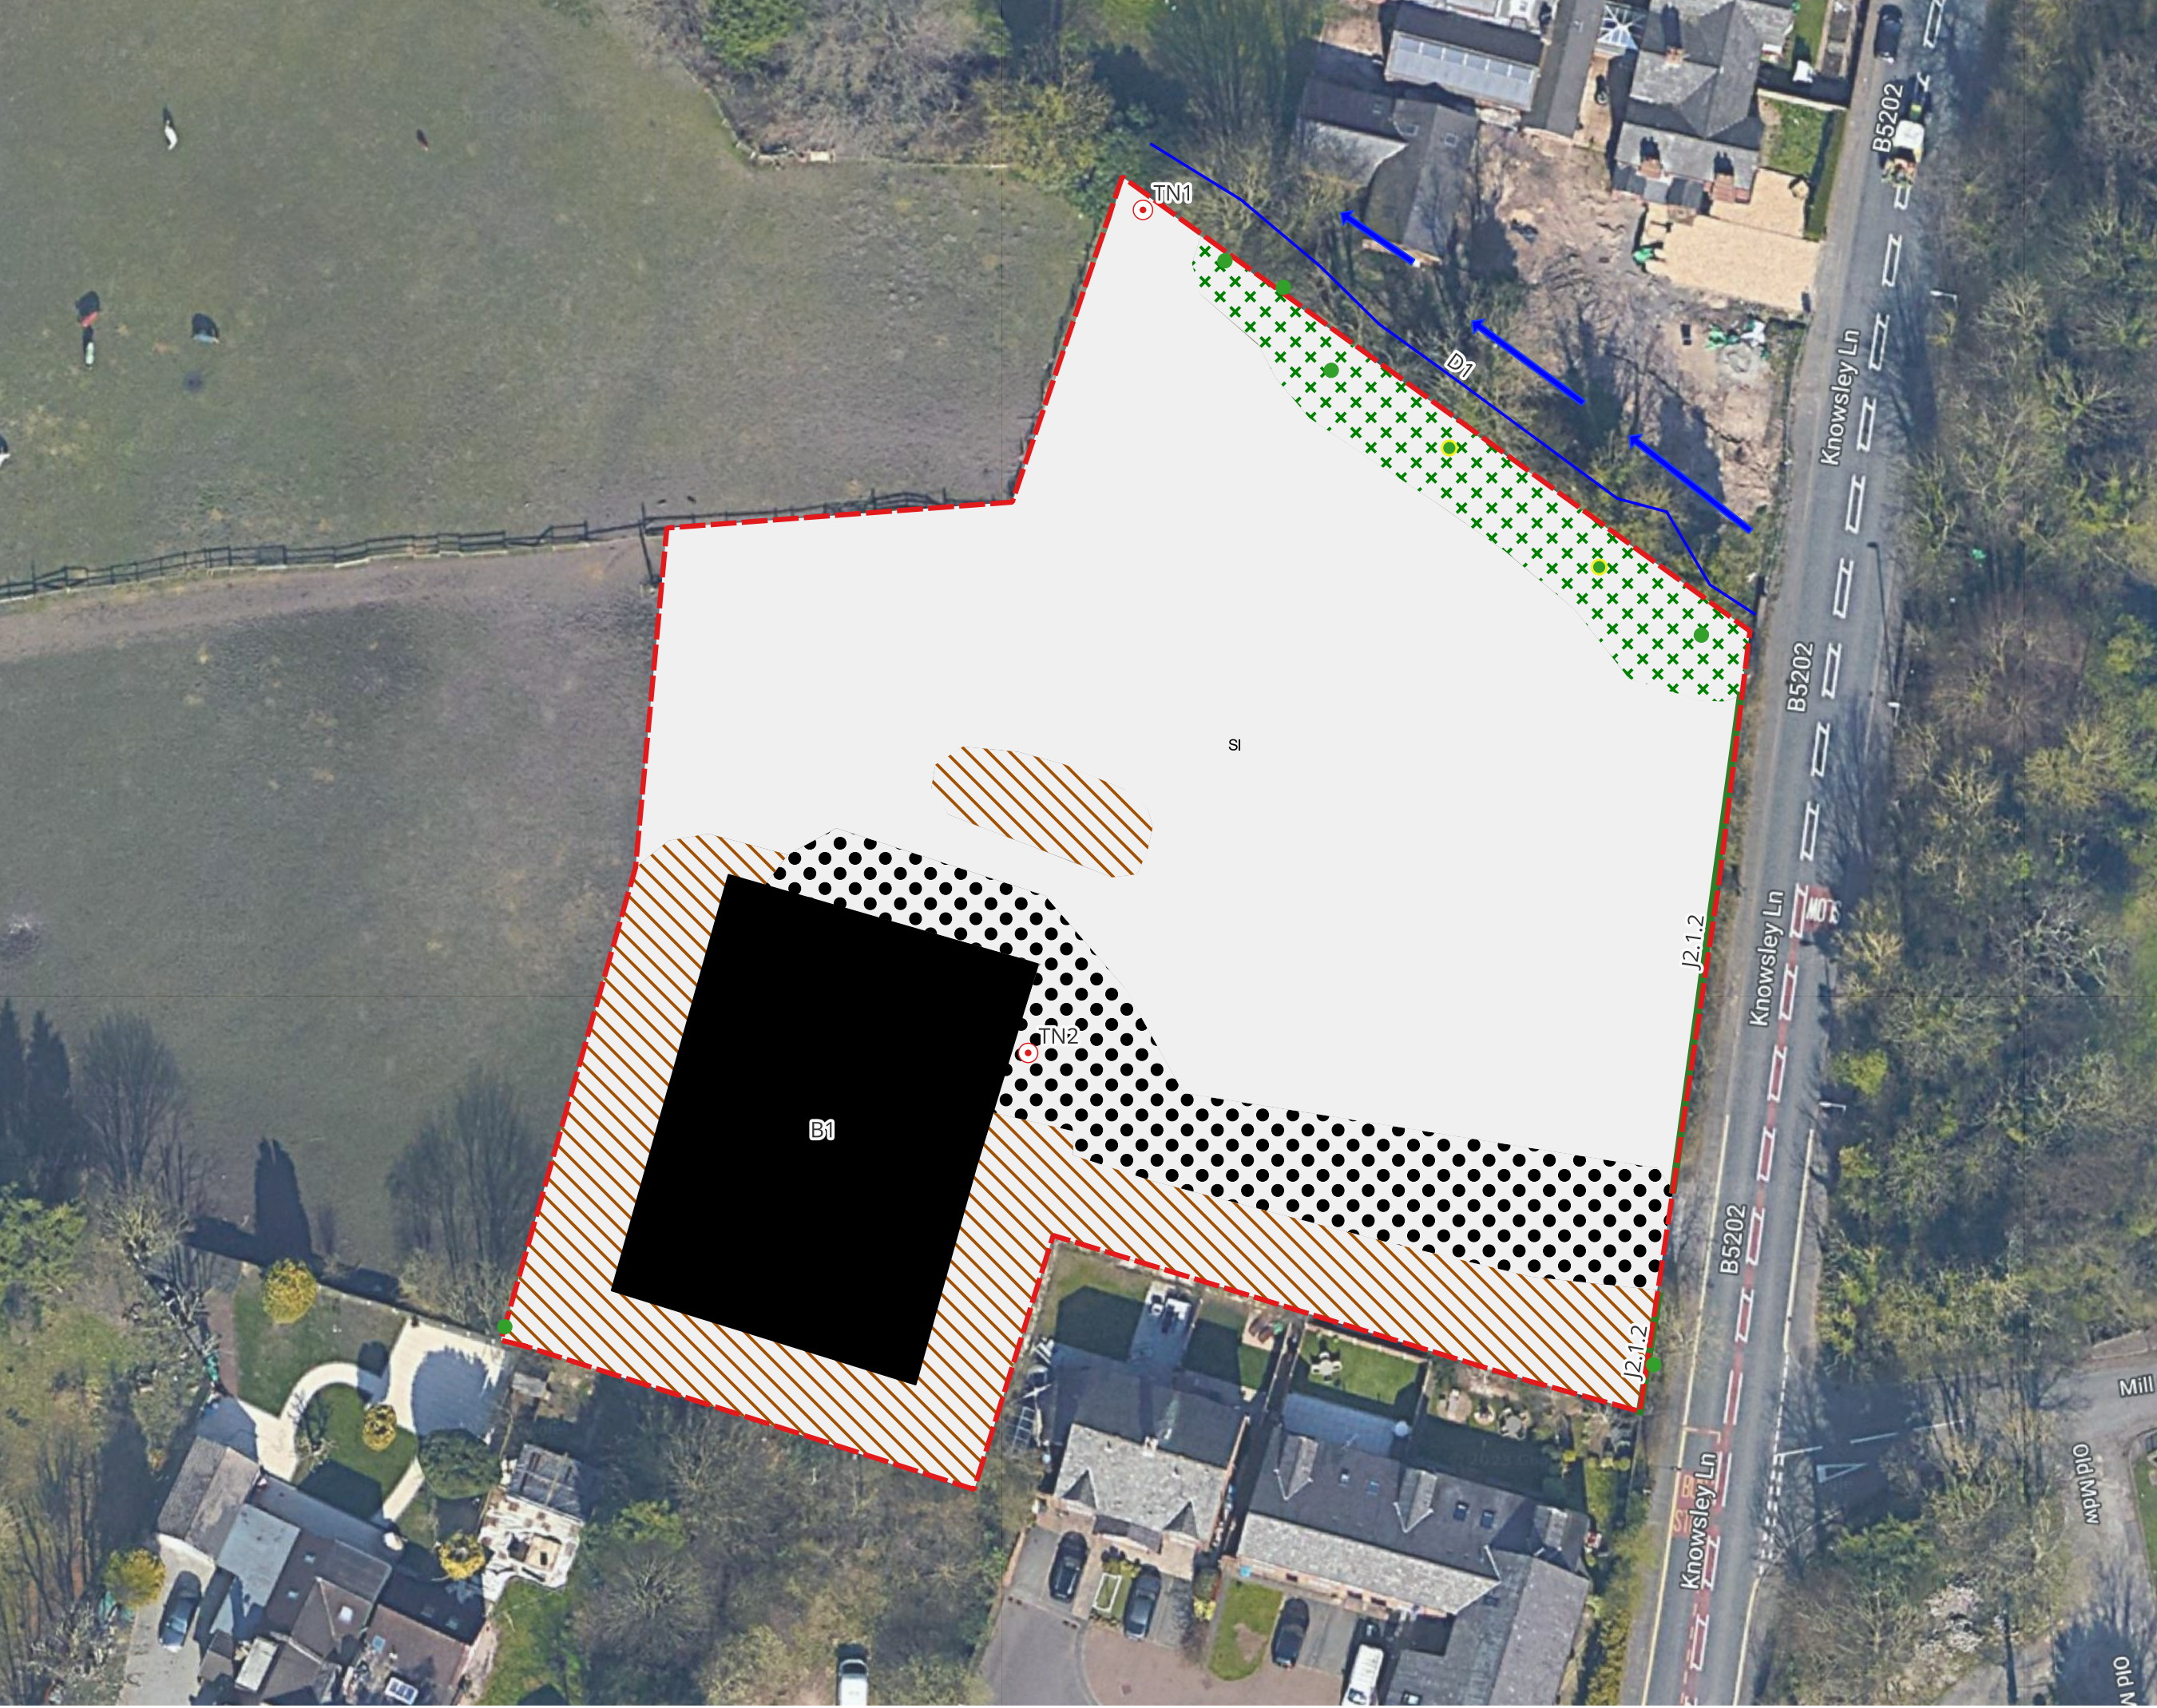
Ditch D1, drawing P.1889.23.E02, water vole survey appendix 1) flows adjacent to the northern boundary to the site, entering the site through a culvert from the east, before becoming dry. The approximate 55m section of the ditch that lies adjacent to the site boundary features soil and stone bolder banks with steep gradients >45°. Scrub and scattered trees line the south bank with a horse paddock beyond. To the northern bank is an existing residential dwelling and associated front /rear gardens.

No field signs for water vole were observed during the survey and no water vole were seen, indicating water vole do not utilise this section if D1.

Rhododendron (TN1) has been identified within the site. To avoid the spread (complying with the Wildlife and Countryside Act 1981) of these species within the site during site clearance, it is recommended that an **invasive species management plan** is produced and adhered to during the works. It is recommended that the management plan details suitable management of these species, biosecurity measures and avoidance measures where possible.

No field signs for water vole were observed during the survey and no water vole were seen, indicating water vole do not utilise this section if D1. The off-site section of the ditch, in the direction that the water flows is made, providing limited habitat for water vole and providing reduced connectivity to the section of the ditch that lines the northern site boundary.

A toolbox talk is also recommended for all construction workers prior to the start of works for water vole if in the event the species are found. Ecological supervision may also be required during works immediately adjacent to the brook following the outcome of the water vole and otter check prior to the works commencing.

In the event that water vole are encountered during the proposed works, all works should stop, and a suitably qualified ecologist contacted for advice.
