## Tree Survey, Arboricultural Impact Assessment, and Arboricultural Method Statement

A report to accompany a planning application for the proposed development of a new lambing shed on an existing foundation

**Site Address: Knowsley Hall, Merseyside, Prescot L34 4AJ**

| Reference: | RA.BS5837.037 |

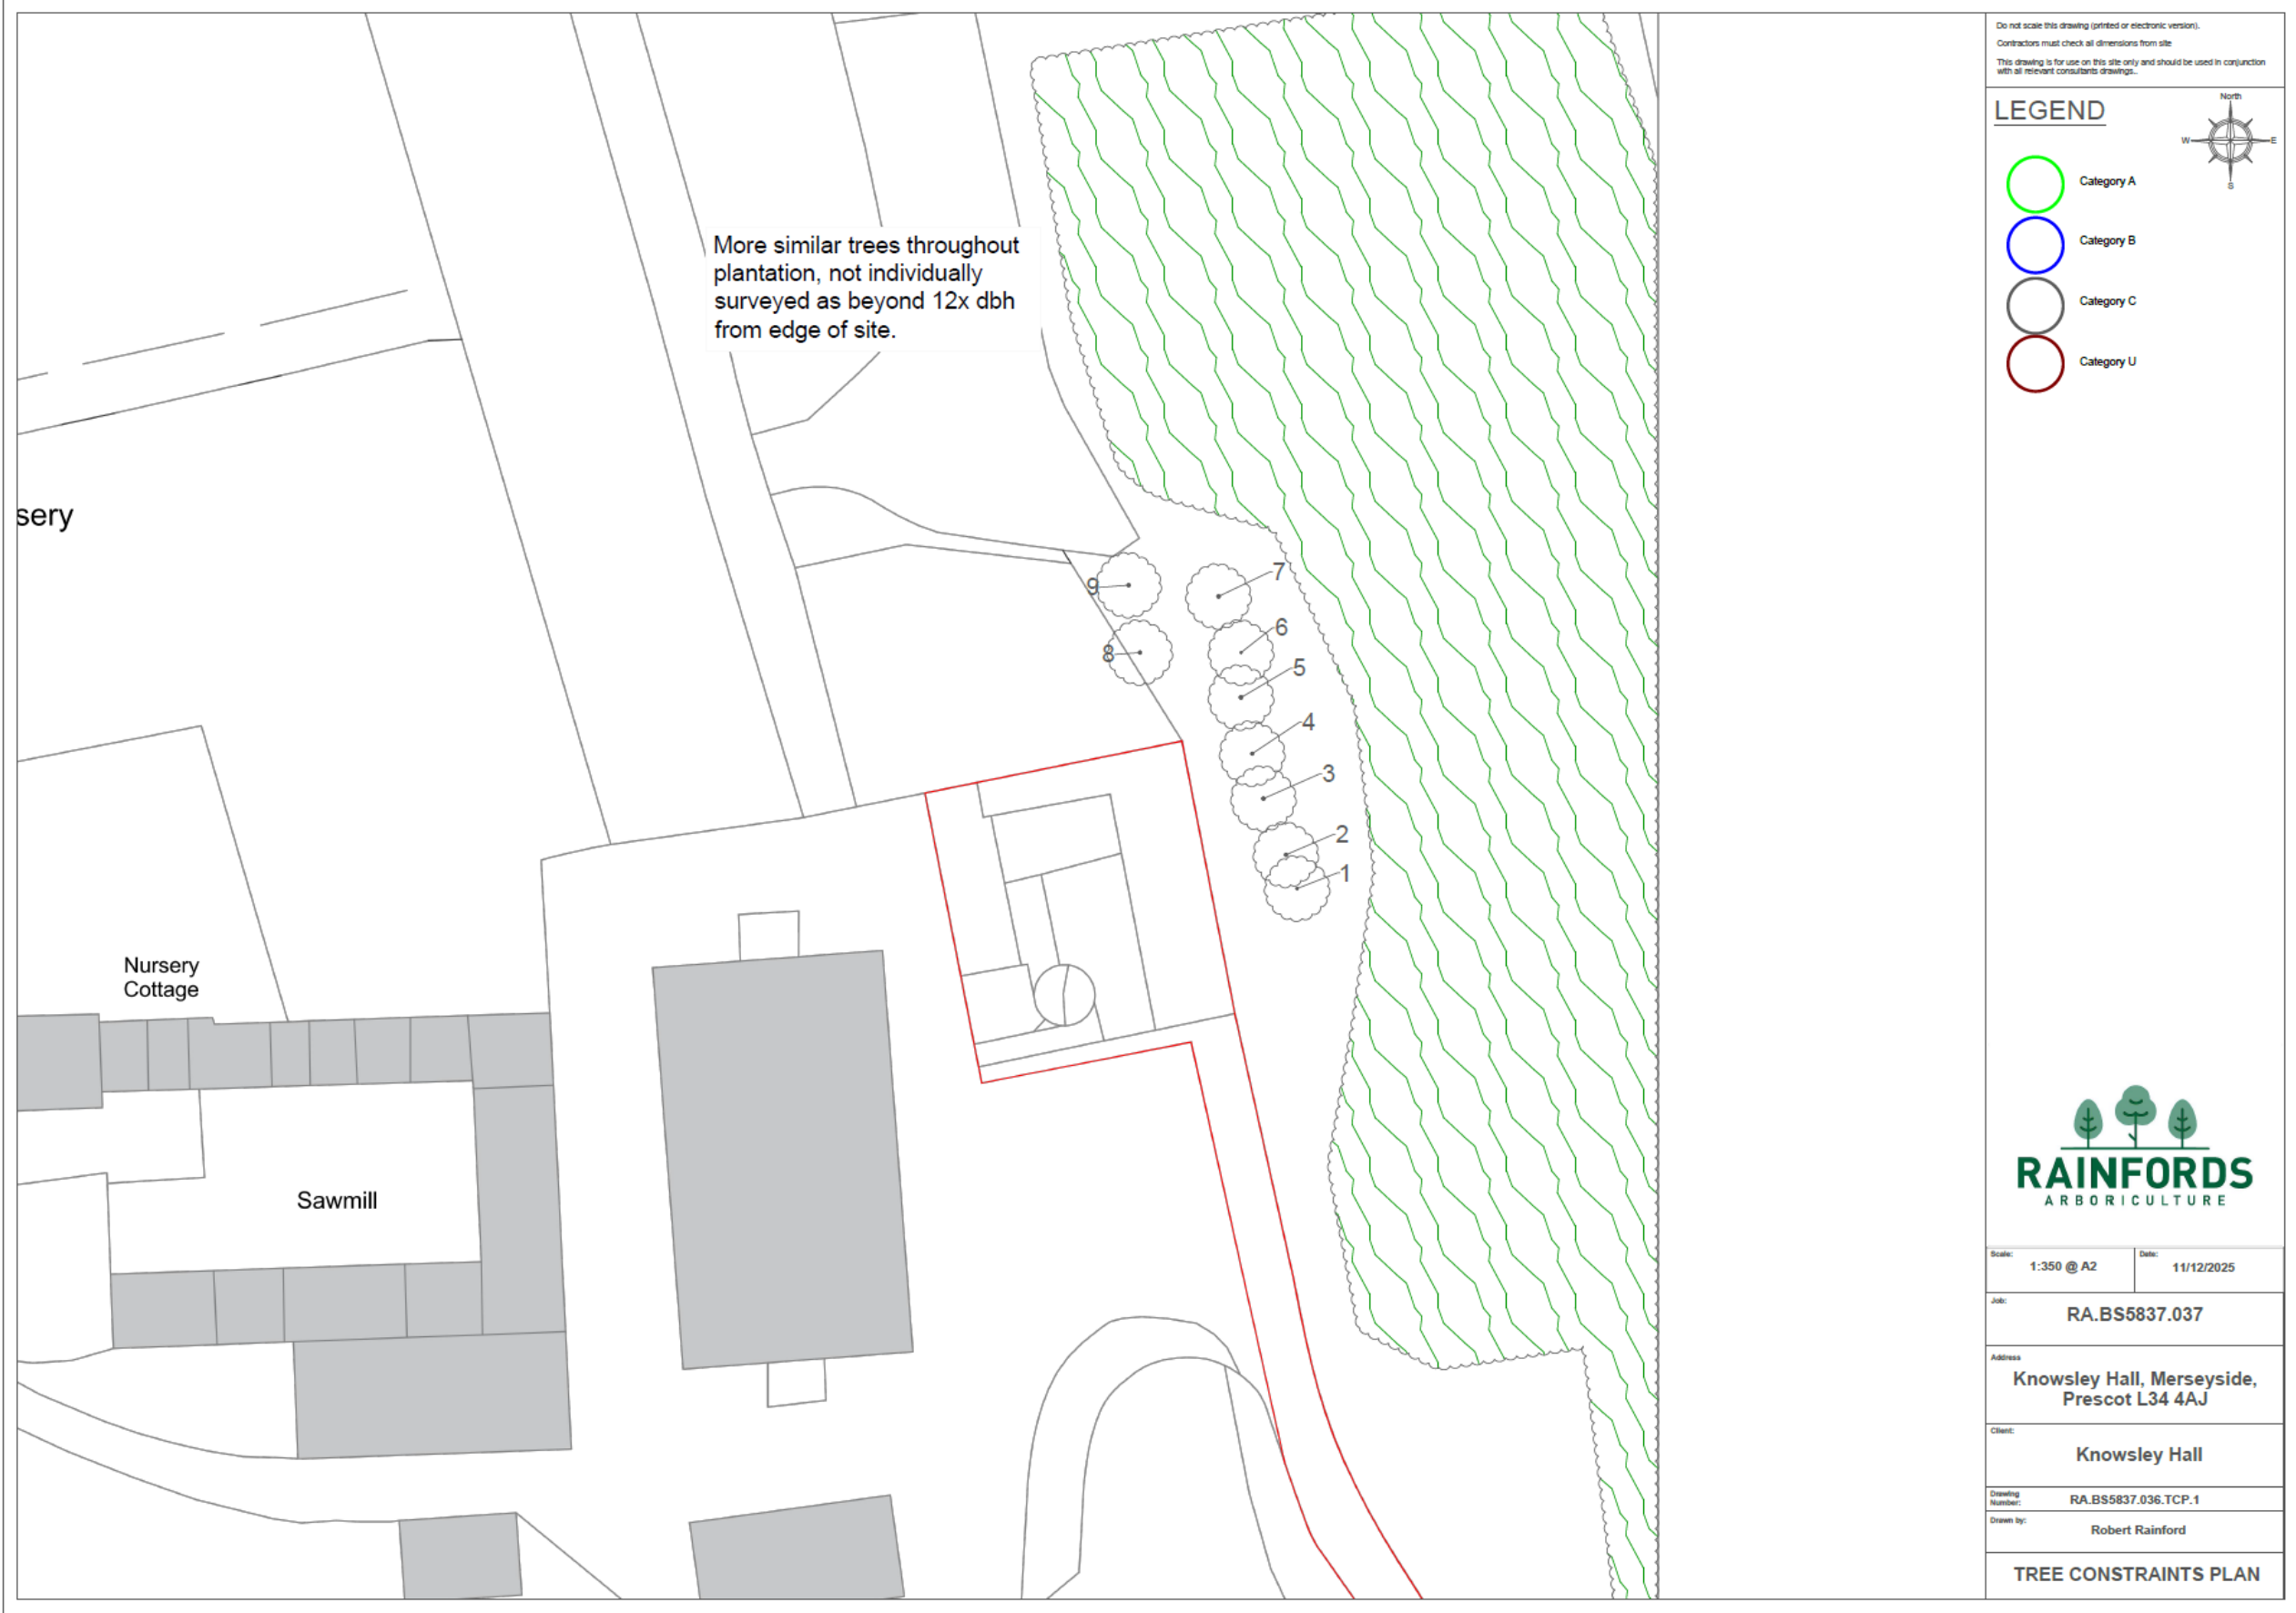
8 APPENDIX B - Tree Constraints Plan

The proposed lambing shed will be constructed on an existing concrete foundation. The Root Protection Areas (RPAs) of T1–T9 do not extend to the edge of this concrete pad, so there is no direct RPA incursion. A low soil mound of approximately 1 m height lies between the trees and the pad and is proposed to be pushed back.

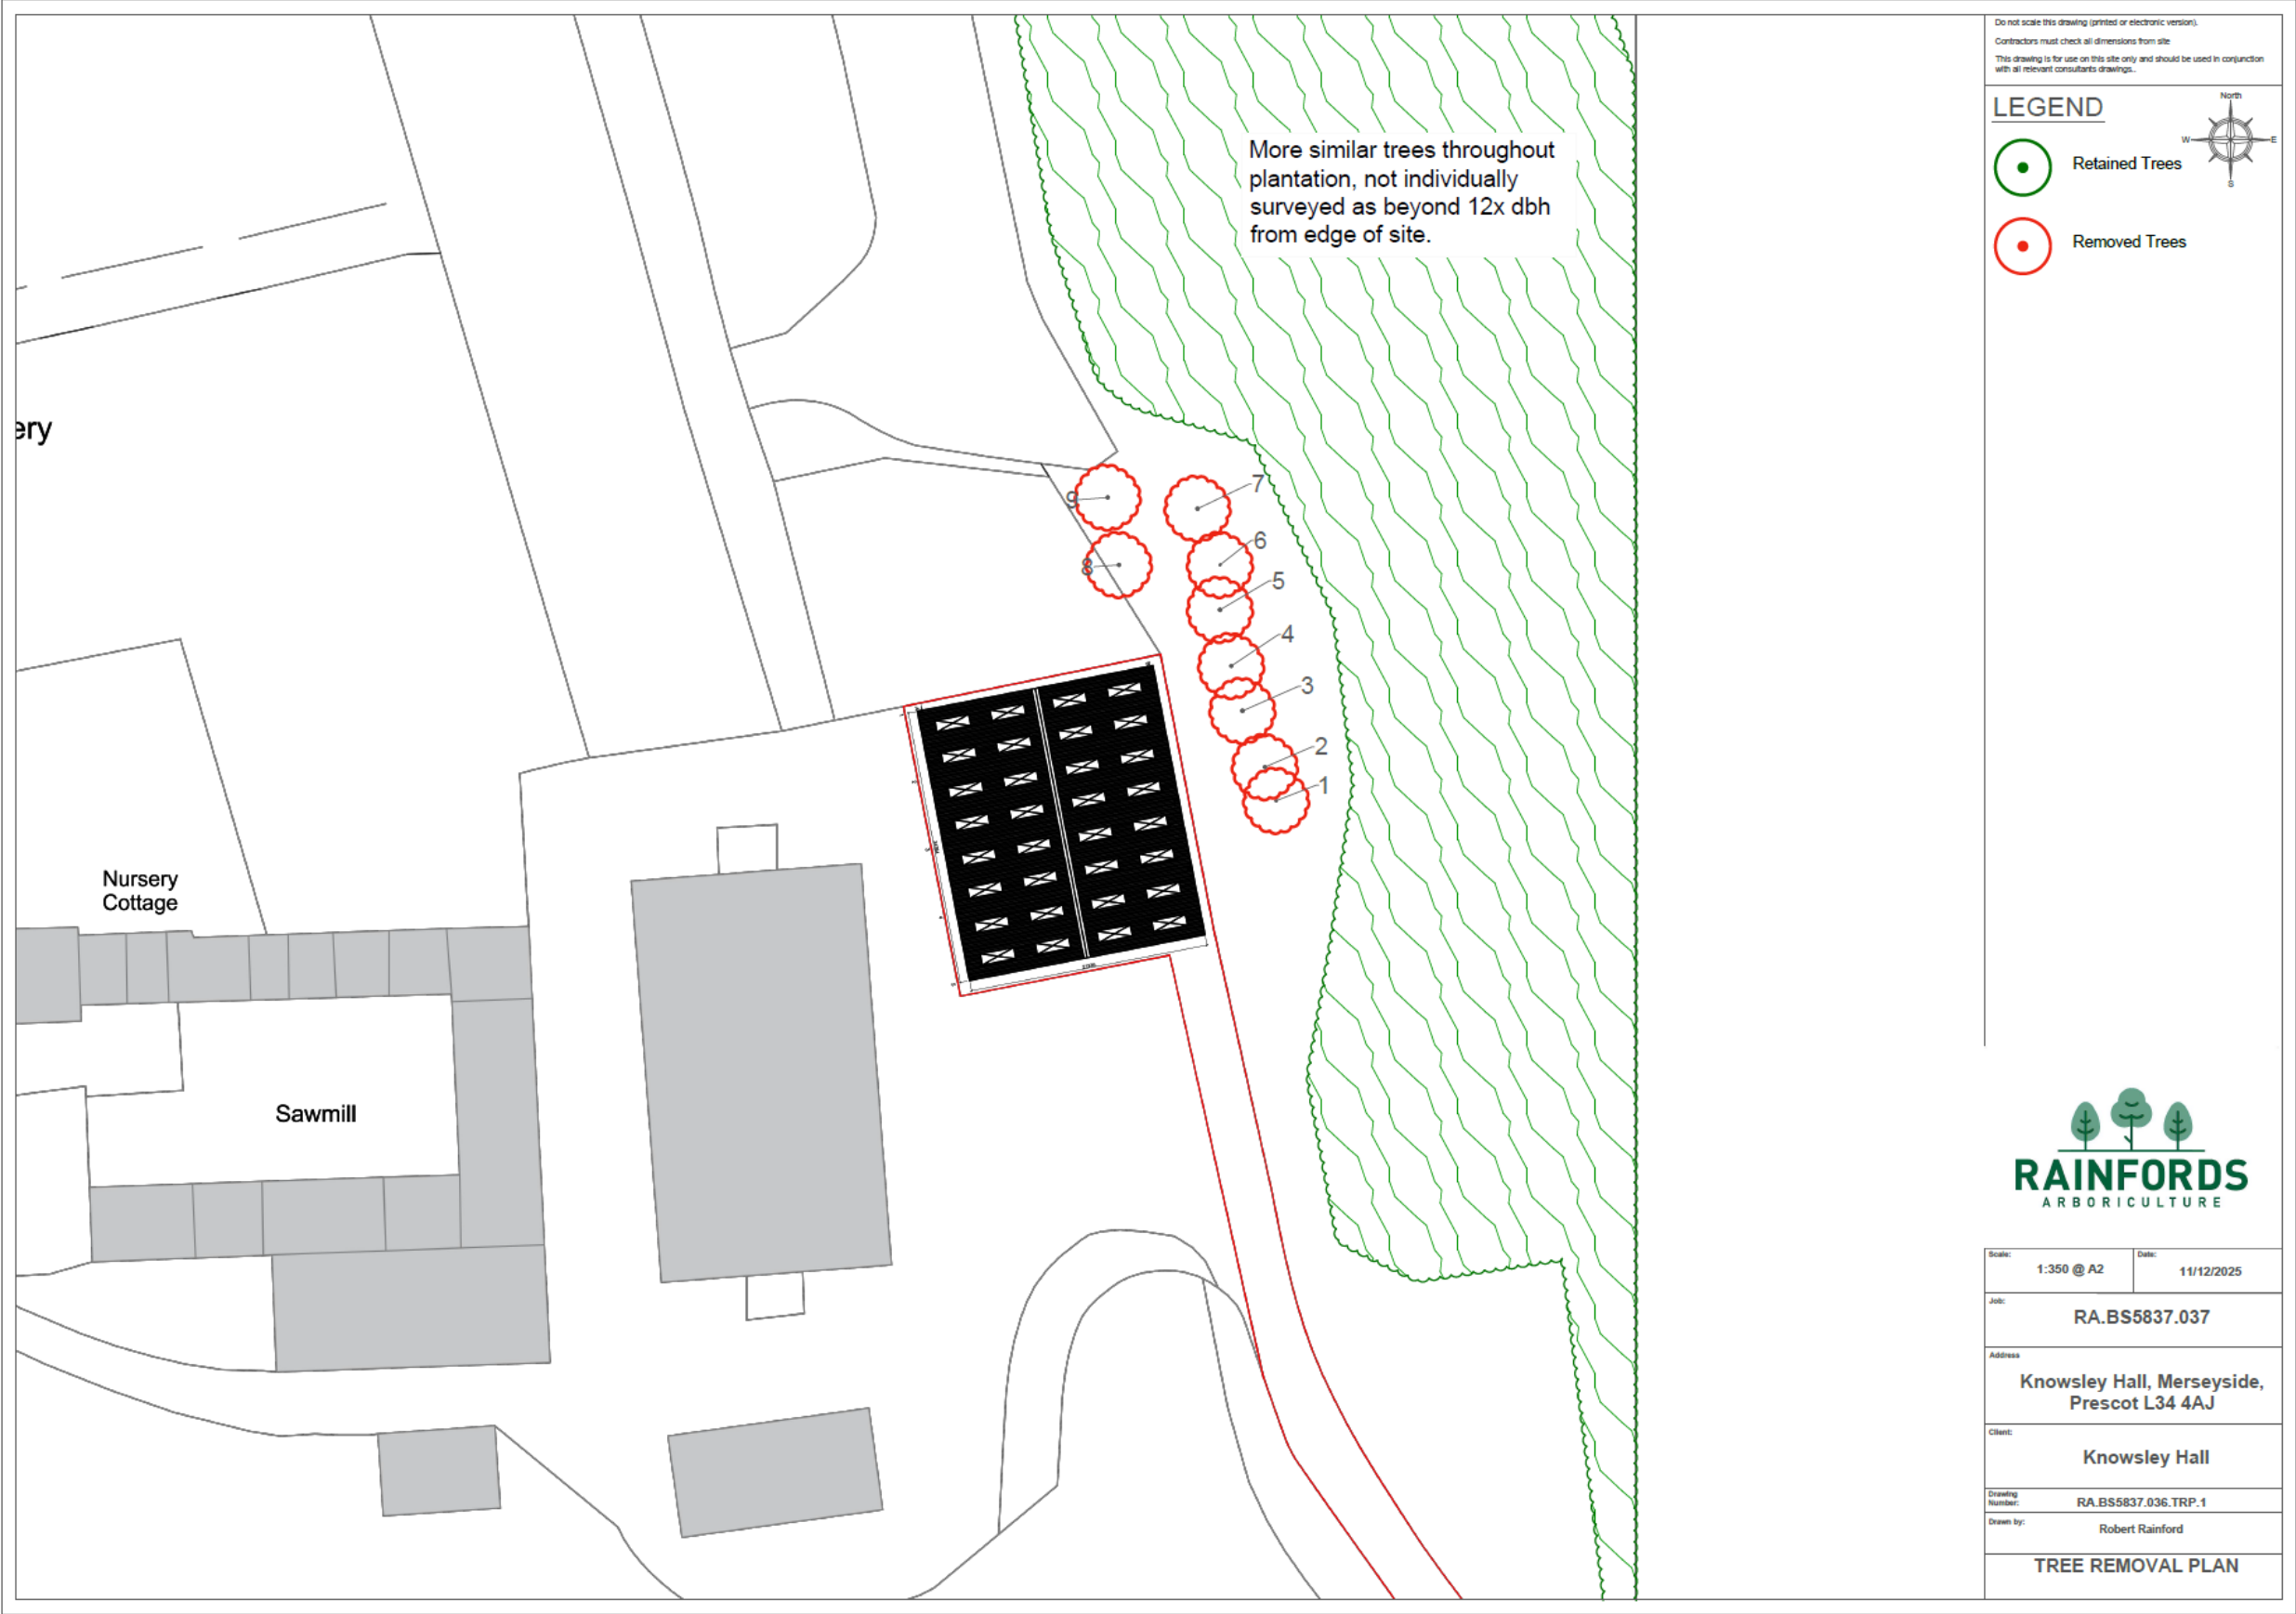
10 APPENDIX D – Tree Removal Plan

The 9 Poplars (T1–T9) are already scheduled for removal under a wider estate woodland management plan. Their removal will also prevent future branch or stem failure onto the new building.

The surveyed trees (T1–T9) are early mature Hybrid Poplar in generally good physiological condition but of limited structural quality and amenity value. Most stems are slender plantation specimens with relatively small crowns, and several trees show evidence of previously snapped-out tops.

- Fell trees T1–T9 (Hybrid Poplar) in accordance with the Knowsley Estate woodland management plan. Their removal will prevent future branch or stem failure towards the new building and is consistent with the ongoing restructuring of the poplar plantation.
- No pruning works are proposed, and no other trees are directly affected by the development.
