# TARBOCK COUNTRY MANOR,

## Preliminary Bat Roost Assessment Report

*September 2023*

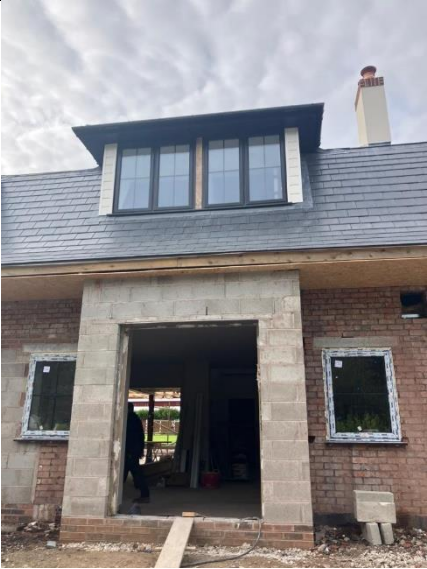
- 3.2.5. The northern aspect of the building included two dormer windows which were a new addition to the new roof of the building. These were well sealed and did not create any roosting features for bats. The overhanging eaves along this aspect were still apart of the current works and currently consisted of wooden boards. There were small gaps identified along these boards. However, these are a part of the current works and of a temporary creation. Whilst it is considered with extensive construction disturbance, will deter bats from this area. The doorway is also located on this aspect of the building which consisted of breeze block walls and a door which was not fitted this feature could provide internal access. However, there were no PRFs internally. A gap was identified within the red brick work, this allowed for access into the building, this led into the floorboards of the building and did not provide a PRF.

| Feature | Photograph |
|---|---|
| Northern aspect of the building | |

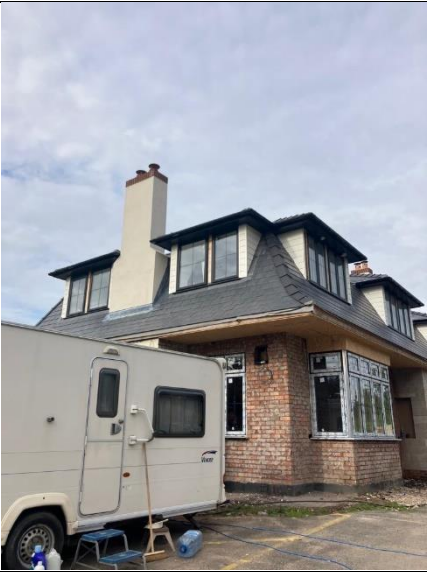
- 3.2.6. The eastern aspect of the building also consisted of a new chimney which was well sealed and did not provide any gaps. There were dormer windows also located on this aspect which were apart of the new development, they were well sealed with no gaps or crevices. Wooden boards were located along the overhanging eaves and was in similar condition to the northern aspect of the building. A gap within the red brick work was also located along the eastern aspect however this also led into the floorboards of the building and did not provide a PRF.

| Feature | Photograph |
|---|---|
| Eastern Aspect | |

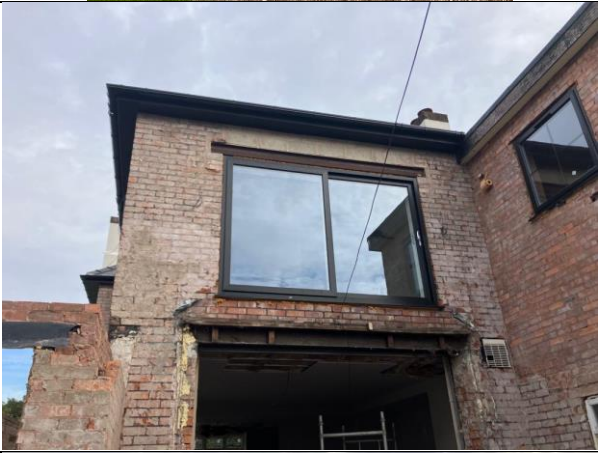
- 3.2.3. The balcony is to be placed on the southern aspect of the building located underneath a newly fitted sliding door. This is to be placed along the brickwork which all sealed throughout the area and awaiting to be rendered. A small vent is located adjacent to this area which consisted of a small hole, it was considered that this may provide an access point however, upon internal inspection this led to the floorboards which did not provide a PRF. Areas along the southern aspect were not completed during the inspection and large gaps within the brickwork were located on this aspect although these were a part of the current works, this could provide access into the building.

| <p><i>Proposed balcony area along the southern aspect of the building.</i></p> | |

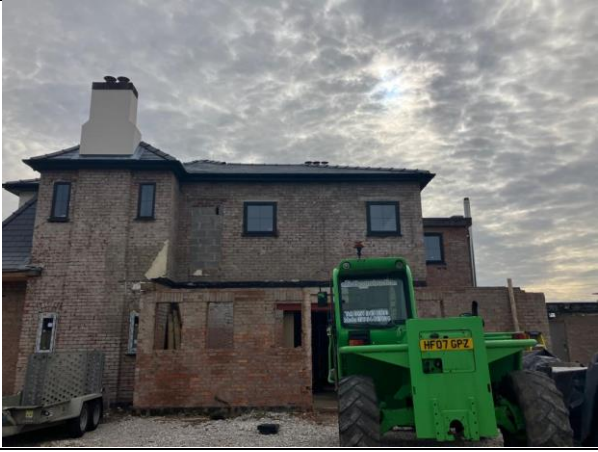
- 3.2.4. The western aspect of the building consisted of one area which was open as all works had not been completed on this side during the inspection however this was identified as an extension onto the current building and did not provide access into the building. There were no potential roosting features identified along this aspect.

| <p><i>Western aspect of the building.</i></p> | |

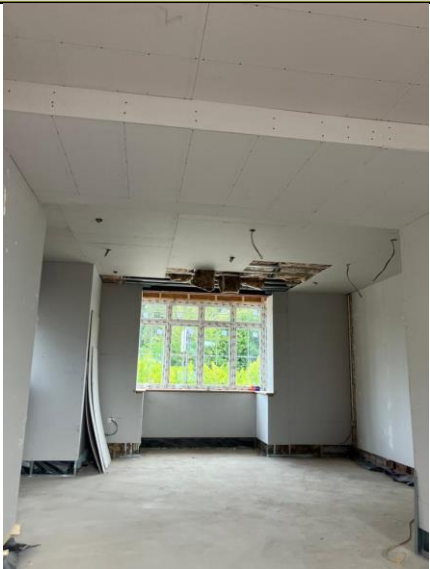
- 3.2.7. The internal aspect was mainly sealed other than areas of brickwork and floorboards which were apart of the current works and were not completed during the site visit. The first floor of the building was well sealed throughout and the renovation works on this aspect were completed. There were no gaps or crevices identified on the first floor. There was no loft space within the building as this had been removed throughout the ongoing works. One small room was located within at the top of a wall in the first-floor bedroom which is to be used as a storage room, this was also well sealed throughout with no gaps identified. No PRFs were identified across the internal aspect of the building.

| <p><i>First floor internal aspect</i></p> | |

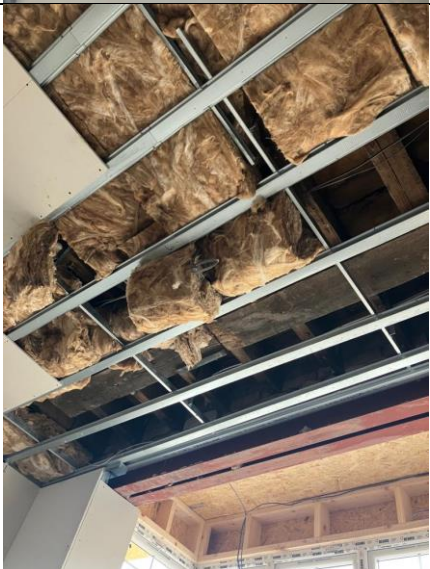
| <p><i>Open area under floor boards with ventilation.</i></p> | |

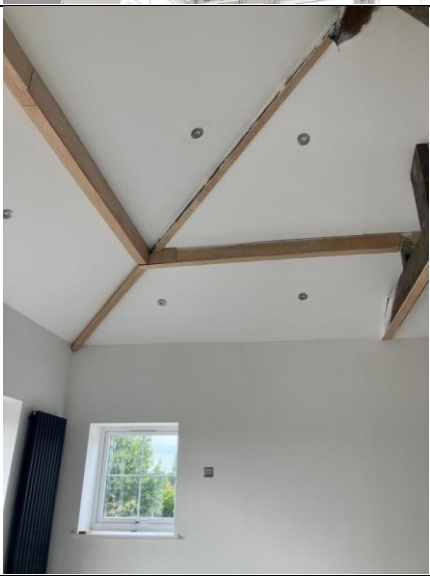
| <p><i>First Floor</i></p> | |

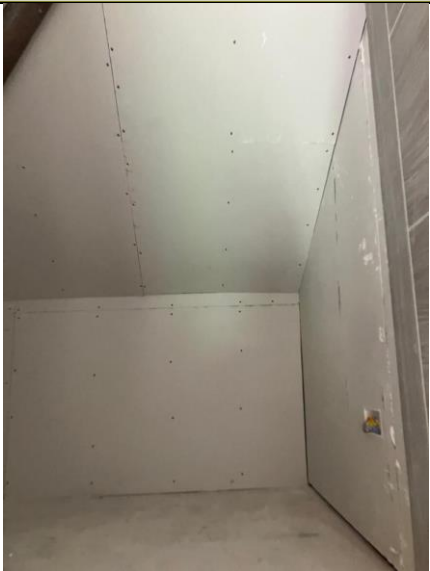
| <p><i>Small third story storage area.</i></p> | |
