# **JLR Halewood Eastlands Car Park**

Arboricultural Impact Assessment (AIA)

25/03/2026

UK0028072.5026-ARB-AIA

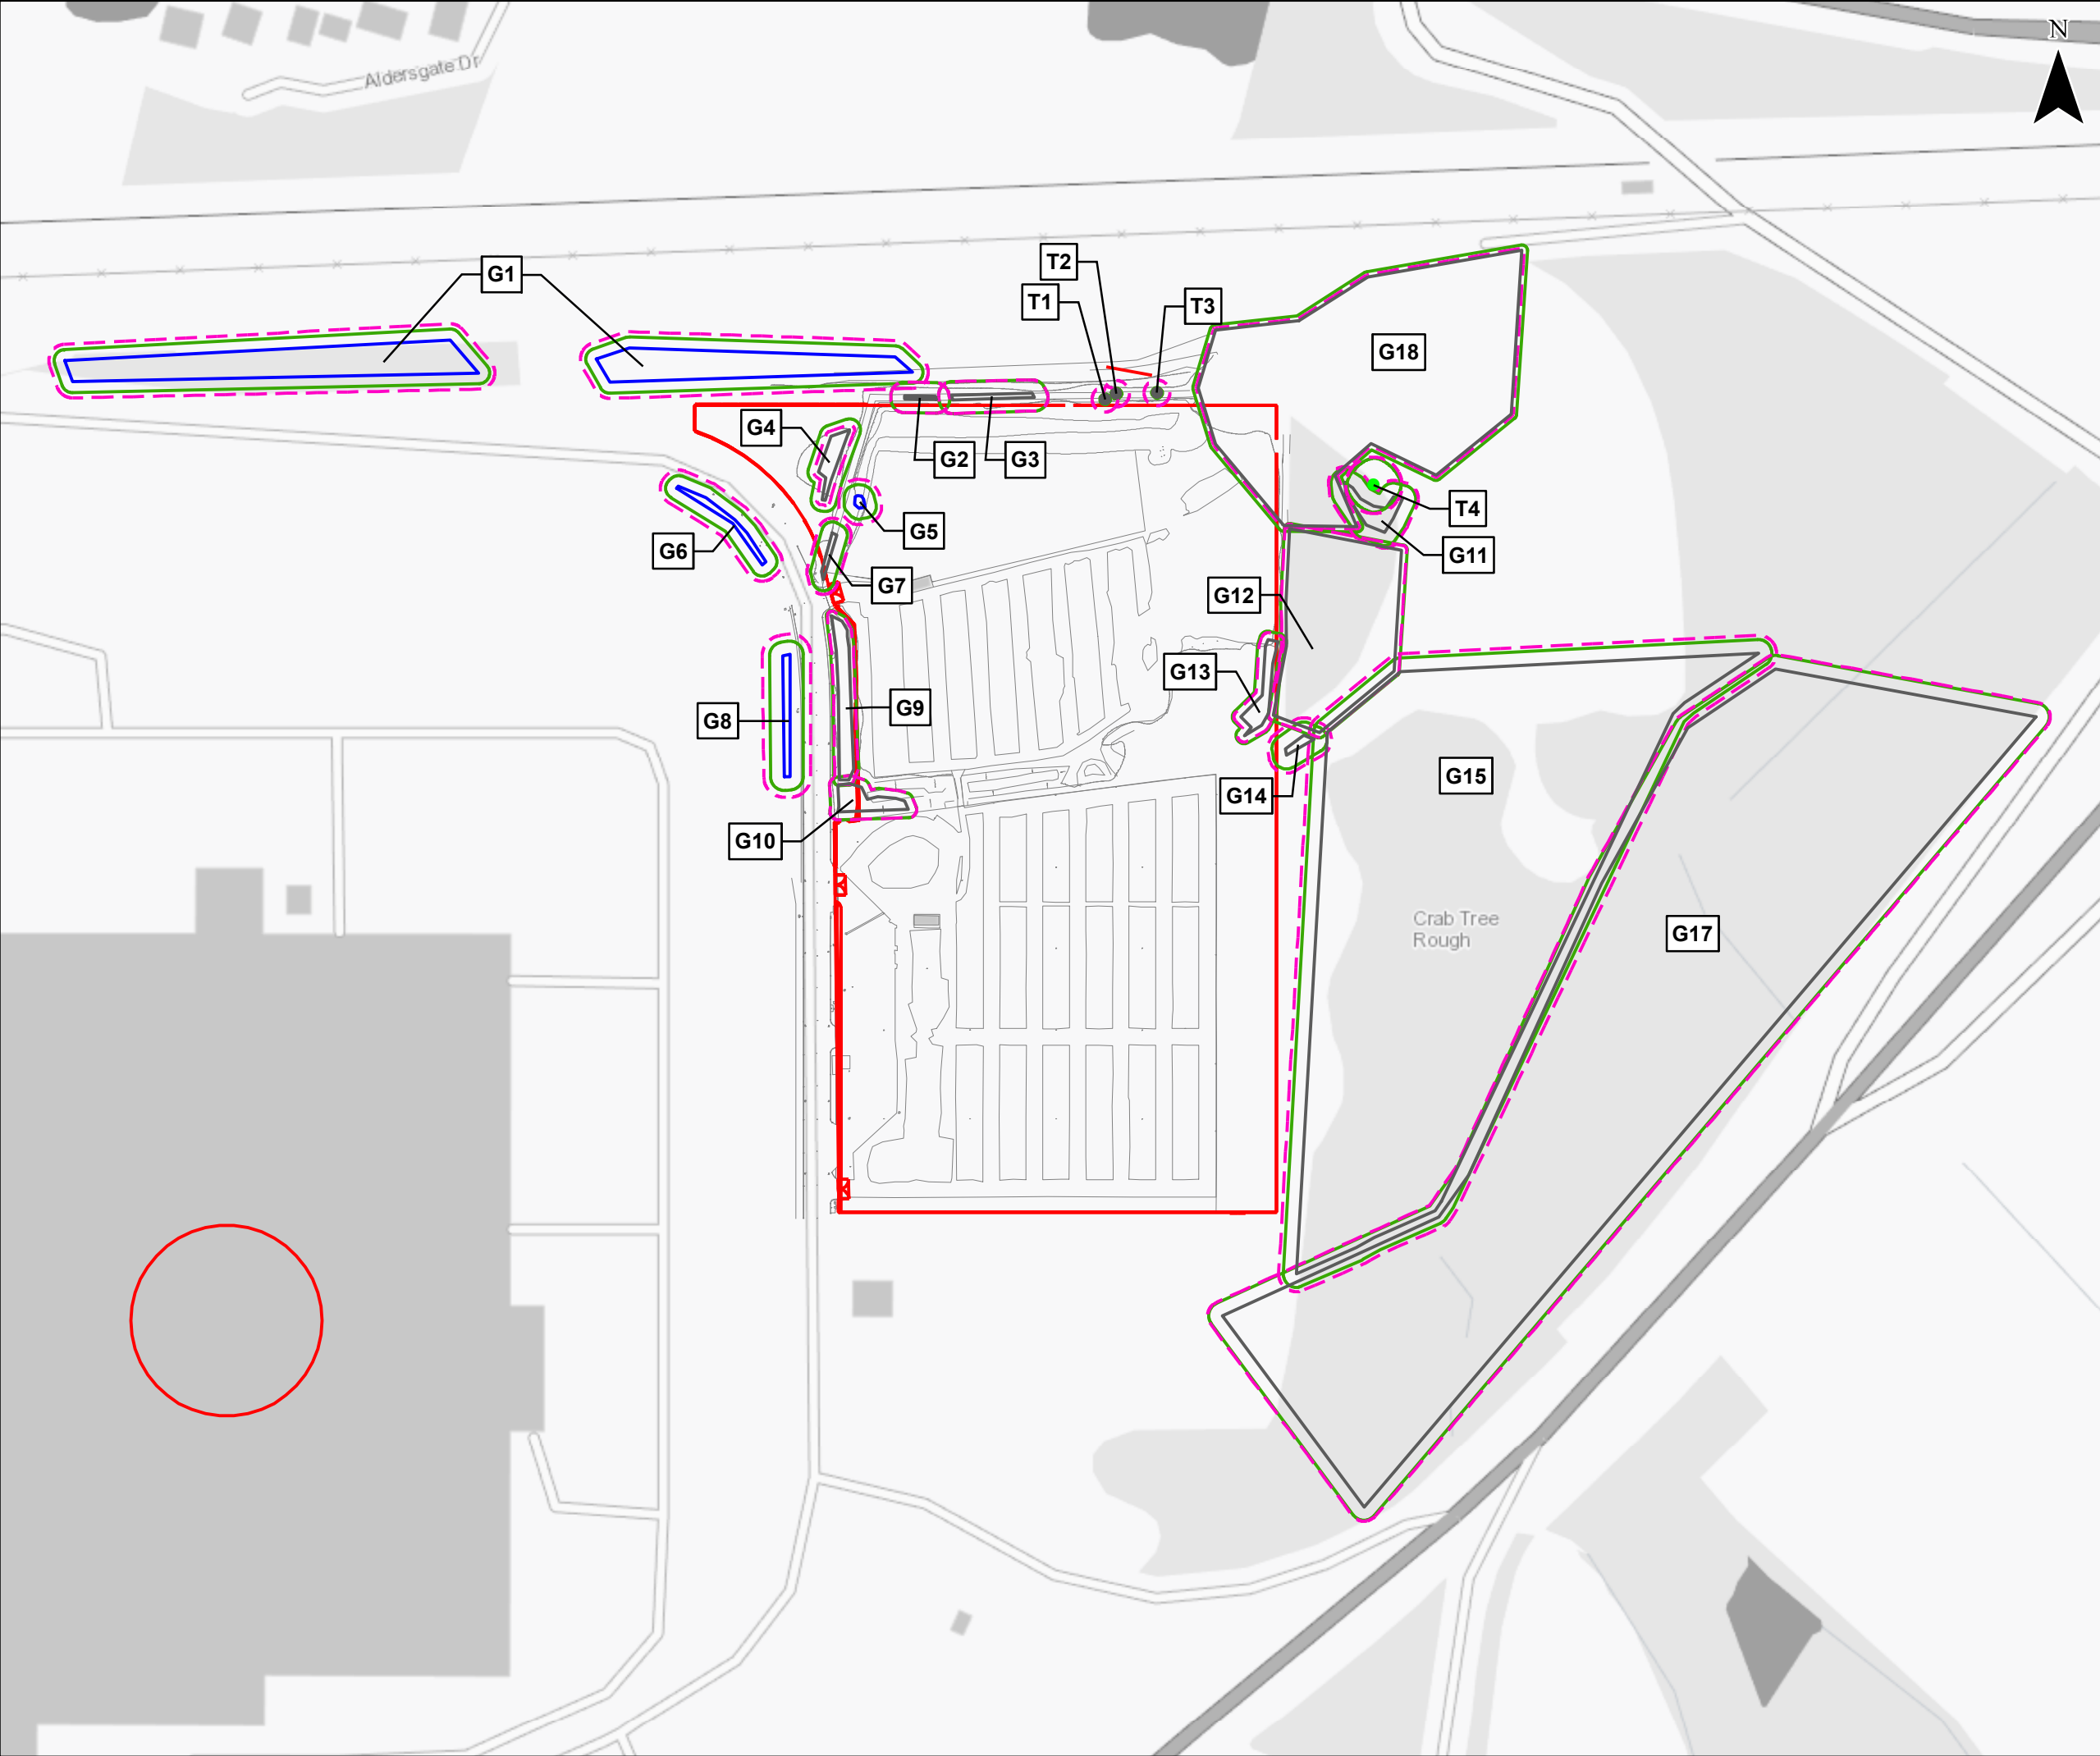
**Tree Survey Plan**

- 4.1.2 Baseline locations for trees surveyed at Eastland Car Park are shown on the TSP in Appendix B. The site exhibits characteristics of early-successional woodland (secondary regeneration), with a predominance of young, self-seeded trees and scrub developing along the site margins and beyond the former hardstanding.

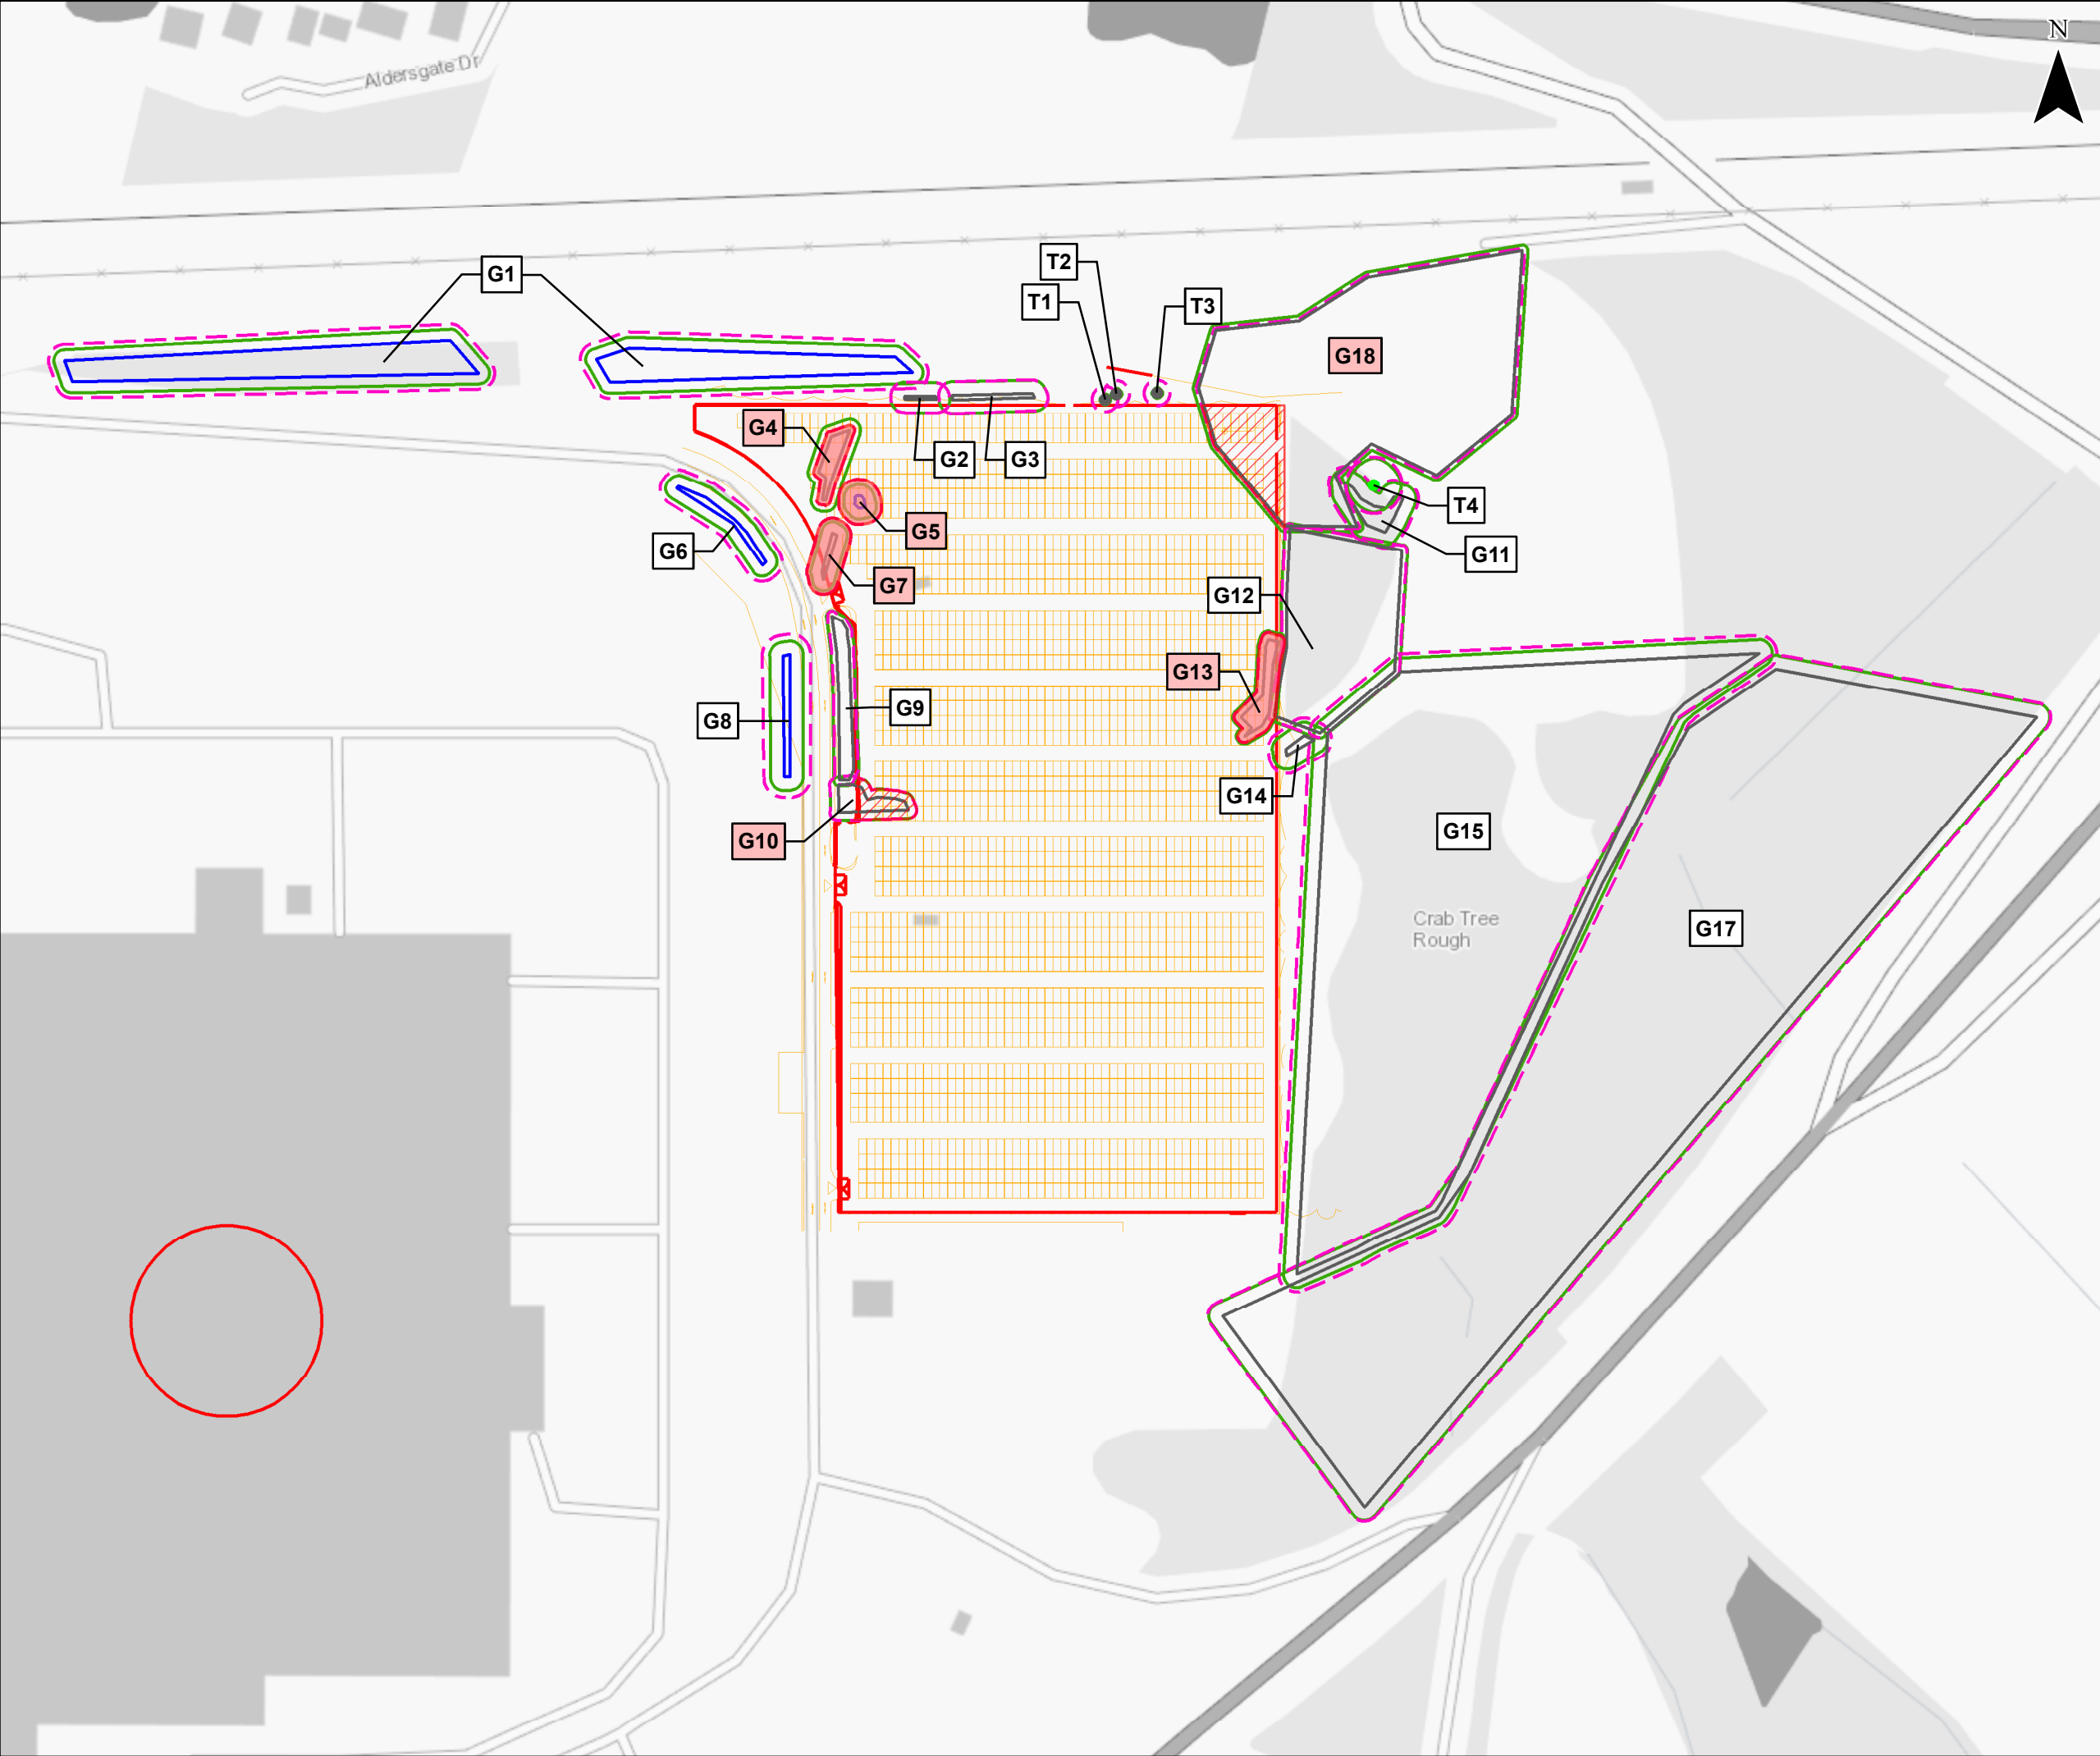
## Tree Retention Plan

- 5.1.2 The proposed development will require the removal of four tree groups and the partial removal of two tree groups.
- 5.1.3 G5 tree group is identified for removal which is of moderate value (Retention Category B). It is recommended that suitable replacement tree planting will therefore be required to offer an adequate level of mitigation for this loss.
- 5.1.4 The remaining groups (G4, G7, G10, G13, G18) that are to be removed or partially removed were considered to be of a low value (Retention Category C) during the Arboricultural Survey Assessment. The proposed removal of these trees should be considered acceptable as they were found to be of low quality and new tree planting of higher quality trees more suited to the new development and will make a lasting contribution to the visual amenity value and canopy coverage of the site.

5.2.2 The proposed works within the RPAs will involve ground levelling and the installation of hard surfacing to facilitate the creation of parking spaces. All operations within or adjacent to RPAs should be undertaken in accordance with a detailed Arboricultural Method Statement (AMS) to ensure that construction methods are appropriately controlled and that retained trees are afforded adequate protection throughout the works.
