# **Site Tree Appraisal**

***Hall Cleaning Services Ltd, Caddick Road, Knowsley Business  
Park, Knowsley L34 9HP***

**‘BS 5837 2012: Trees in Relation to Design, Demolition and Construction – Recommendations’**

Ref: RTS/22082023

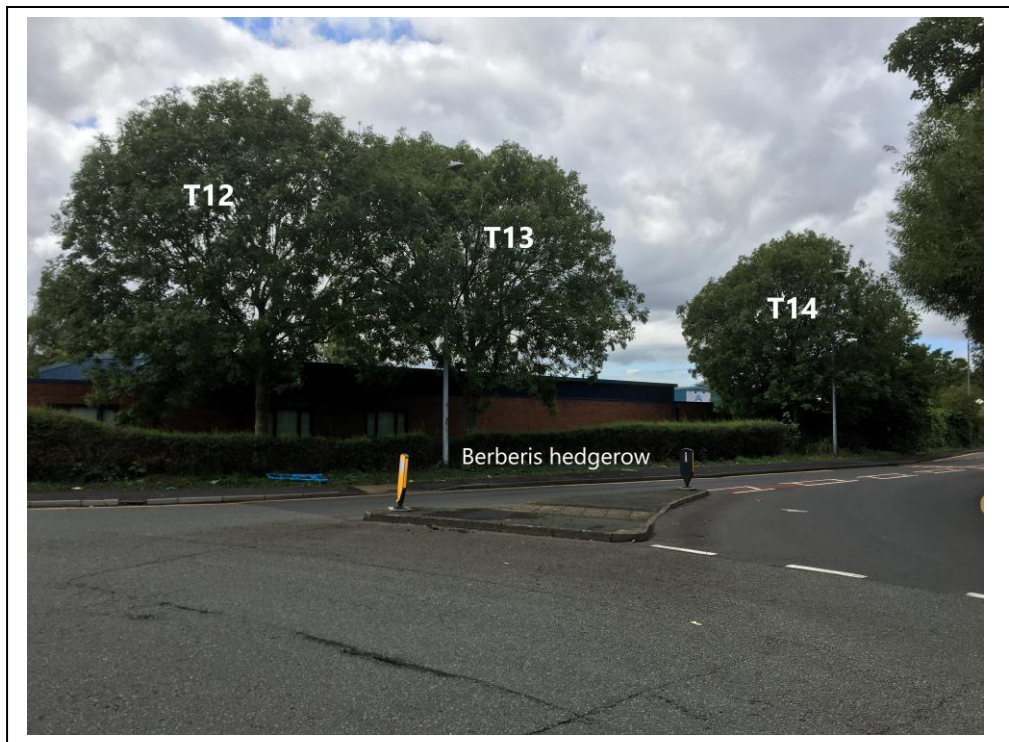
Photo 01:

- 3.5** Trees T12 to T16, at the rear north east of the existing building, will be unaffected by the development proposal. Cutting back or removal, however, of the north east Berberis hedgerow (photo 01) may be required to facilitate installation of the new boundary fence. All contractor access to the site is to be via the existing site entrance off Caddick Road. However, to avoid the temptation for contractors to access the small north east area (adjacent to T12, T13, T14, T15 & T16), temporary protective tree fencing is recommended. The protective fence specifications are noted in the Recommendations at section 5 of the report.
- 3.6** Installation of the proposed boundary fencing, adjacent to trees T12 to T16, should follow the work method noted in the Recommendations at section 5 of the report.

| Tree | Tree Work | Priority |
|---|---|---|
| Berberis hedgerow adjacent to School Lane (at the north east boundary) | Remove or cut back as required to facilitate the new boundary fence installation. | Prior to any other site works |
