| Envams | Kirkby BESS | CGN/05153B |

*Walkover Summary and Photosheet*

## Site Walkover Report Form

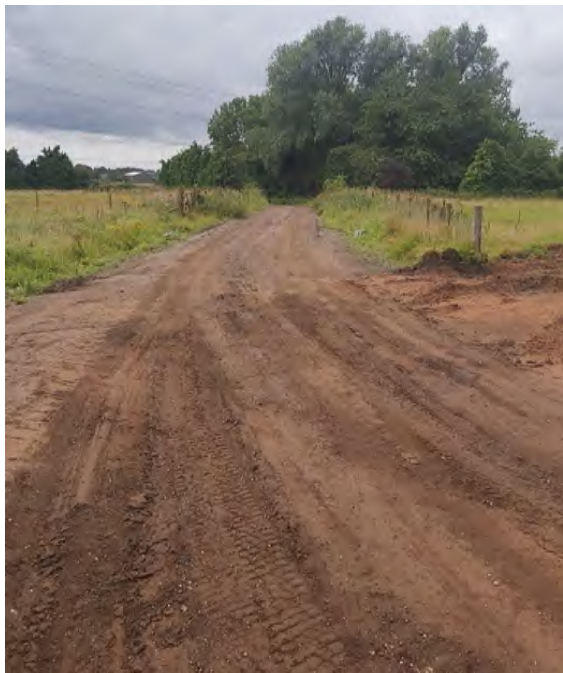
1. Cut Lane access road looking south.

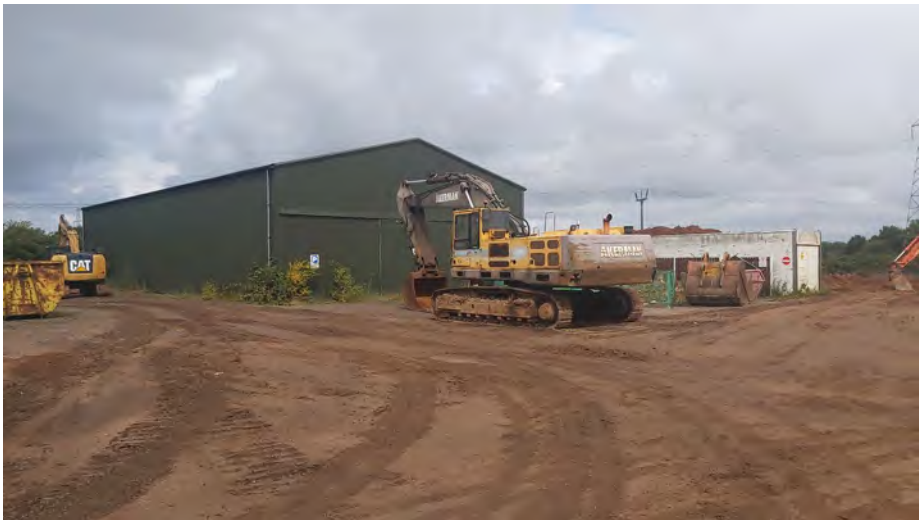
| SITE ACCESS | |
|---|---|
| Evidence of damage/cracking etc. | Metal barn in good condition, stable is poor condition. |

2. Cut Lane site metal storage barn and plant in the west.

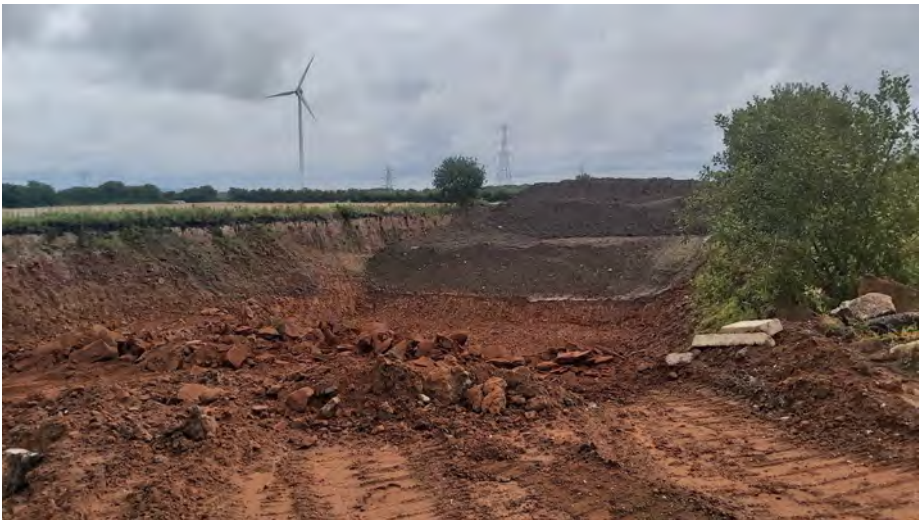
| Evidence of filled ground | Sand pits backfilled with silty sandy Made Ground (like topsoil).<br>5 - 6m depth pit currently open, potential for complete/filled pits around the site. |

3. Cut Lane sand pit looking northeast, partially backfilled with loam/Made Ground.

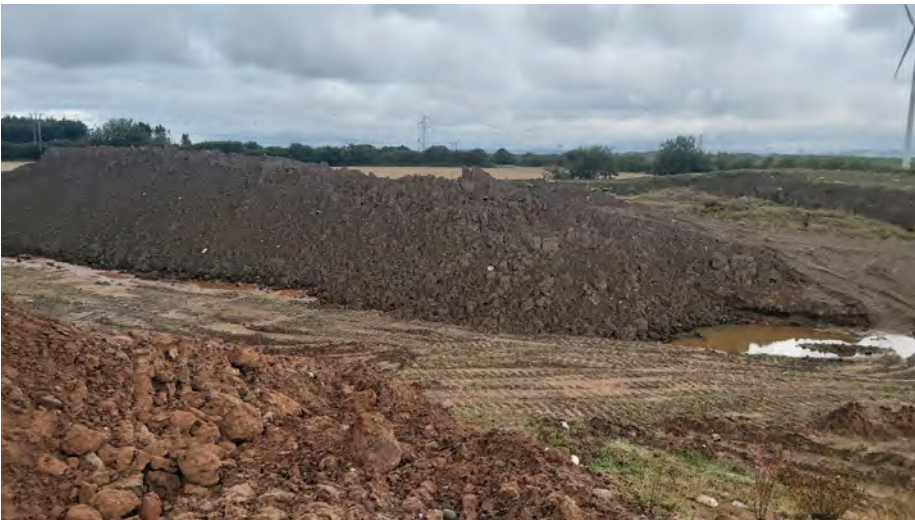
4. Cut Lane site looking west, backfill material spoil.

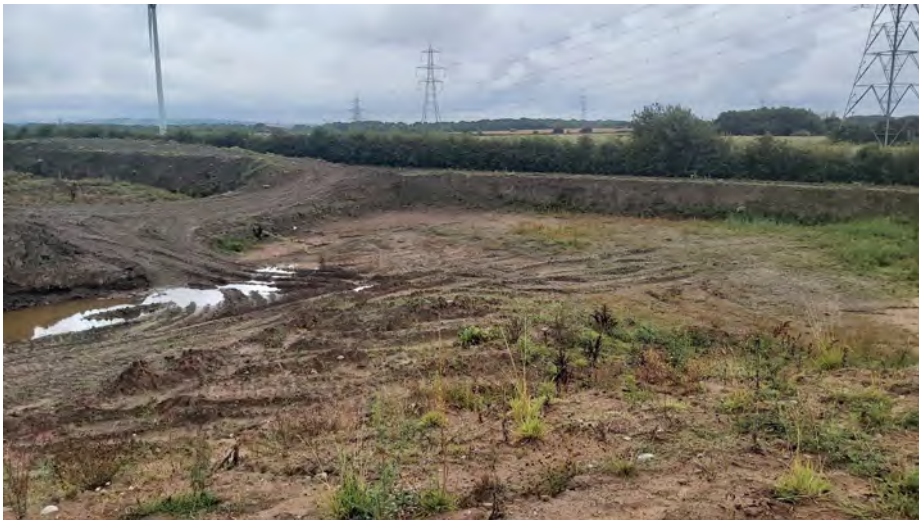
5. Cut Lane site looking north, potentially backfilled pits.

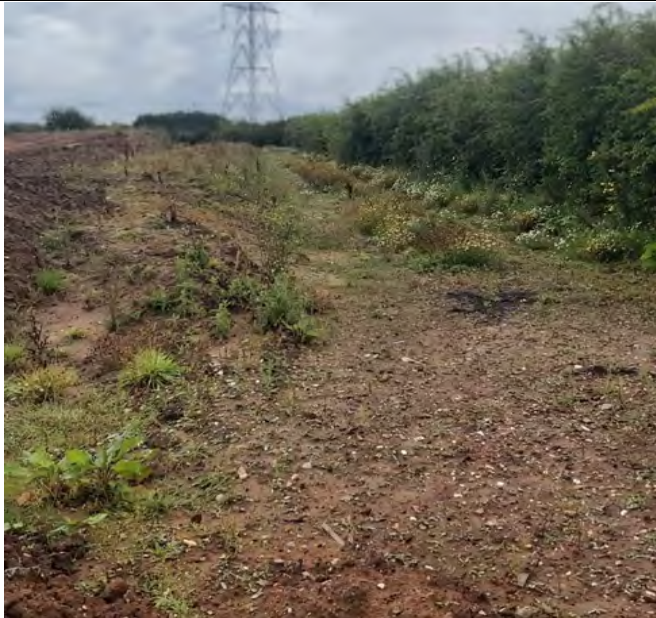
| Overhead services | OHL 15m east of Cut Lane site, Runs SW to substation. Crosses Cut Lane and then runs parallel to the road. |

6. Cut Lane site margin looking north showing vegetation, OHL, and Made Ground.

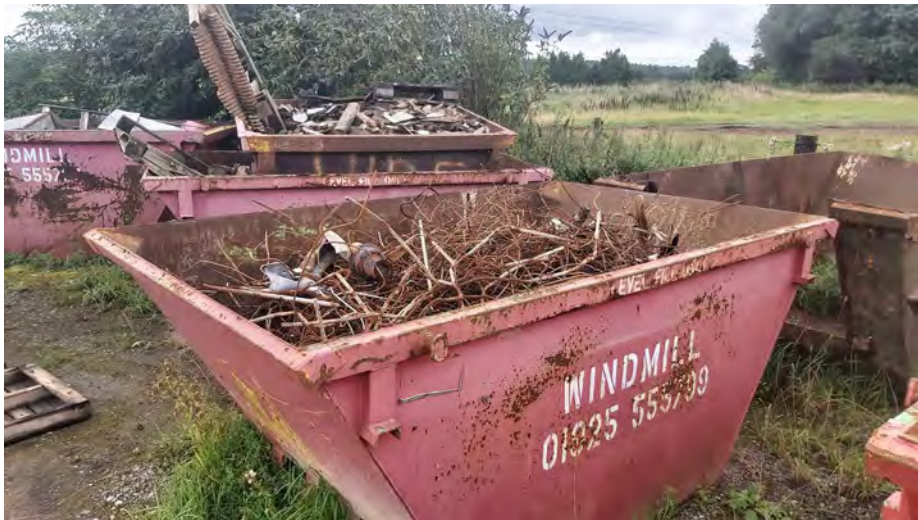
7. Various metal, plastic, and hardcore skips south of the metal barn.

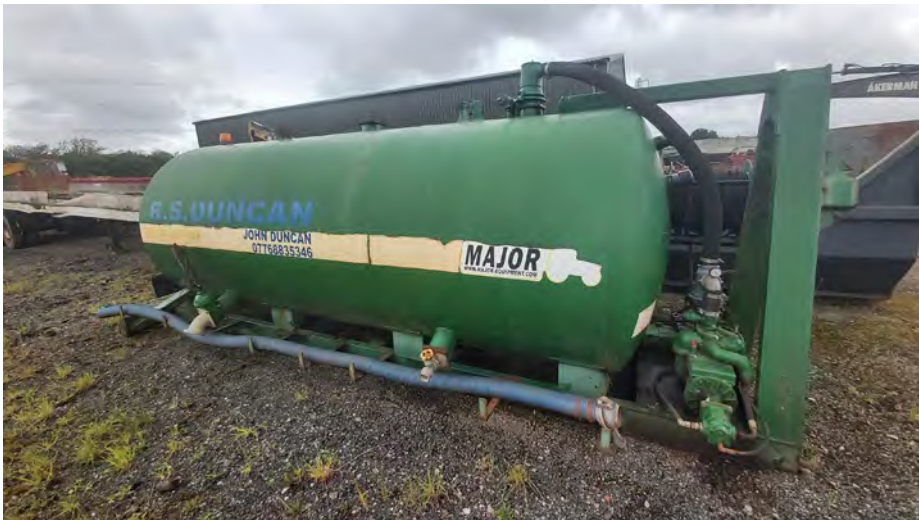
| Evidence of AST or UST | Unknown green tank on Cut Lane site south of metal barn, appears empty. |

8. Unknown empty tank south of the metal barn.

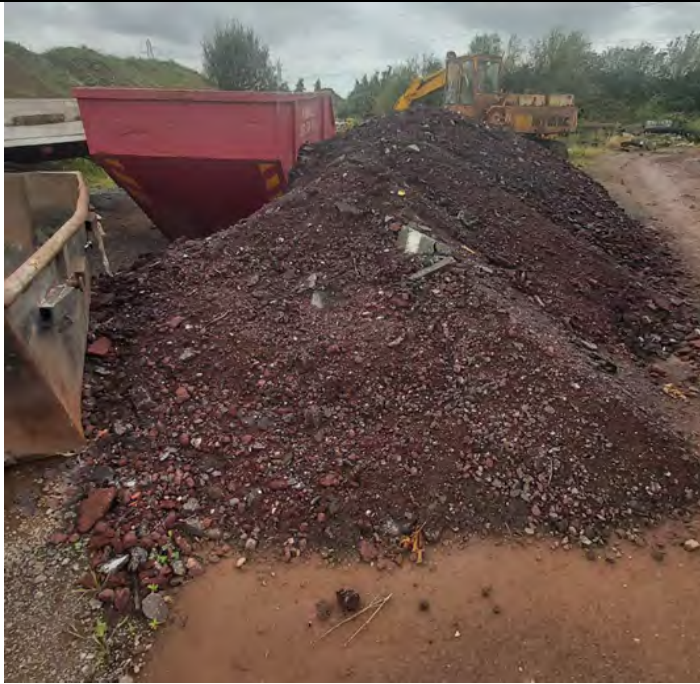
| Fly tipped material | Made ground/tarmac materials tipped on south side of metal barn. |

9. Tarmac/hardcore spoil south of the metal barn.

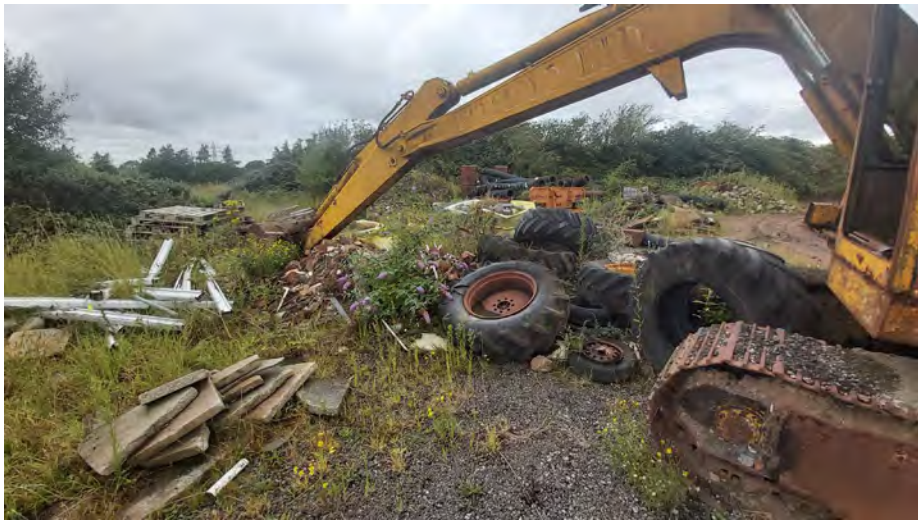
10. Various tipped materials southwest of the metal barn.

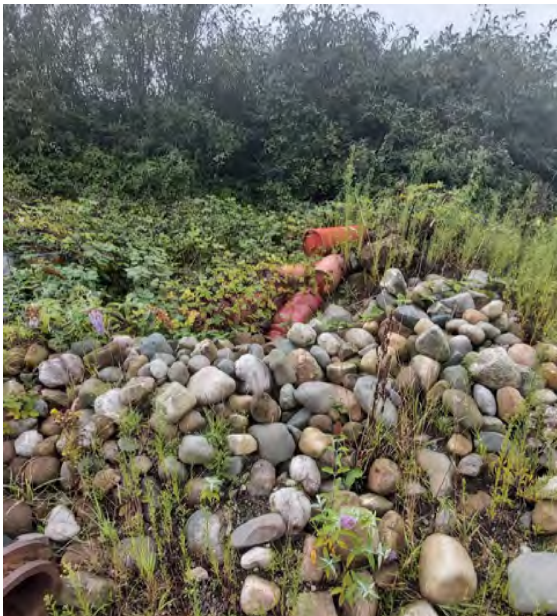
| SITE ACCESS | |
|---|---|
| Possible hazardous materials (e.g. asbestos) | Gas cylinders, Tarmac, and Made Ground spoil tips to the south side of the metal barn.<br>Various skips containing metal and plastic. |

11. Gas cylinder dump southeast of the metal barn.

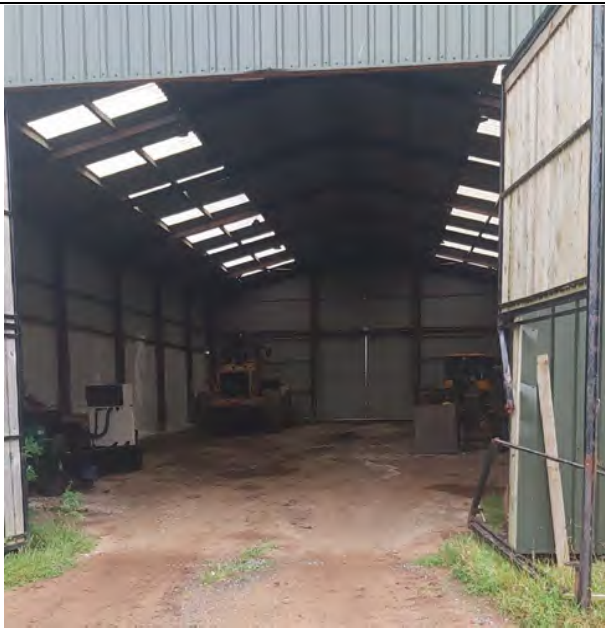
12. Inside the structure.

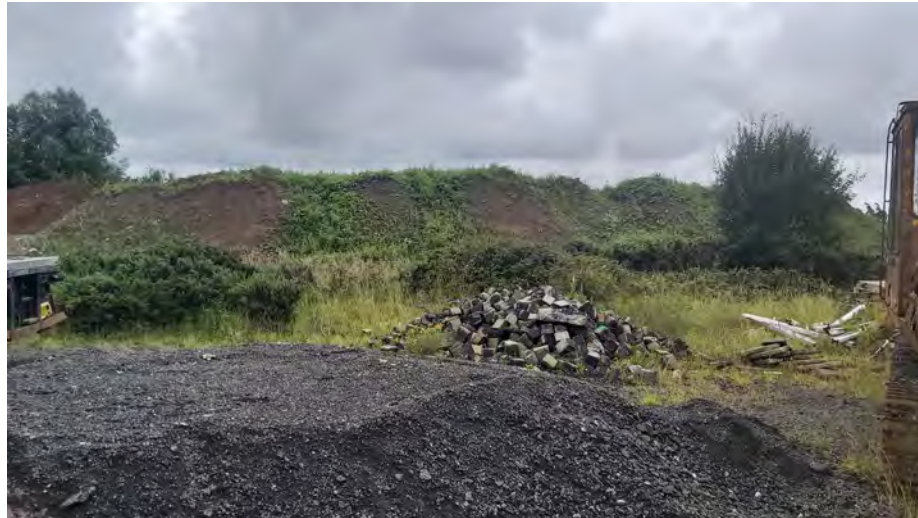
| 13. Old spoil heaps south of the metal barn. | 14. Disused wooden stable northeast of the site entrance. | 15. Cut Lane site entrance onto Cut Lane, looking south. |

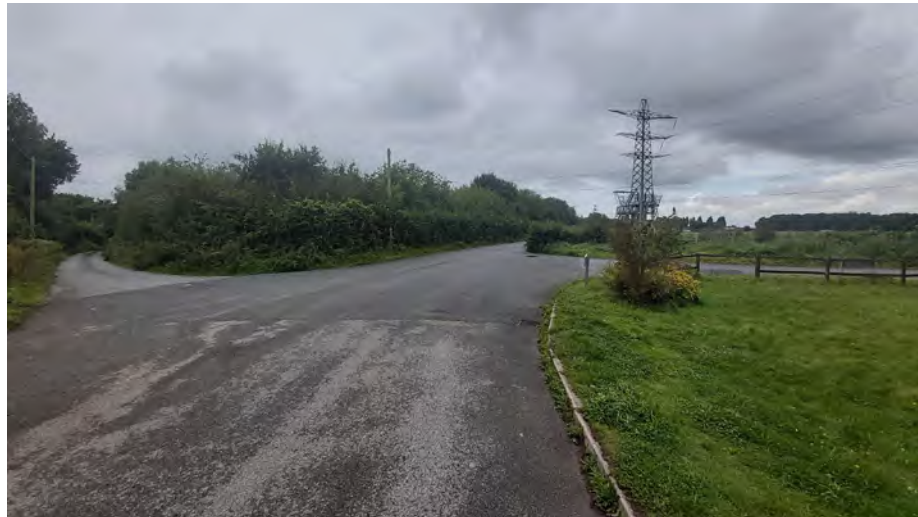
| 16. Cut Lane junction with Molly's Lane and Hewitt Lane, looking west. | 17. 11kV going underground to the west of Cut Lane junction, looking east. | 18. OHL going underground under Molly's Lane, a drainage system runs under the curb running along the right-hand side of the road. |

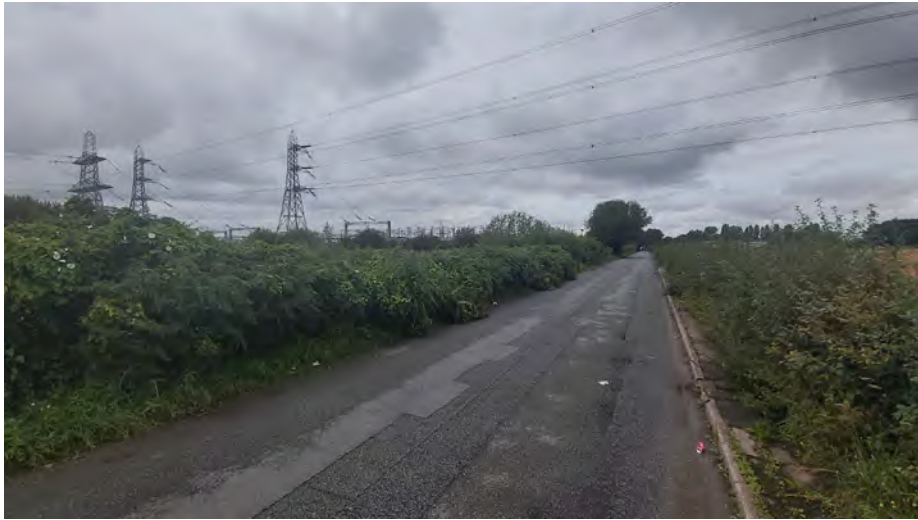
19. OHL crossing Molly's Lane, looking west.

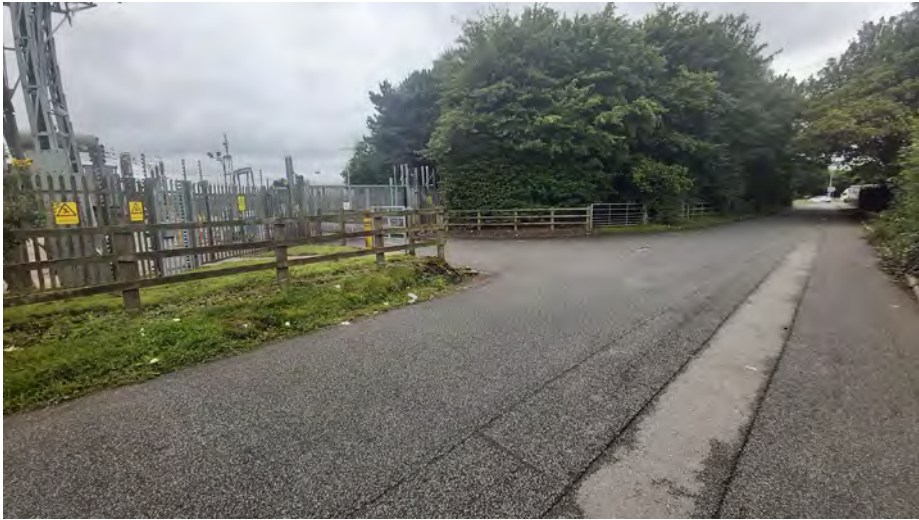
20. Existing substation entrance onto Molly's Lane.

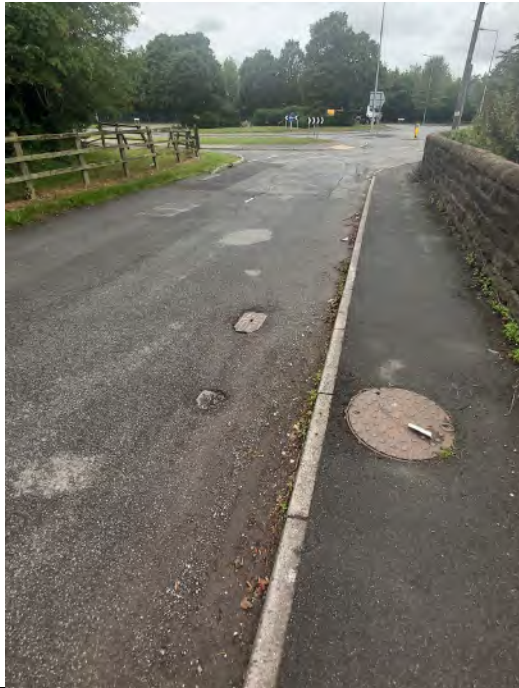
21. Molly's Lane/A5208 junction looking west.

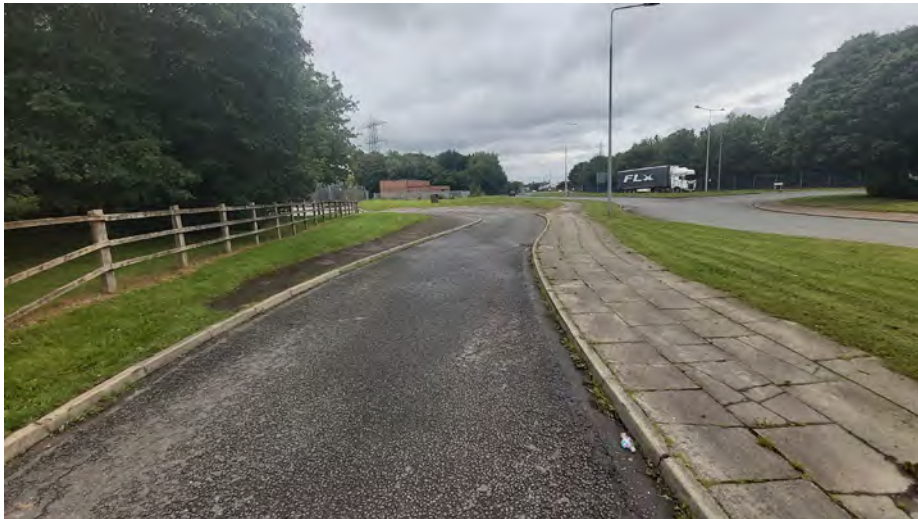
22. A5208 pathway looking north from Molly's Lane junction looking south.

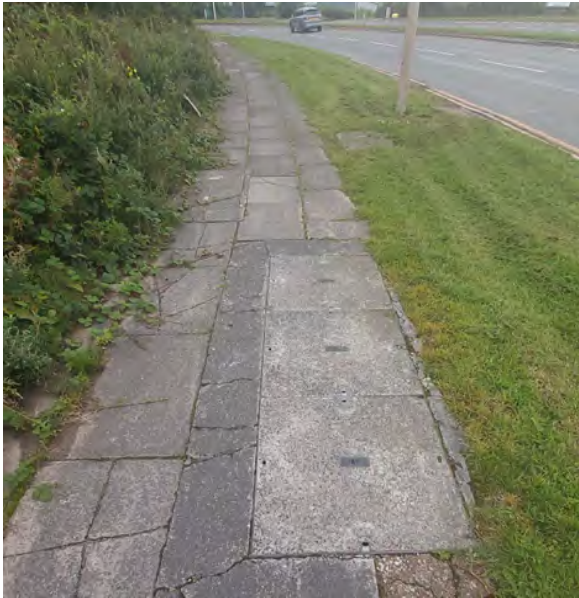
23. One of the various telecoms access grates indicating buried services under A5208 path.

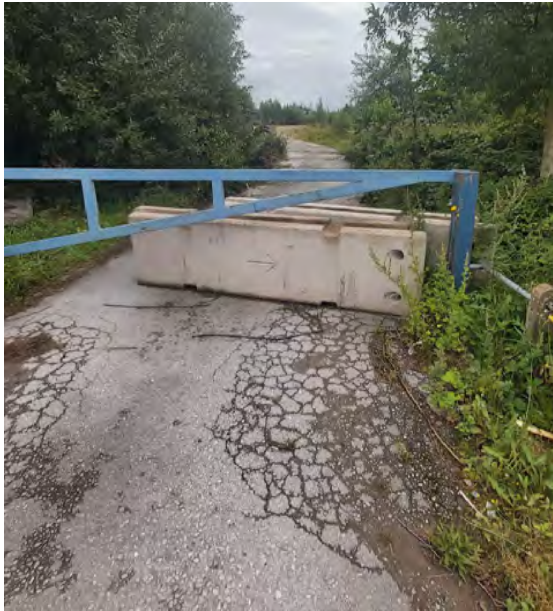
24. Proposed substation entrance looking east.

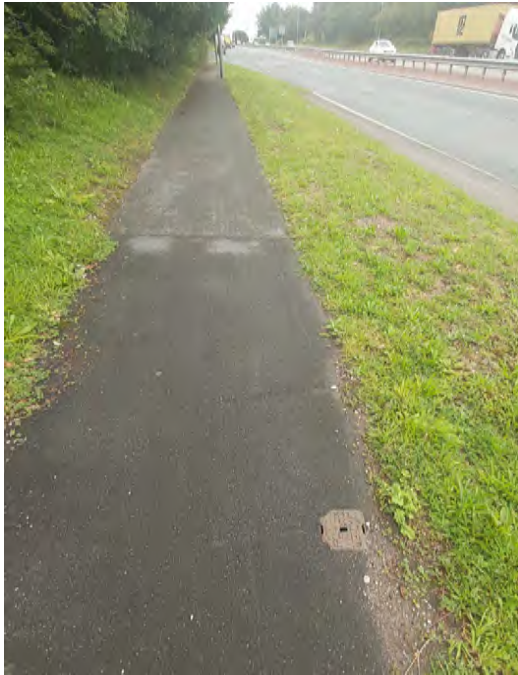
25. A580 pathway looking east from A5208 junction.

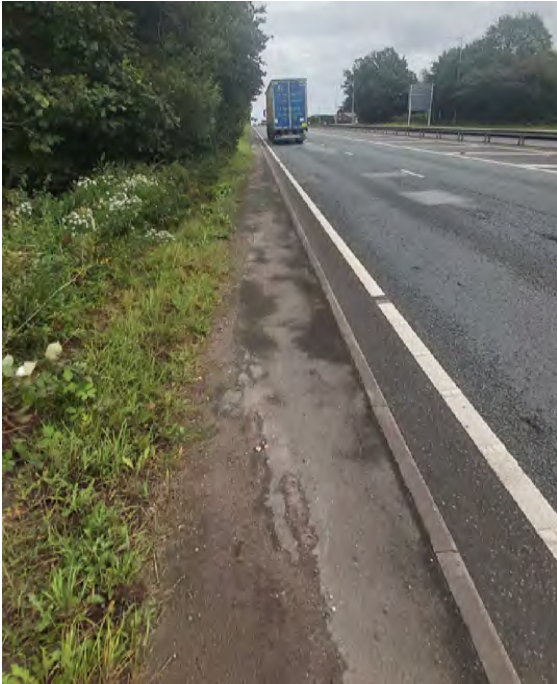
| SITE ACCESS | |
|---|---|
| Restrictions | TM/Road closures required for Cut Lane, Molly's Lane, Hewitt's Lane to allow GI.<br>A580 TM/Lane closure needed to allow GI on narrow path. |

26. The A580 pathway narrows significantly to the east.

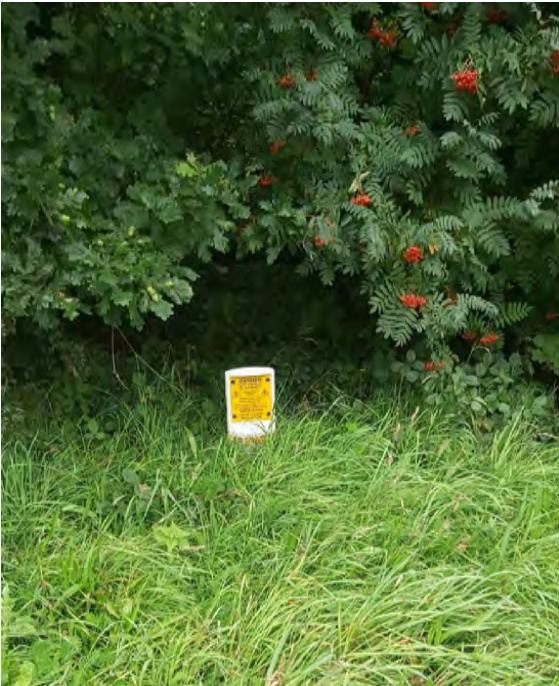
27. Buried 275kV indicator crossing A580 path 30 – 40m west of Hewitts Lane.

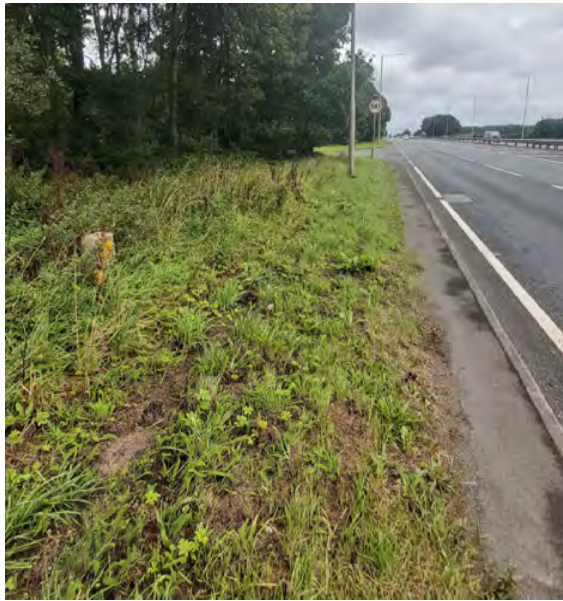
28. Hewitts Lane/A580 junction looking east, MP gas indicator to the left in the verge.

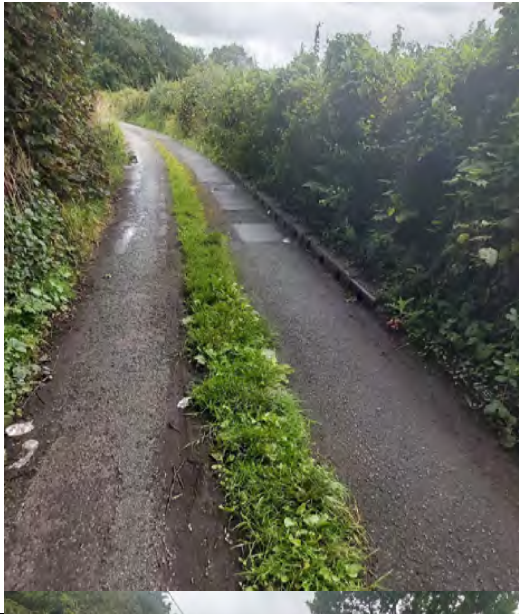
29. Hewitts Lane looking north, inbuilt drains along righthand side of road.

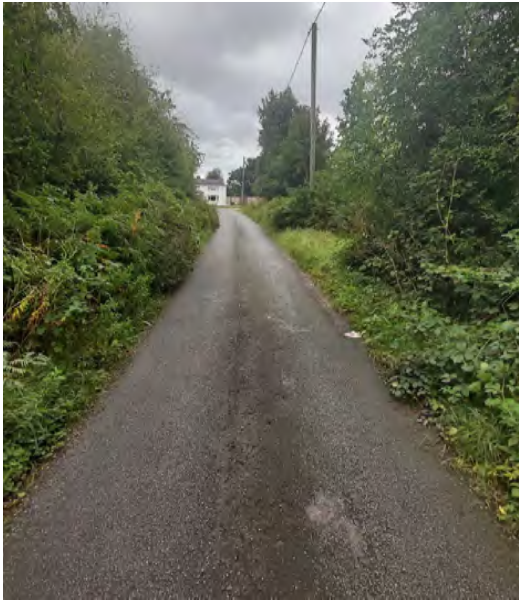
30. Hewitts Lane looking north back to Cut Lane junction.
