## COVER SYSTEM VALIDATION – KNOWSLEY EAST HUB

| <b>Project Name:</b> | Knowsley East Hub |
| <b>Project Number:</b> | 17-659 |
| <b>Plots:</b> | POS 101-105 |

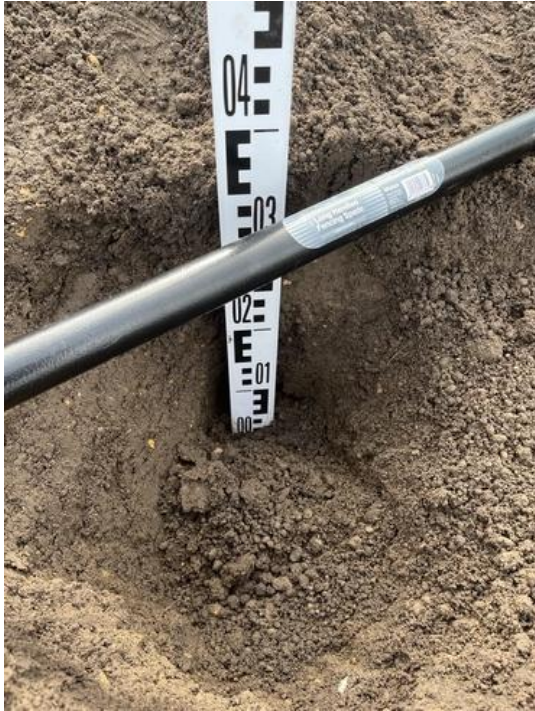
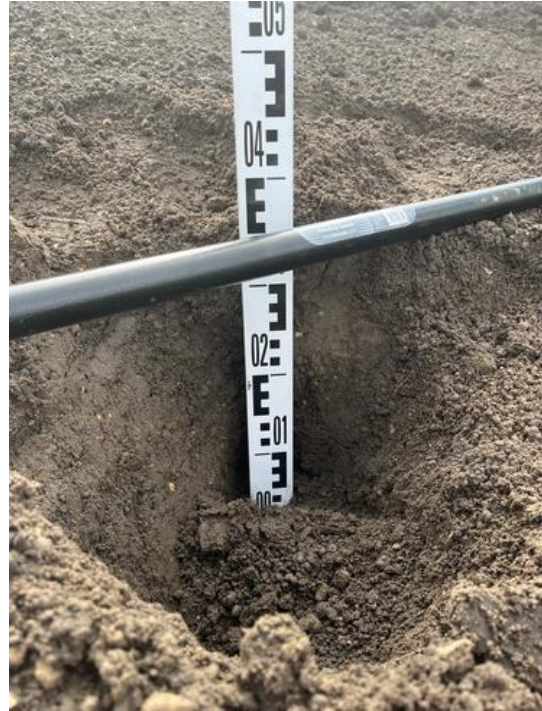
| <b>Depth of Cover System Materials (record the depth and support with Photo down the hole)</b> | | 350 |
| <b>Depth of Topsoil (mm)</b> | | 350 |

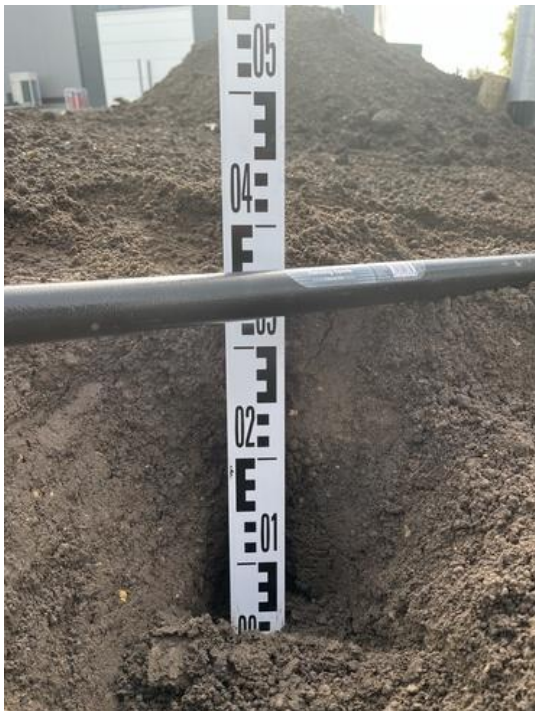
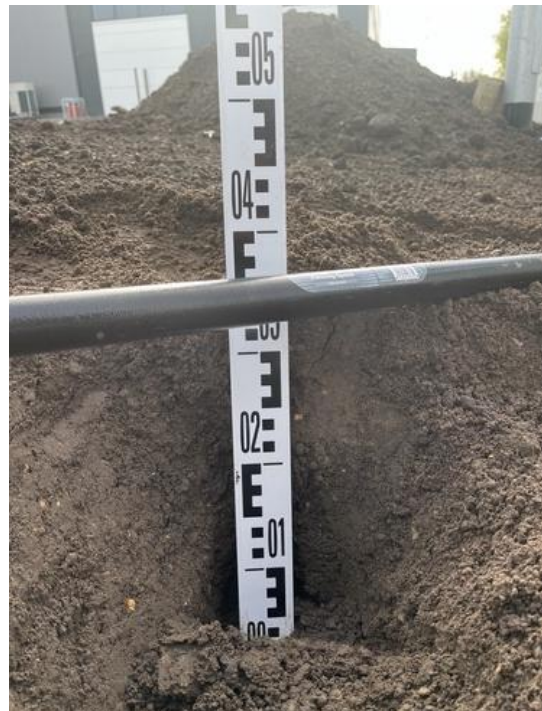
| <b>Depth of Cover System at Ground Level (Photo)</b> | | <input checked="" type="checkbox"/> |

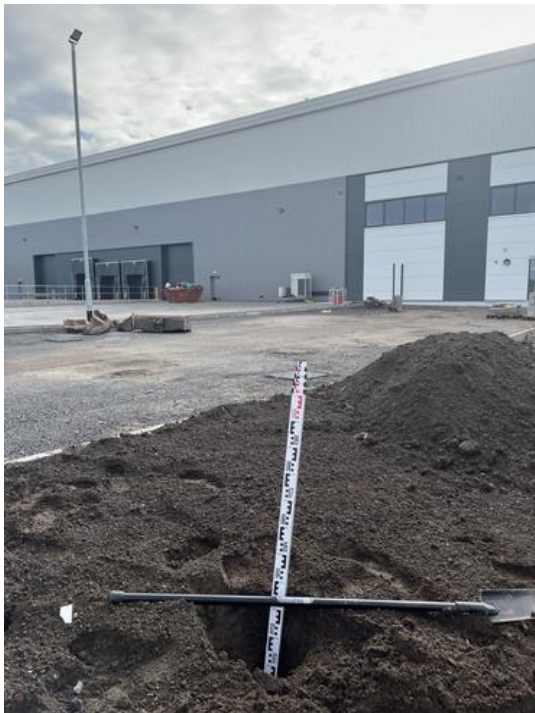
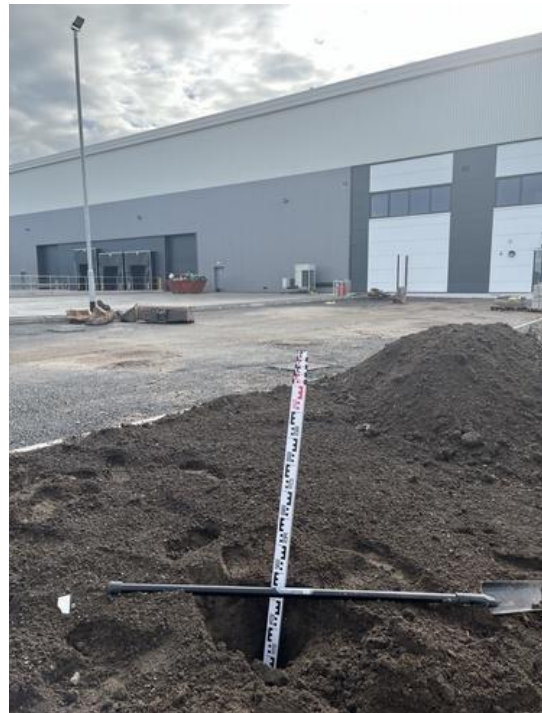
| <b>Depth of Cover System in Relation to Plot (Ensure the whole plot can be seen in the photo)</b> | | <input checked="" type="checkbox"/> |

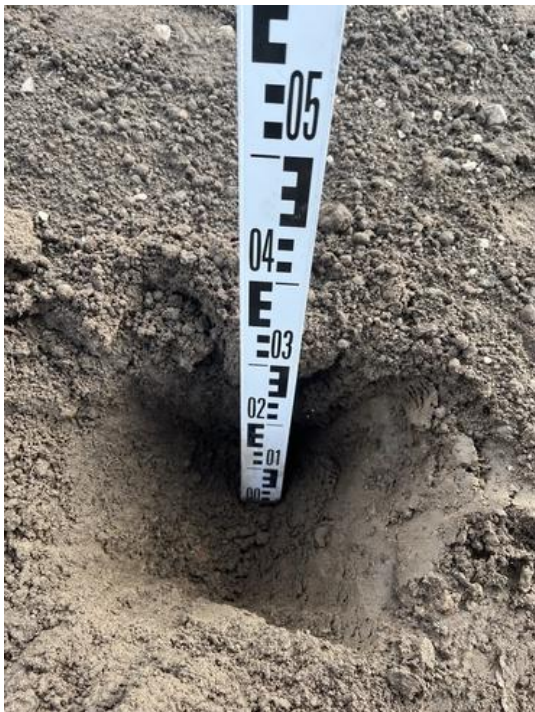
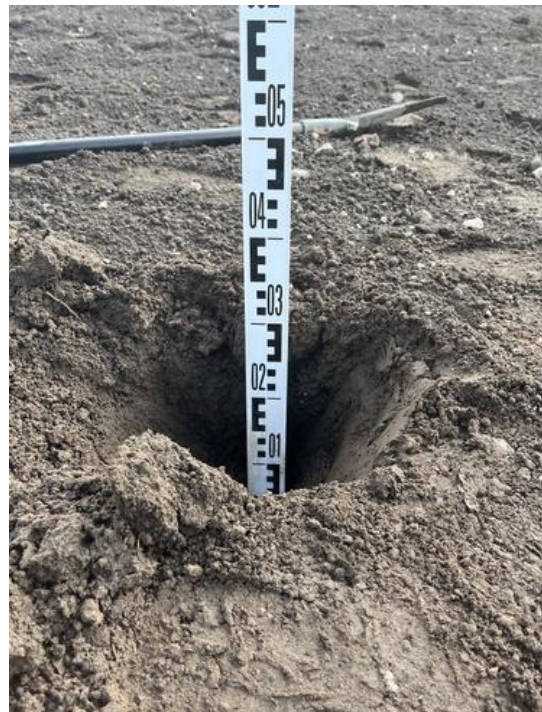
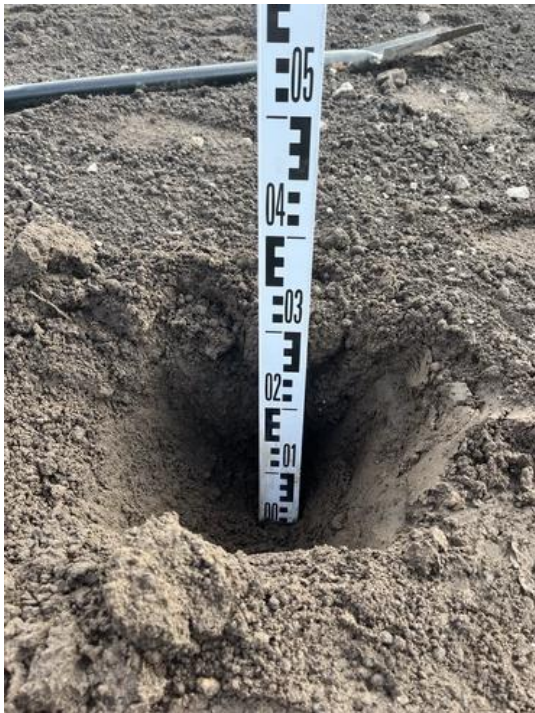
| <b>Depth of Cover System Materials (record the depth and support with Photo down the hole)</b> | | 300 |
| <b>Depth of Topsoil (mm)</b> | | 300 |

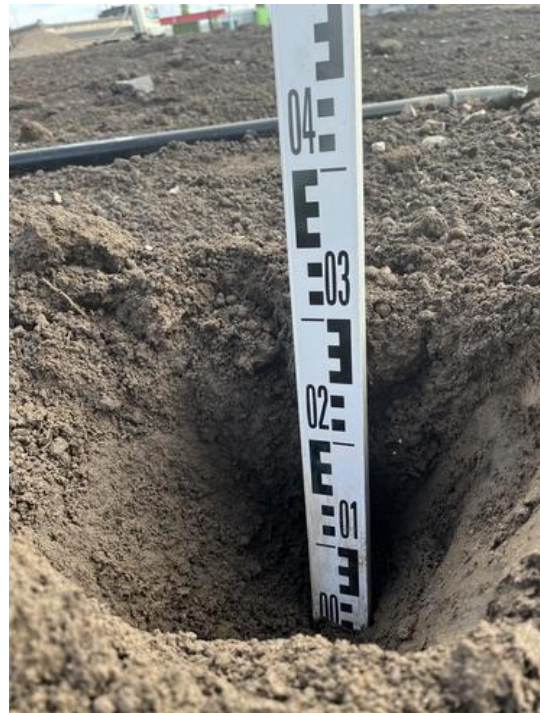
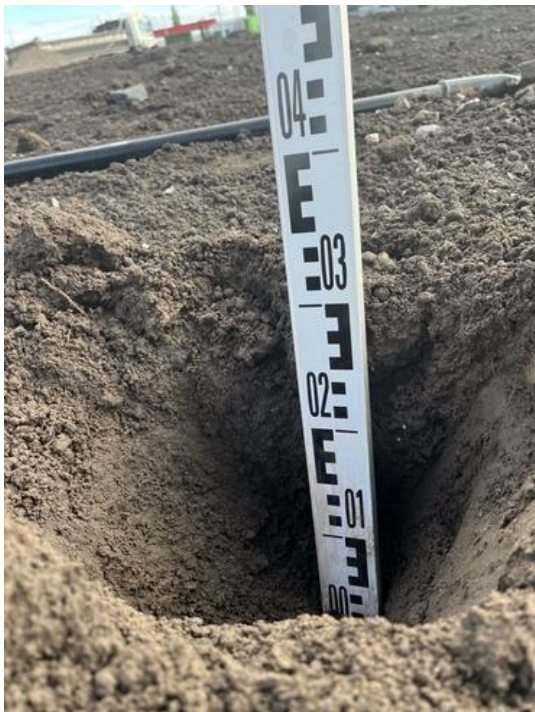
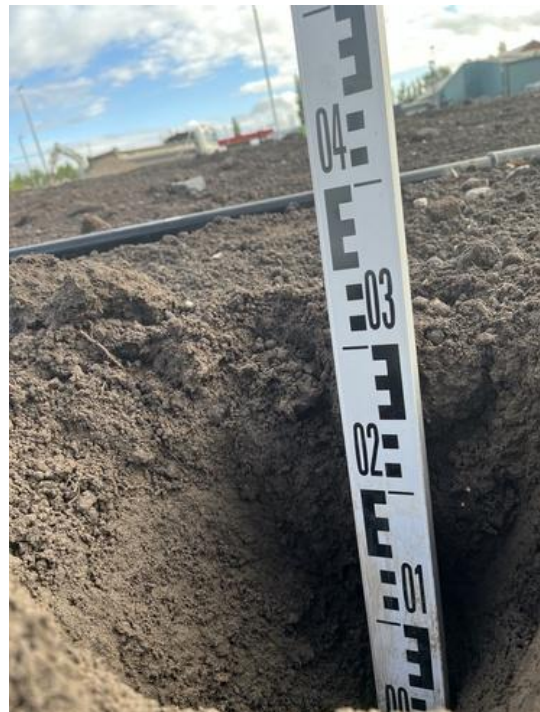
| <b>Depth of Cover System at Ground Level (Photo)</b> | | <input checked="" type="checkbox"/> |

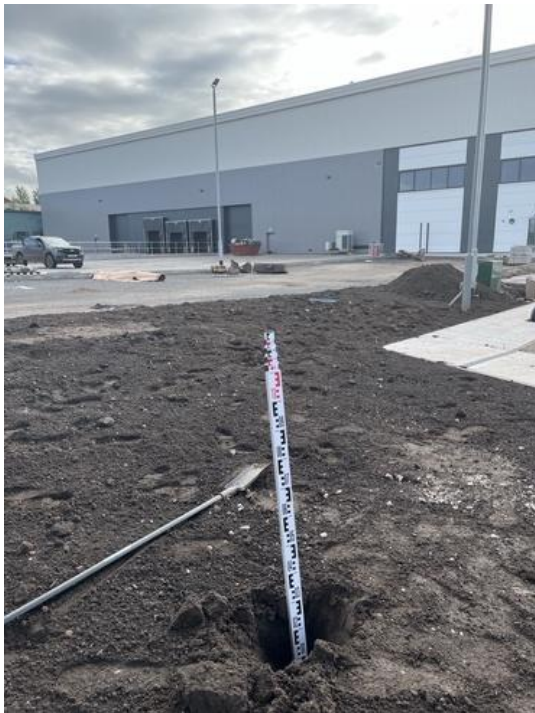
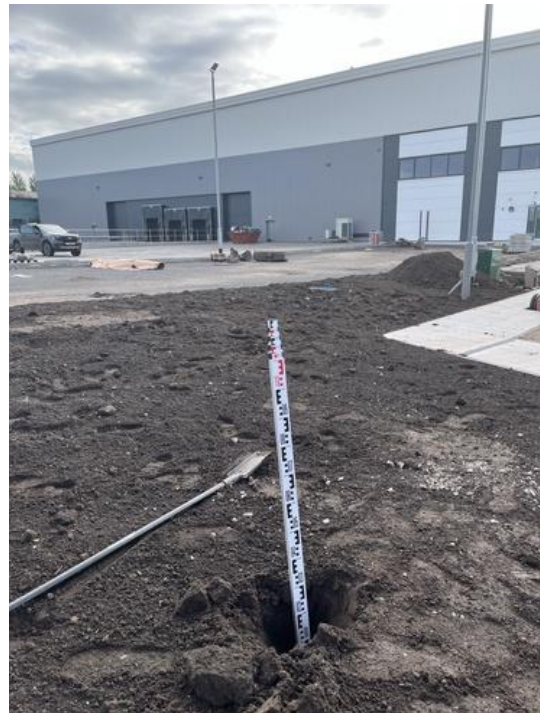
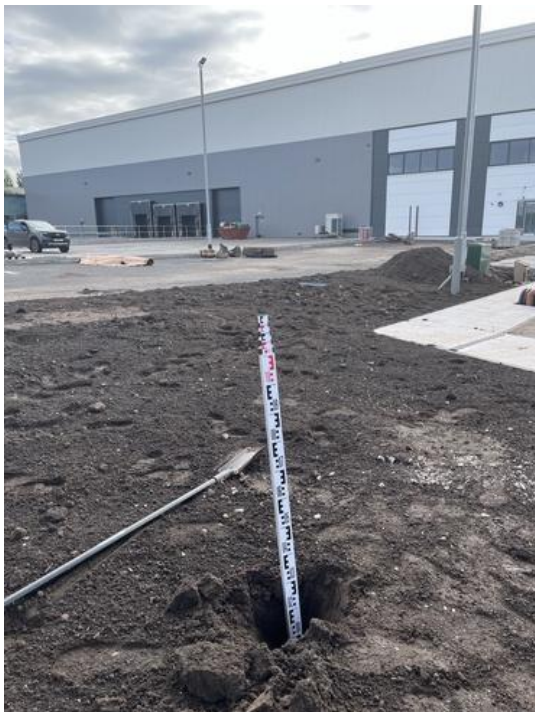
| <b>Depth of Cover System in Relation to Plot (Ensure the whole plot can be seen in the photo)</b> | | <input checked="" type="checkbox"/> |

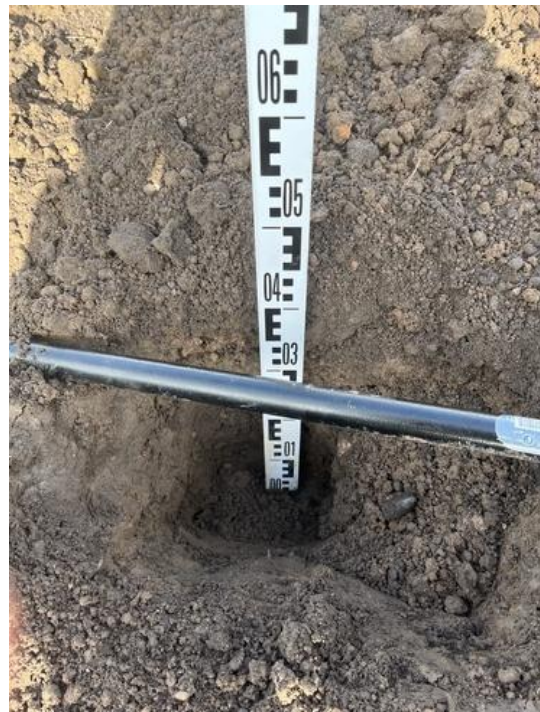
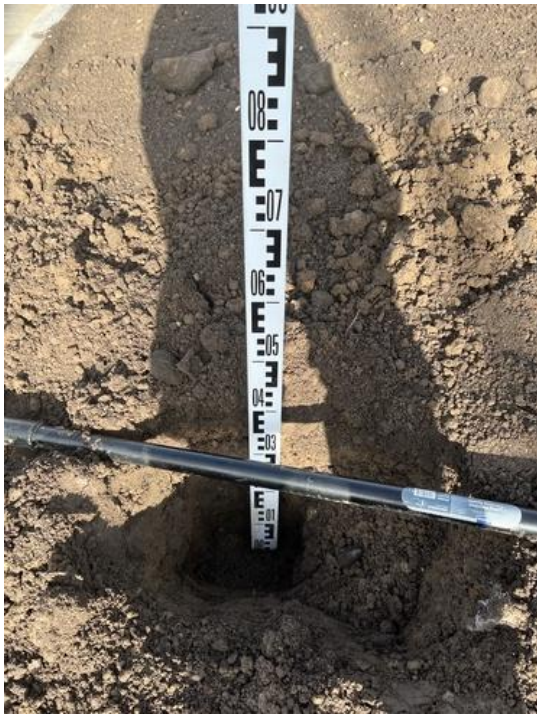
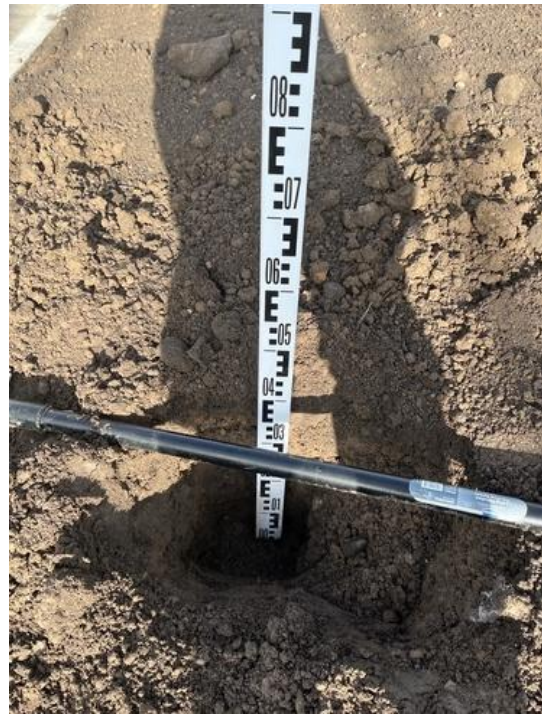
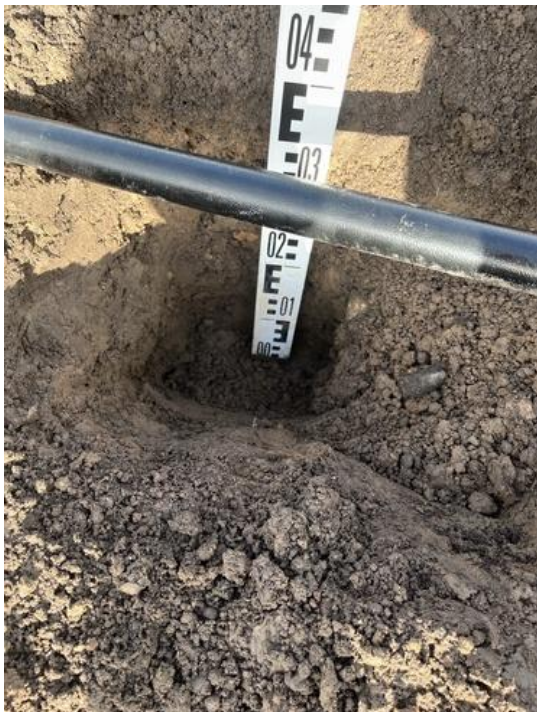
| <div> </div> <div> Photo 16      Photo 17      Photo 18      Photo 19 </div> | | |

| <b>Depth of Cover System Materials (record the depth and support with Photo down the hole)</b> | | 380 |
| <b>Depth of Topsoil (mm)</b> | 380 | |

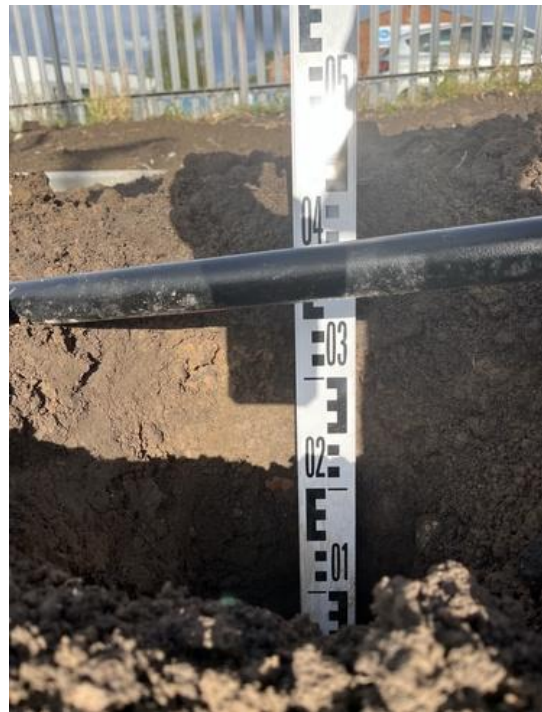
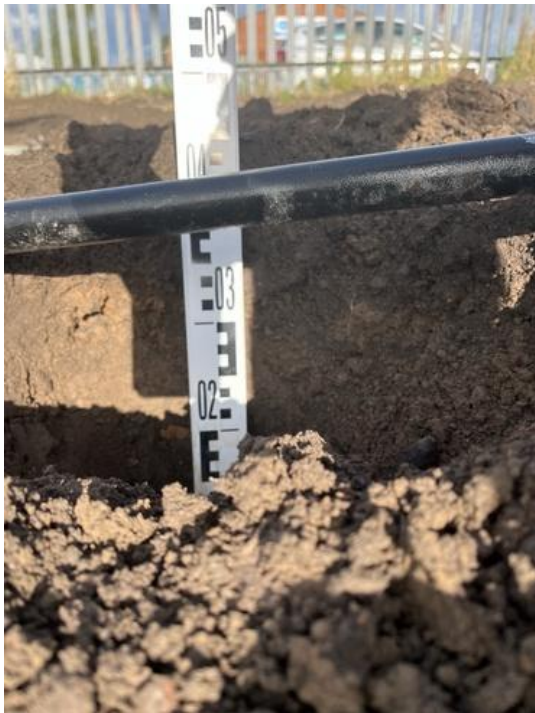
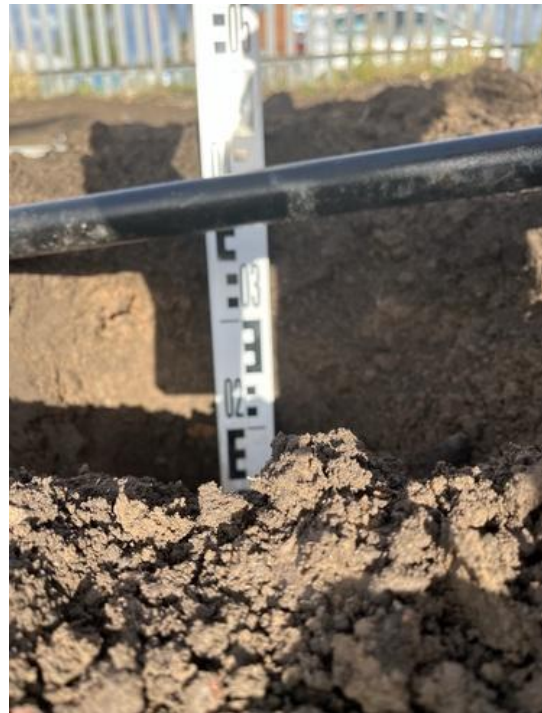
| <b>Depth of Cover System at Ground Level (Photo)</b> | ☒ | |

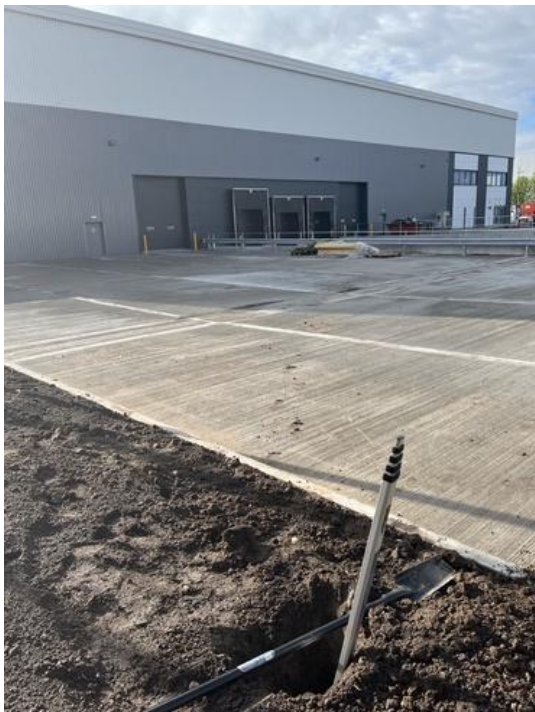
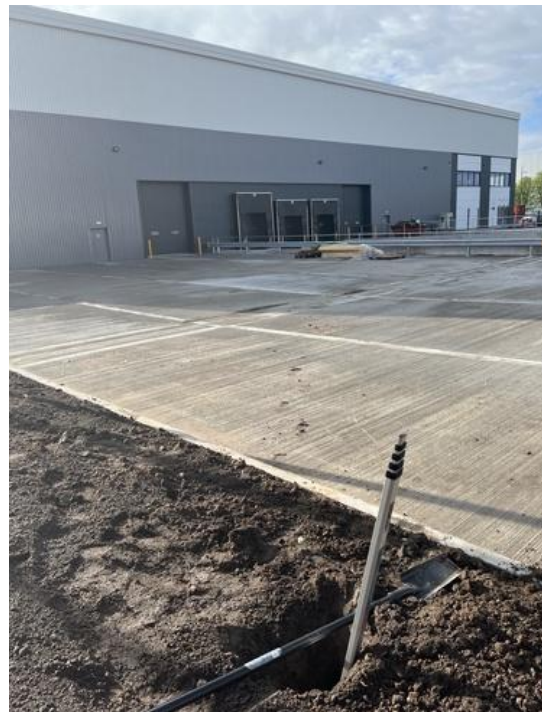
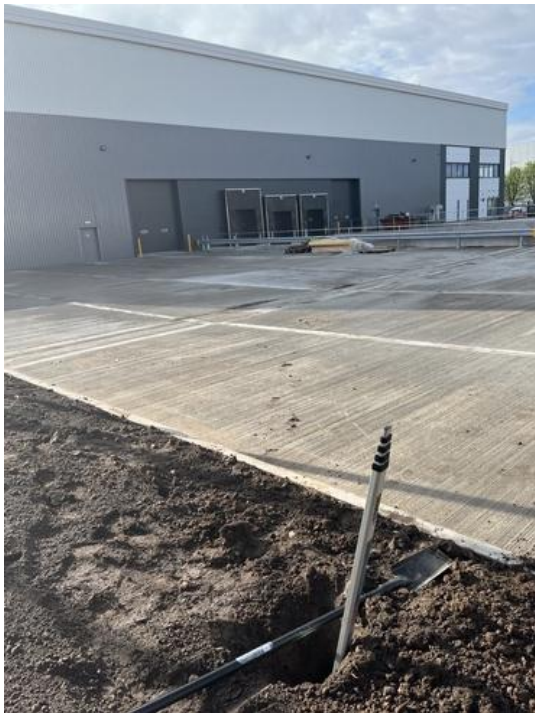
| <b>Depth of Cover System in Relation to Plot (Ensure the whole plot can be seen in the photo)</b> | ☒ | |

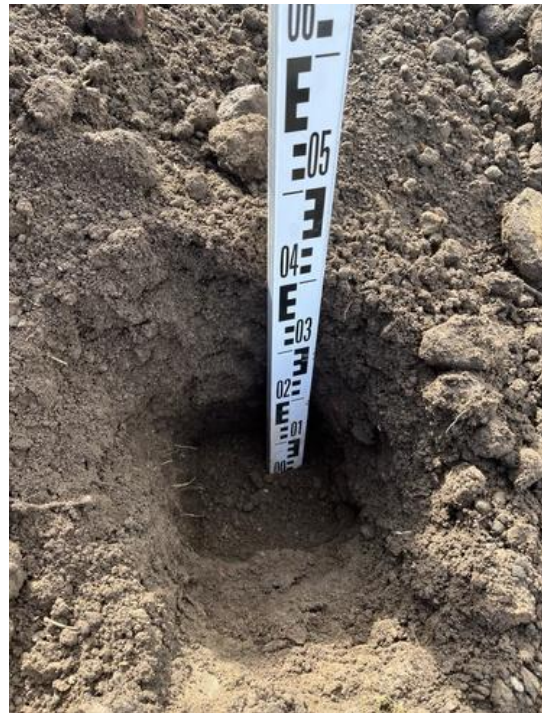
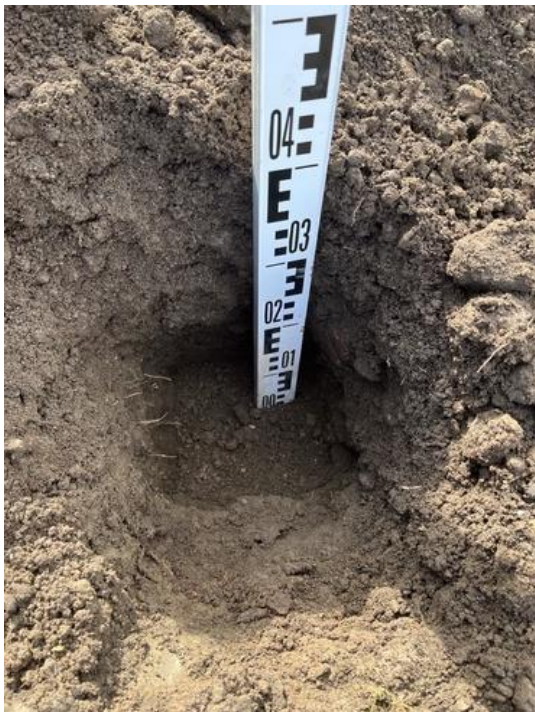
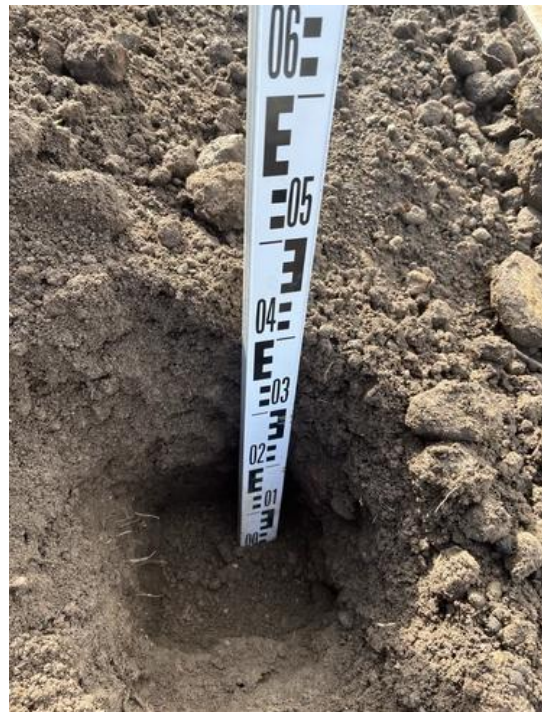
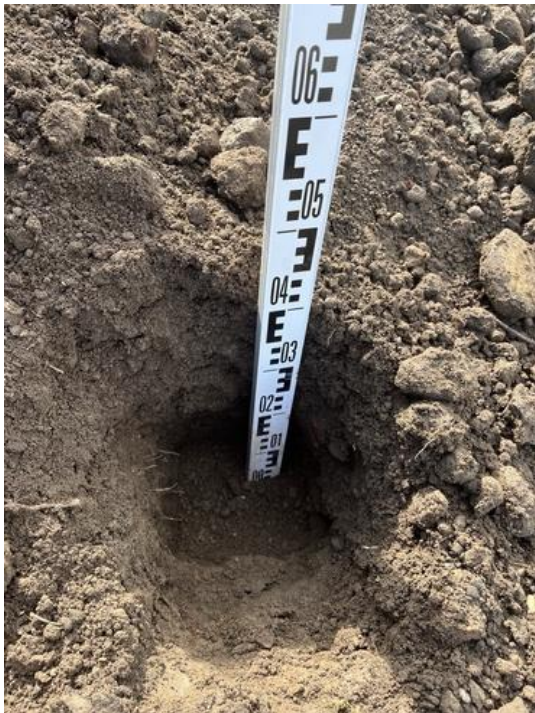
| <b>Depth of Cover System Materials (record the depth and support with Photo down the hole)</b> | | 400 |
| <b>Depth of Topsoil (mm)</b> | | 400 |

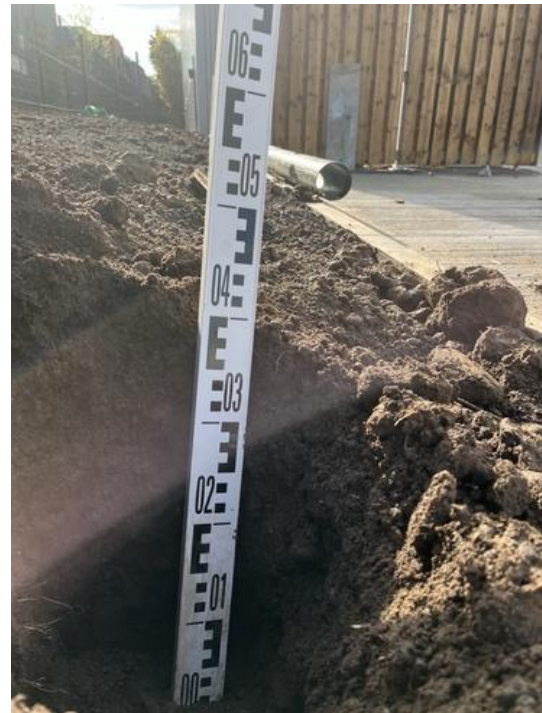
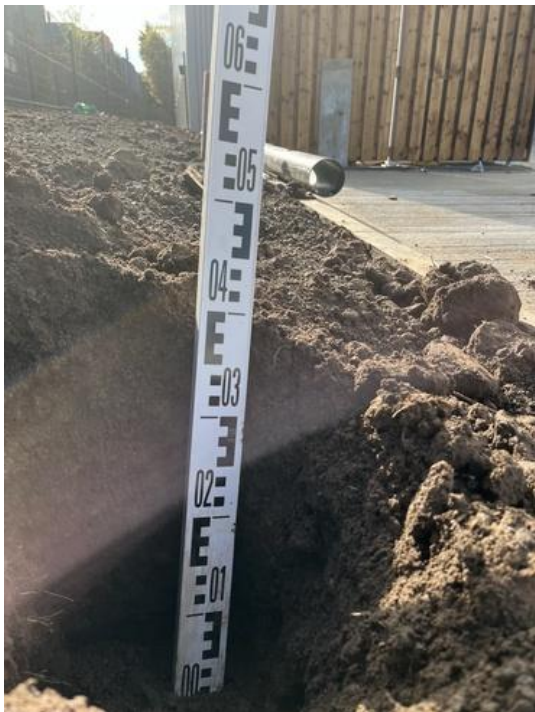
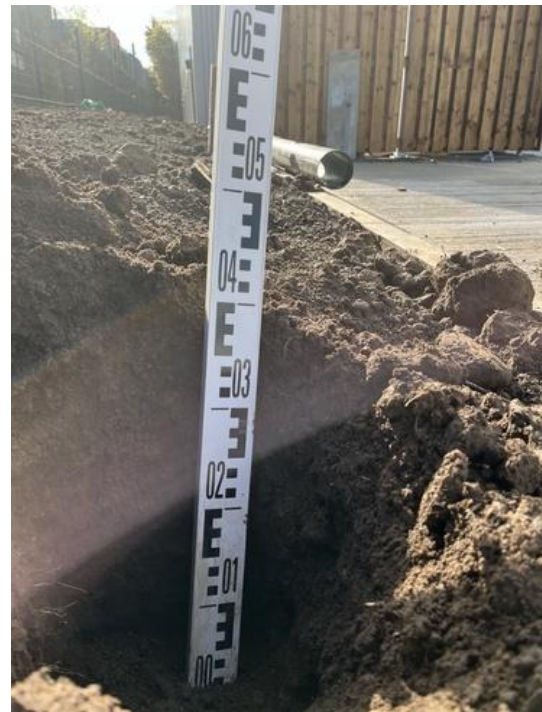
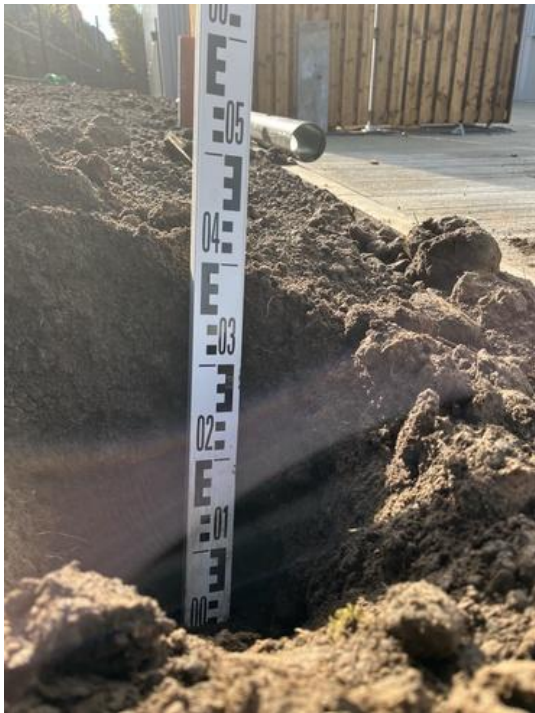
| <b>Depth of Cover System at Ground Level (Photo)</b> | | <input checked="" type="checkbox"/> |

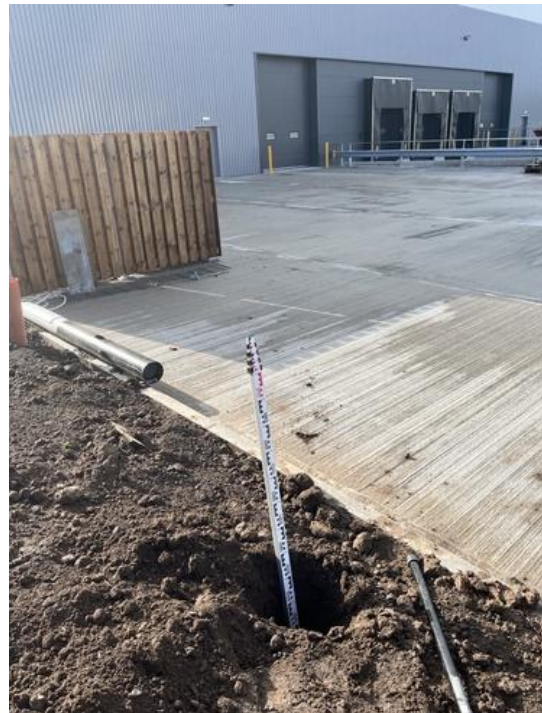
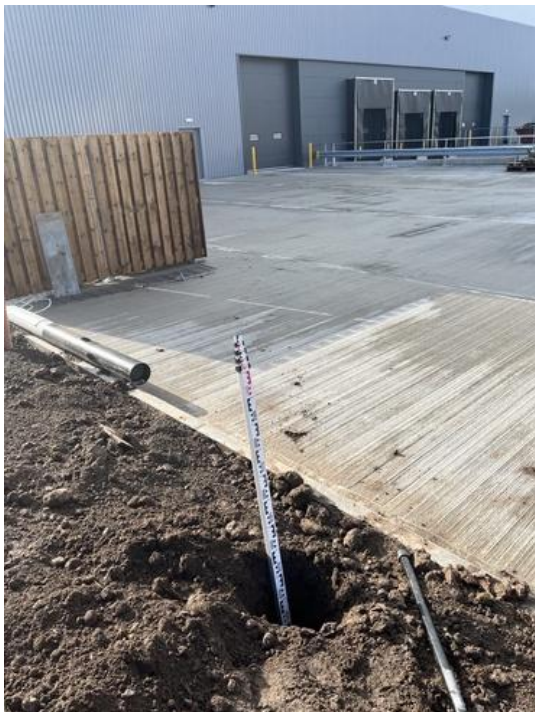
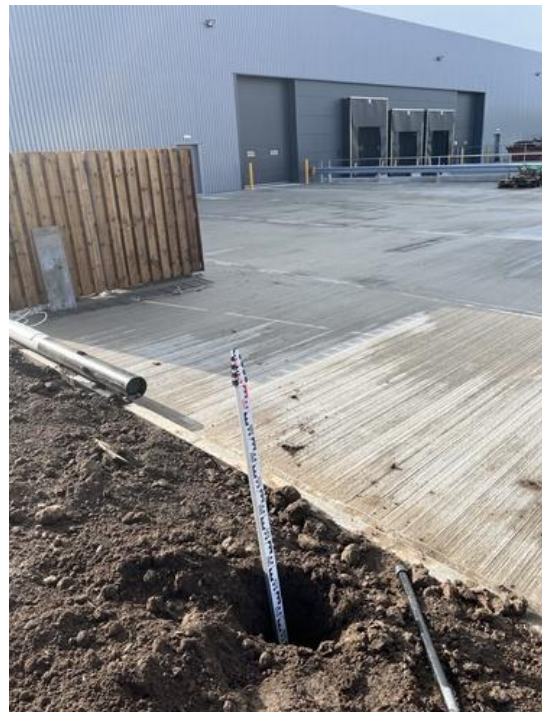
| <b>Depth of Cover System in Relation to Plot (Ensure the whole plot can be seen in the photo)</b> | | <input checked="" type="checkbox"/> |

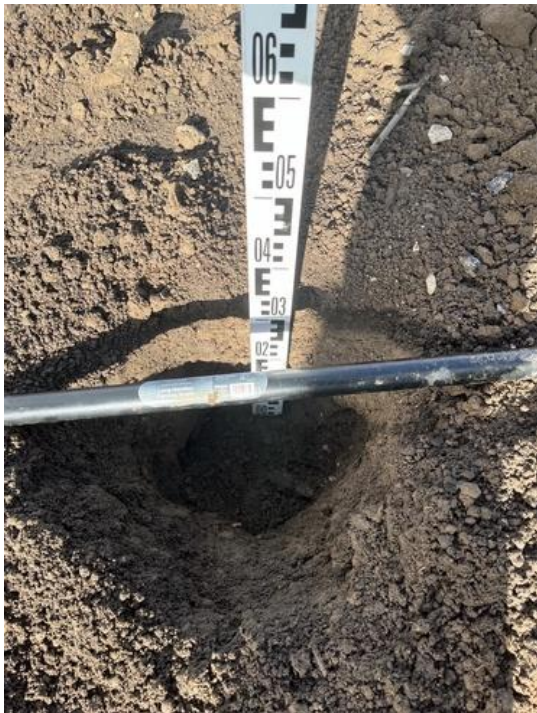
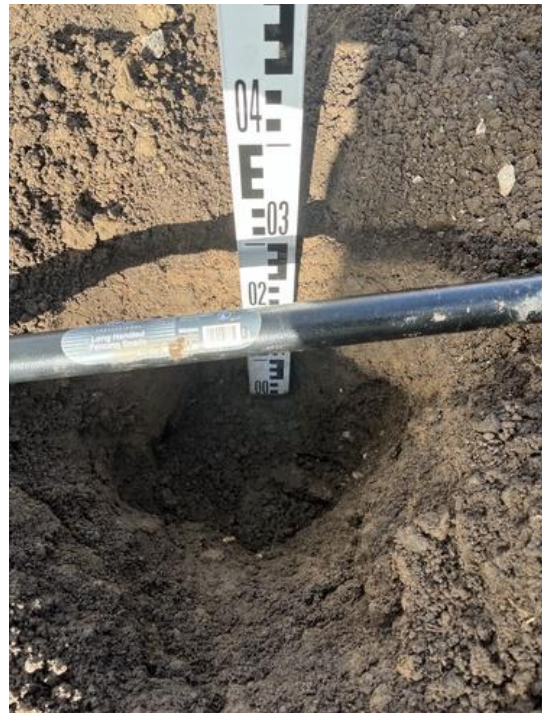
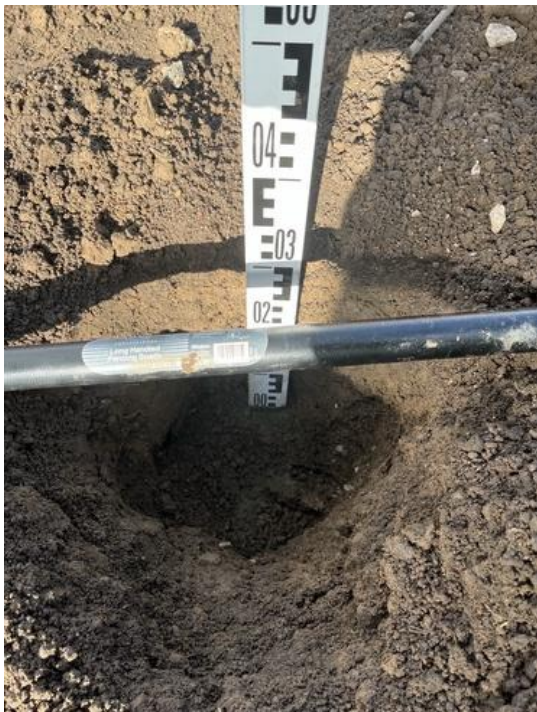
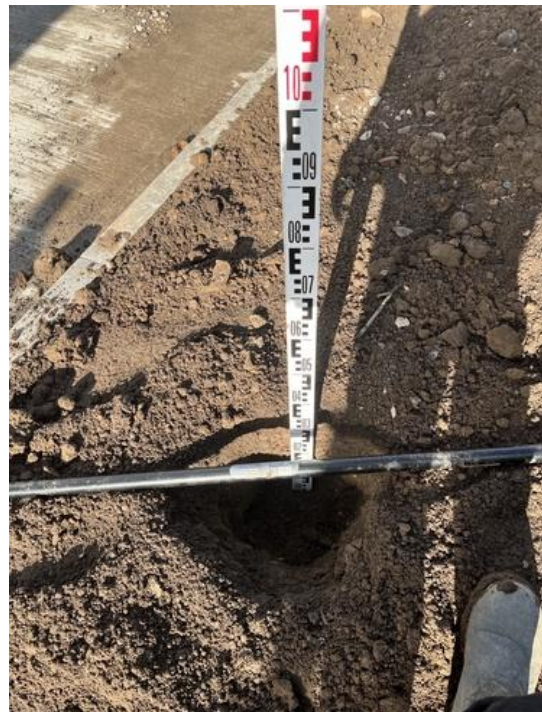
| <b>Depth of Cover System Materials (record the depth and support with Photo down the hole)</b> | | 300 |
| <b>Depth of Topsoil (mm)</b> | 300 | |

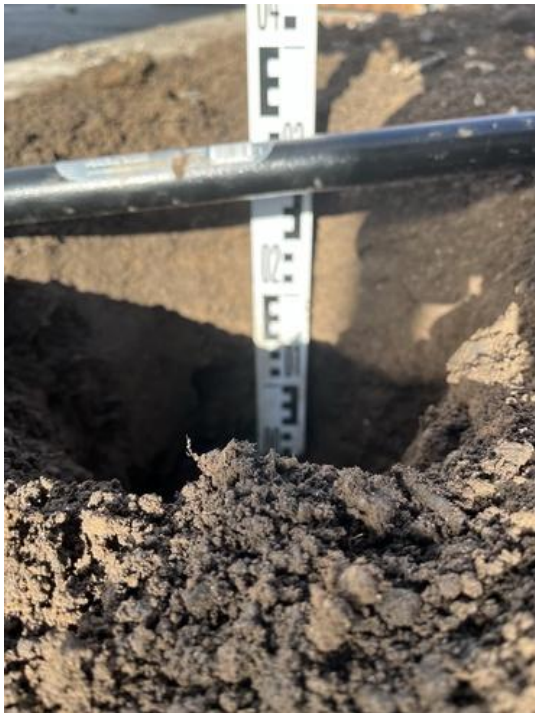
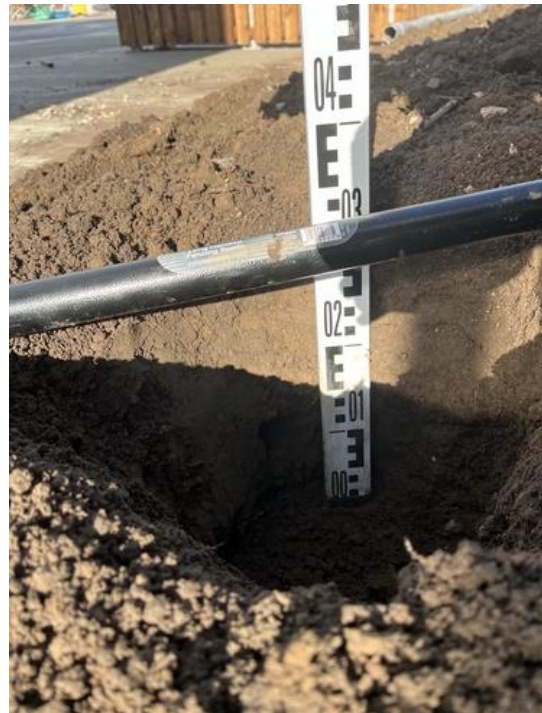
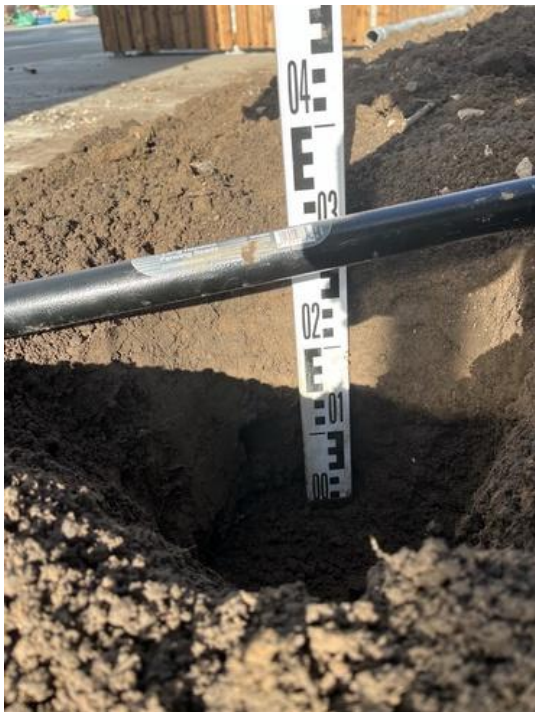
| <b>Depth of Cover System at Ground Level (Photo)</b> | | ☒ |

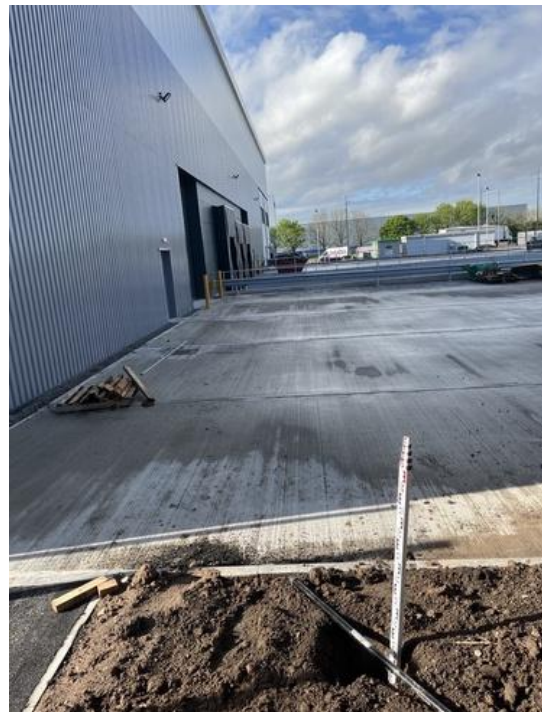
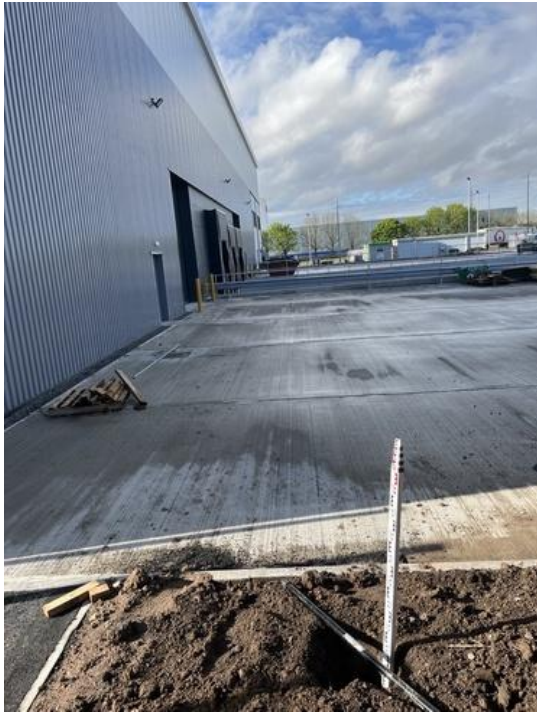
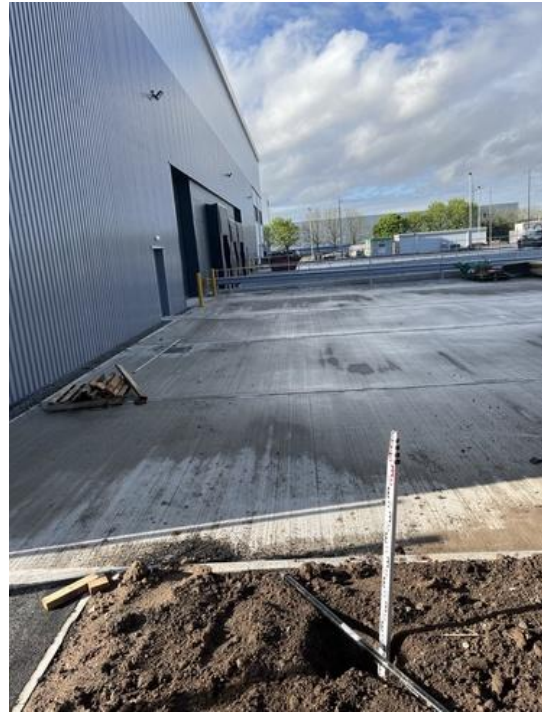
| <b>Depth of Cover System in Relation to Plot (Ensure the whole plot can be seen in the photo)</b> | | ☒ |
