# **East Halewood Historic Building Recording**

Redrow Homes Ltd (Lancashire)

13 June 2025

- 1.1 This Level 2 Historic Building Record has been prepared by Lichfields on behalf of Redrow Homes Lancashire. It relates to the 19<sup>th</sup>-century dwelling house located at 75 Baileys Lane.
- 1.2 The site is located east of Halewood, circa 11km from Liverpool City Centre and circa 3.3km north of the River Mersey. The site is bounded by the Finches development to the north (accessed from Lower Road) which is currently under construction by Redrow. To the east of the site is Baileys Lane and Finch Farm Woods is located to the southeast. There are no designated heritage assets within or adjacent to the site.
- 1.3 The proposed development seeks the demolition of 75 Baileys Lane. This Historic Building Record was requested by Knowsley Metropolitan Borough Council during pre-application discussions, to provide a lasting record of the property.

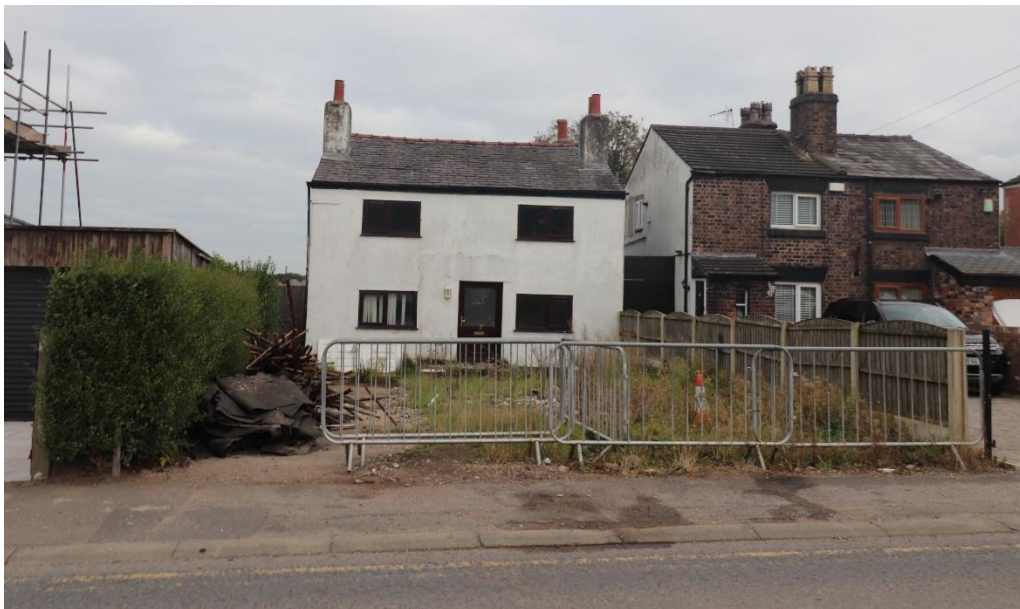
*Figure 2: Photograph of 75 Baileys Lane (white dwelling in centre of image)*

- 3.6 The building features two chimney stacks on the right-hand gable and one on the left. All external brickwork is rendered, including the chimneys. The roof of the main range appears to be slate, with terracotta ridge tiles, while the roof of the rear extension features concrete ridge tiles.

- 3.7 The front elevation is of three bays, featuring 4x4 pane casement windows, with a door in the central bay, slightly offset to the right.
- 3.8 The rear elevation comprises two windows at first floor level, and a door at ground floor level to the left. The right-hand side of the elevation adjoins a single-storey rear extension. The extension is of broadly square plan, with window openings to the rear and left (south) elevations, and a door to the right (north) elevation.

- 3.9 On the right-hand (south) gable of the main range, there is a single window at first floor level. On the left-hand (north) gable, there are windows at both ground and first floors. Given the proximity of neighbouring properties, these side windows may suggest the building was originally constructed in isolation, without assuming flank-to-flank neighbours.

- 3.10 All windows have been replaced with brown uPVC casements, with matching uPVC doors. No stone sills or lintels were identified, although most of these areas are concealed by render. Exposed sills comprise vertical courses of brick.

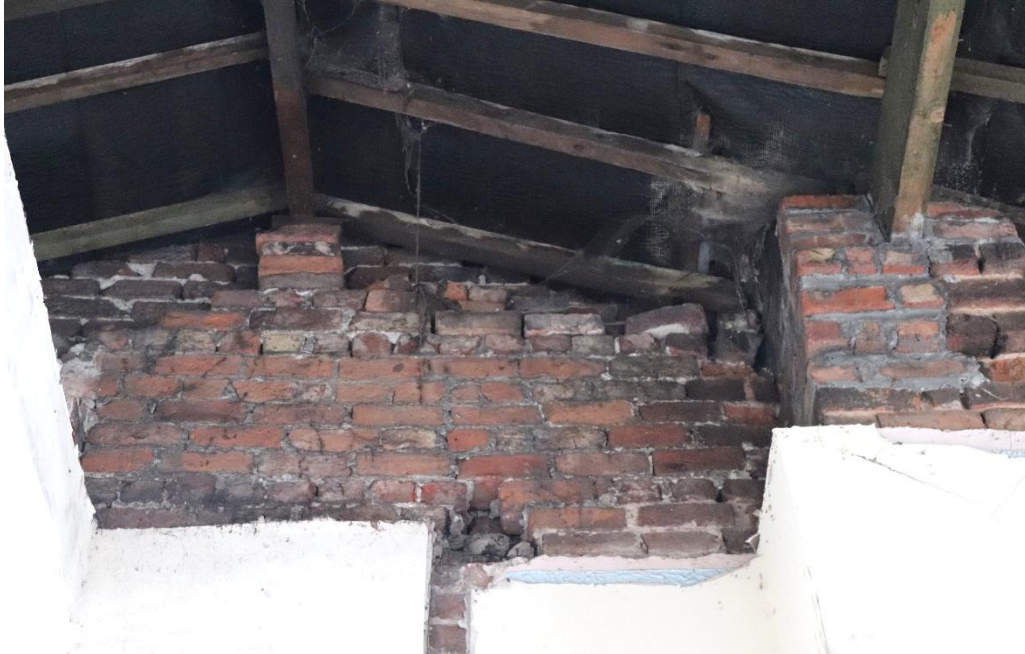
- 3.12 Most brickwork is concealed by plaster. In isolated exposed areas, some bricks appear handmade or early machine-made, with variation in size and tone. They are generally laid in a modified stretcher bond, with inconsistent courses of headers, as shown in Figure 3.

*Figure 3: External Wall Brickwork, from room C*

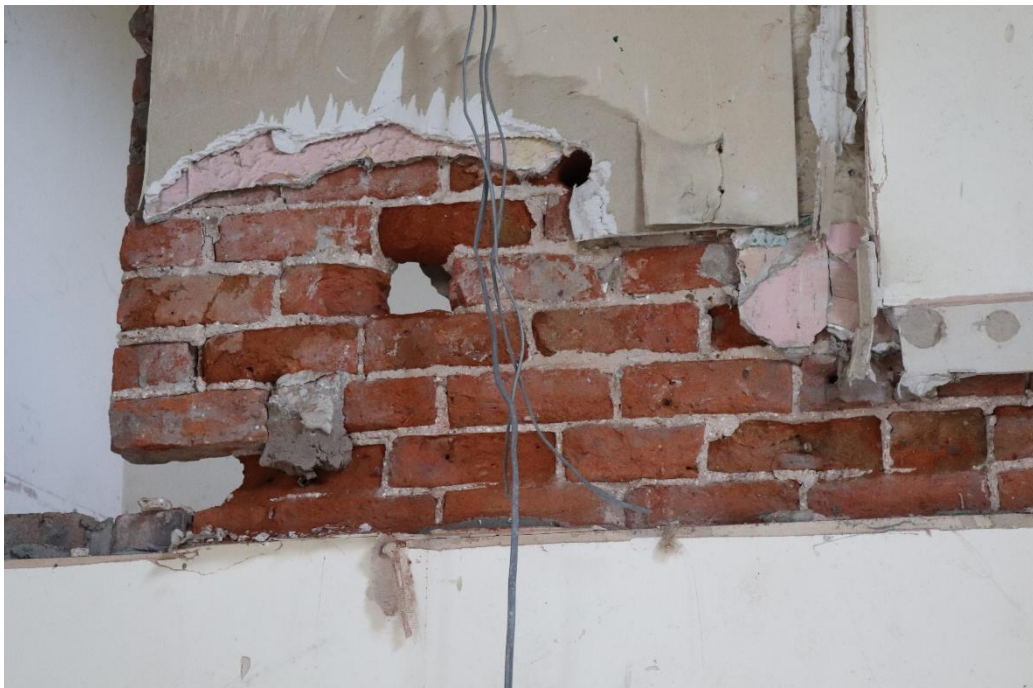
- 3.13 As shown Figure 4 below, some patches of internal brickwork are different in tone, indicating later repair or remodelling.

*Figure 4: Internal Wall Brickwork, from Room C*

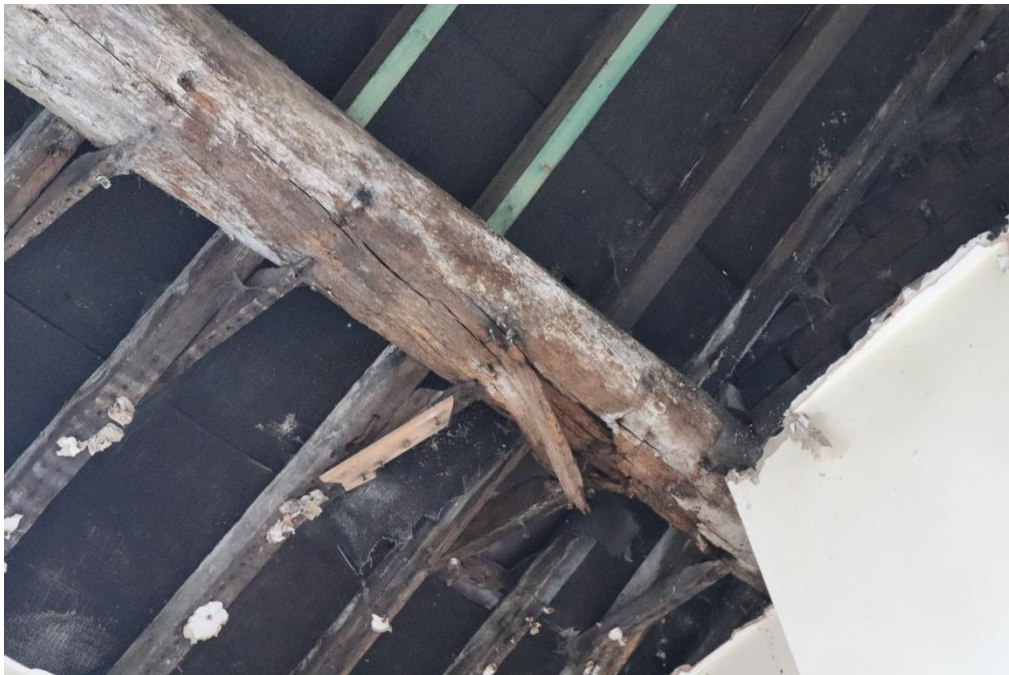
- 3.17 There are no surviving skirting boards, architraves, or doorframes.
- 3.18 The roof timbers are exposed and appear to be a mix of older, likely hand-cut or early machine-sawn rafters, and more recent insertions. This suggests alteration over time. A rounded timber purlin in the rear pitch appears to be historic. The roof timbers are shown in Figures 5 and 6 below.

*Figure 5: Principal purlin on rear pitch, Room C*

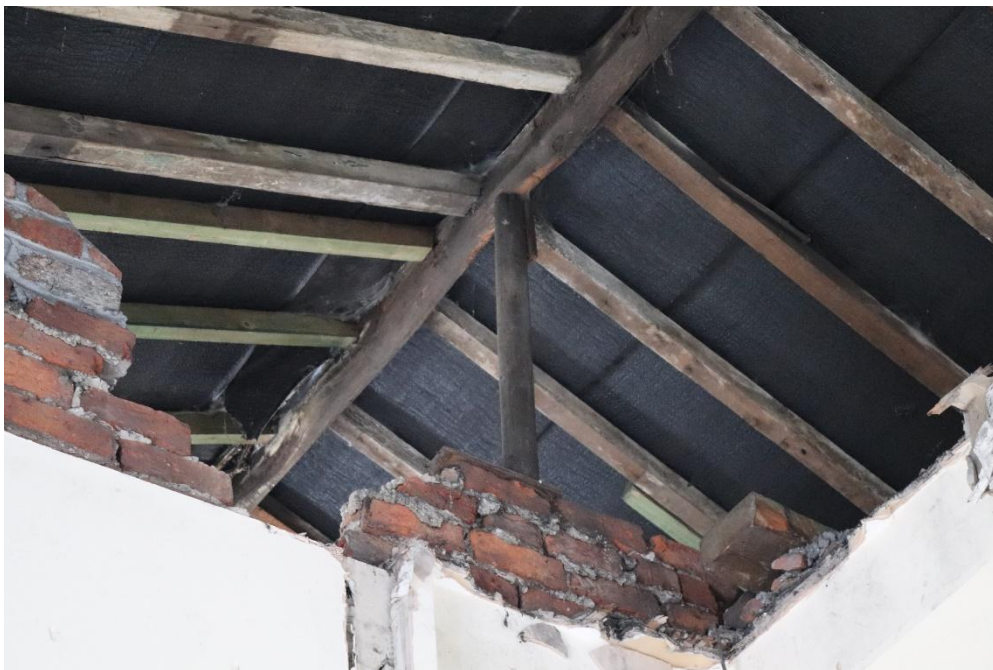
*Figure 6: Roof timber, viewed from Room B*

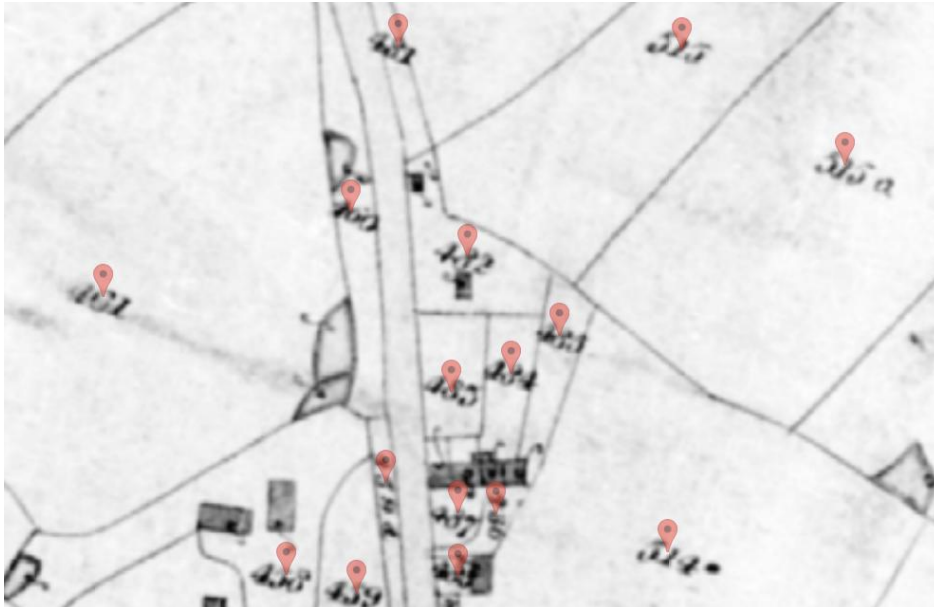
- 4.5 The rear (eastern) part of the site appears as enclosed agricultural land on the 1843 tithe map, recorded as a mixture of meadow and arable land under the ownership of the Earl of Derby and William Grapel. Within the site there is one post-medieval building recorded on the HER comprising No. 75 Baileys Lane MME21310. The HER entry simply sets out the mapping evidence. The house is not shown on the Derby Estate plan 1783/5 or the 1803 Enclosure plan. Greenwood's map of 1818 shows two buildings on the east side of the road in this general vicinity. The accuracy, scale and detail of these maps however do not allow a detailed understanding of the site or the position of built development. A building is shown in the general location of 75 Bailey's Lane on the 1843 Tithe Map, recorded within Plot 482. The building is described as a 'cottage and garden' occupied by Thomas Tarbock and belonging to Charles Pownall, a farmer from Prescott.

*Figure 8 - 1843 Tithe Apportionment Map*

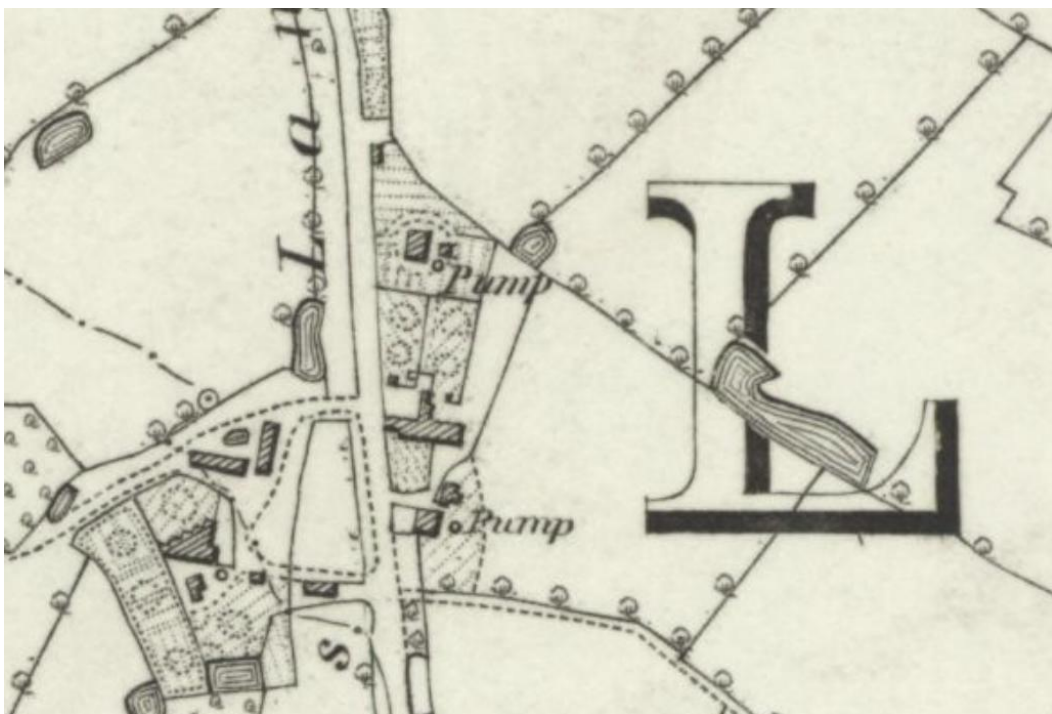
- 4.6 The 1st edition 6 Inch Series OS map of 1849 shows a building with a small outbuilding to the rear. The 25 Inch Series OS map of 1904 shows a detached building on the site, sitting flush with the southern party boundary to the southern plot. Two semi-detached properties are situated in the plots to the south. The 25 Inch Series OS appears to reflect the building on site today. Due to the scale and accuracy of the earlier OS maps, it is not entirely clear

*Figure 9 - Lancashire Sheet CXIV (Six-inch Series) Surveyed: 1845 to 1846, Published: 1849*
