# **Bat Roost Suitability Assessment (BRSA)**

**75 Bailey's Lane, Halewood**

**June 2025**

For and on behalf of  
**Redrow Homes Limited**

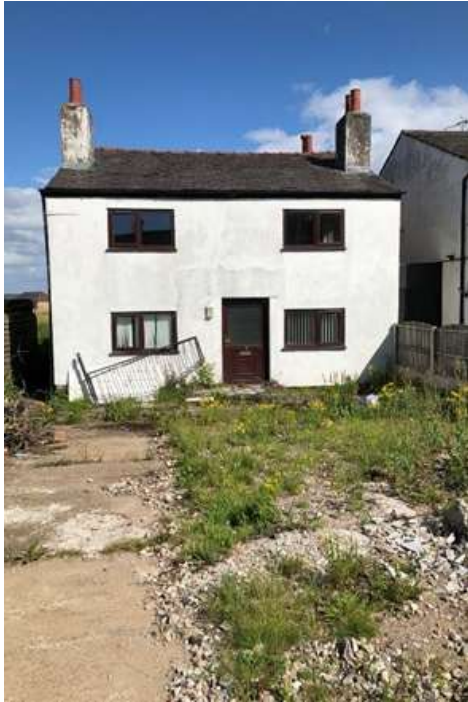
**Photo 1:** General view of Building 1 from Bailey's Lane (west)

- 4.2 This is a double pitched two storey rendered building with gable ends, and slate tile roof. Single storey elements extend from the eastern elevation. The building is in reasonable condition and generally well sealed, supporting no Potential Roost Features (PRFs).
- 4.3 There were some instances of lifted slate tiles, and displaced mortar along the ridge which have the potential to support roosting. Additionally, the barge boards were lifted away from the render in areas along the western elevation, offering a PRF.
- 4.4 Building 1 is assessed as offering *low* suitability for roosting bats.

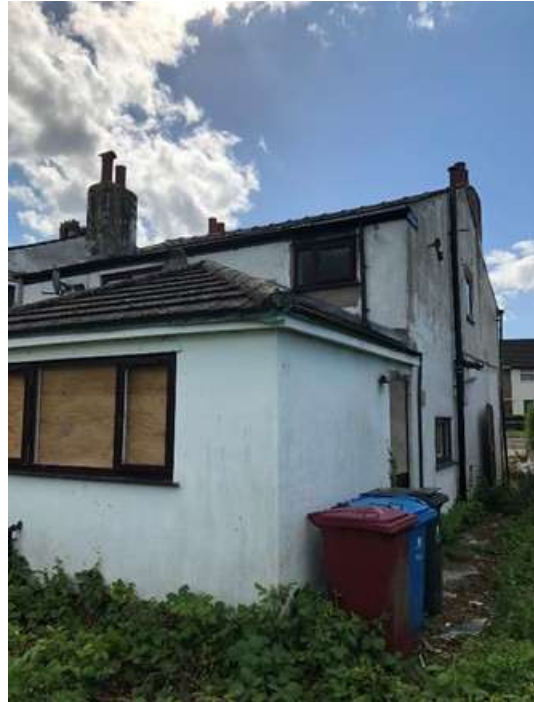
**Photo 2:** General view of Building 1 – eastern elevation and northern gable end

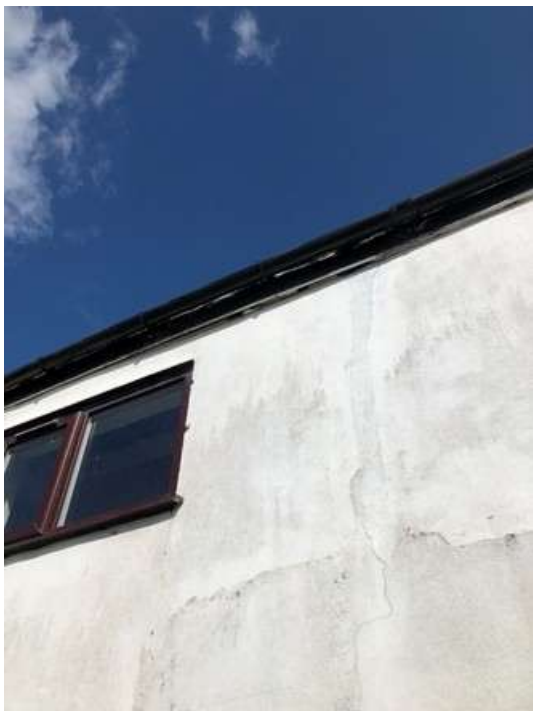
**Photo 3:** Lifted barge board on western elevation of Building 1.

- 5.1 Building 1 is assessed as having low suitability for roosting bats. A single emergence survey was undertaken on the 29<sup>th</sup> of August 2024 which concluded the likely absence of roosting. The results of this survey are presented in a separate report<sup>3</sup>.
- 5.2 Building 2 is assessed as having *negligible* suitability for roosting bats and its demolition presents minimal risk of impacting on bat roosts.

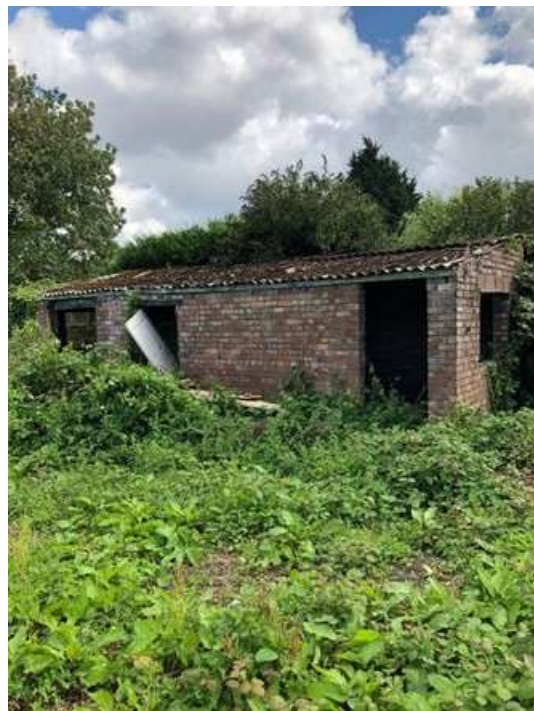
- 4.5 This is a single storey outbuilding constructed of solid brick, with single pitch corrugated asbestos roof on a wooden frame.
- 4.6 The interior is open and exposed and supported no evidence of roosting bats.

**Photo 4:** General view of Building 2.

4.7 This building is assessed as offering negligible suitability for roosting bats.

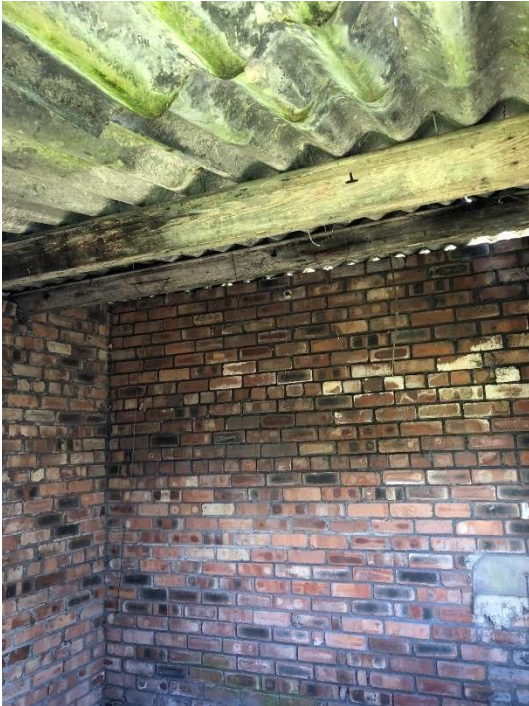
**Photo 5:** Building 2 interior
