Cockpit House, Prescott  
for Purcell

Elevation D

Drawing No: X54/107    Rev: -    Scale: 1:100 @ A3    Date: October 2021

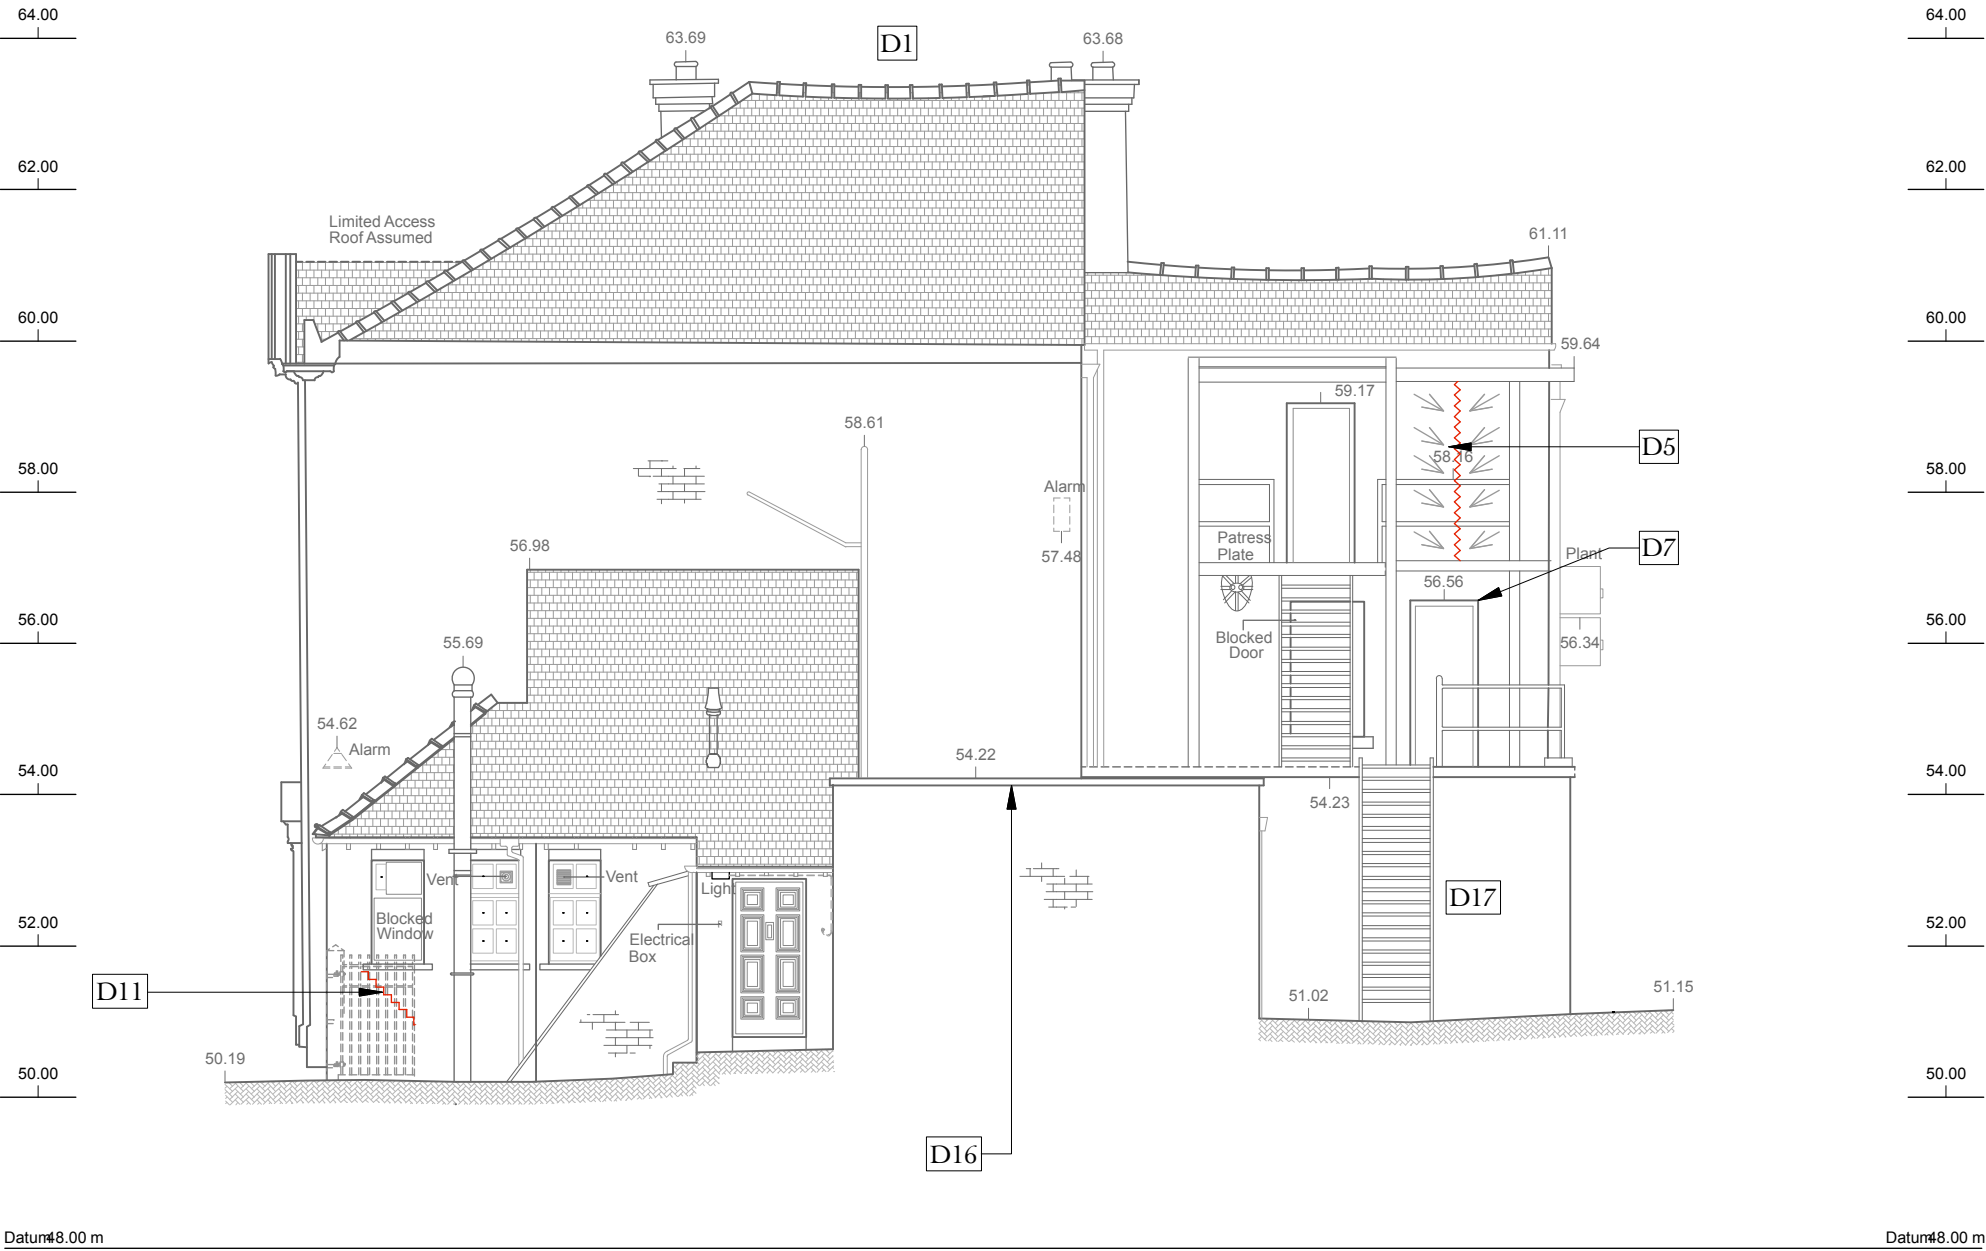
| Ref. | STRUCTURAL DEFECT |
|---|---|
| D1 | Refer to Elevation A – A1. Ridgeline sags. |
| D5 | Bed joints lean in/down to either side of the boundary between old and new, bricks have been replaced this side. |
| D7 | Stone lintel with timber lintel above |
| D11 | 5mm diagonal crack from cill of blocked window |
| D16 | Refer to Elevation B – B10. Open perpend joint in coping. |
| D17 | Existing steel escape staircase not fit for purpose |
