Cockpit House, Prescott  
for Purcell

Elevation E

Drawing No: X54/108 Rev: - Scale: 1:100 @ A3 Date: October 2021

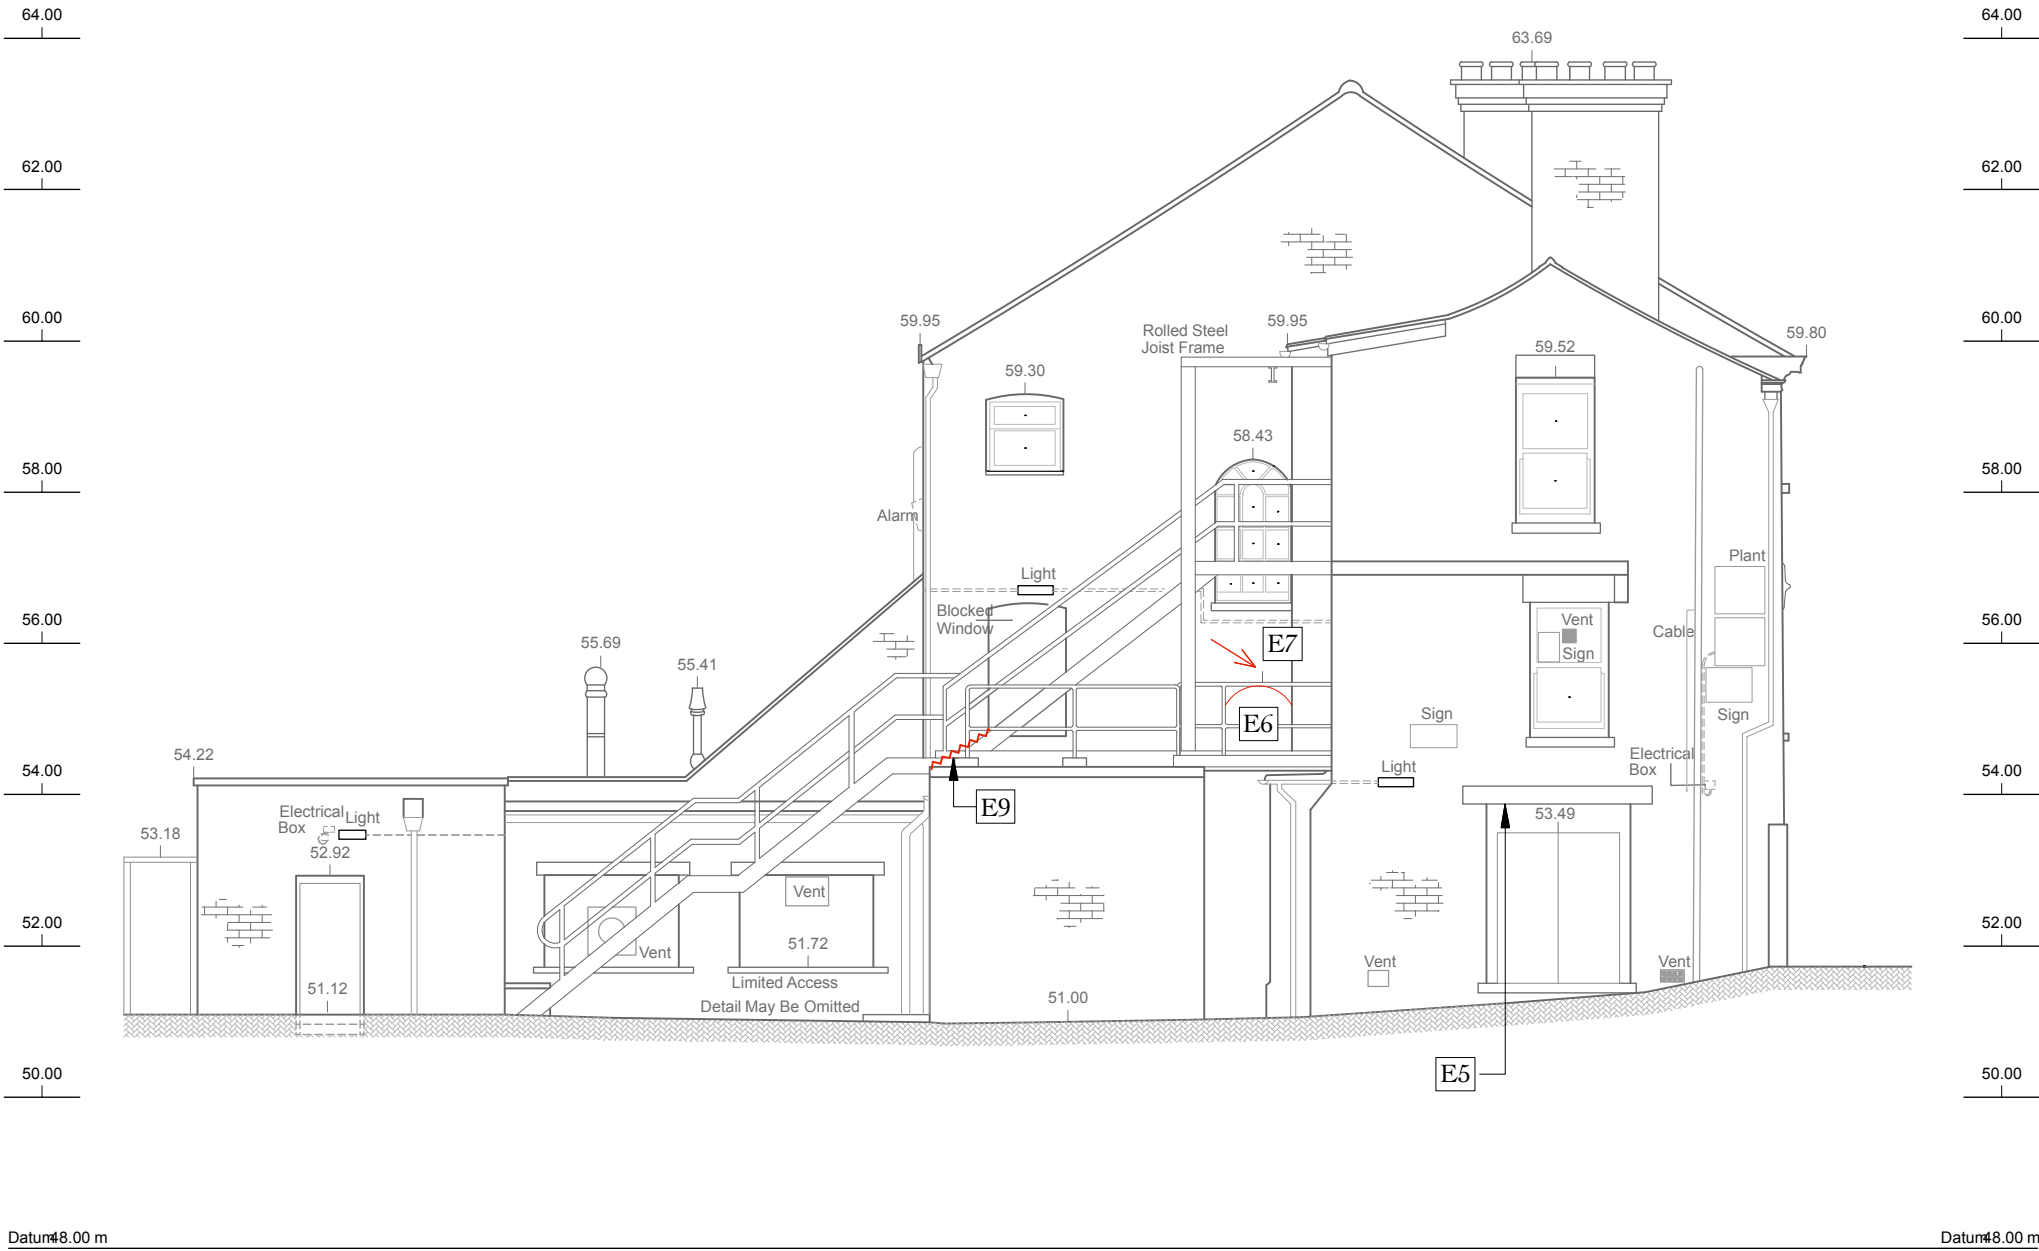
| Ref. | STRUCTURAL DEFECT |
|---|---|
| E5 | Timber lintel covered by felt |
| E6 | Distorted arched window |
| E7 | Bed joints crank down significantly, hairline crack from cill to arch |
| E9 | 10mm diagonal crack from cill to corner at interface with flat roof |
