Cockpit House, Prescot  
for Purcell

Ground Floor Plan

Drawing No: X54/101    Rev: -    Scale: 1:100 @ A3    Date: October 2021

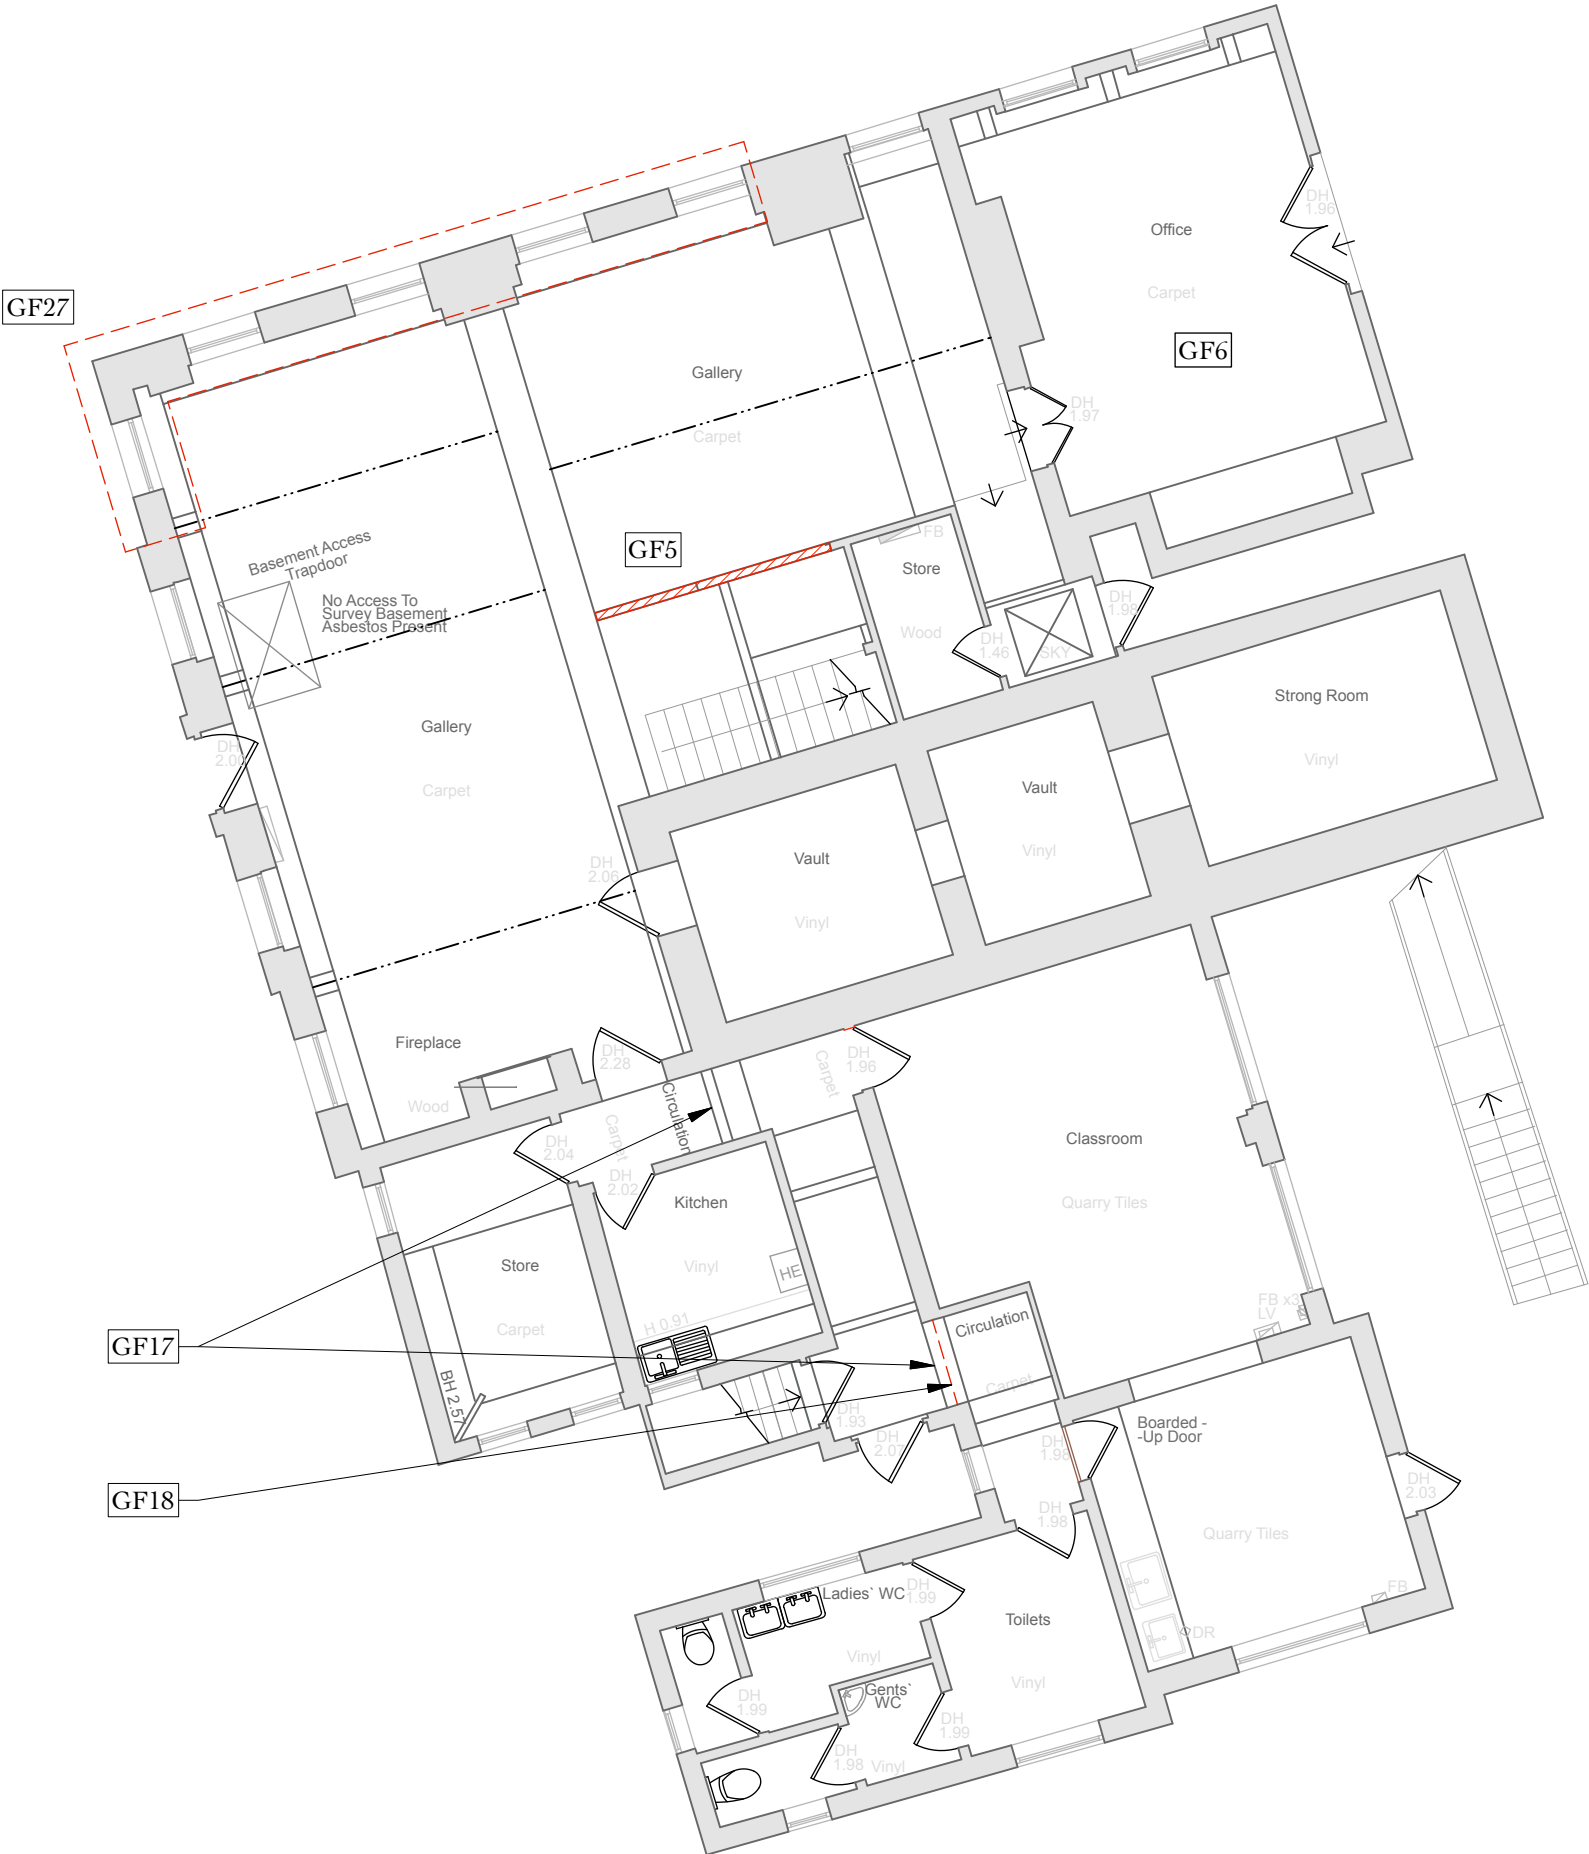
| Ref. | STRUCTURAL DEFECT |
|---|---|
| GF5 | Load bearing wall above. Partition has been removed. |
| GF6 | No access |
| GF17 | Openings through here |
| GF18 | Cracked lintel – investigate |
| GF27 | Refer to Elevation A – A23. Wall rebuilt when bank use ended. |
