## Huyton Cricket Club, Huyton

### Phase 2 Geo-Environmental Investigation Report

For: Breck Homes Ltd

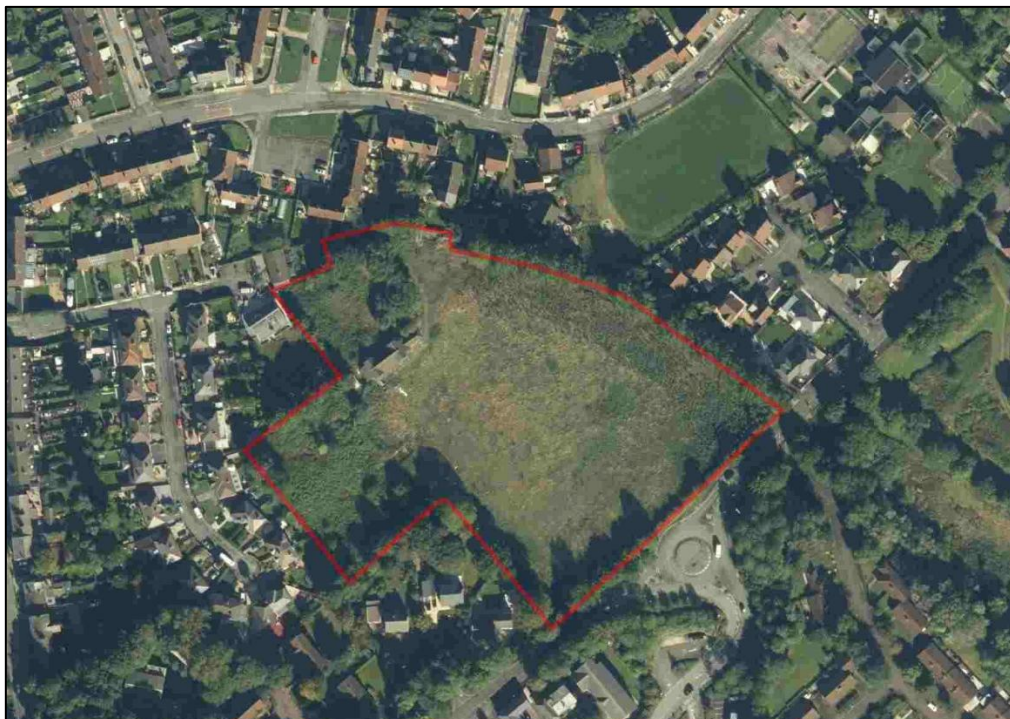
The site currently comprises a vacant plot of land, formerly a cricket club and bowling green, with associated hardstanding in the north-western site section and a disused grade II listed cricket club pavilion building. The site is bound by residential properties to the north, west and south and Huyton Lane to the east and south-east. Access to the site is off the unnamed track running from Huyton Lane along the north-eastern site boundary. An aerial photo of the site is included below and a site location plan is contained in Appendix 2.

*Figure 1: Aerial image of the site dated September 2022.*

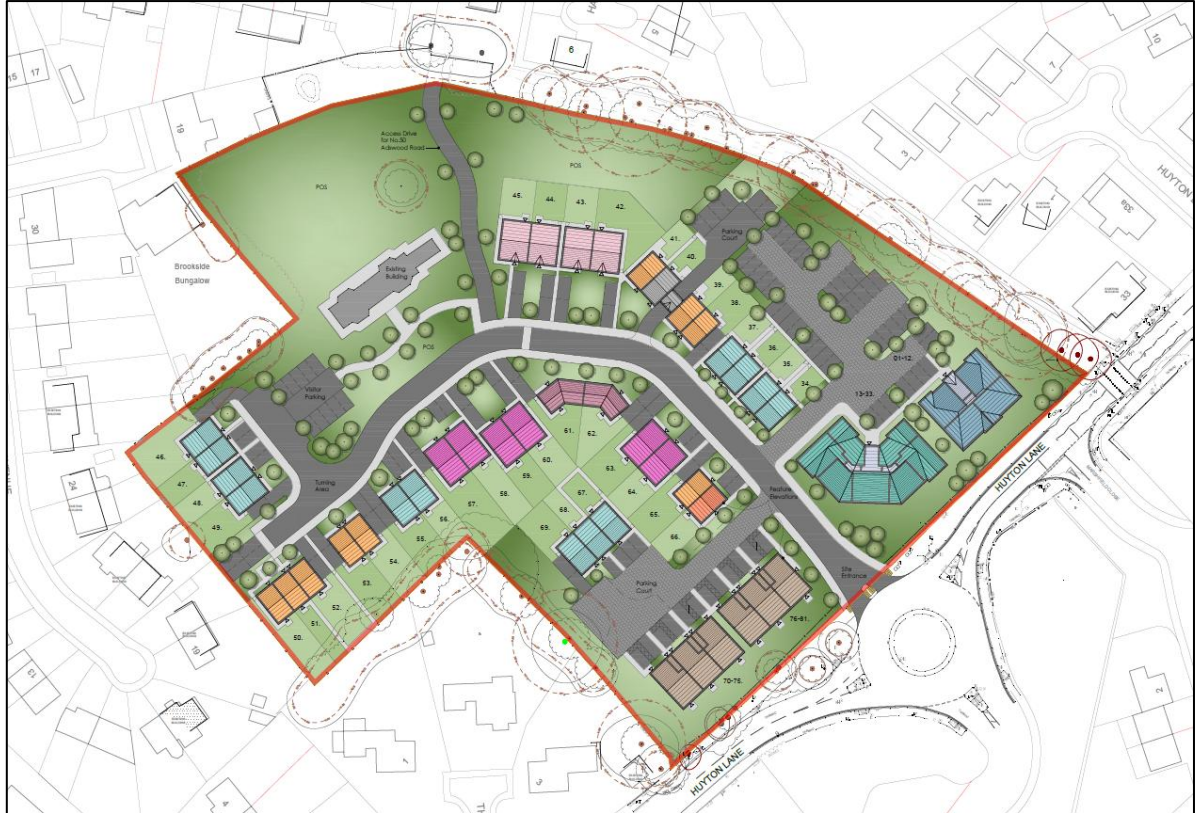
Figure 2: Extract of proposed development plan. Taken from "Proposed Site Layout – Option A" Rev E

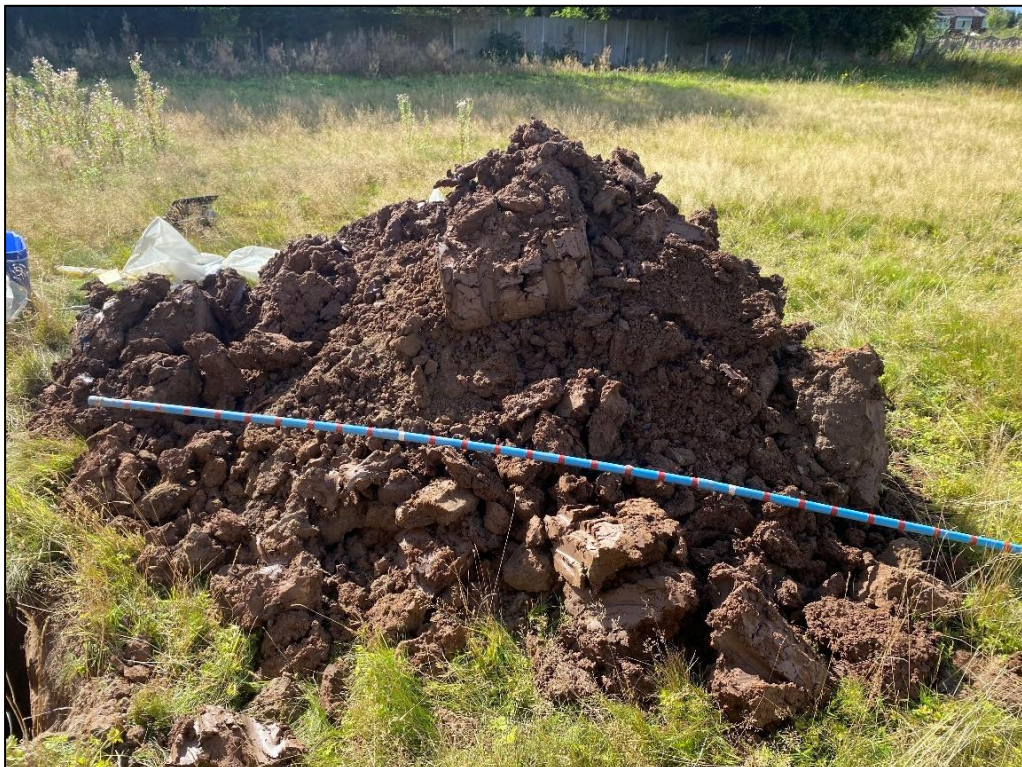
Figure 4: Typical Glacial Till deposits encountered on site (Image of TP05).

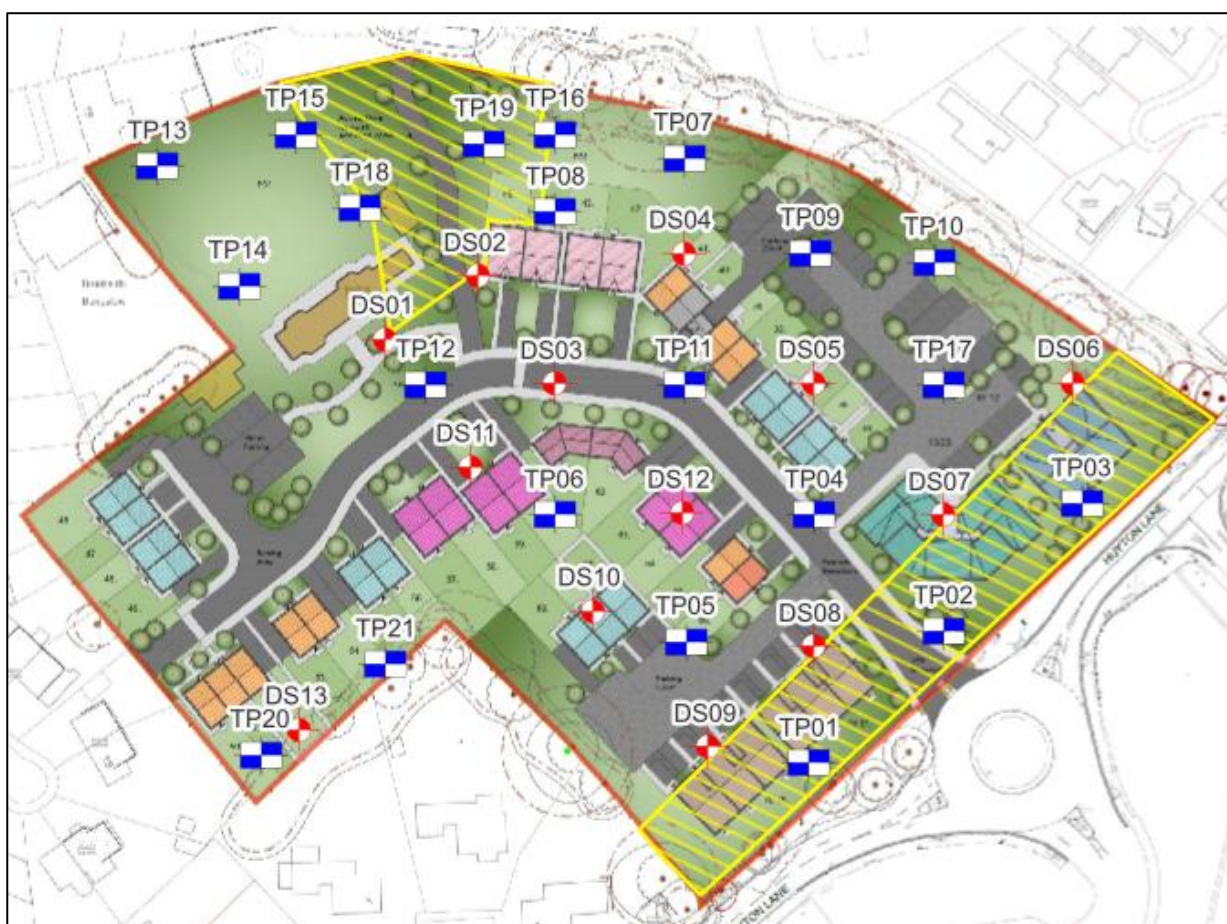
As discussed in section 4.2.3, due to the human health GAC exceedances for the residential with plant uptake scenario recorded within the Made Ground on site, and feasible contaminative pathways being identified, remedial measures are required for some areas of the proposed development where Made Ground exists (excluding Topsoil Made Ground as this will be stripped prior to development). Remedial measures are not required site wide, however, where Made Ground will be present within 600mm of finalised garden levels or within 300mm of proposed POS or soft landscaping, a clean cover system will be required in order to break the contaminative linkages. Based on the Made Ground encountered, the areas where clean cover systems are likely to be required are included on the plan below:

Figure 9: QGIS Extract showing the anticipated areas where a clean cover system is required (yellow hatch)), based on Made Ground encountered.

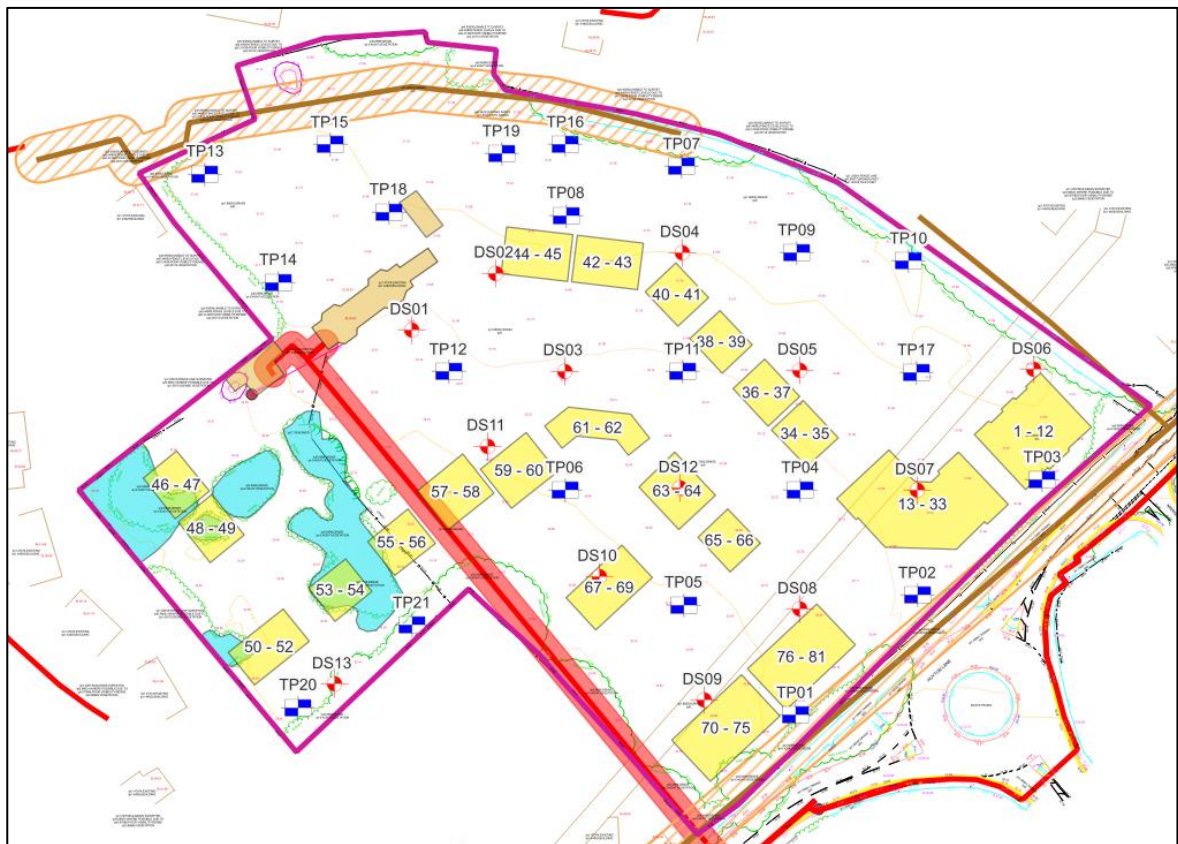
Figure 10: GQIS Extract of the exploratory hole location plan showing proposed plots (yellow), dynamic sample boreholes (red) and trial pit locations (blue).

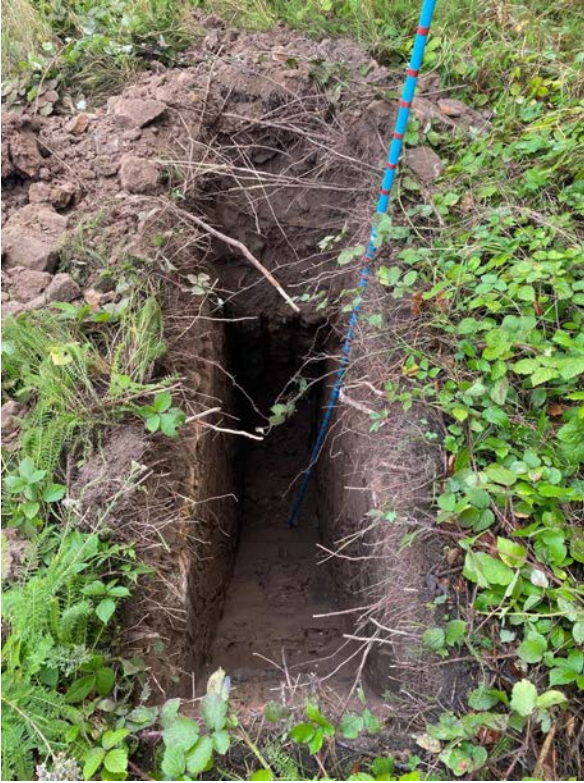
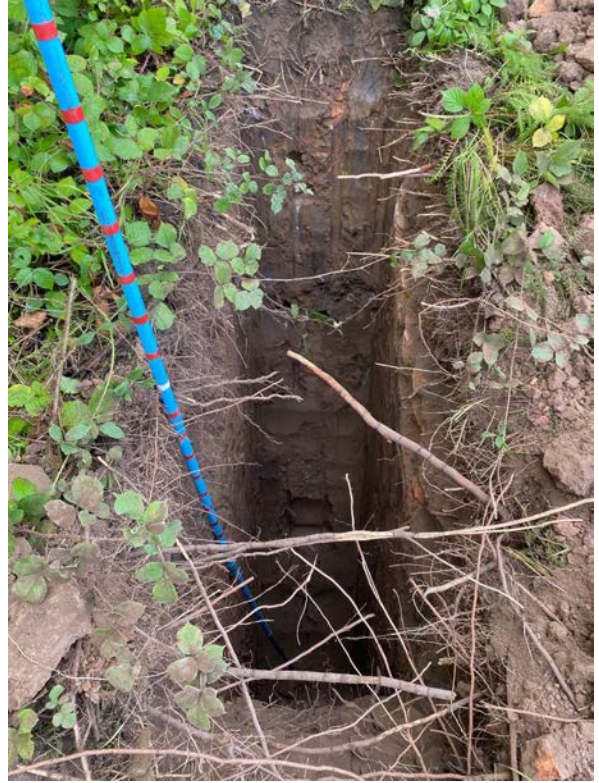
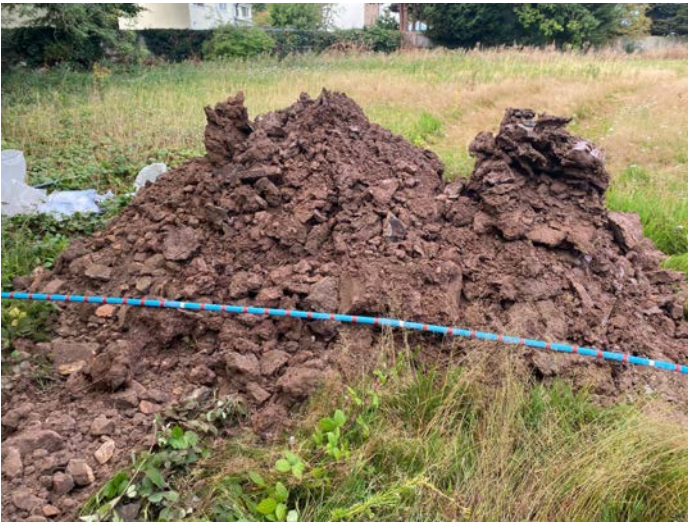
Trial pit terminated at target depth. No water ingress. Clay recovered as coarse gravel and cobble sized pieces between 0.50m and 1.10m: no HSVs.

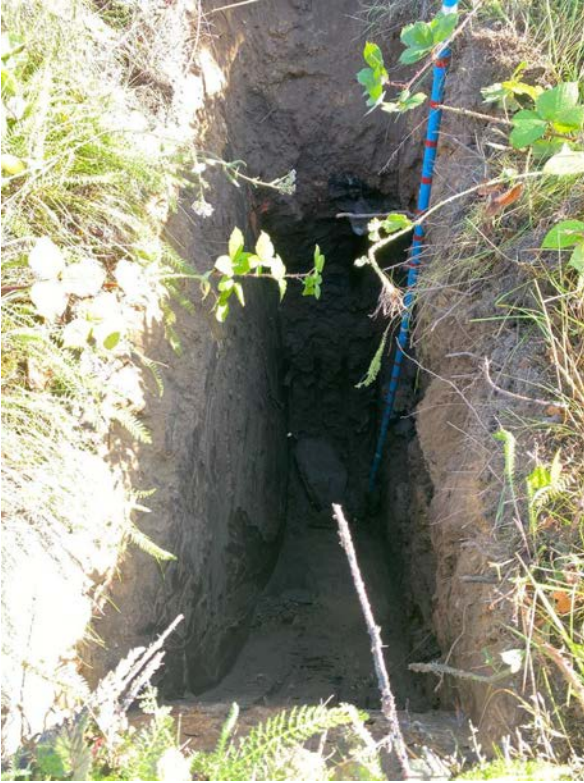
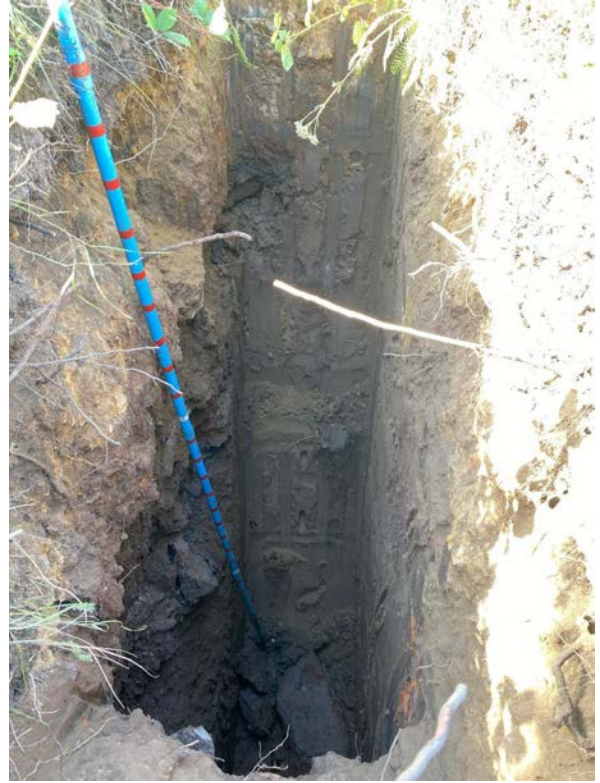
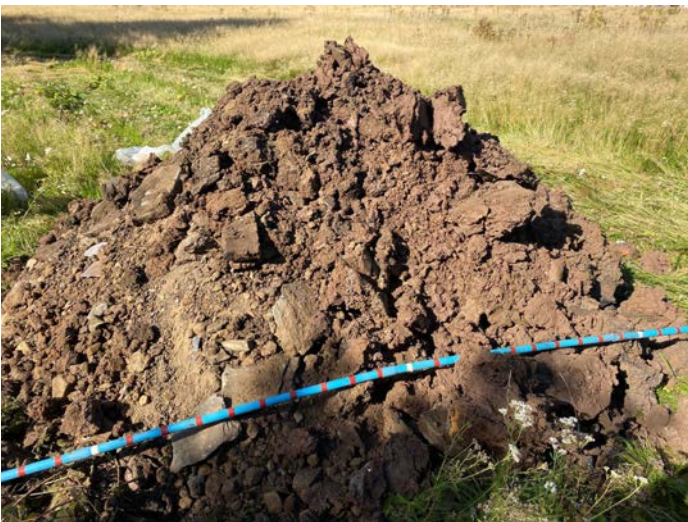
Trial pit terminated at target depth. No water ingress. Clay recovered as coarse gravel and cobble sized pieces between 0.60m and 1.30m: no HSVs.

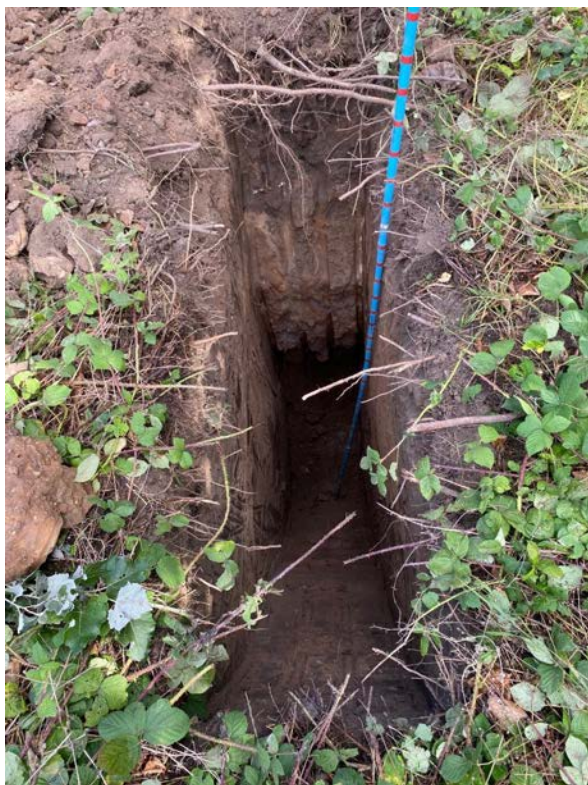
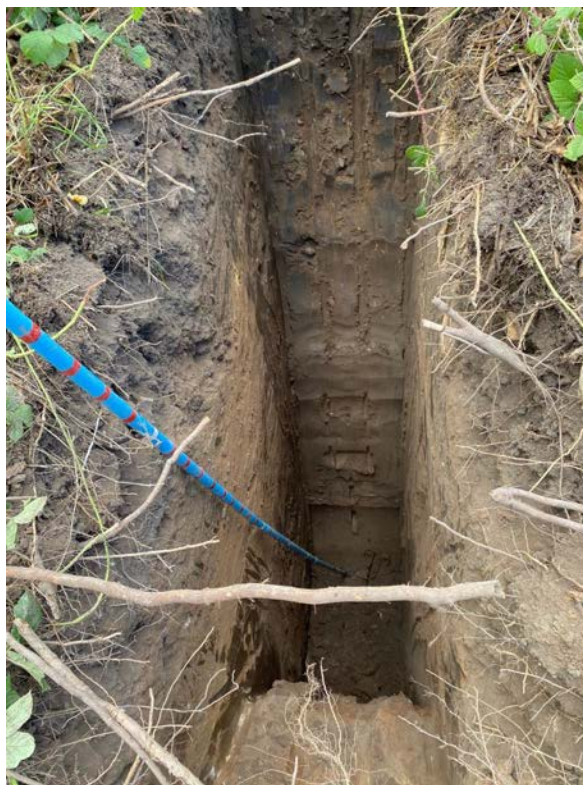
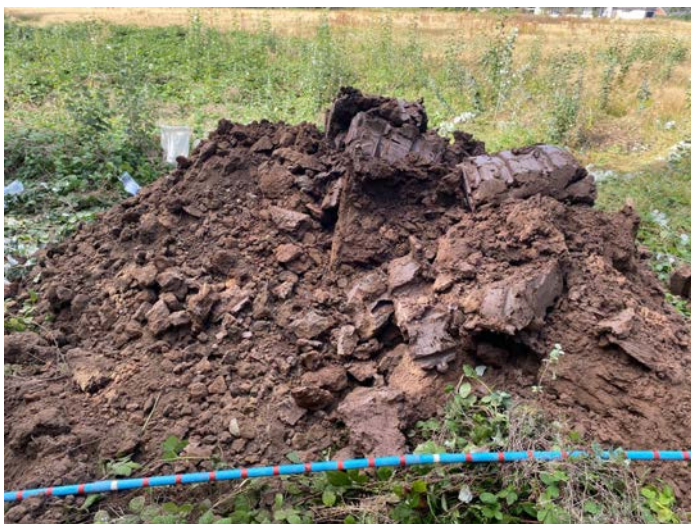
Trial pit terminated at target depth. No water ingress. Clay recovered as coarse gravel and cobble sized pieces between 0.60m and 1.20m: no HSVs.

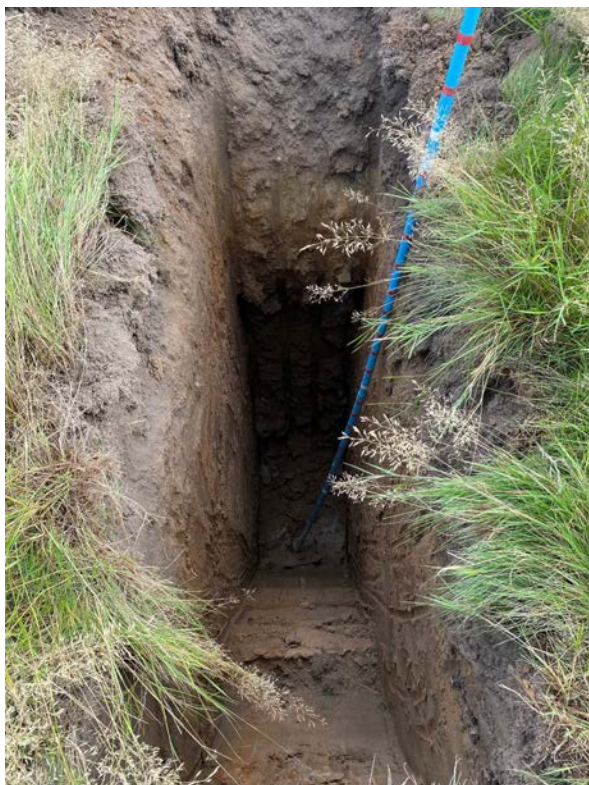
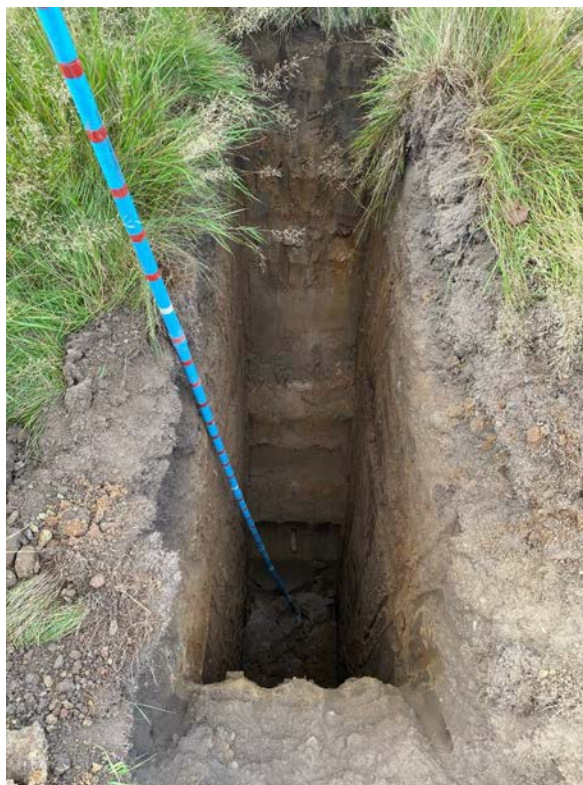
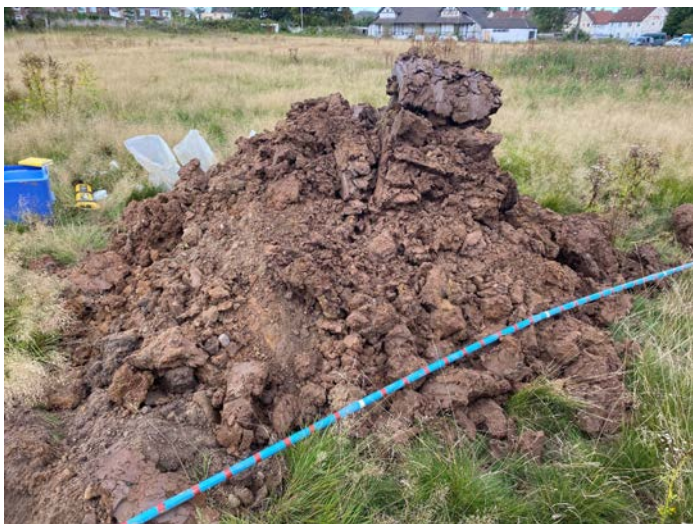
Trial pit terminated at target depth. No water ingress.

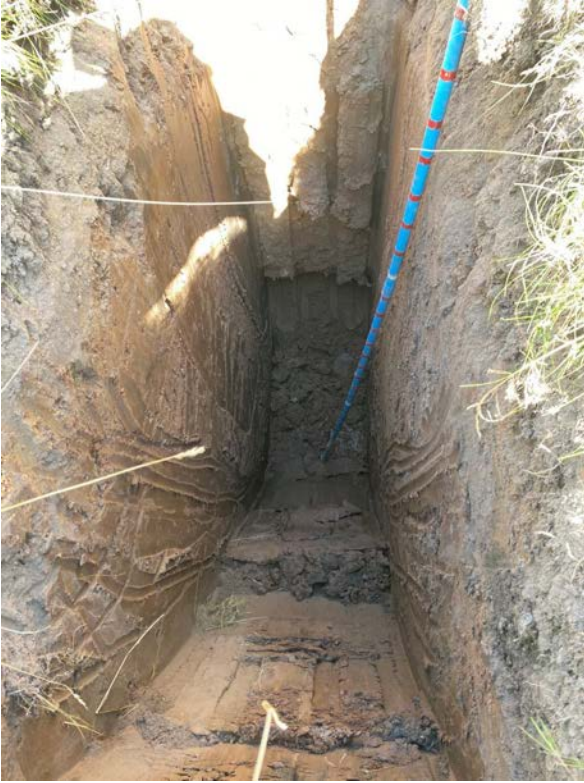
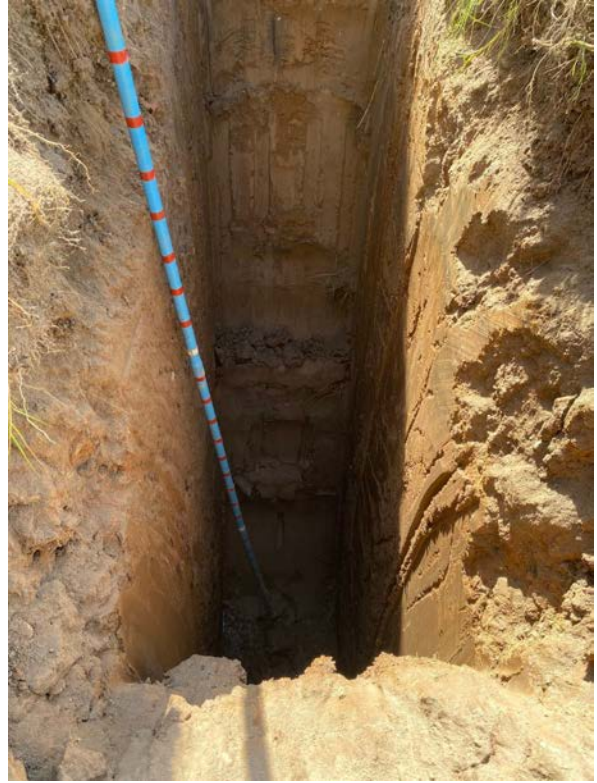
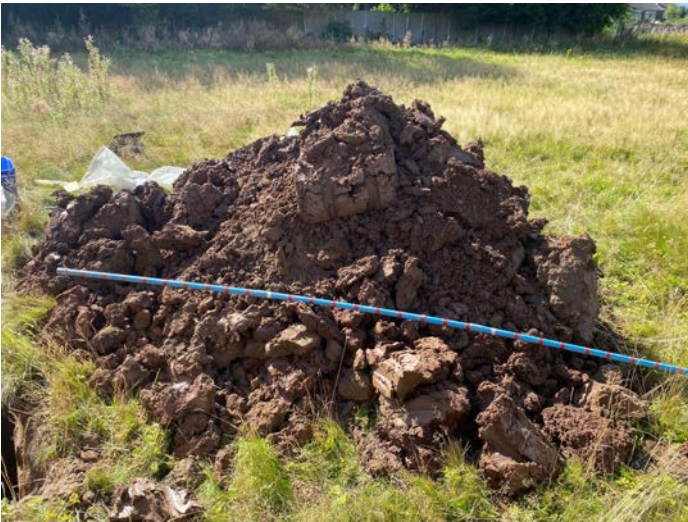
Trial pit terminated at target depth. No water ingress. Clay recovered as coarse gravel and cobble sized pieces between 0.30m and 1.20m: no HSVs.

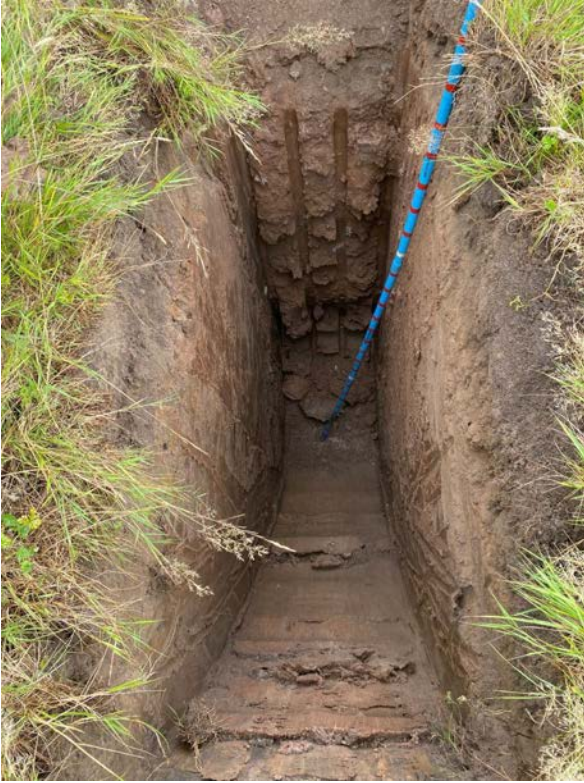
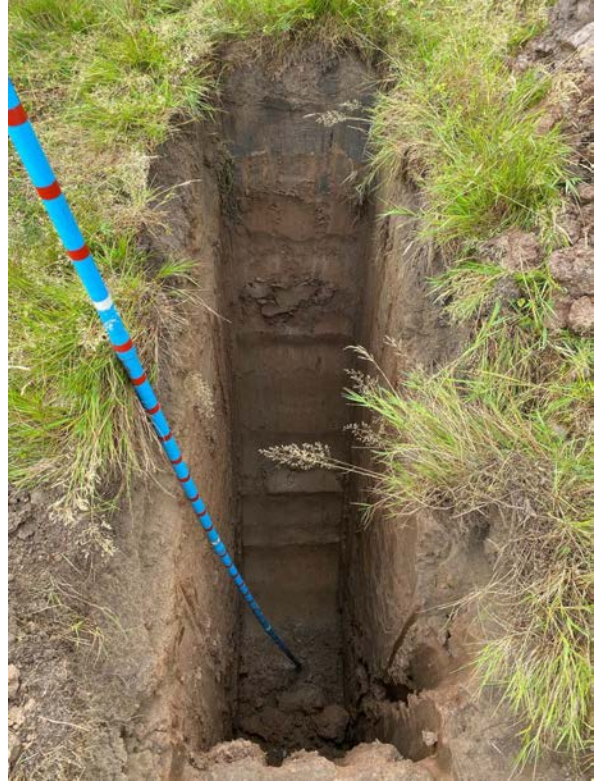
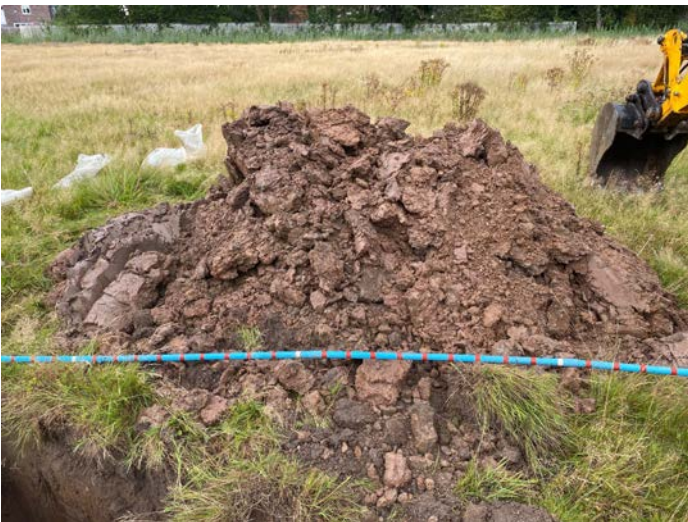
Trial pit terminated at target depth. No water ingress. Clay recovered as coarse gravel and cobble sized pieces between 0.35m and 0.80m: no HSVs.

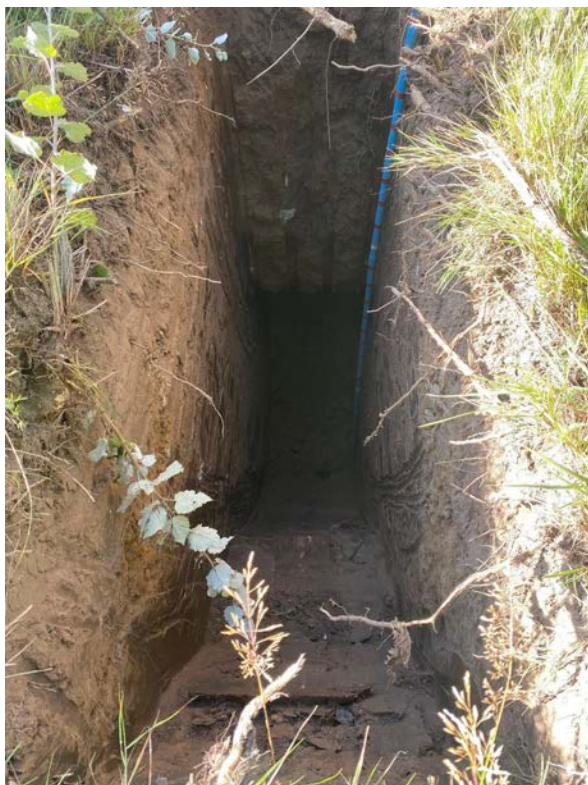
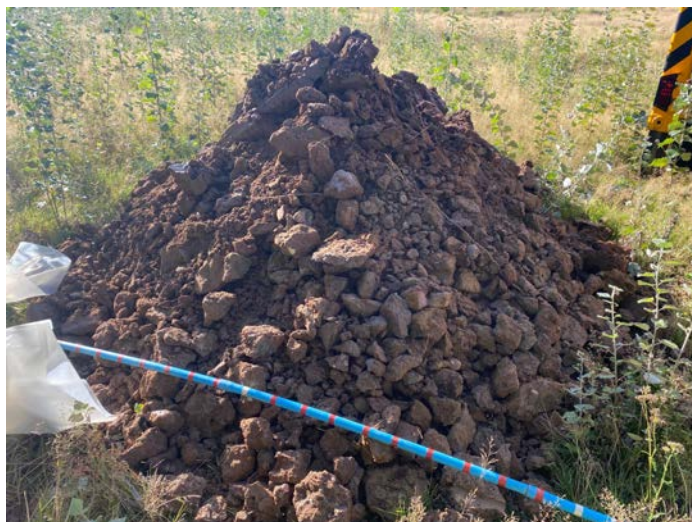
Trial pit terminated at target depth. No water ingress. Clay recovered as coarse gravel and cobble sized pieces between 0.40m and 1.30m: no HSVs.

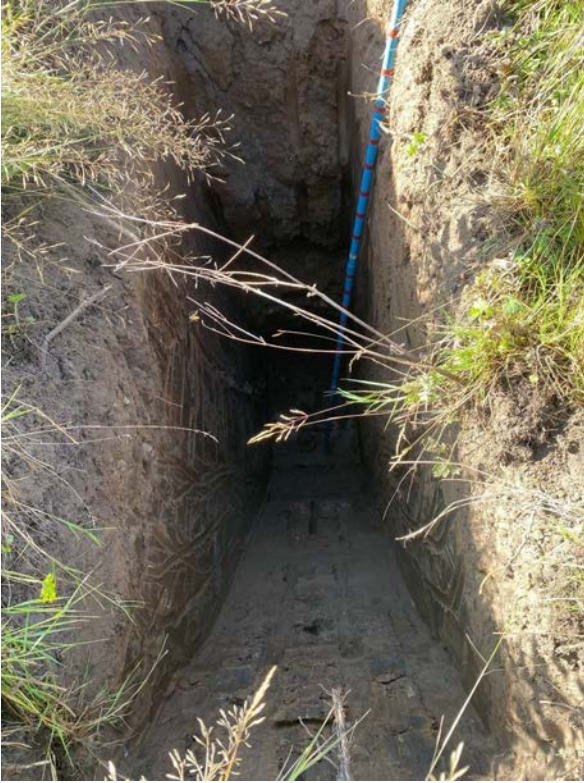
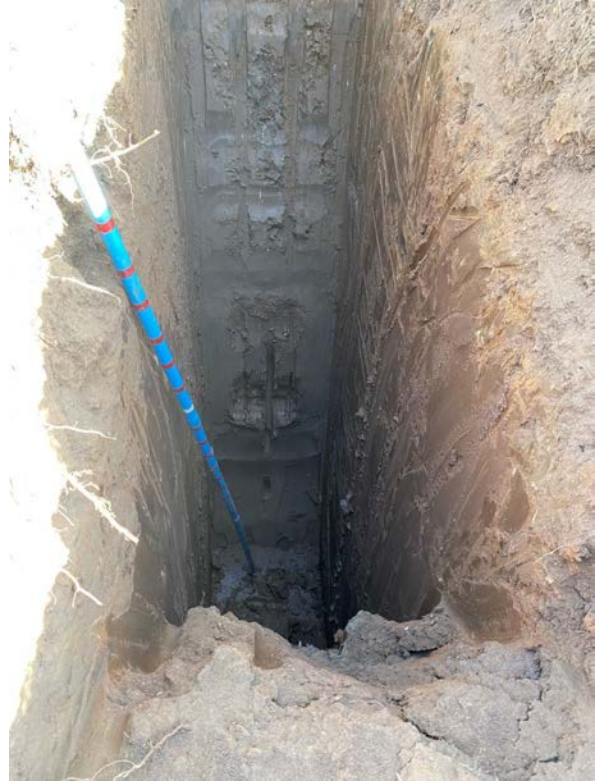
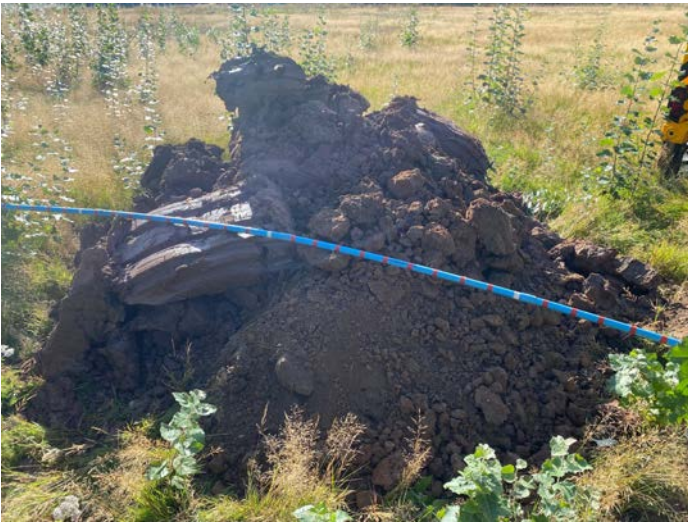
Trial pit terminated at target depth. No water ingress. Clay recovered as coarse gravel and cobble sized pieces between 0.30m and 1.90m: no HSVs.

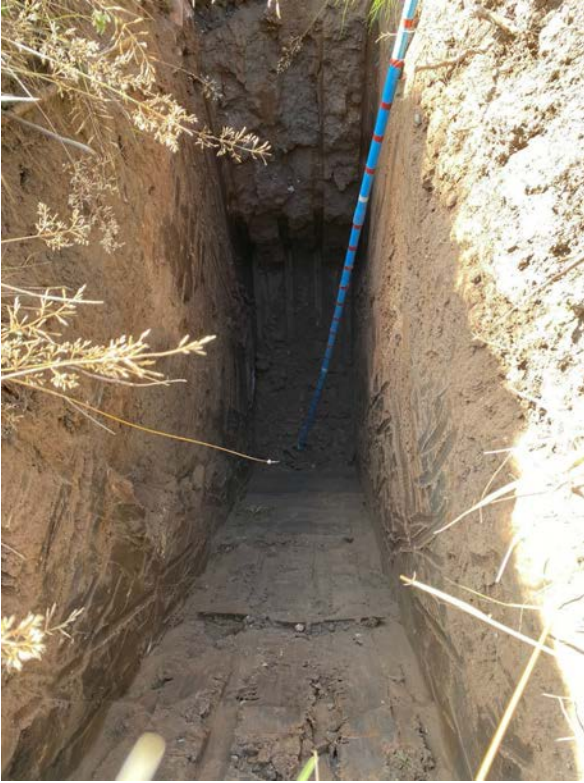
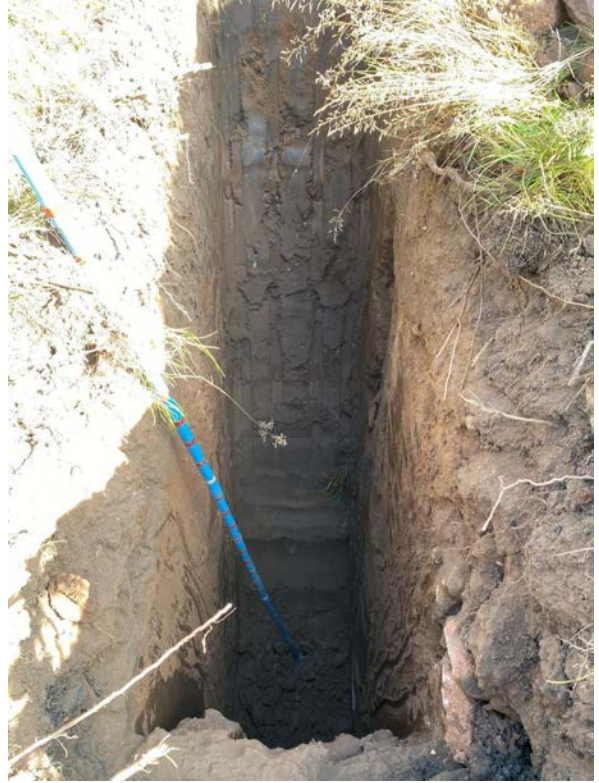
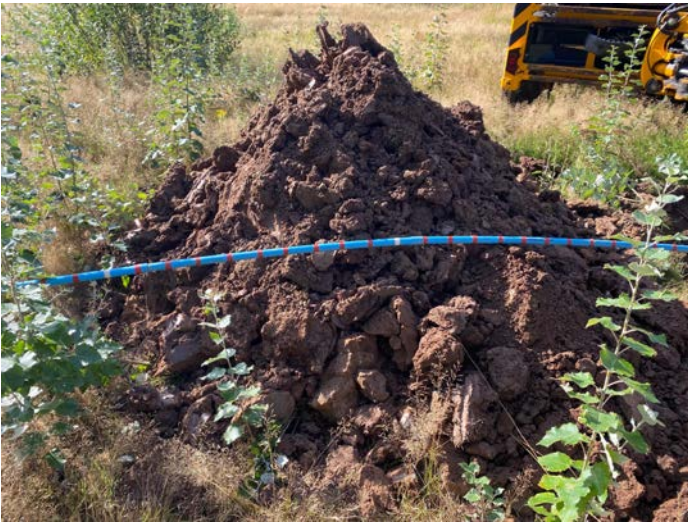
Trial pit terminated at target depth. No water ingress. Clay recovered as coarse gravel and cobble sized pieces between 0.45m and 1.80m: no HSVs.

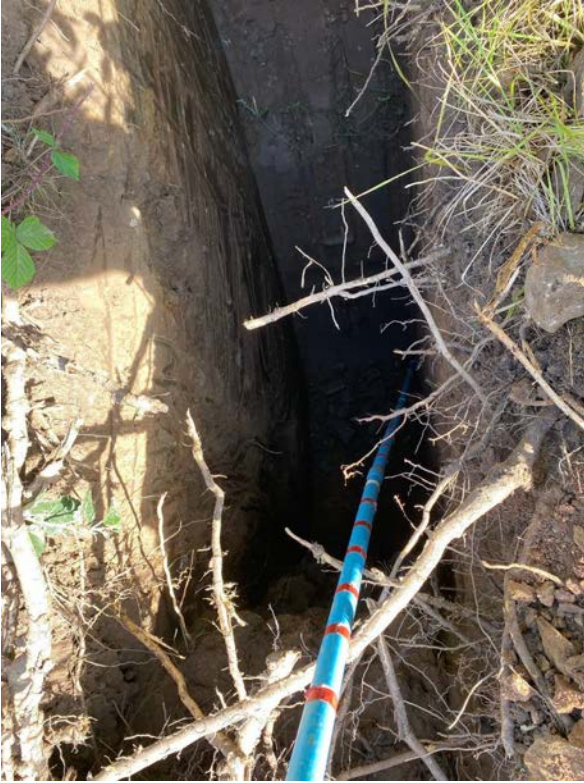
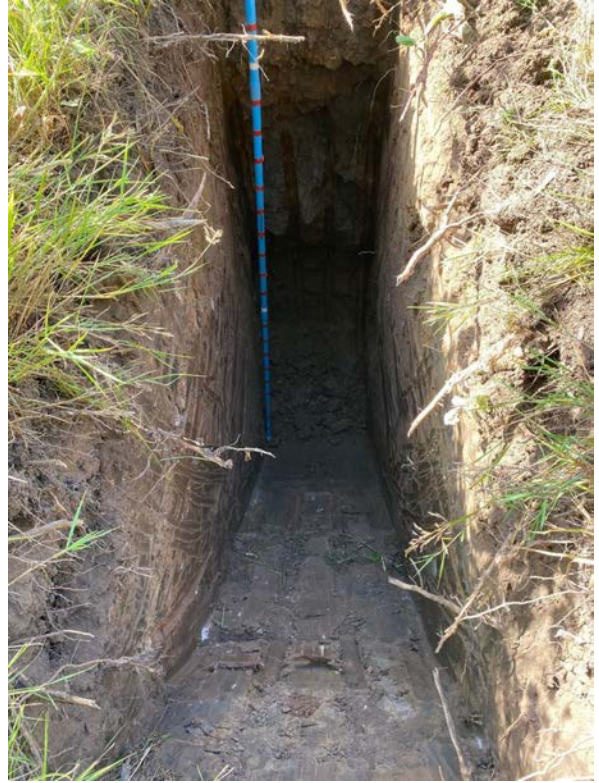
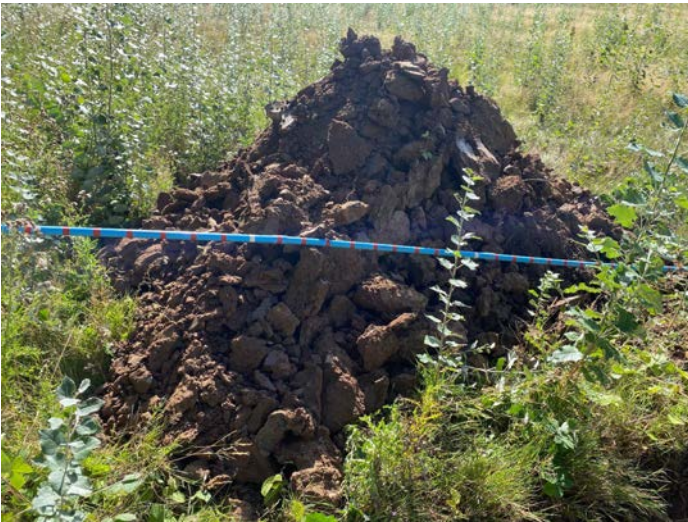
Trial pit terminated at 2.60m bgl due to hard digging in stiff clay. No water ingress. Clay recovered as coarse gravel and cobble sized pieces between 0.30m and 2.60m: no HSVs.

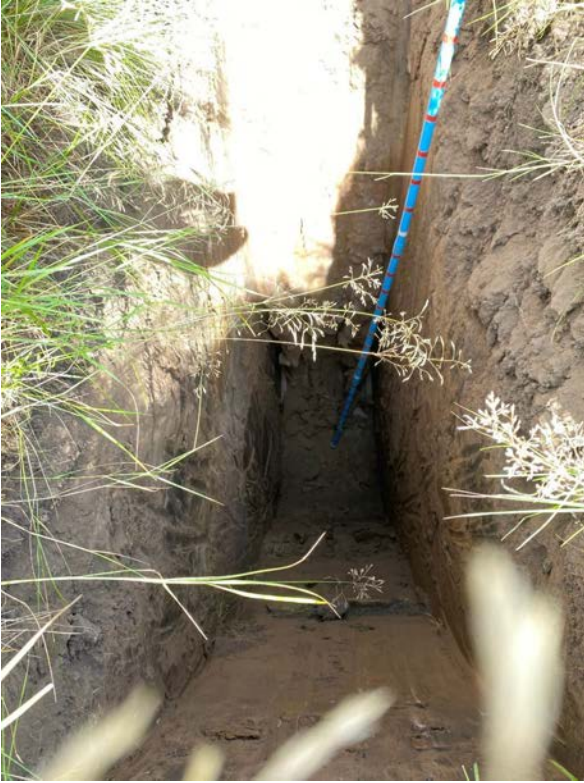
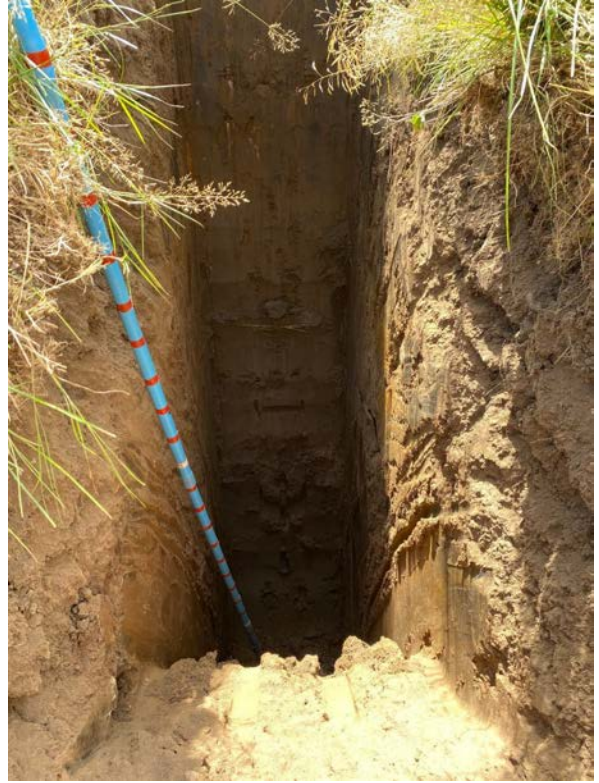
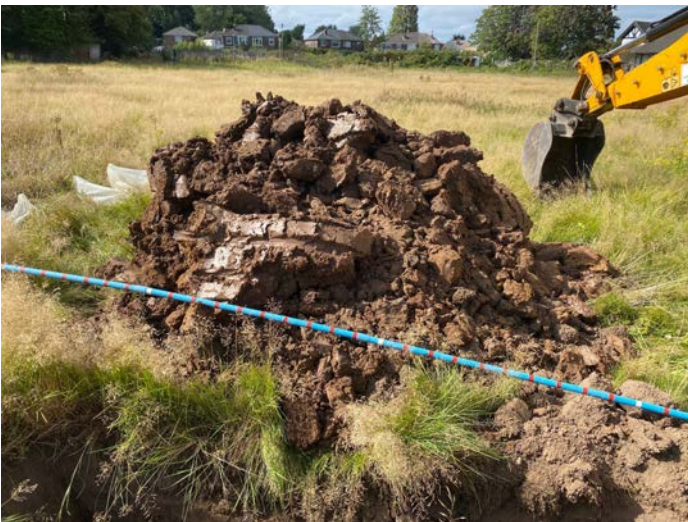
Trial pit terminated at target depth. No water ingress. Clay recovered as coarse gravel and cobble sized pieces between 0.50m and 0.90m: no HSVs.

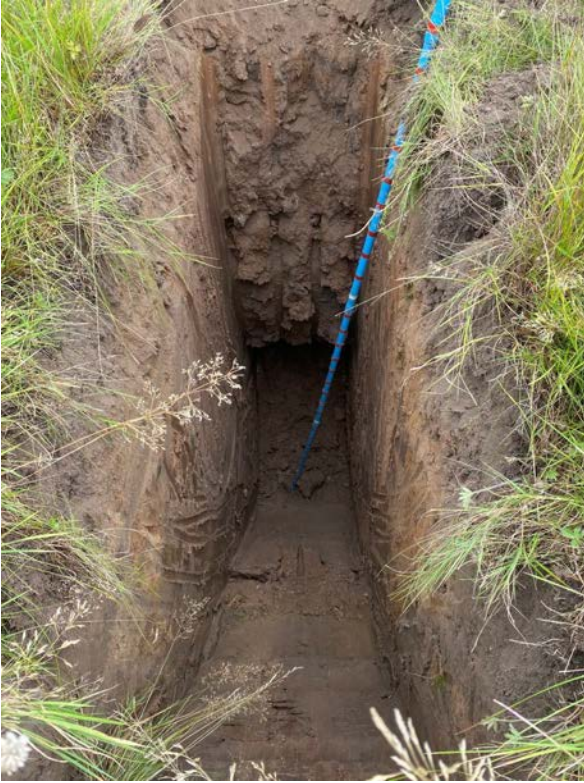
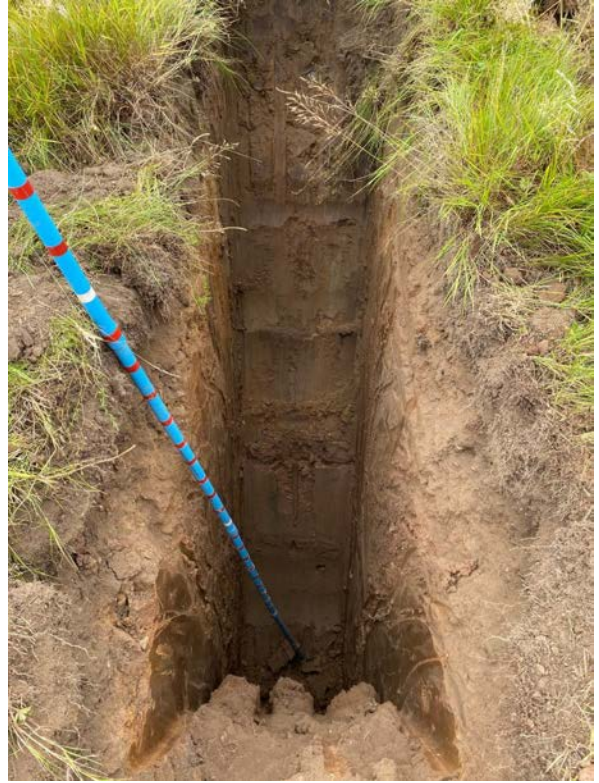
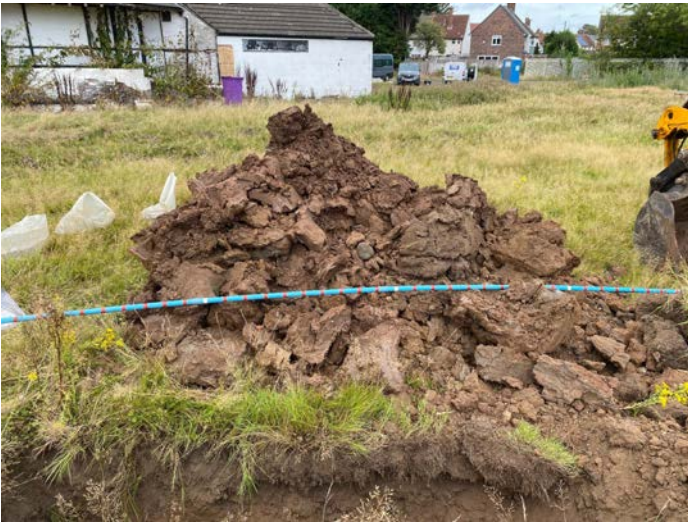
Trial pit terminated at target depth. No water ingress. Clay recovered as coarse gravel and cobble sized pieces between 0.40m and 1.00m: no HSVs.

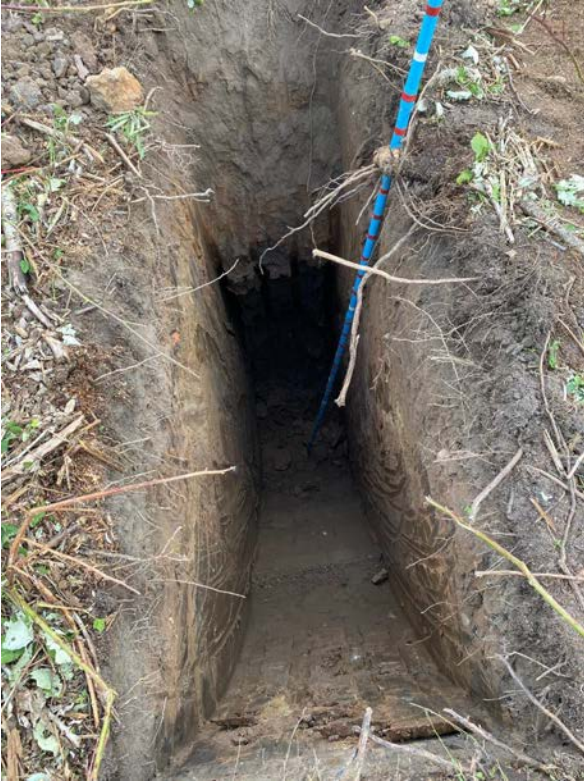
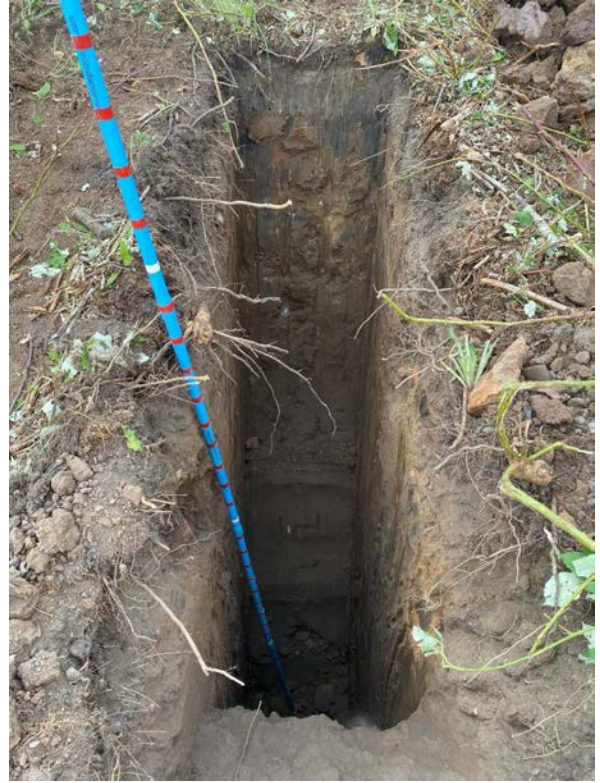
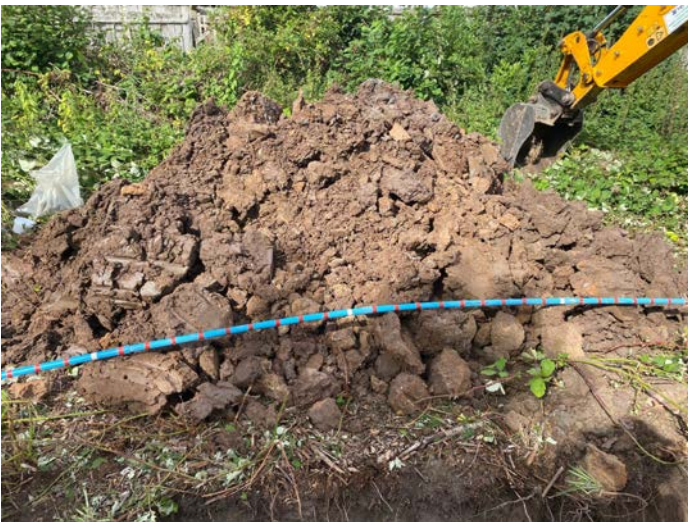
Trial pit terminated at target depth. No water ingress. Clay recovered as coarse gravel and cobble sized pieces between 0.40m and 0.90m and 2.50m and 2.80m: no HSVs.

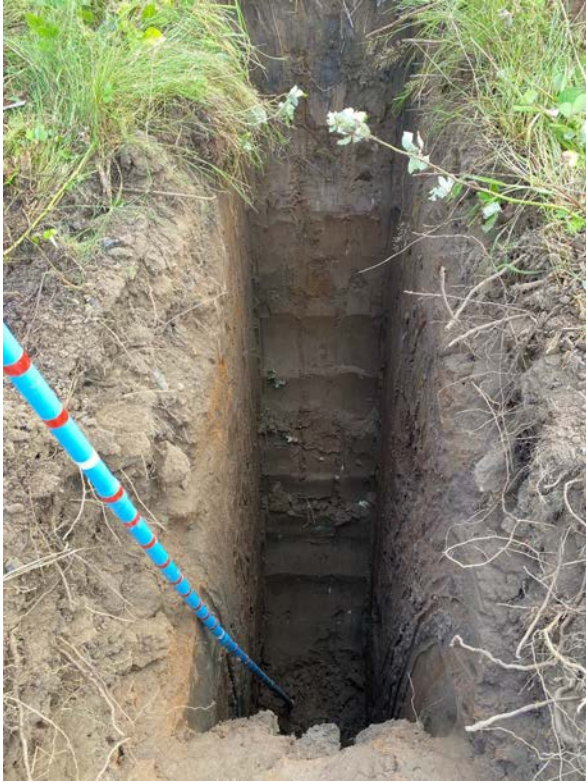
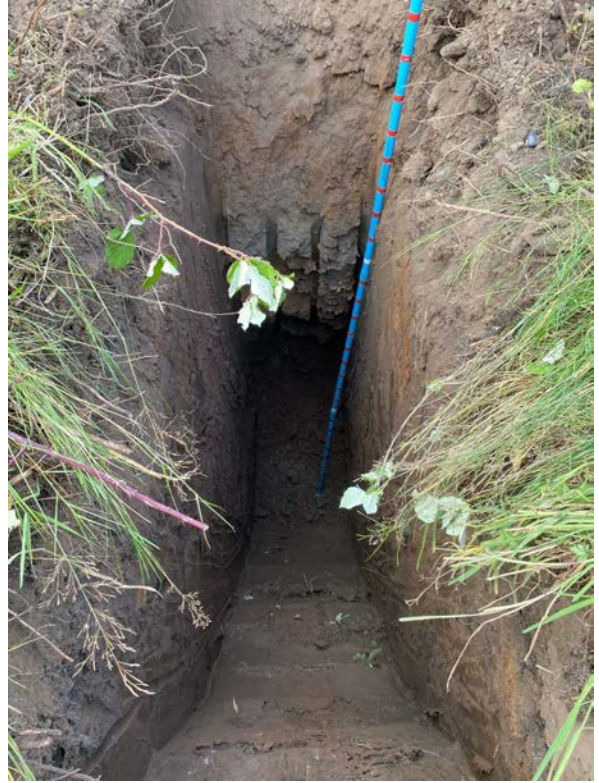
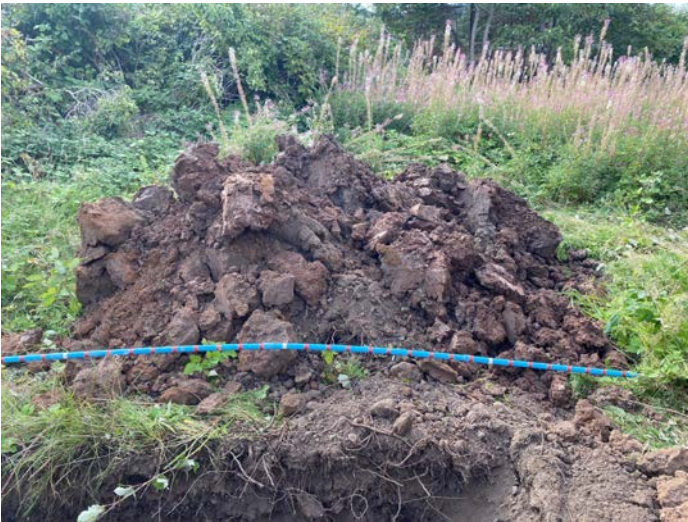
Trial pit terminated at target depth. No water ingress. Clay recovered as coarse gravel and cobble sized pieces between 0.40m and 0.80m: no HSVs.
