## Huyton Cricket Club, Huyton

### Phase 2 Geo-Environmental Investigation Report

For: Breck Homes Ltd

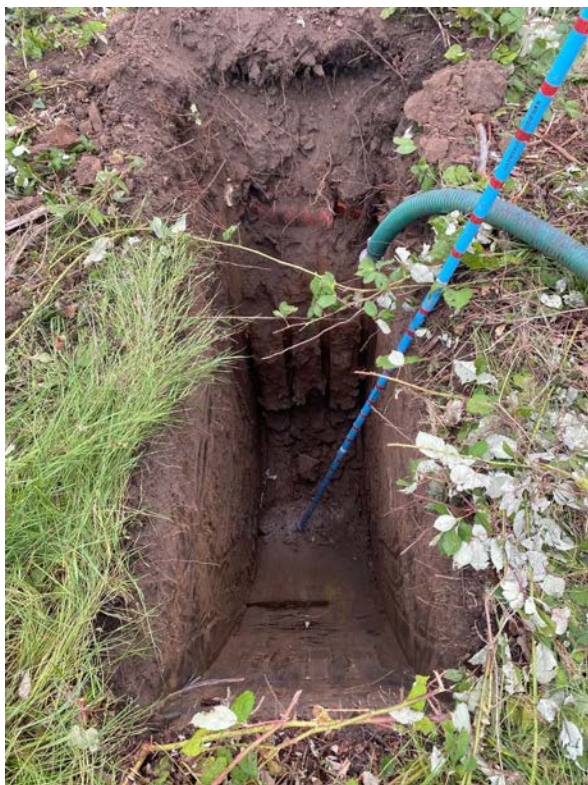
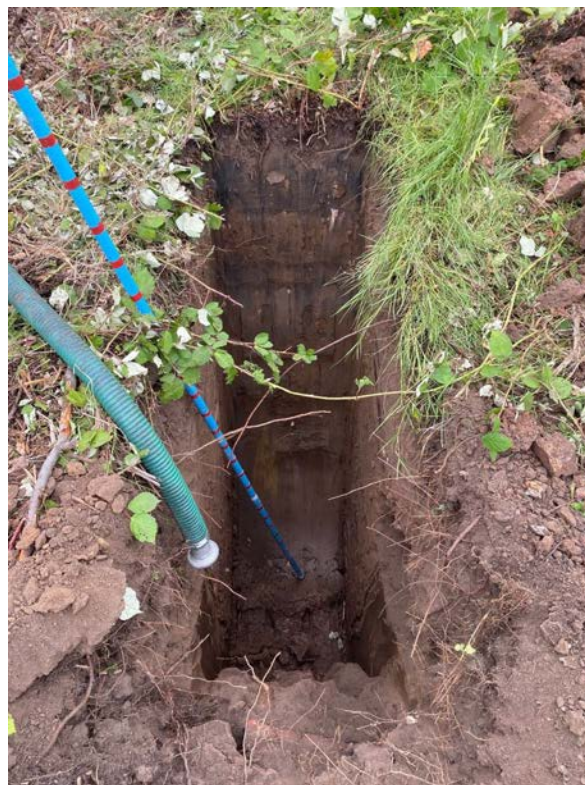
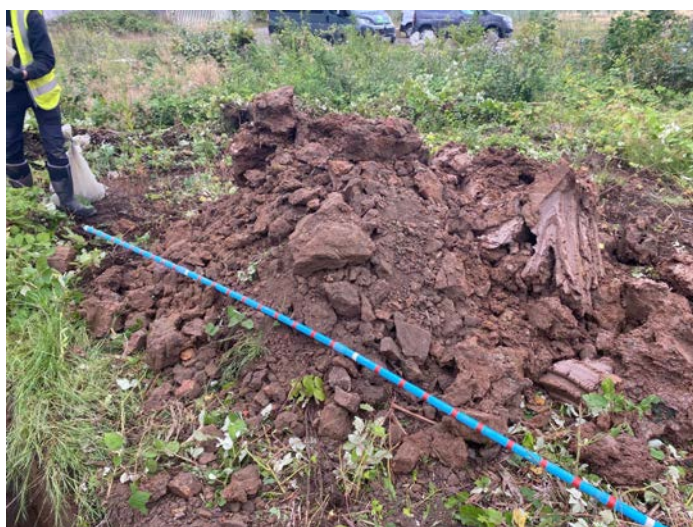
Trial pit terminated at target depth. No water ingress. BRE 365 infiltration testing completed between 1.00m and 2.00m bgl. Clay recovered as coarse gravel and cobble sized pieces between 0.30m and 1.50m: no HSVs.

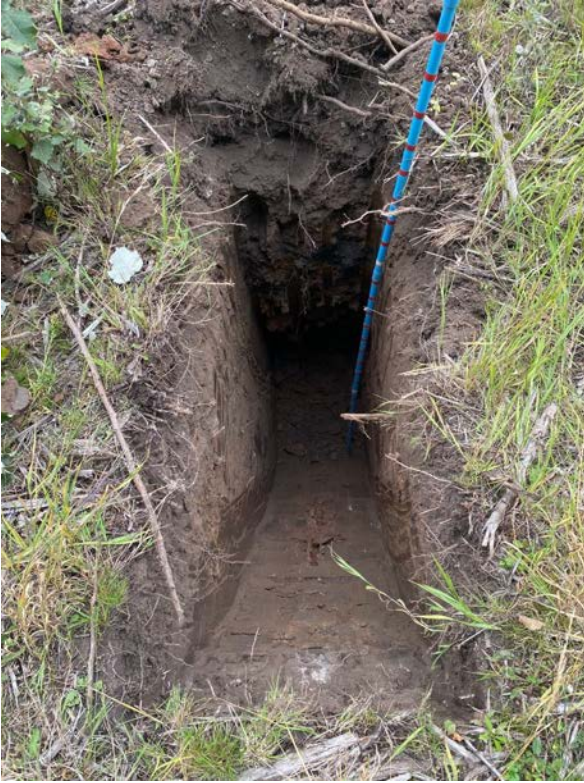
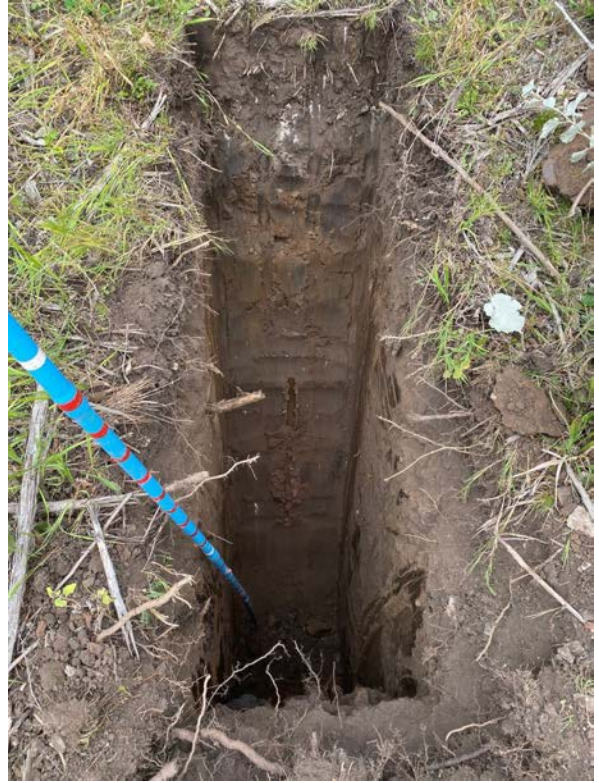
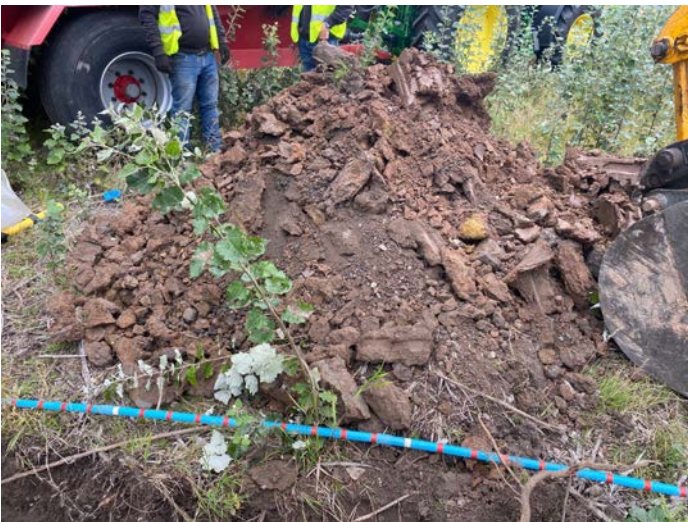
Trial pit terminated at target depth. No water ingress. BRE 365 infiltration testing completed between 1.50m and 2.50m bgl. Clay recovered as coarse gravel and cobble sized pieces between 0.40m and 2.20m: no HSVs.

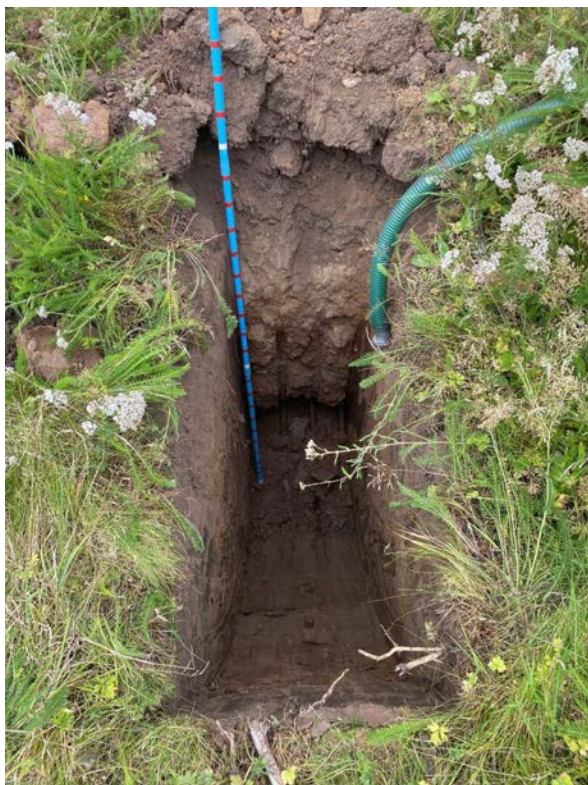
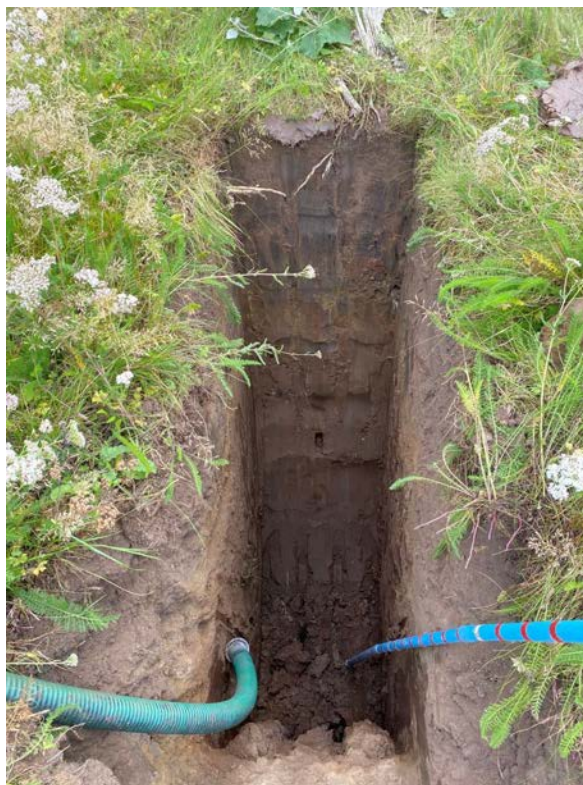
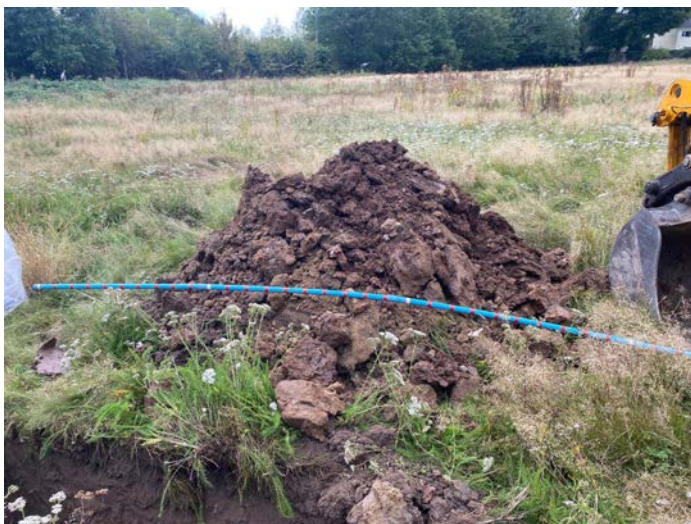
Trial pit terminated at target depth. No water ingress. BRE 365 infiltration testing completed between 1.00m and 2.00m bgl. Clay recovered as coarse gravel and cobble sized pieces between 0.40m and 2.20m: no HSVs.

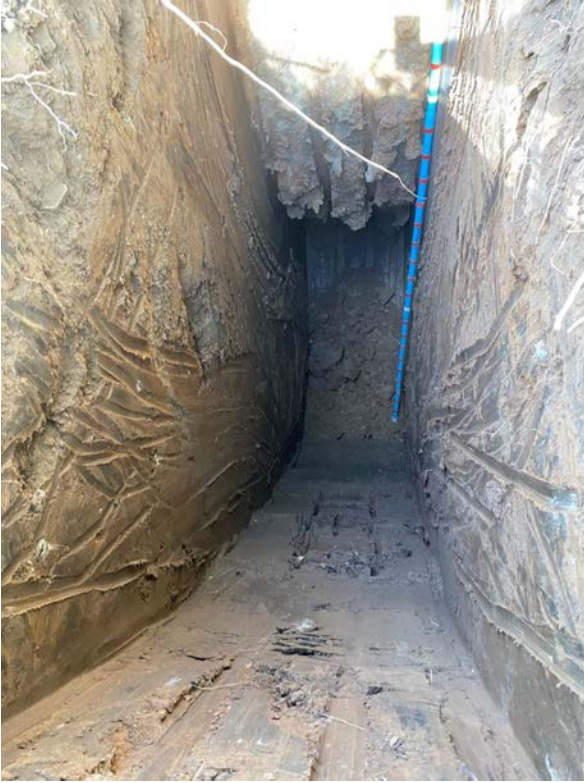
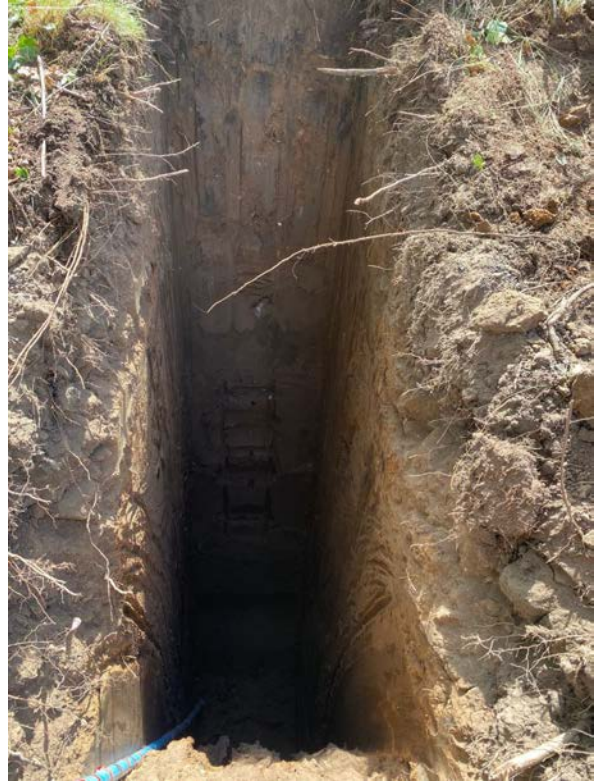
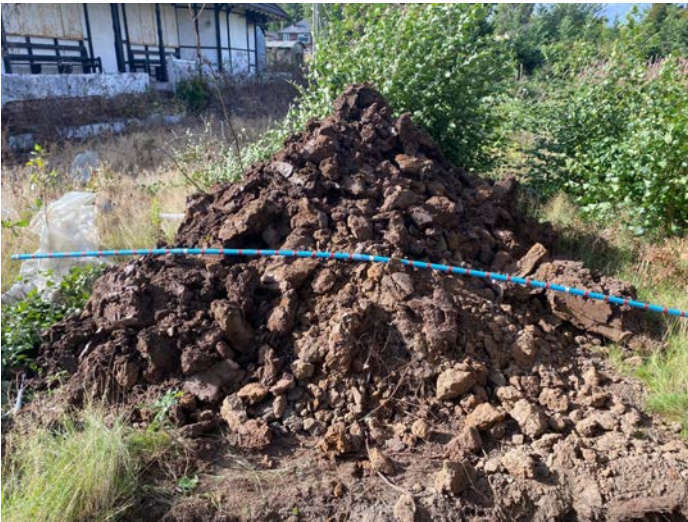
Trial pit terminated at target depth. No water ingress. Clay recovered as coarse gravel and cobble sized pieces between 0.40m and 1.10m: no HSVs.

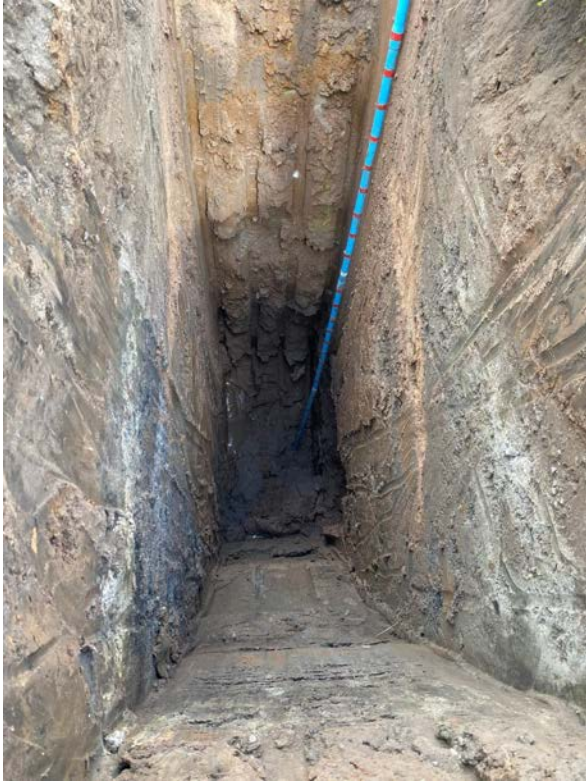
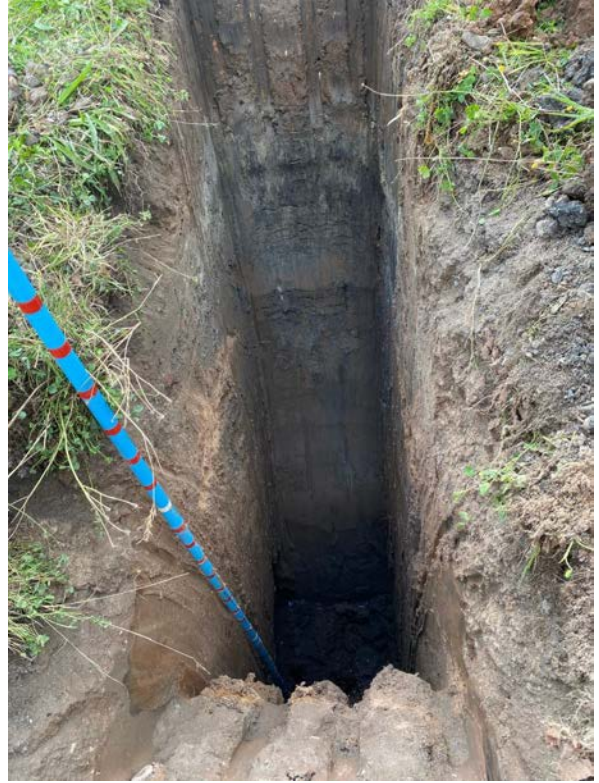
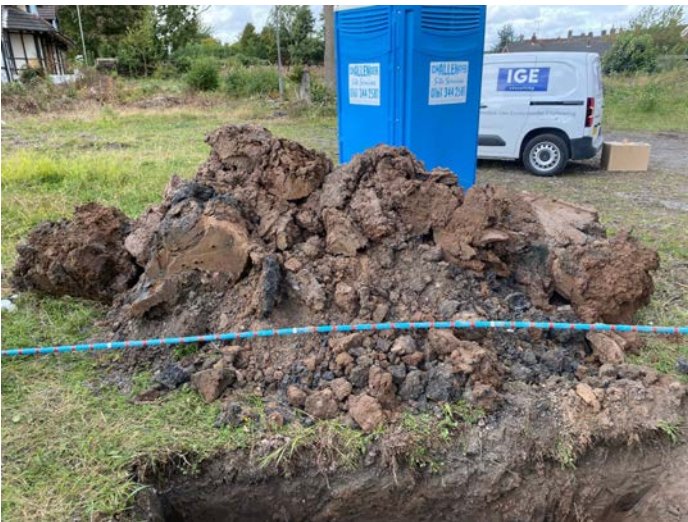
**Remarks**  
Trial pit terminated at target depth. No water ingress.

**Method, Plant, Stability, Dimensions**  
0.00 - 3.40m TP JCB 3CX  
Trial pit unstable between 0.70m and 0.90m bgl.  
**Orientation:** 340°

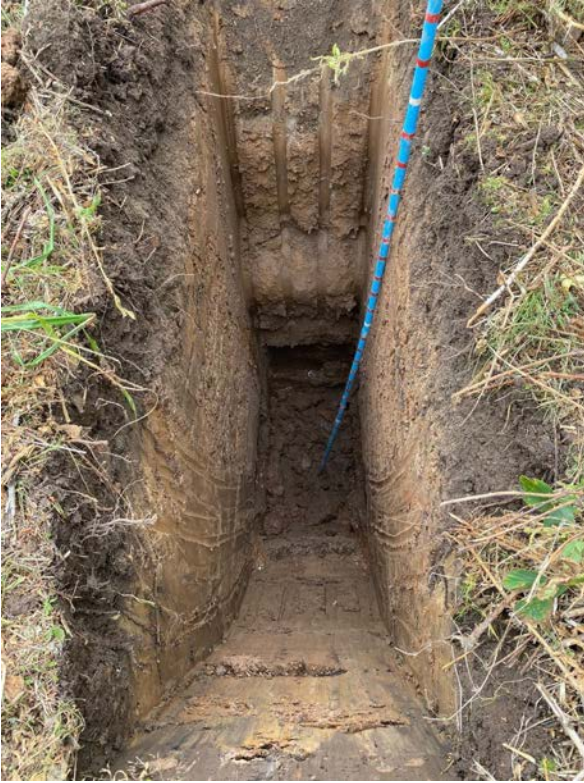
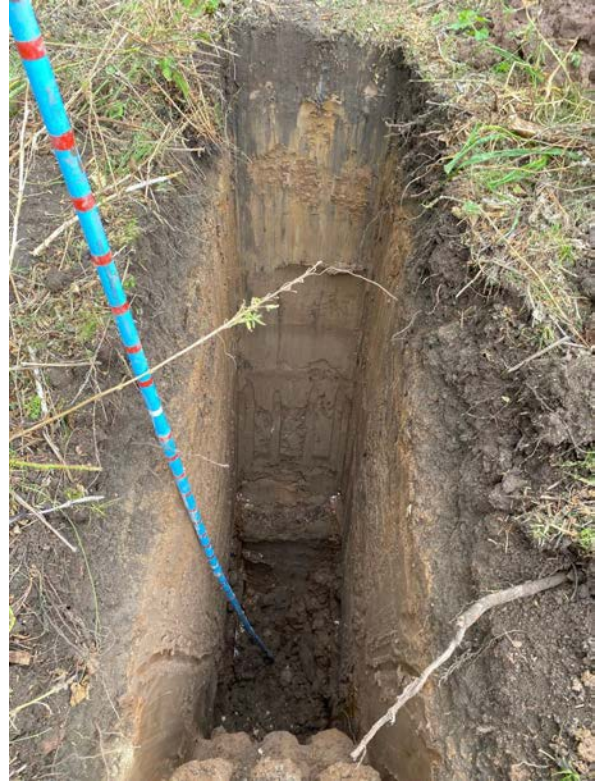
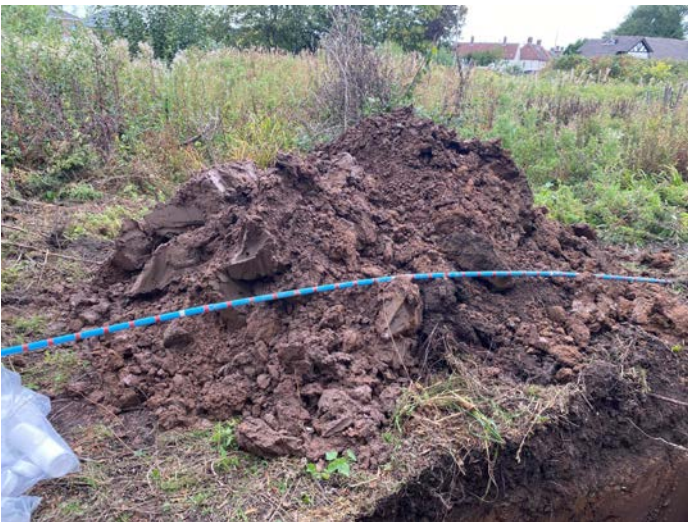
**Remarks**  
Trial pit terminated at target depth. No water ingress.

**Method, Plant, Stability, Dimensions**  
0.00 - 3.20m TP JCB 3CX  
Trial pit unstable between 2.20m and 3.00m bgl.  
**Orientation:** 50°

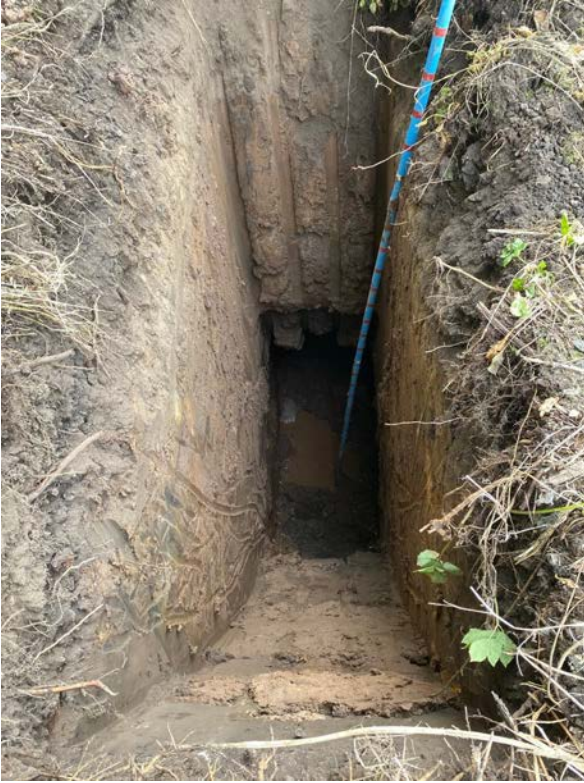
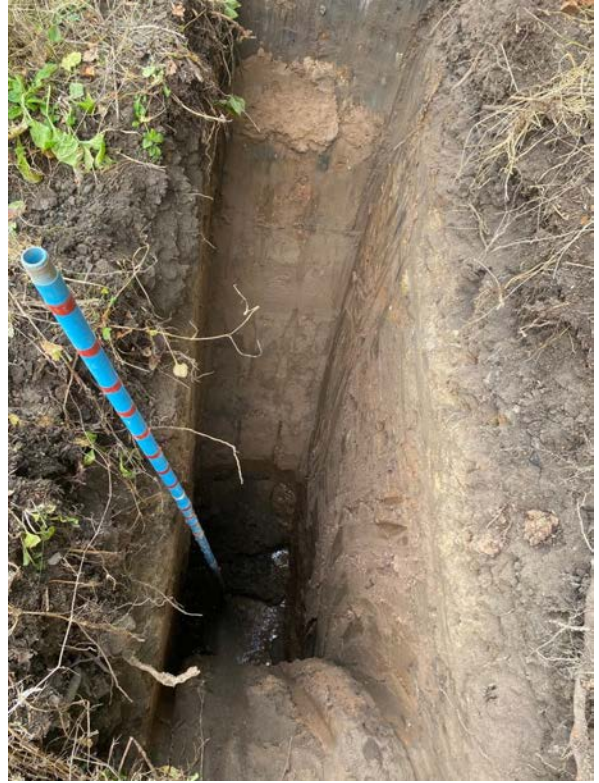
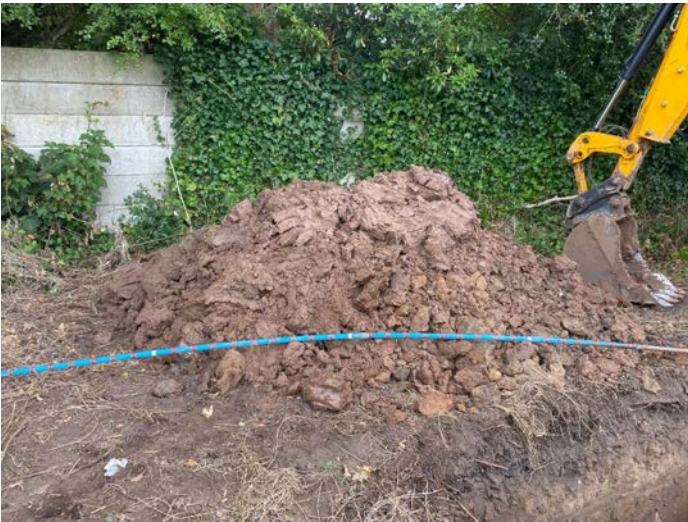
Trial pit terminated at target depth. No water ingress. Clay recovered as coarse gravel and cobble sized pieces between 0.40m and 1.00m: no HSVs.

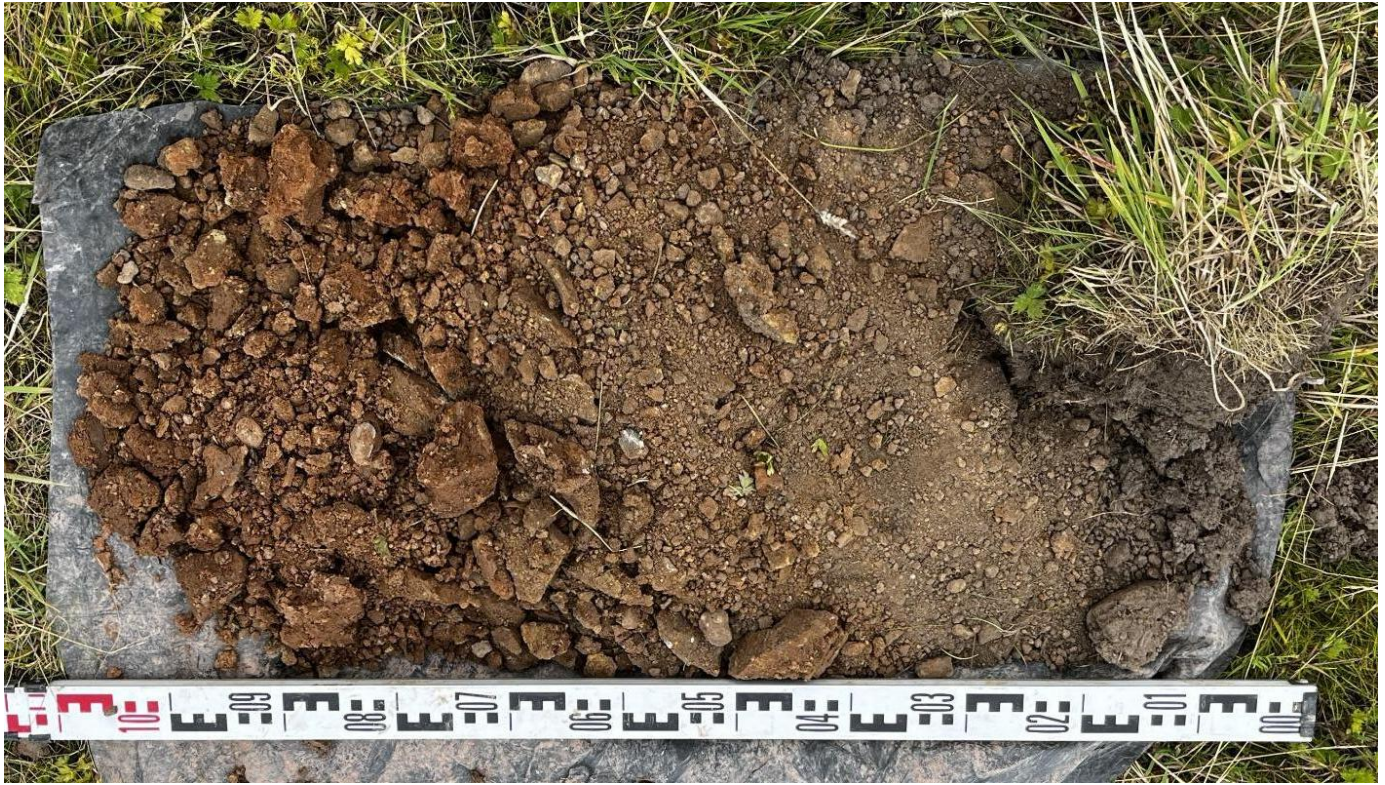
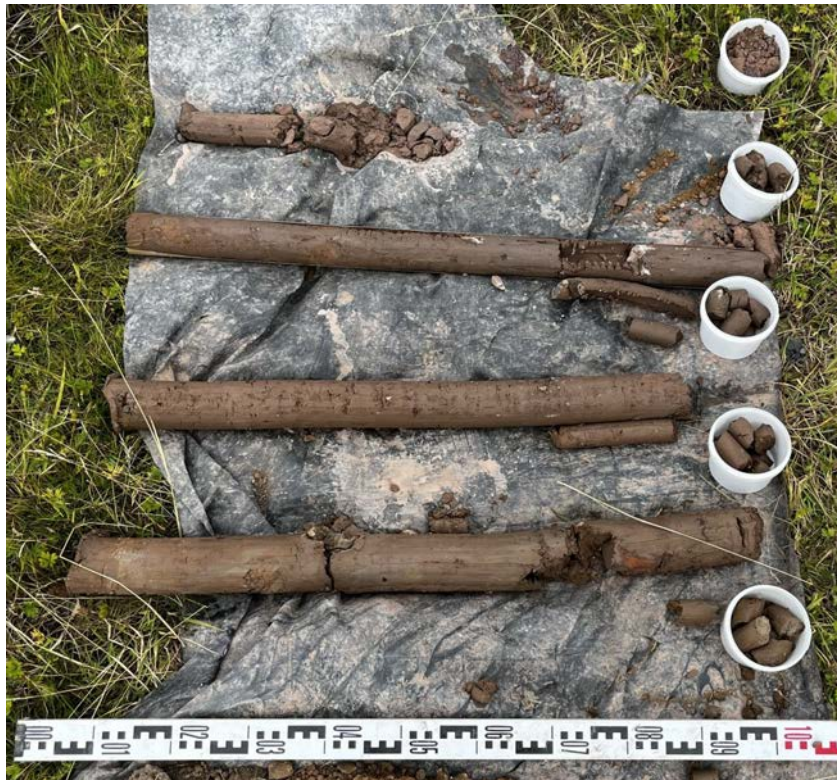
Terminated at target depth. Borehole dipped upon completion, water at 1.95m bgl, base at 4.55m bgl.

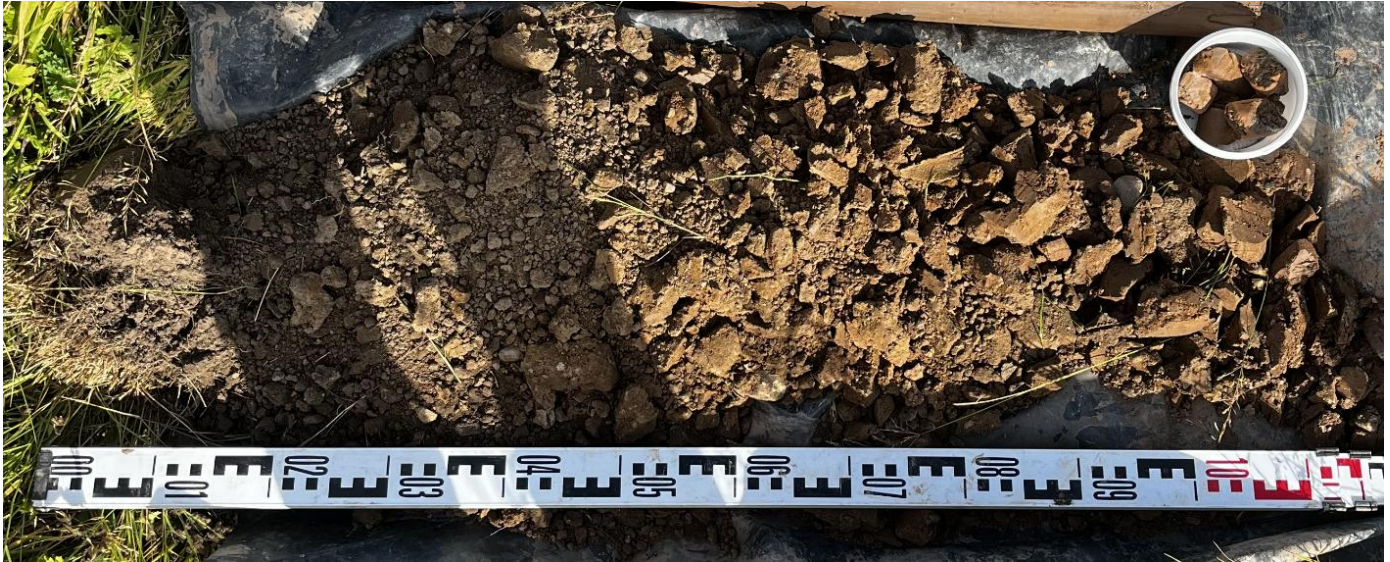
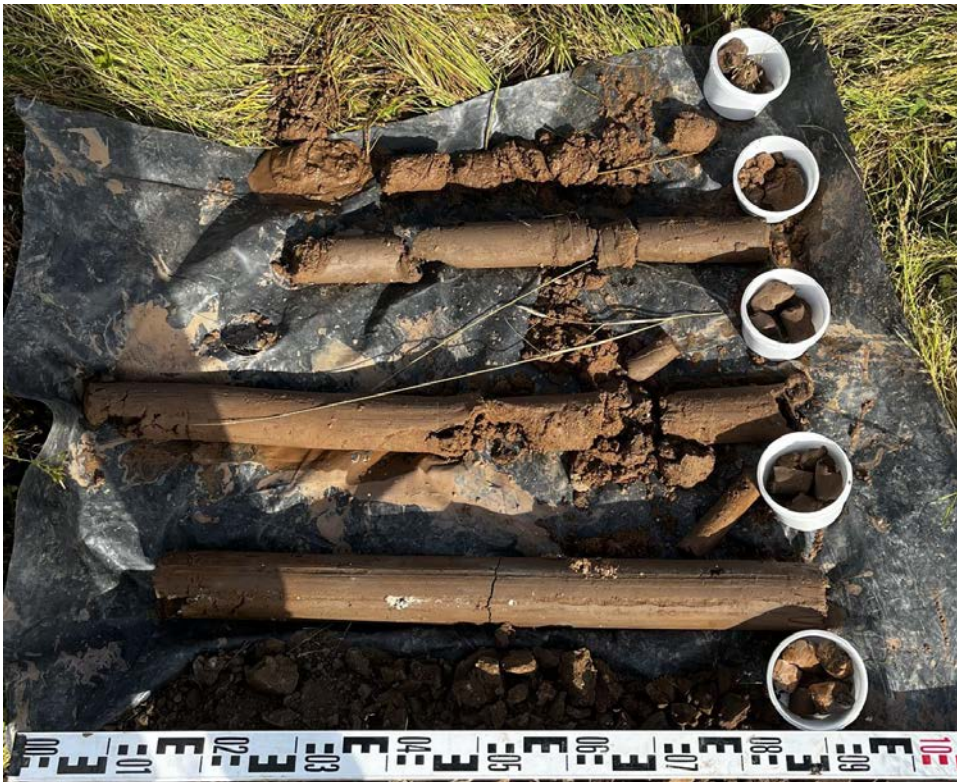
Terminated at target depth. Borehole dipped upon completion, water at 1.90m bgl, base at 2.60m bgl.

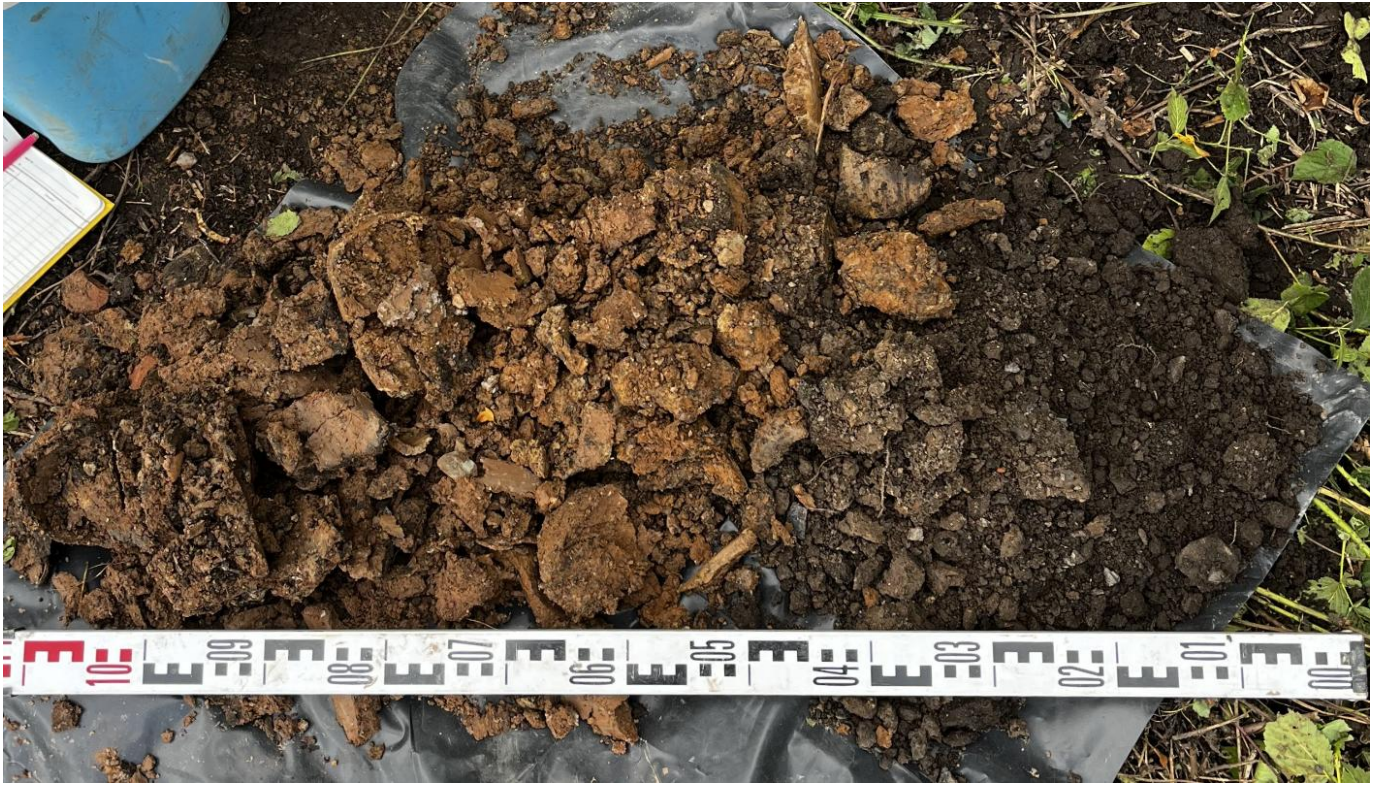
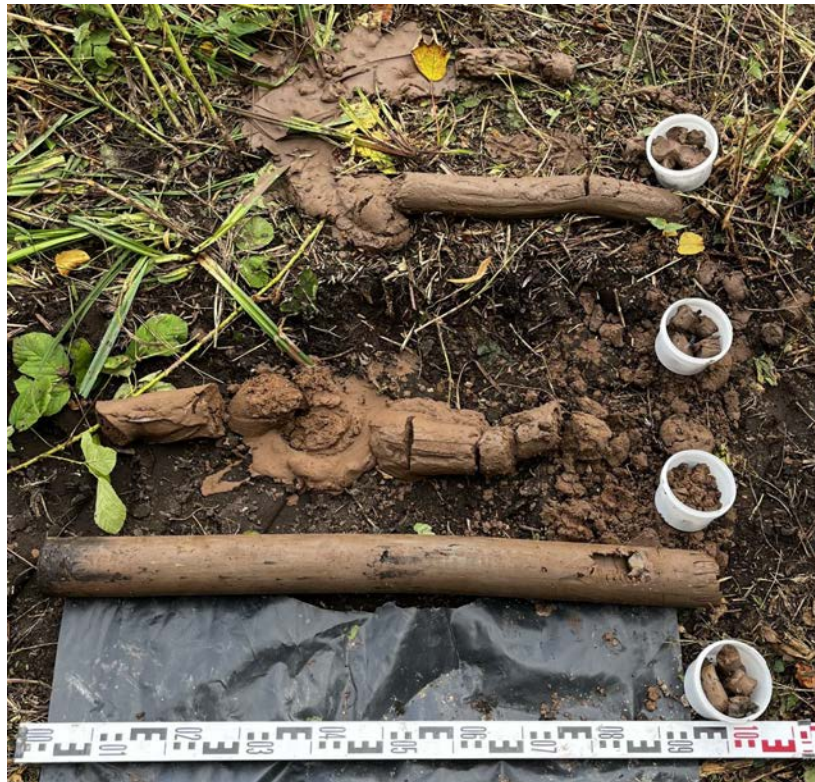
Terminated at target depth. Borehole dipped upon completion, water at 2.20m bgl, base at 2.90m bgl.
