## REMEDiation AND ENABLING WORKS VALIDATION REPORT

**Parcel C**

**Former Prysmian Cable Works,  
Carr Lane,  
Prescot**

**E3P Report: 10-021-R12-Rev 1  
Issued: February 2017**

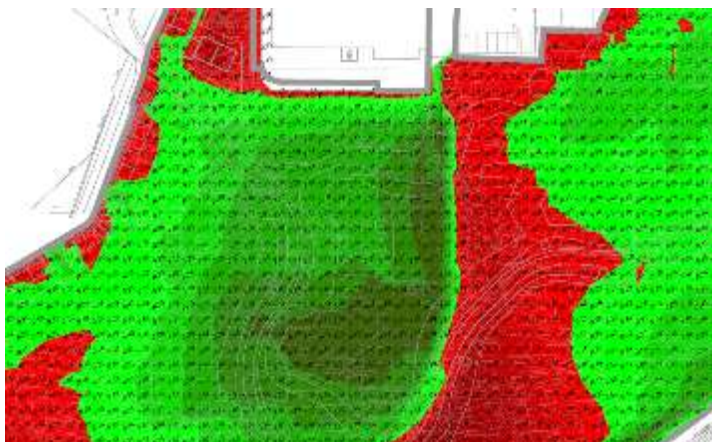
**Figure 3.1 – Extract of Cut / Fill Drawing**

The eastern sector (area shaded red) of Parcel C was generally subject large earthwork exercise that required the removal of between 2-3 meters of historically placed fill that formally comprised a large earth embankment that sub-divided the upper and lower plateau. Subsequent to the cut operation, a turn-over of 3.0m was instigated with subsequent replacement of re-engineered material. In the western sector the landform was upfilled by circa 3.0 - 4.0 at the south west boundary to facilitate the construction of the appropriate road grade (area shaded green).

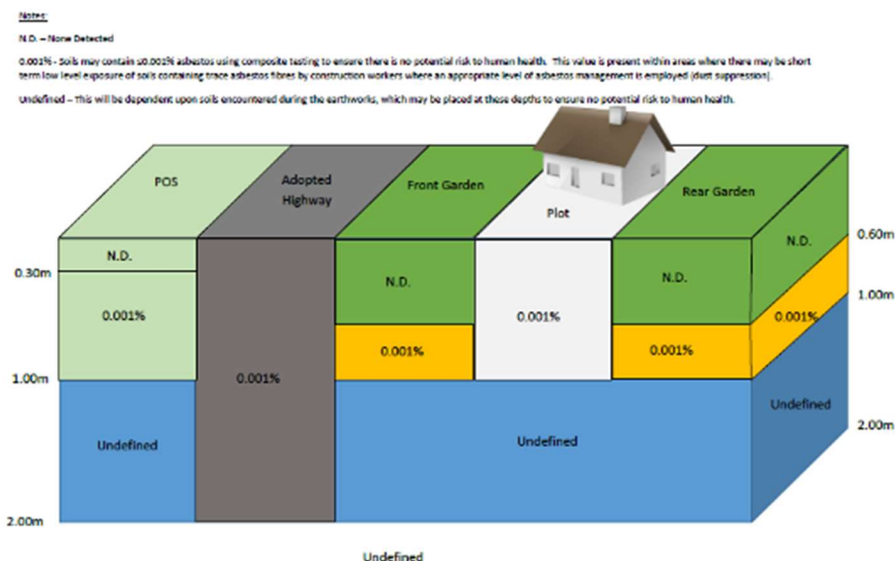
**Figure 4.3 Asbestos Conceptual Site Model**

The developed CSM has been prepared in accordance with industry guidance CIRIA 733 with the works instigated in such a manner to ensure no future exposure to the critical residential receptor.

Given the former site use and nature of filled materials, it is self-evident that impact to all anthropogenic materials across the entire site, however given the quantities of material involved and the absence of any visible notifiable asbestos containing materials the overarching risk profile is reduced.

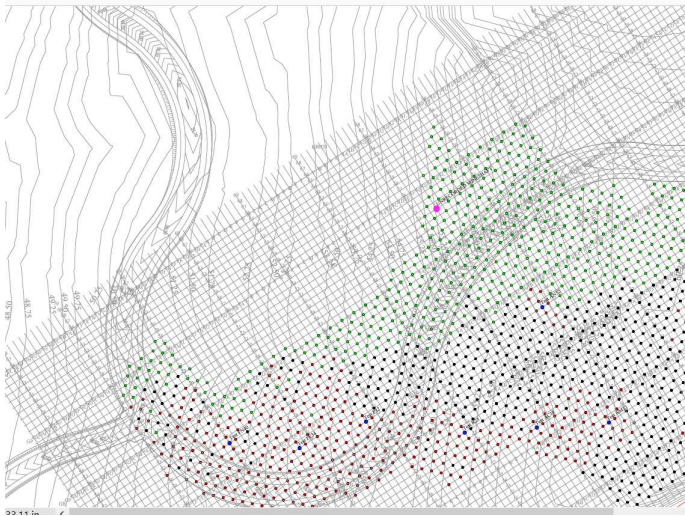
**Figure 6.1 Area of Drill & Grout Pertinent to Parcel C**

In light of the detailed information obtained from the Drill & Grout Operations, it was determined that the Wigan Five Feet Seam (Bastian) had been mispositioned by the BGS & Coal Authority as was suggested within the E3P Specification for the Consolidation of Abandoned Mine Workings.

To further disprove the presence of either a shallow coal seam or unrecorded workings beneath the untreated sector of the proposed development Parcel, 16 No. Boreholes were advanced by Groundshire within Parcel C, all of which confirmed the absence of any coal seam or unrecorded mine workings within the wider parcel that was not subject to stabilisation works.

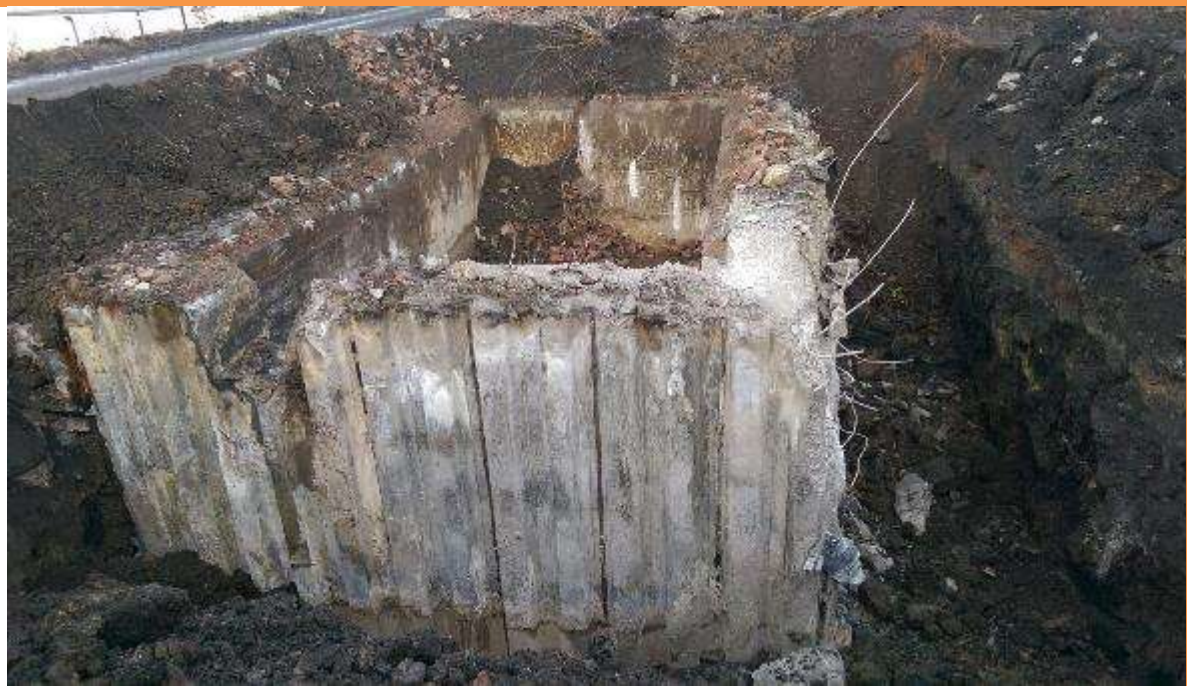
**PLATE 7 – REMOVAL OF CONCRETE BELOW GROUND STORAGE TANK**

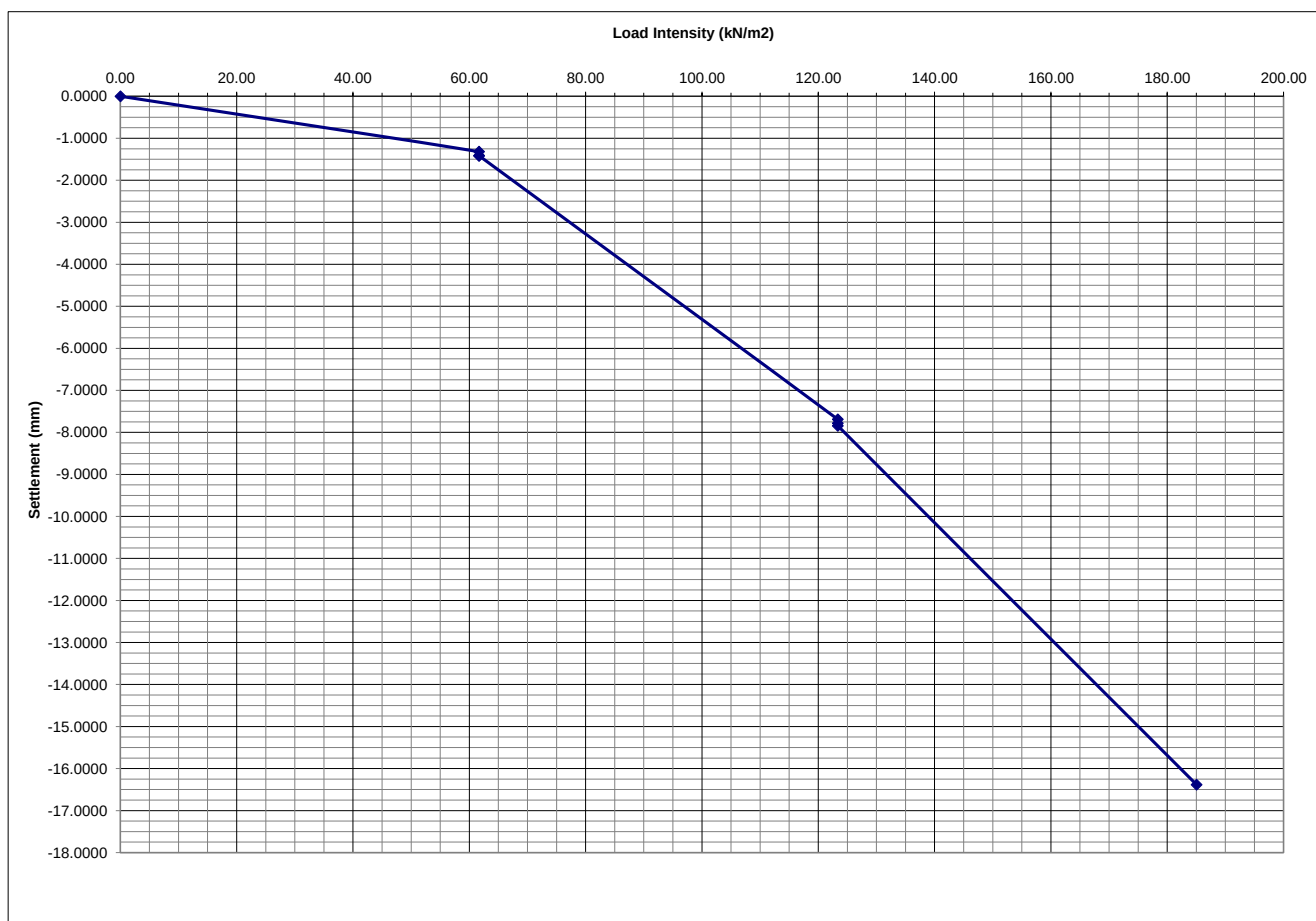
## Equivalent CBR Value of 3%

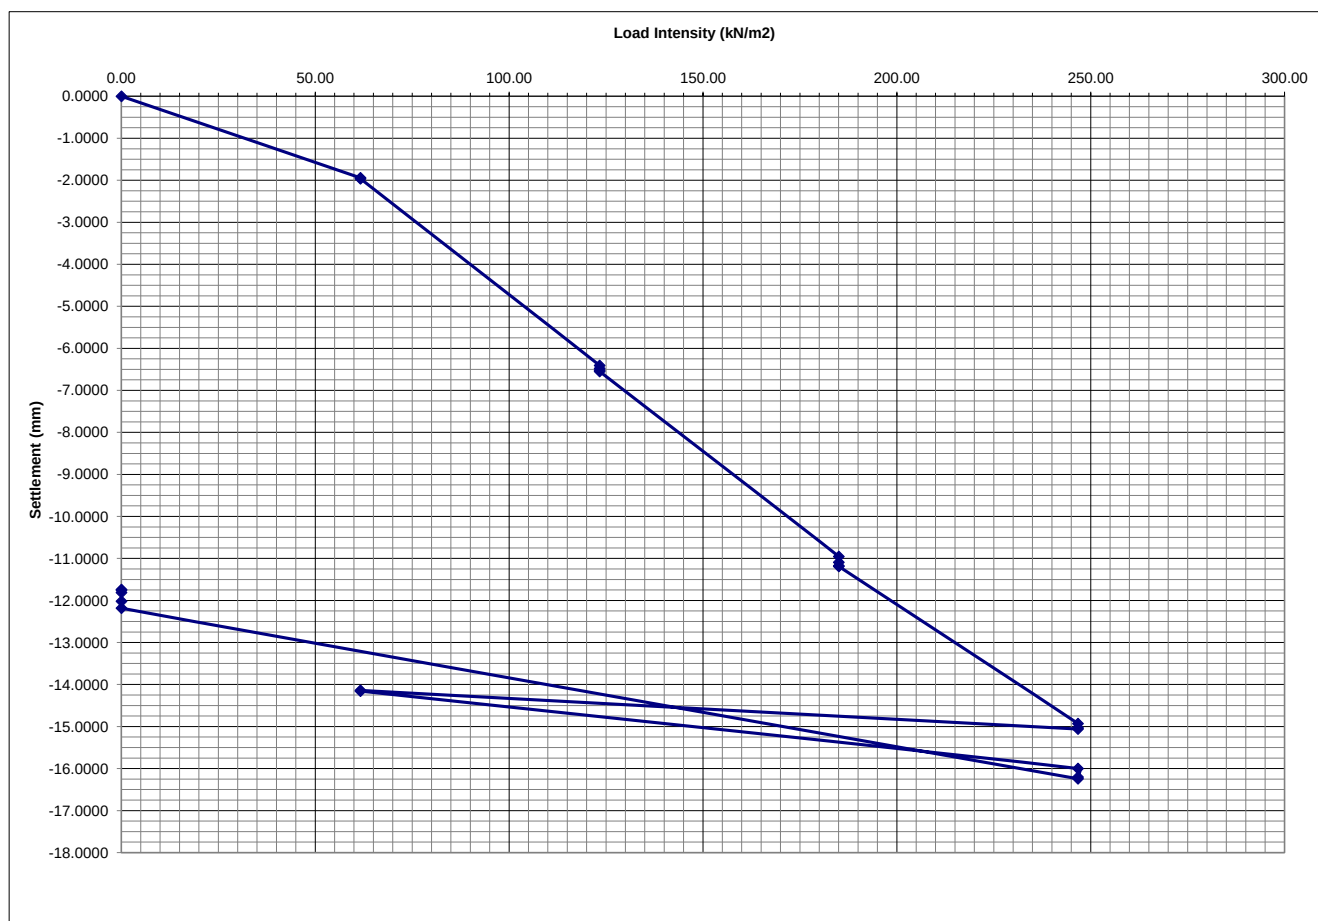
## Equivalent CBR Value of 2%

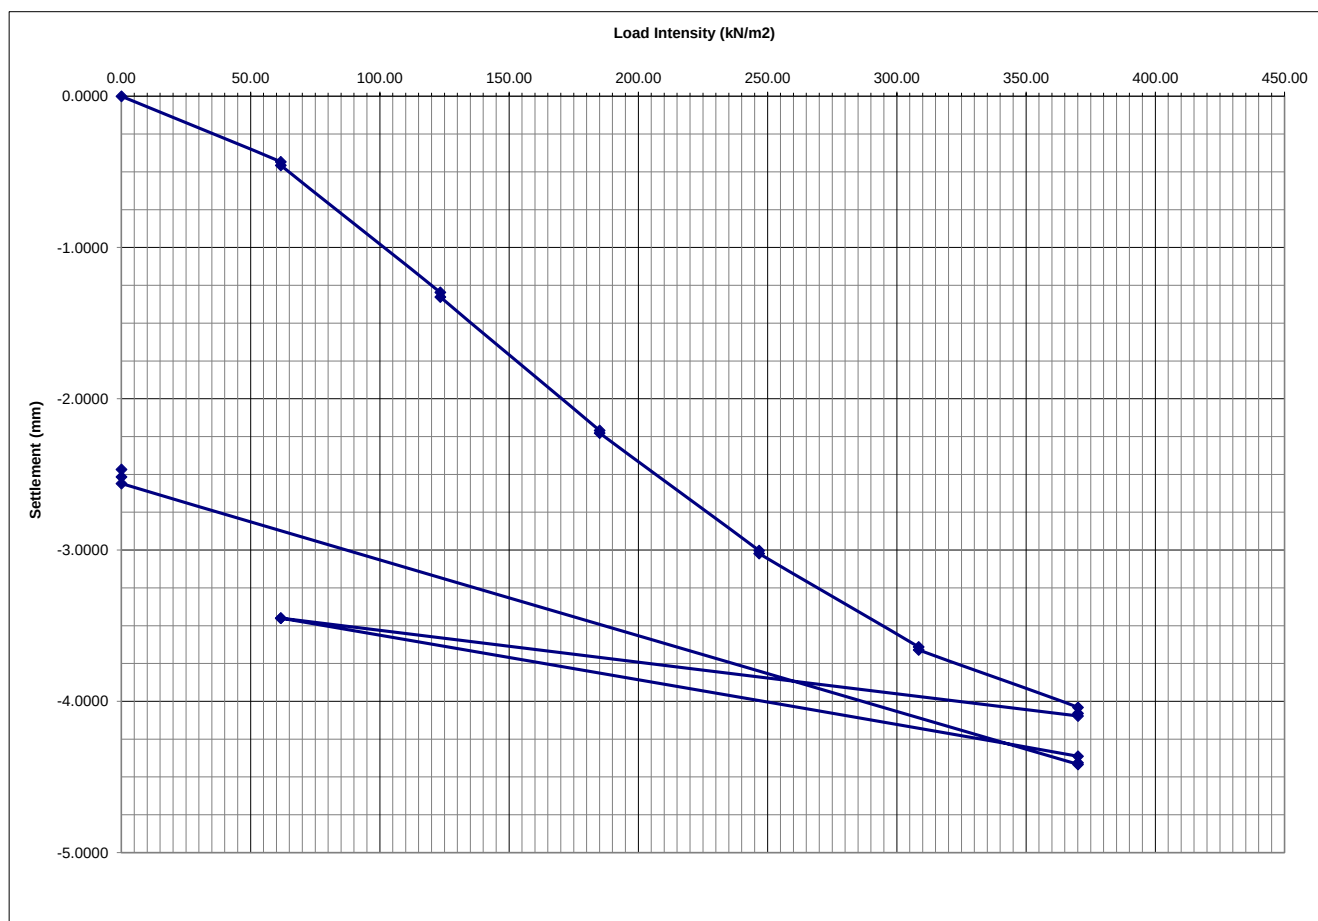
**Equivalent CBR Value of 13%**

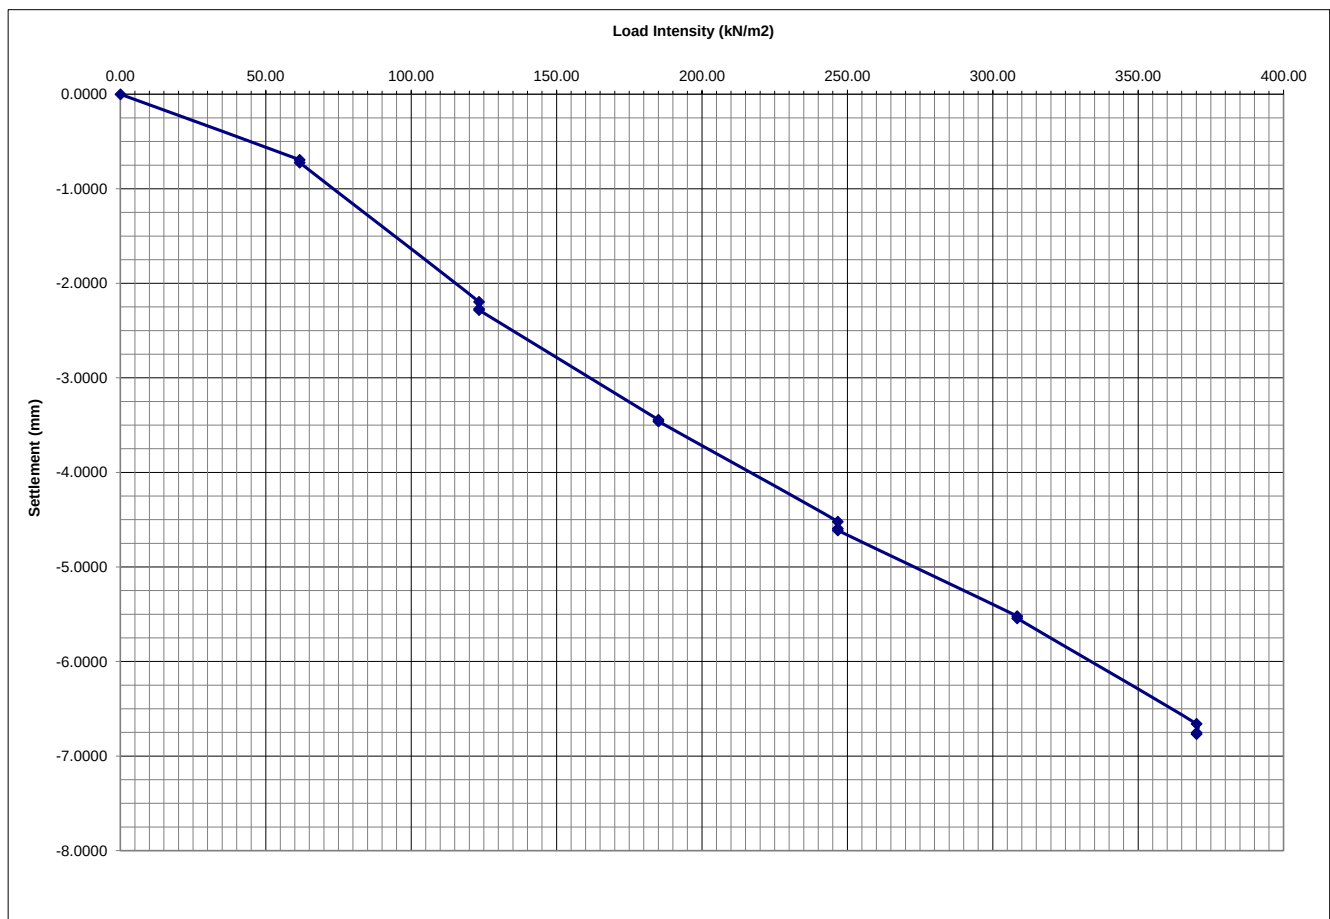
## Equivalent CBR Value of 7%
