## Pilch Lane, Liverpool

### Phase 2 Geo-Environmental Investigation Report

For: Breck Homes

| <b>Report Reference:</b> | | <b>4399-02A</b> |

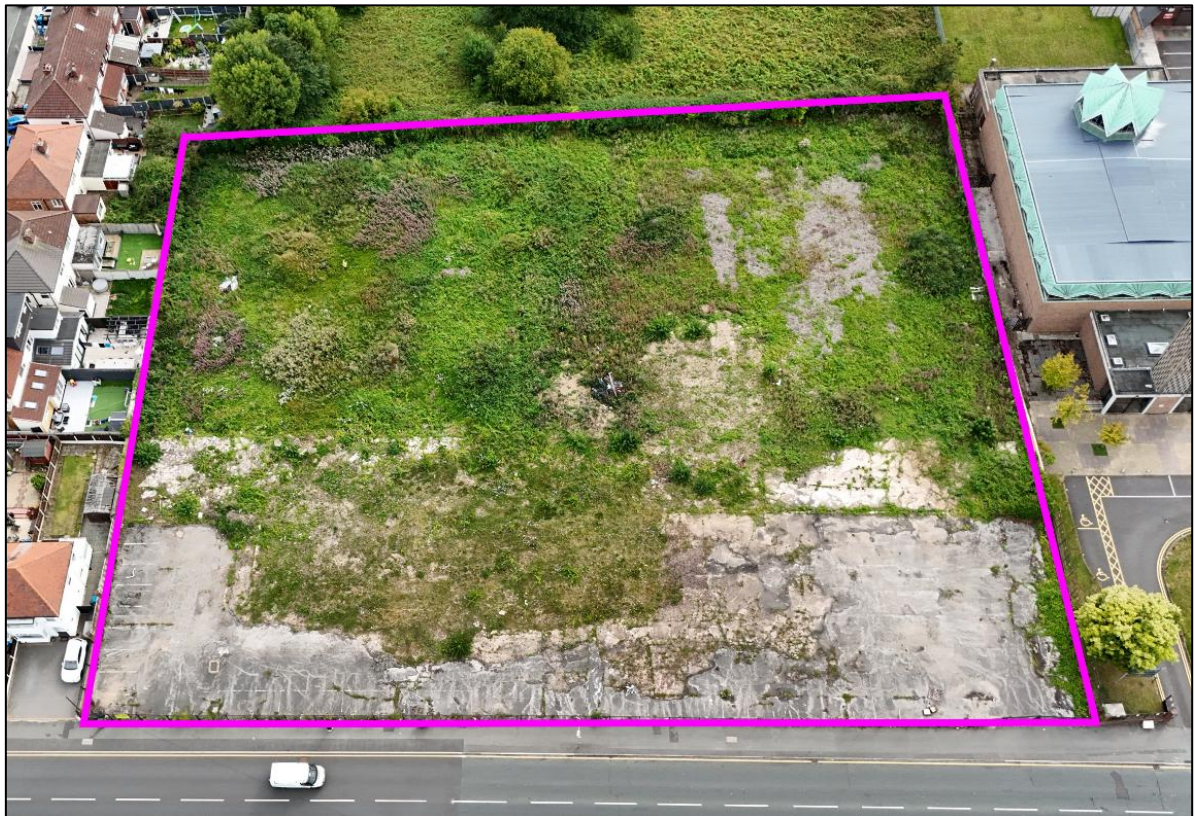
Figure 1: Drone image of the site dated August 2025, looking south to north. The site boundary is highlighted in pink.

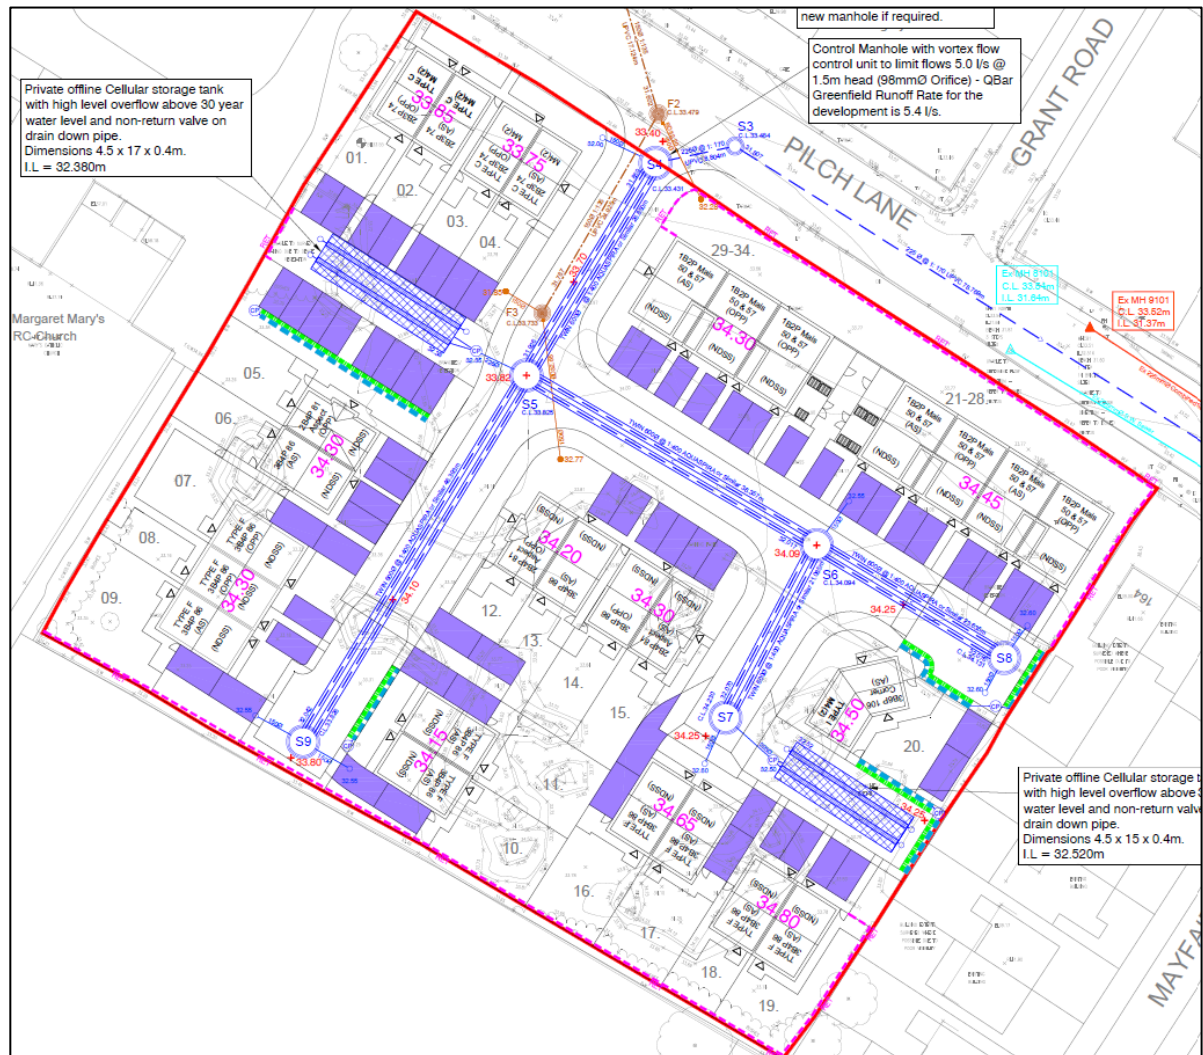
Figure 2: An extract of the proposed development plan '30686\_100C Preliminary Drainage Layout'

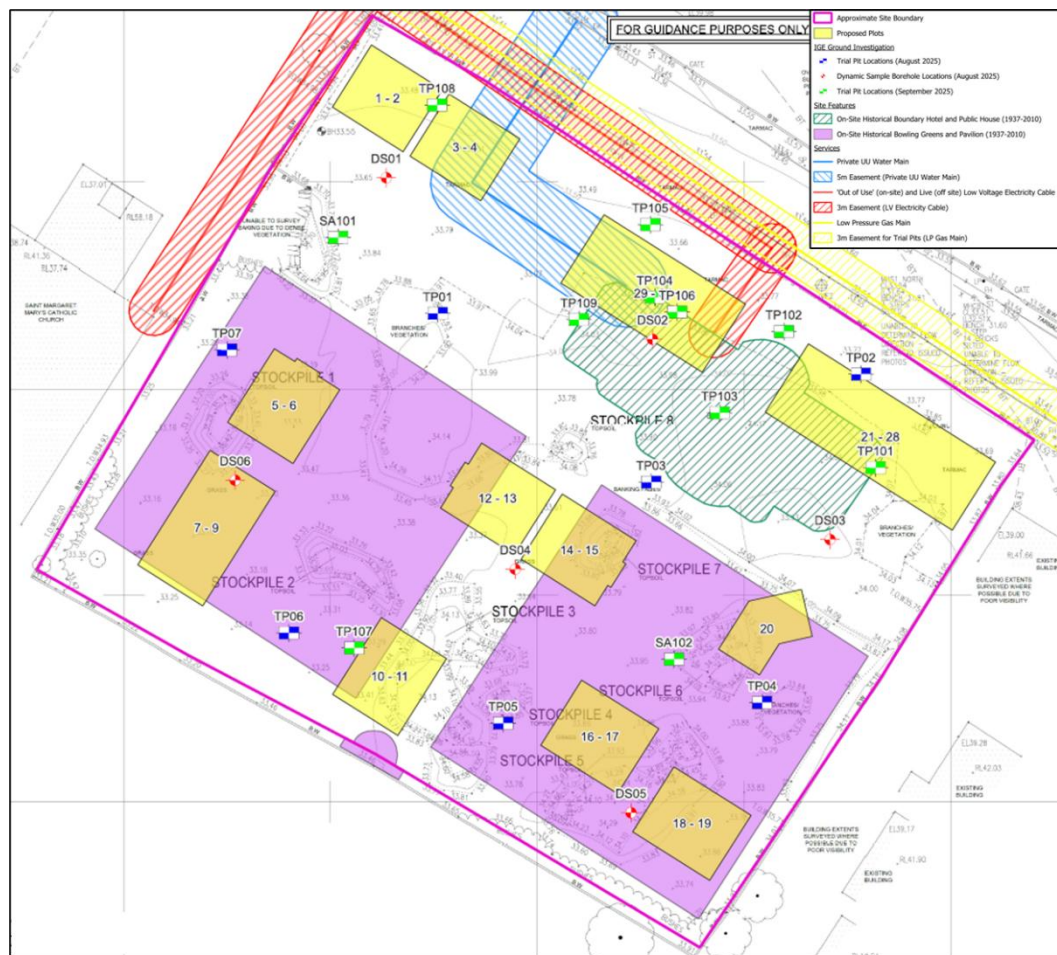
Figure 3: An extract of the exploratory hole location plan.

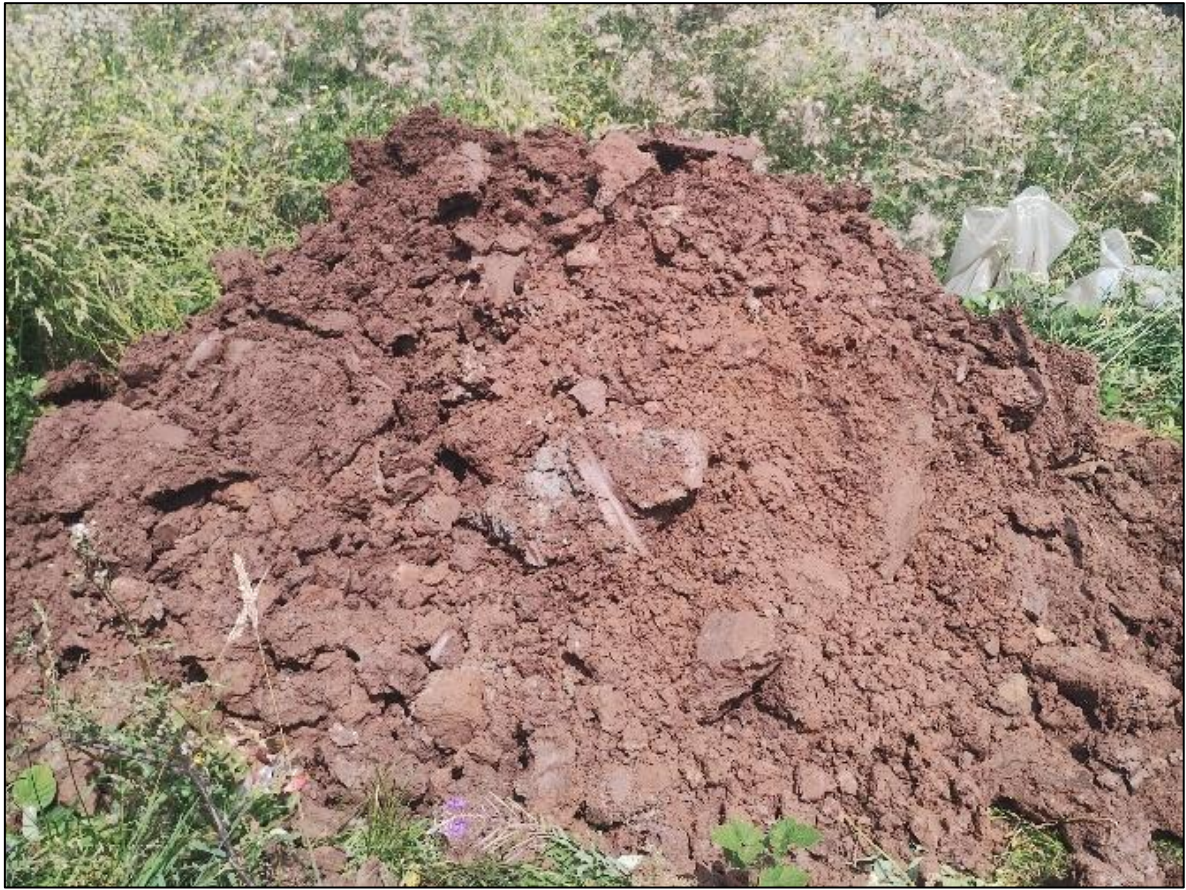
*Figure 4: Typical Glacial Till encountered in TP03.*

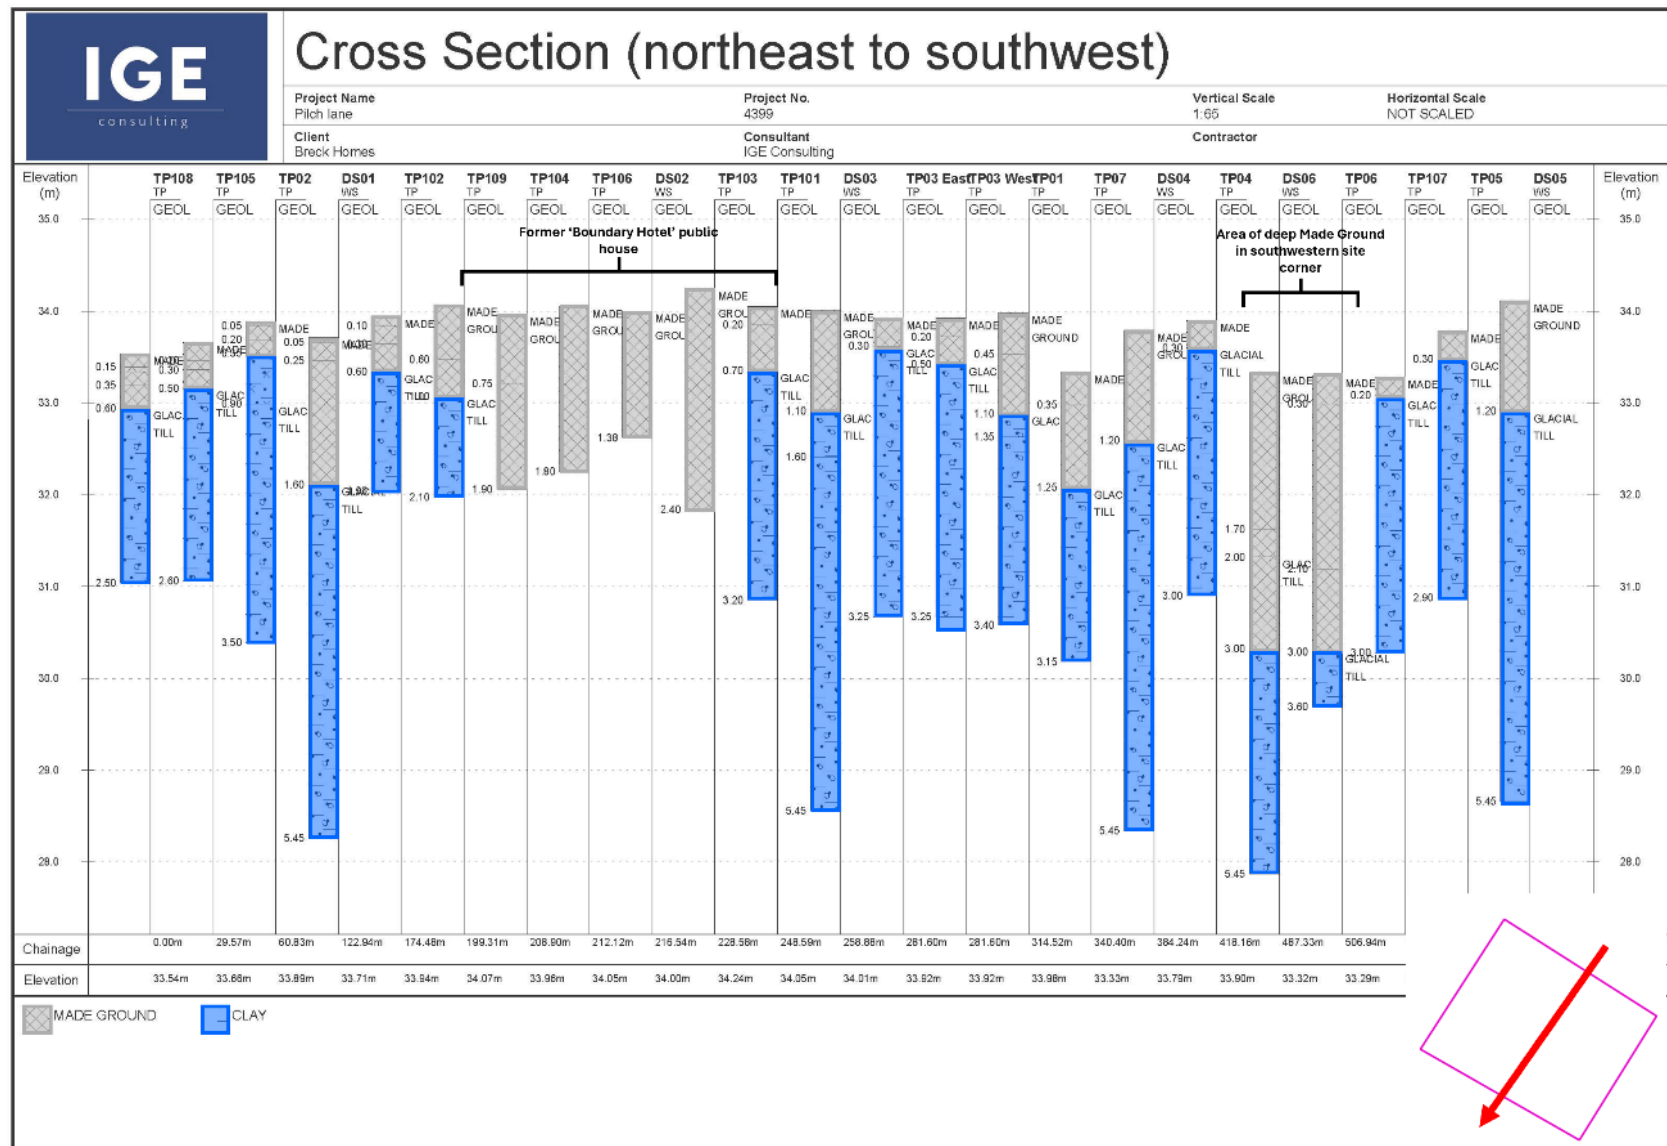
The cross section presented in Figure 5, below, highlights the recorded depths of Made Ground across the site from northeast to southwest. Deeper Made Ground associated with the former Boundary Hotel public house in the northeastern site section is highlighted below. Detailed cross sections are included in Appendix 2

Figure 5: Indicative Cross Section from northeast to southwest.

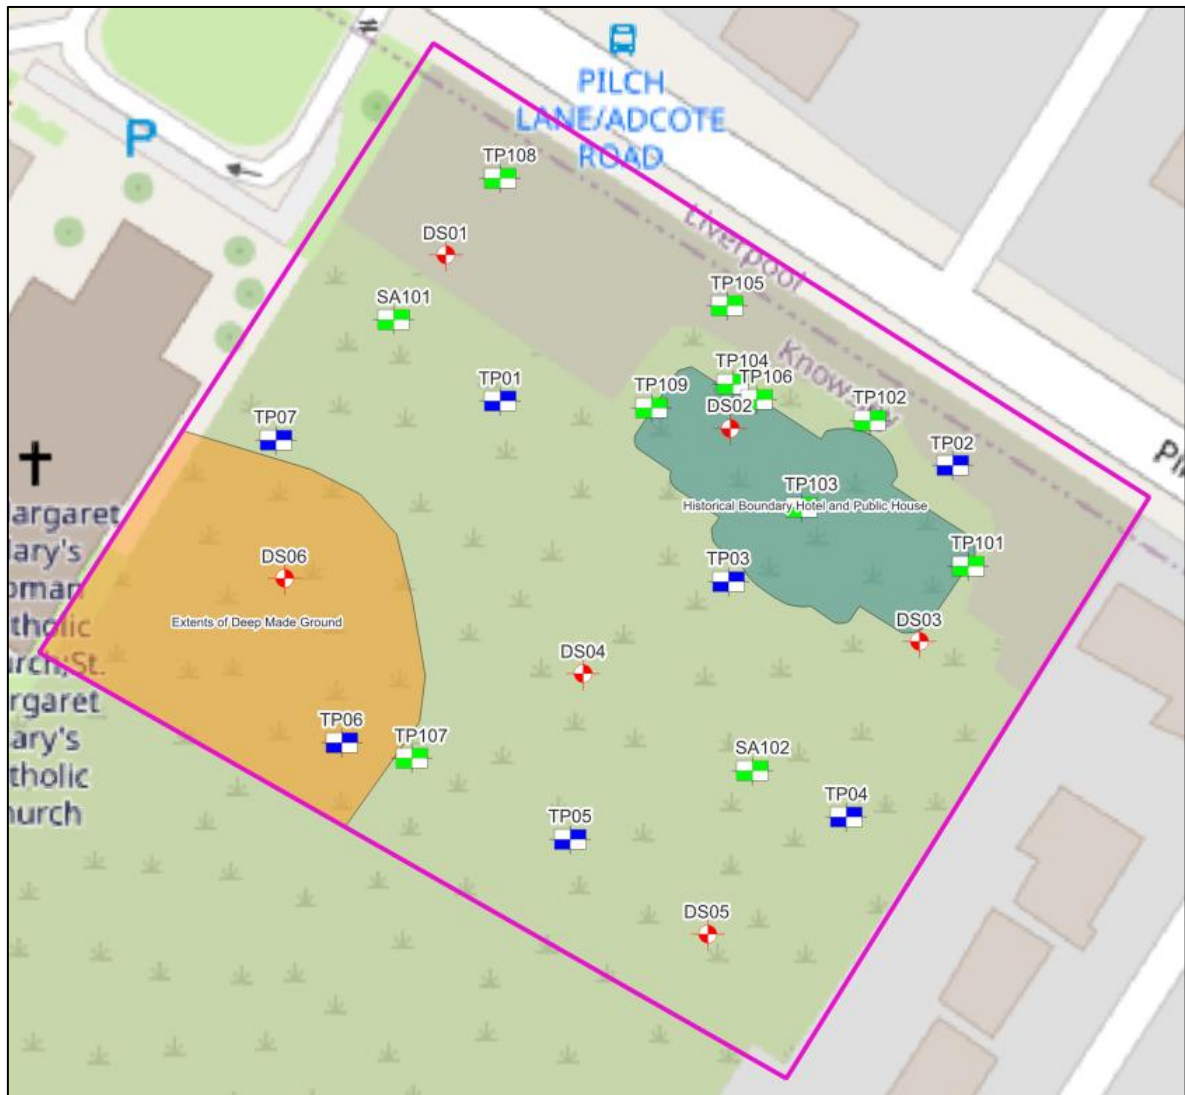
Figure 6: QGIS extract detailing the exploratory hole locations and notable exceptions encountered within the ground conditions.

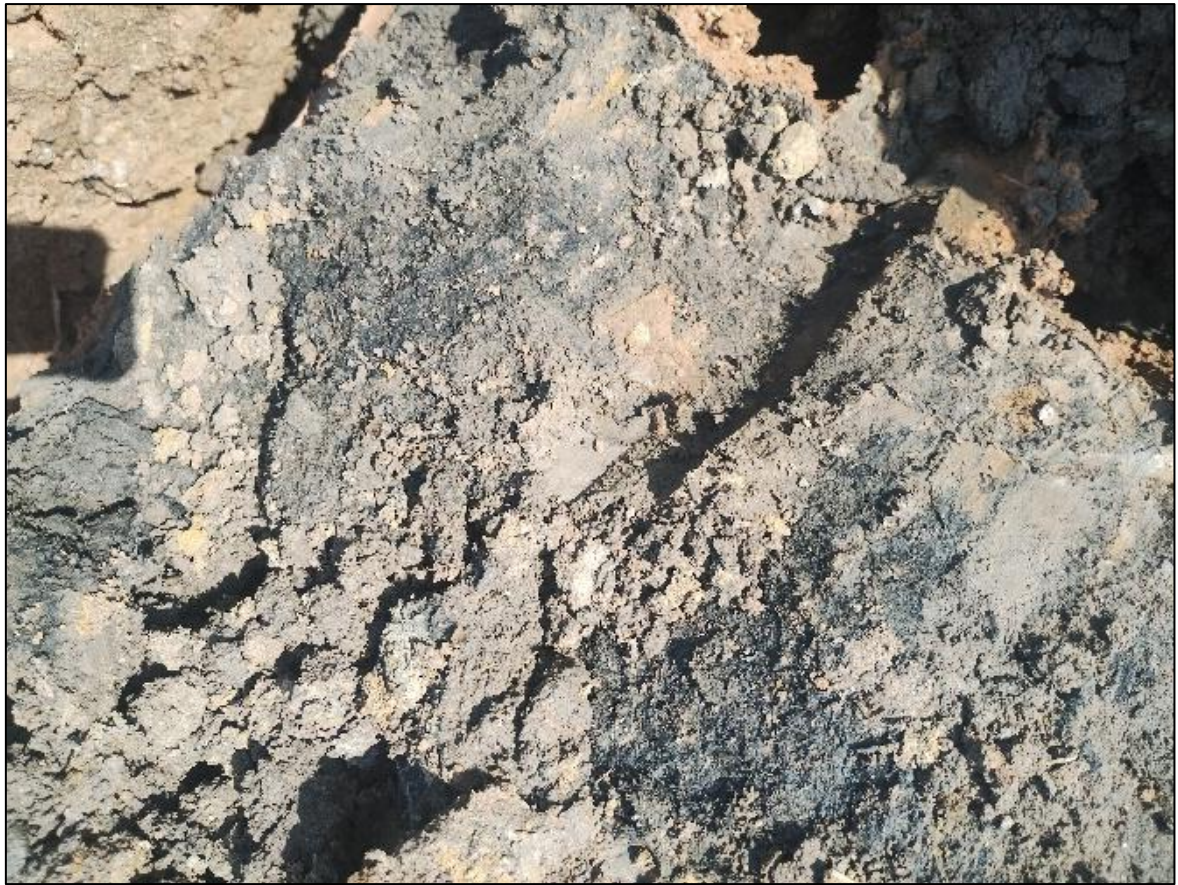
*Figure 7: Deep Made Ground with plant remains encountered within TP06 and DS06 only.*

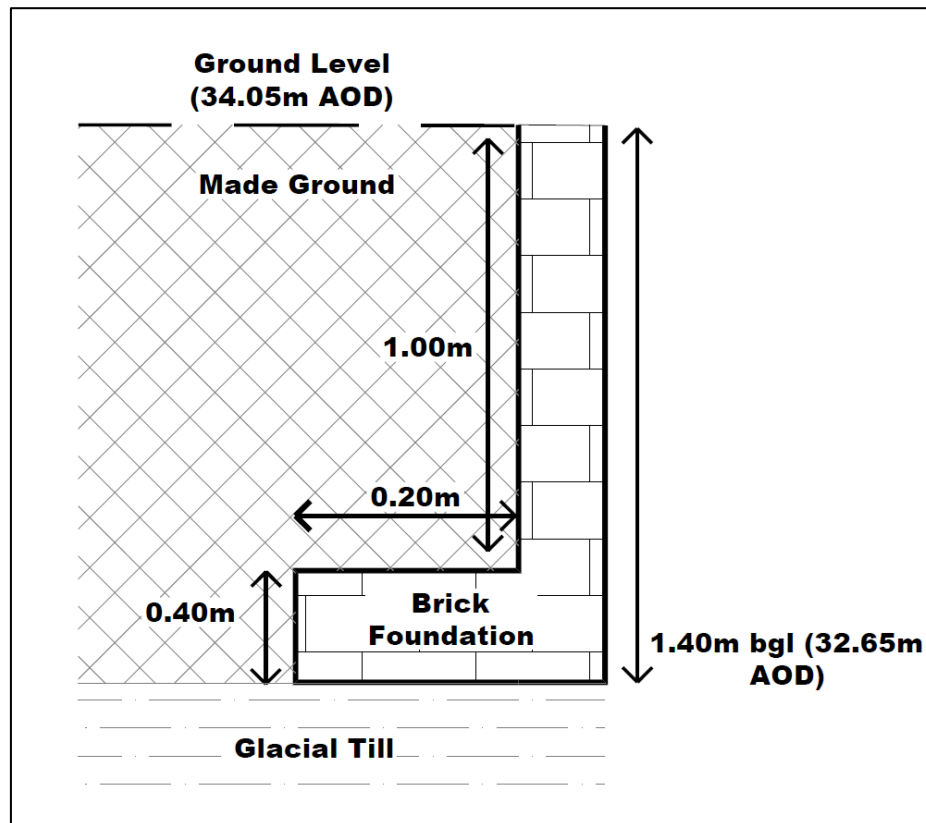
firm Glacial Till, as encountered across the remainder of the site. A schematic of the encountered foundation is included below:

Figure 8: Cross Section of the foundation encountered in TP101.

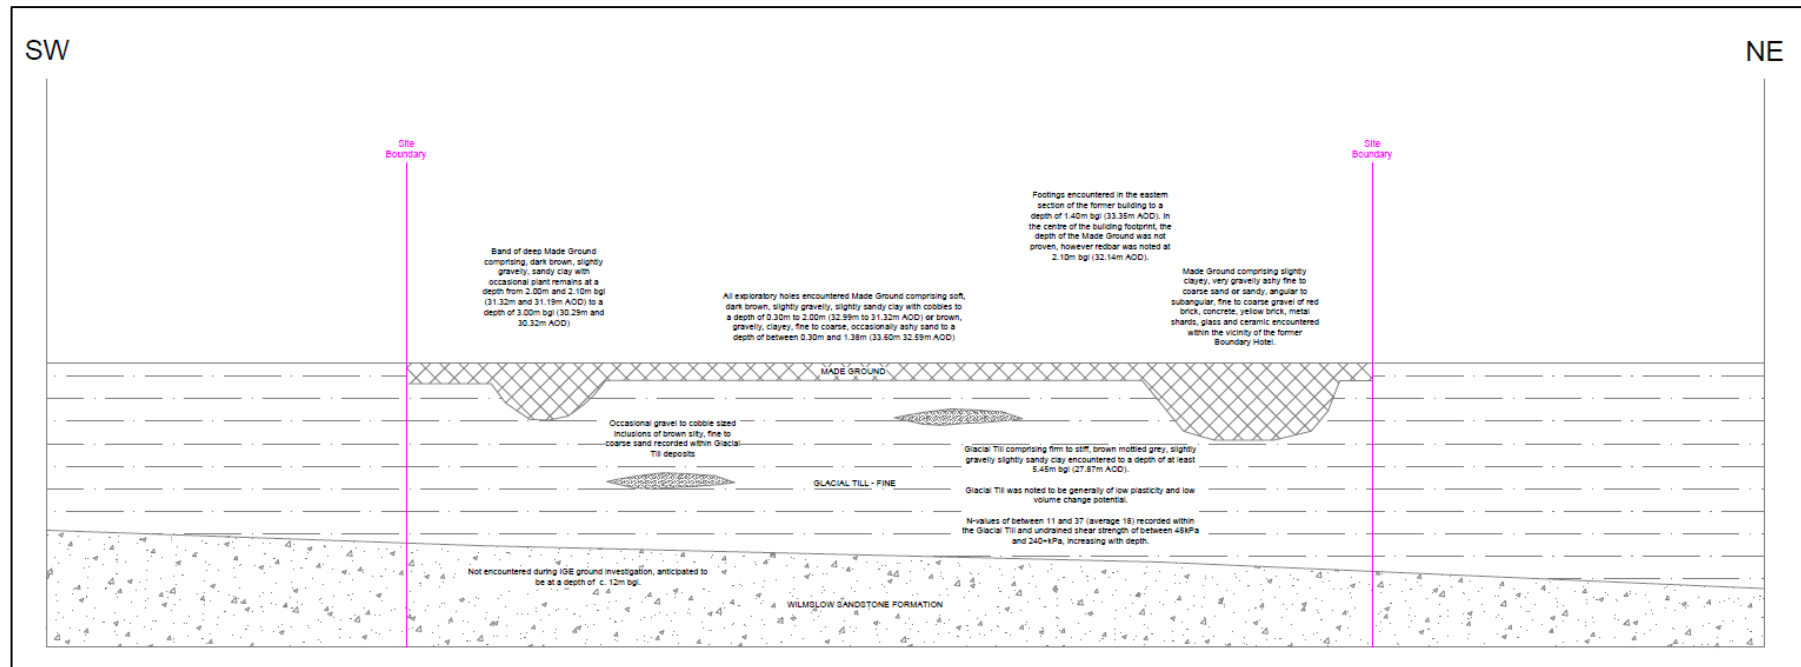
The findings of the Phase 2 ground investigation works have been used to create a conceptual ground model of the site. The conceptual ground model demonstrates the consistent geological strata encountered across the site:

Figure 9: Extract of the conceptual ground model for the site.

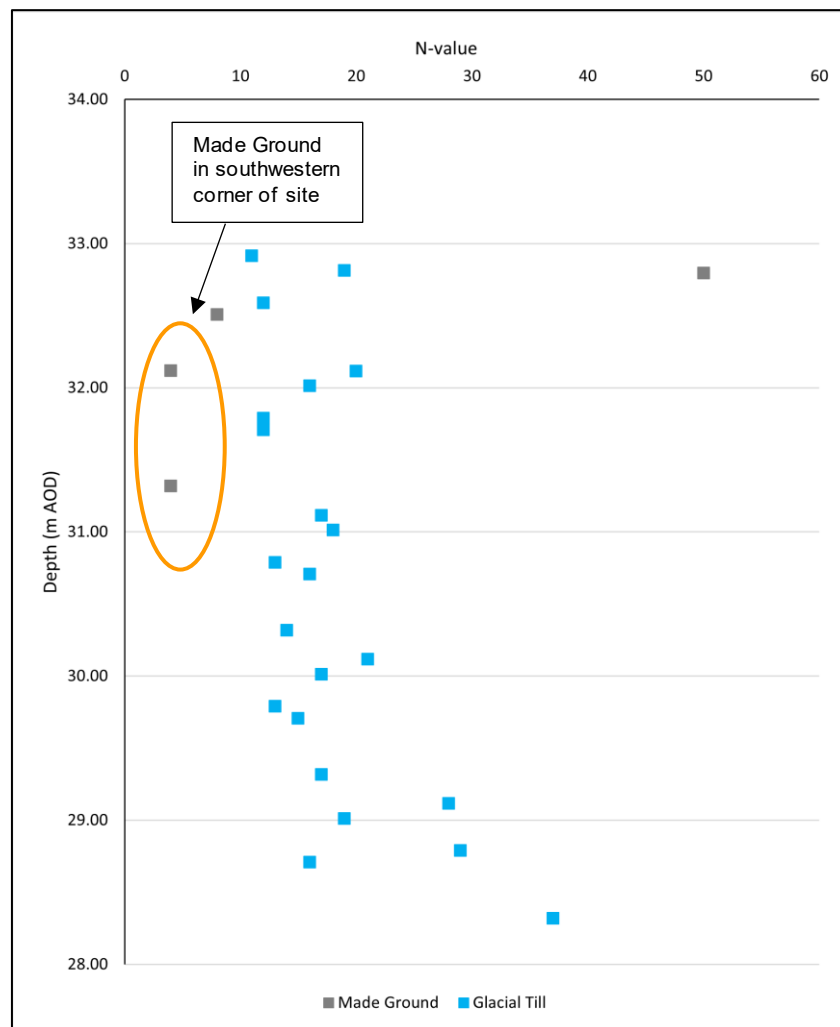
The following scatter graph shows that there was a general positive correlation between increasing uncorrected N-value with depth.

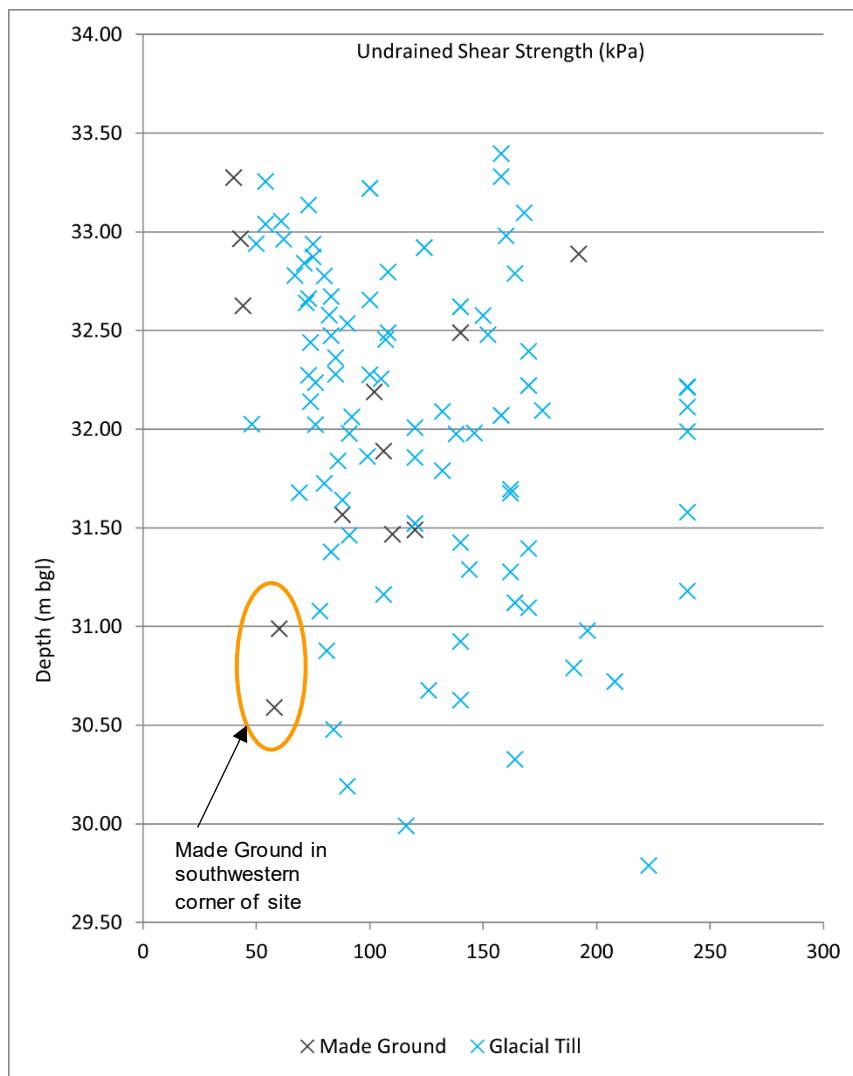
The graph indicates that there is generally a positive correlation between hand shear vane reading and depth.

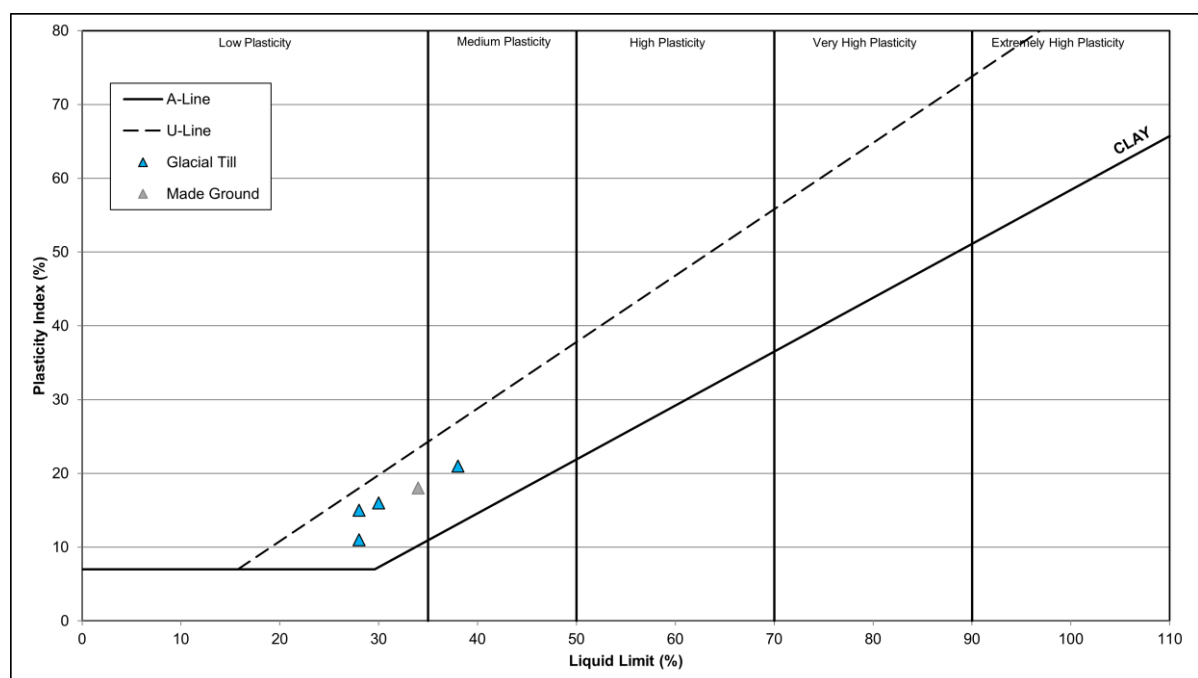
The Atterberg Limit tests indicate that the Made Ground and Glacial Till deposits are generally of low plasticity with the exception of the Glacial Till in the eastern site section (TP04) which is of medium plasticity in-line with BS14688 Part 2.

The Glacial Till and Made Ground are generally of low volume change potential, with the exception of the sample from TP04 in the eastern site section which is of moderate volume change potential in-line with NHBC Chapter 4.2 guidance.

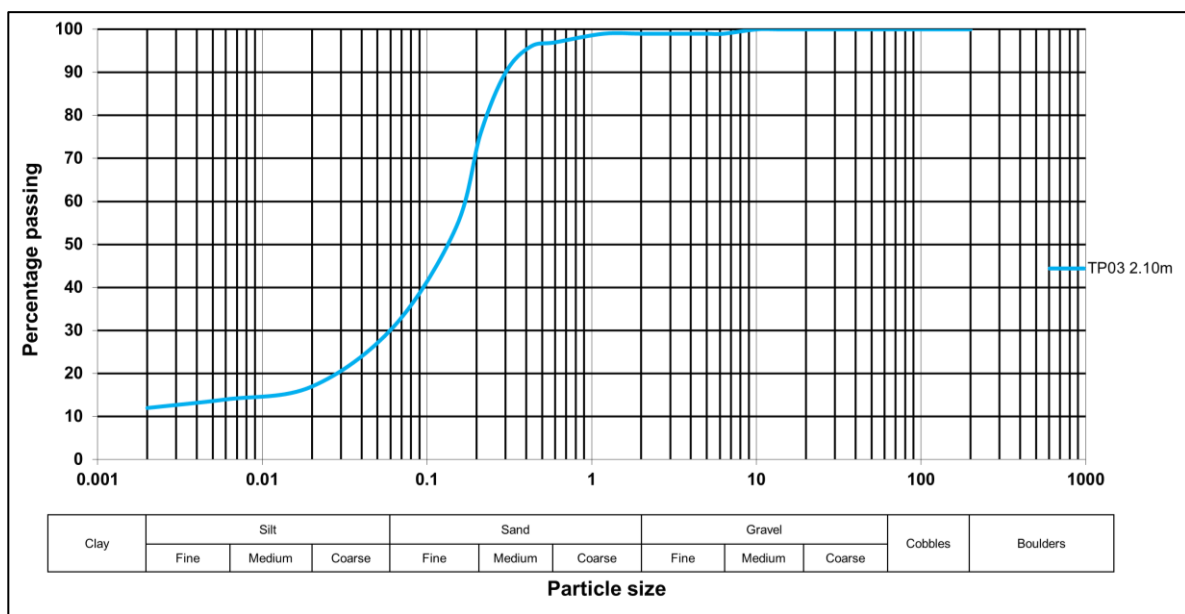
A single particle size distribution test was undertaken on a sample of Glacial Till from a gravel to cobble sized inclusion within TP03.

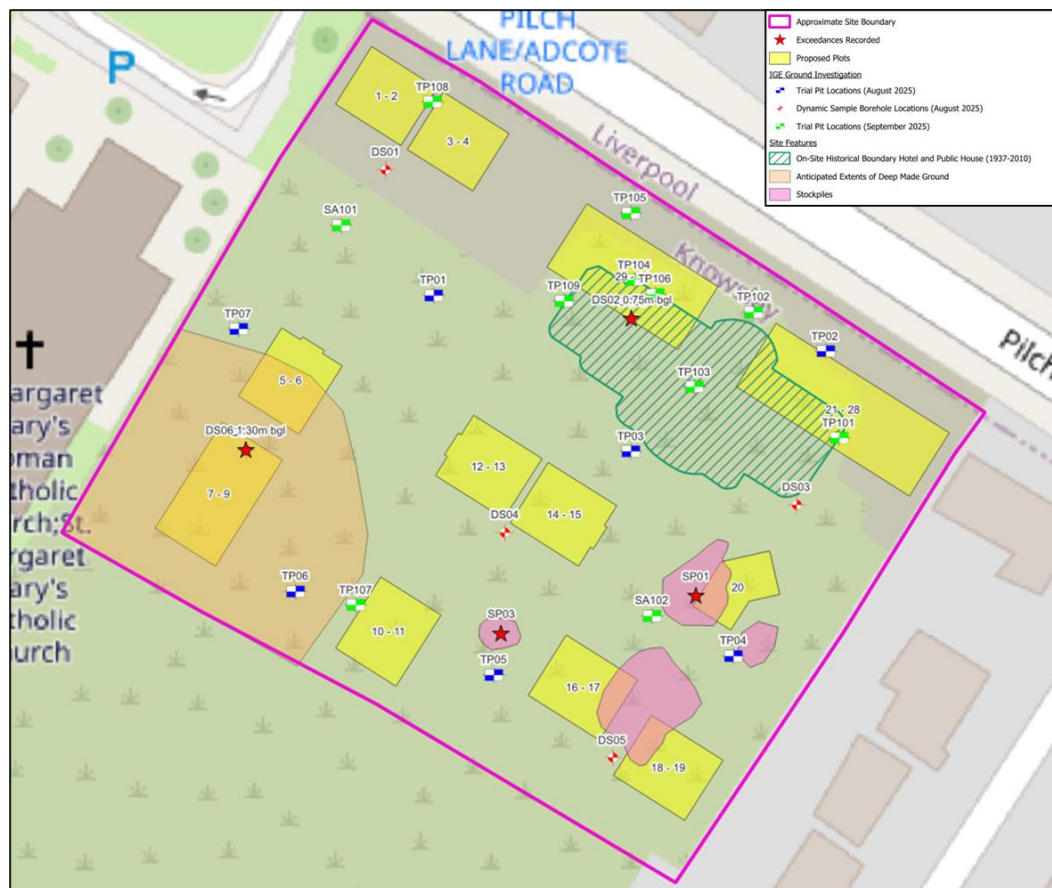
Figure 10: QGIS Extract detailing areas of exceedances: former Boundary Hotel (blue), Stockpiles (pink) and area of deeper Made Ground (orange). Red stars indicate the location of exceedances encountered on site.

Although PAH and heavy metal exceedances associated with the former Boundary Hotel, stockpiles and deep Made Ground within the southwestern corner of the site have been identified, they were noted to be only slightly in excess of the residential with homegrown produce GAC and relatively low PID readings were recorded within the Made Ground. Given the presence of cohesive Glacial Till underlying the site and lack of exceedances within the underlying deposits, migration of contaminants will be reduced. However, feasible pathways to site users and construction workers exist and therefore the risk to human health is deemed **low to moderate**. A separate stand-alone remedial strategy will be produced.

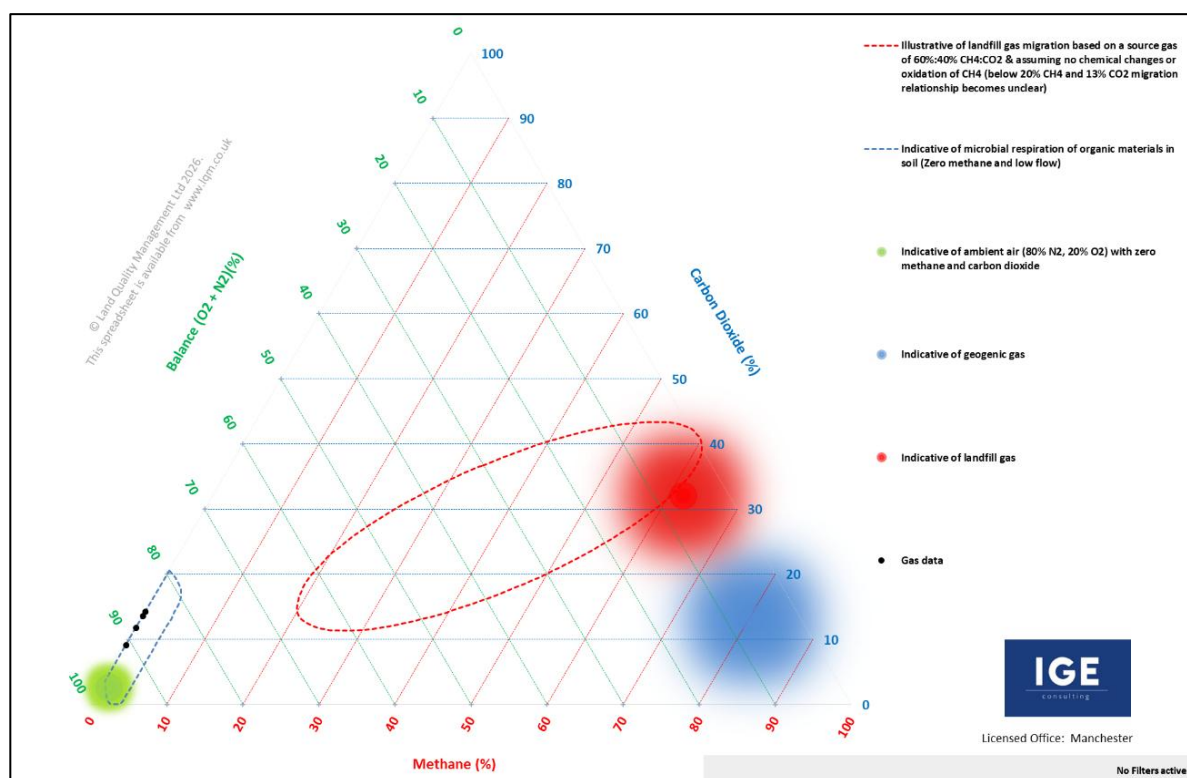
The ternary plot below shows the ground gas monitoring data from DS06 and concurs that the ground gas concentrations in DS06 is indicative of microbial respiration of organic material, represented by methane concentrations and flow rates below detection limit.

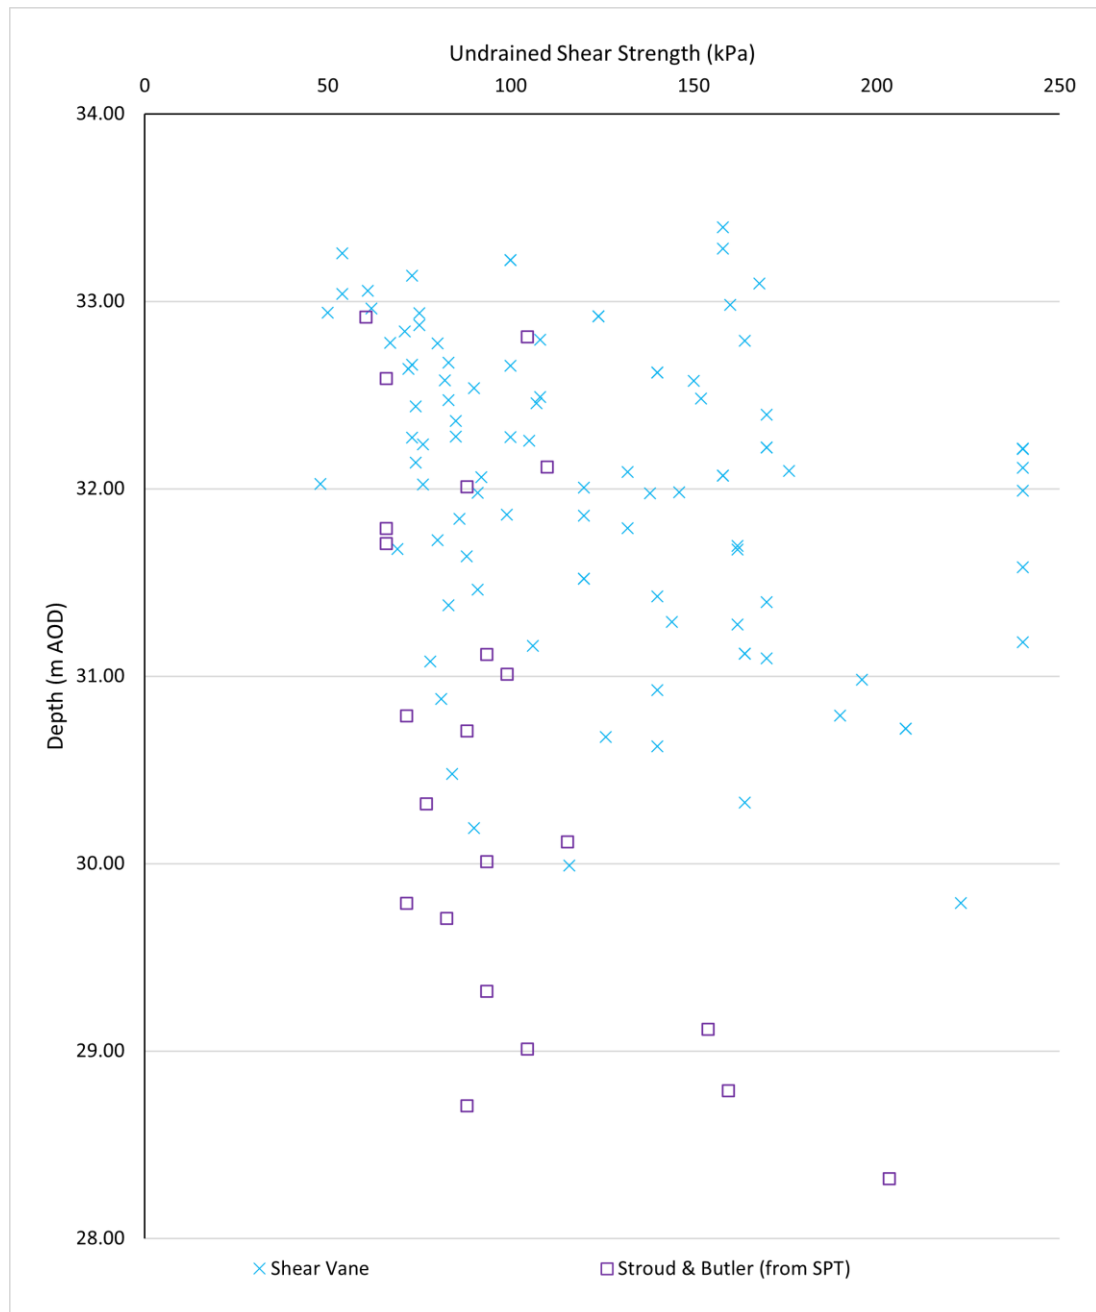
204kPa, with an approximate average of 98kPa. These are slightly lower values than those obtained through direct measurement (shear vane testing), but the graph below shows good general agreement between the two datasets. The graph indicates that there is generally an increase in undrained shear strength with depth.

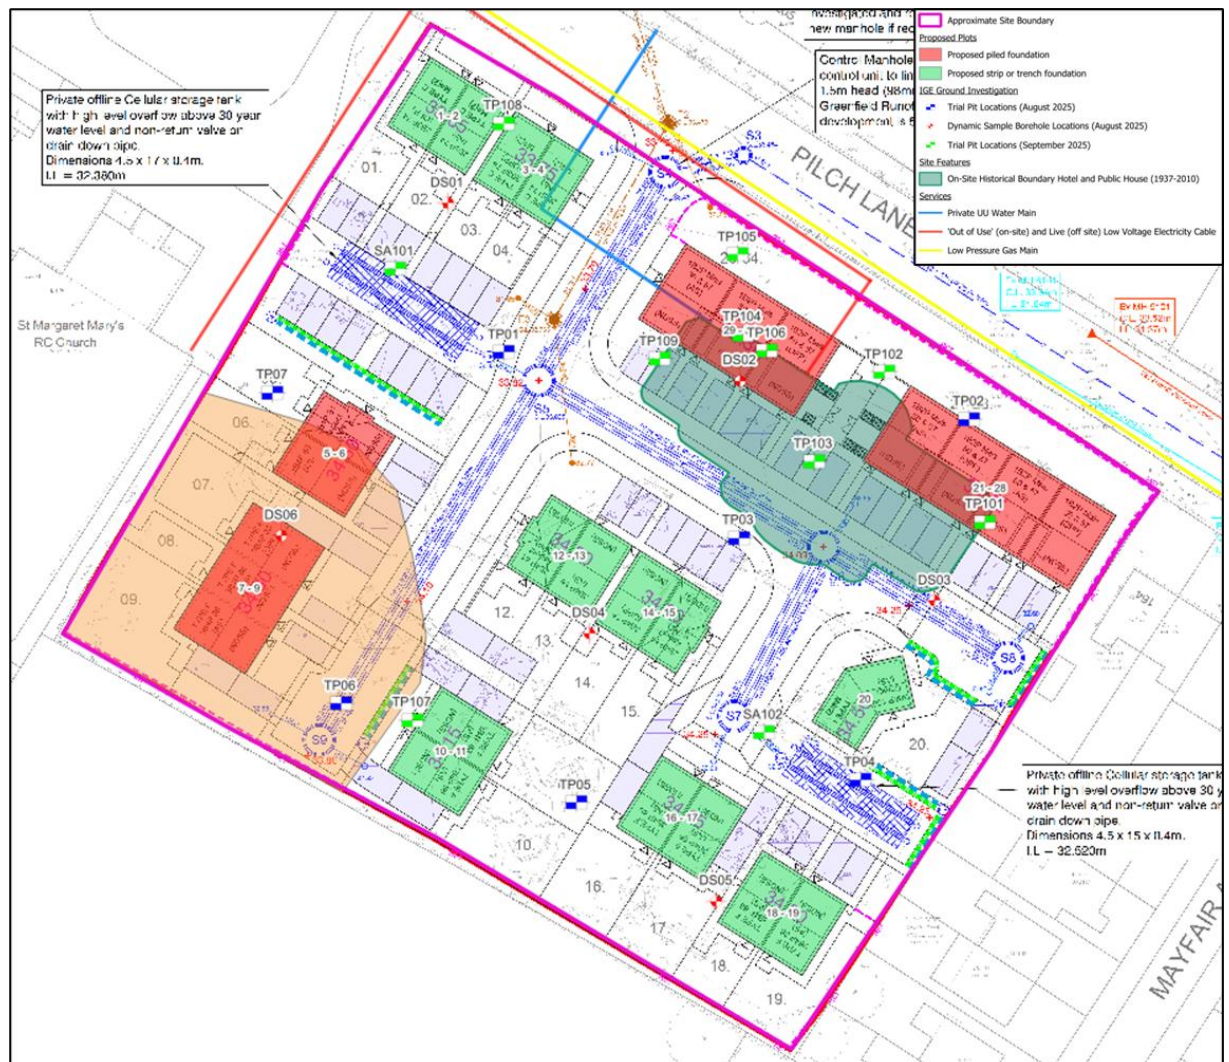
Figure 11: Extract of '30686\_100C Preliminary Drainage Layout' including services and historical features including the former Boundary Hotel extents (blue). Orange indicates the approximate area of deep Made Ground in the southwestern section.

### Plots 1 – 4 and 12 – 20 (Green on plan)

Made Ground was encountered within all exploratory holes typically to a depth of between 0.30m and 1.25m and was noted to comprise either soft clay or sand. Given the variability and low strength nature of the Made Ground, it is not considered a suitable founding stratum for even lightly loaded structures.
