## **Pilch Lane, Liverpool**

### **Remedial Strategy Report and Earthworks Strategy**

For: Breck Homes Ltd

| <b>Report Reference:</b> | | <b>4399-04</b> |

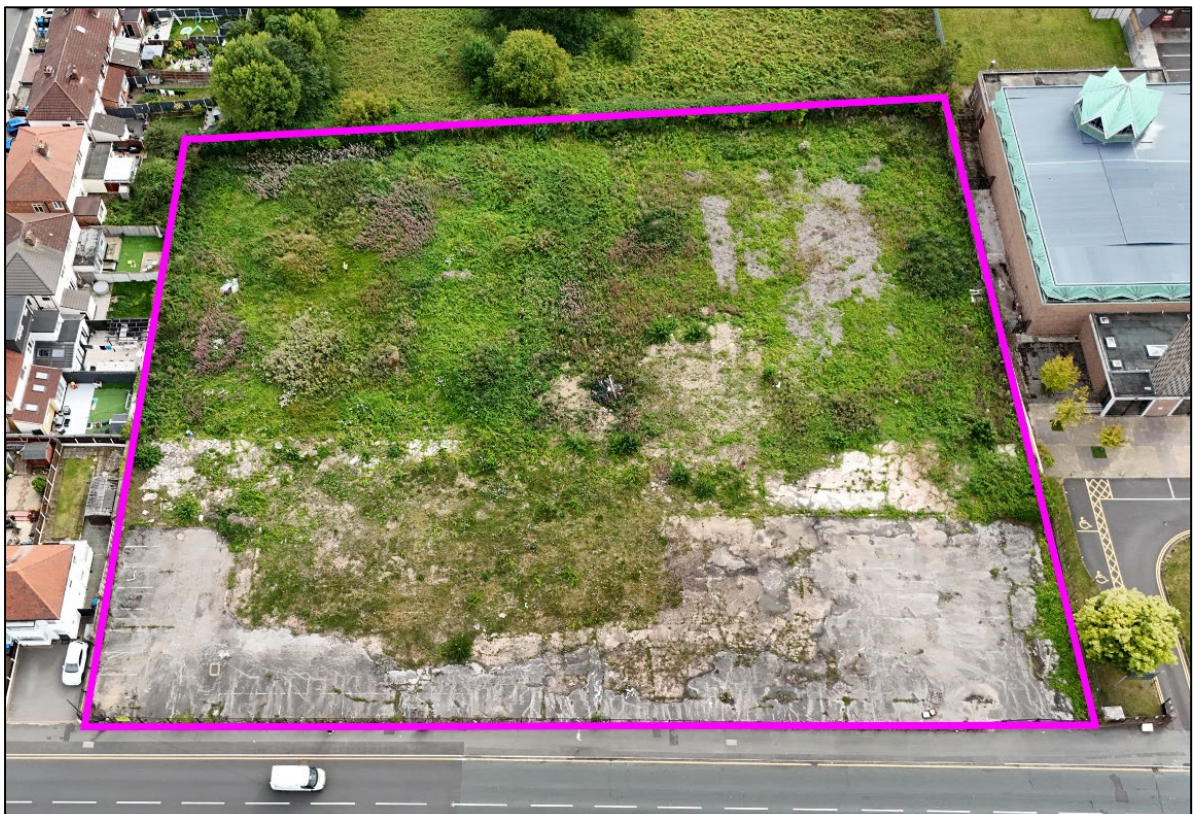
Figure 1: Drone image of the site dated August 2025, taken from the south, looking north. The site boundary is highlighted in pink.

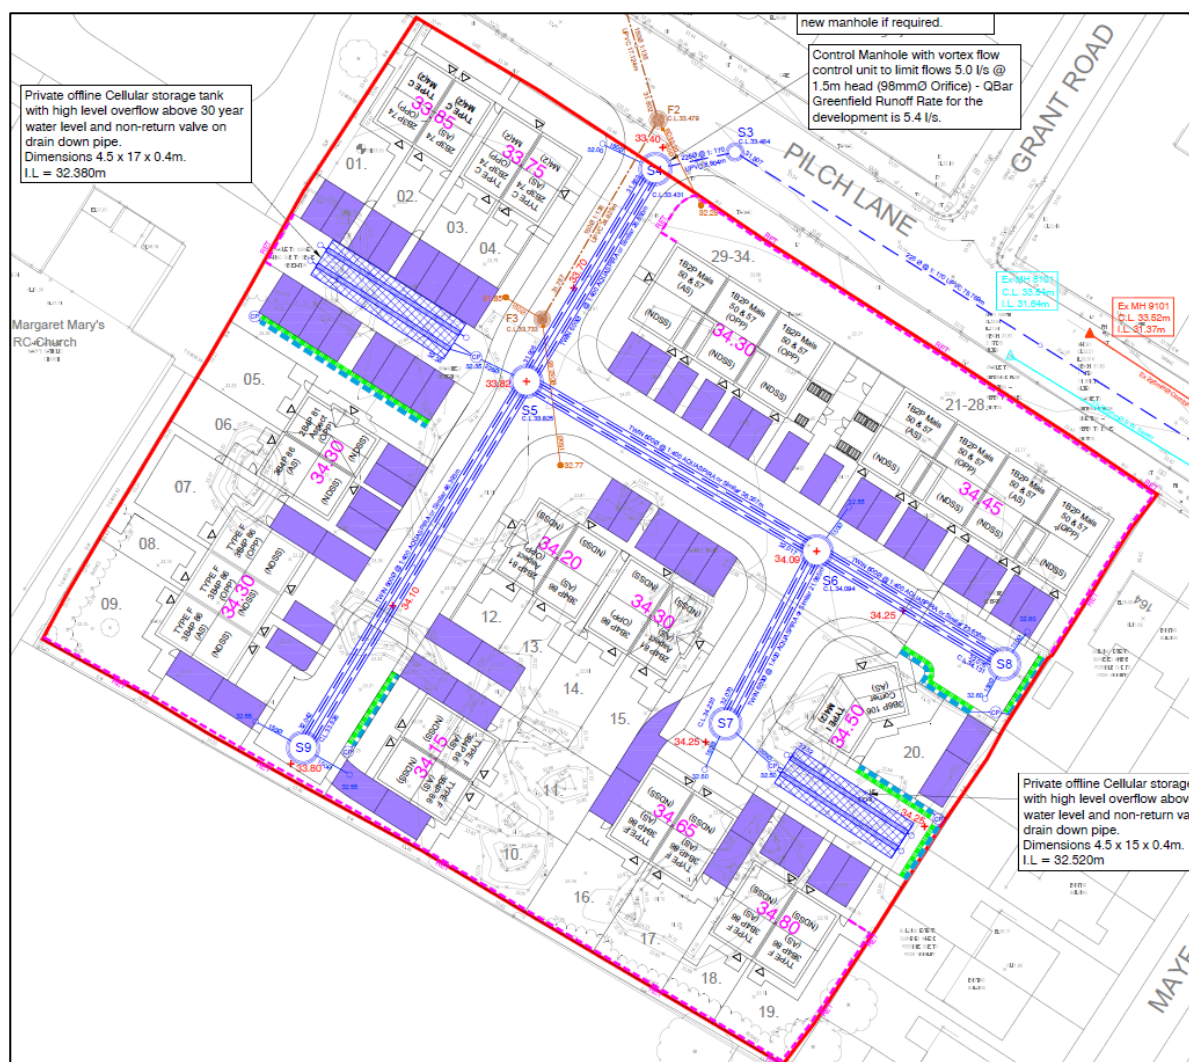
Figure 2: An extract of the proposed development plan '30686\_100C Preliminary Drainage Layout'

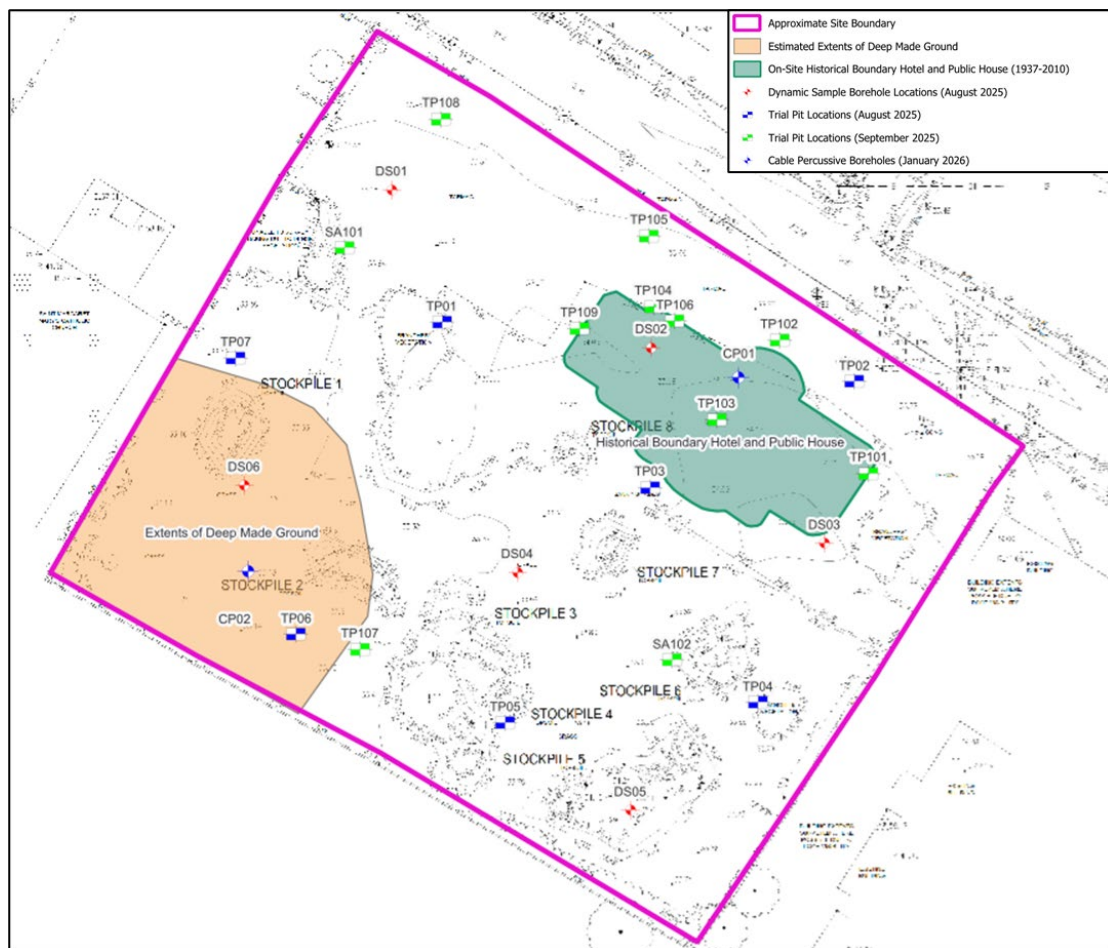
Figure 3: QGIS extract detailing the exploratory hole locations and notable exceptions encountered within the ground conditions.

The following notable exceptions to the aforementioned typical ground conditions were recorded and are highlighted in the plan below:

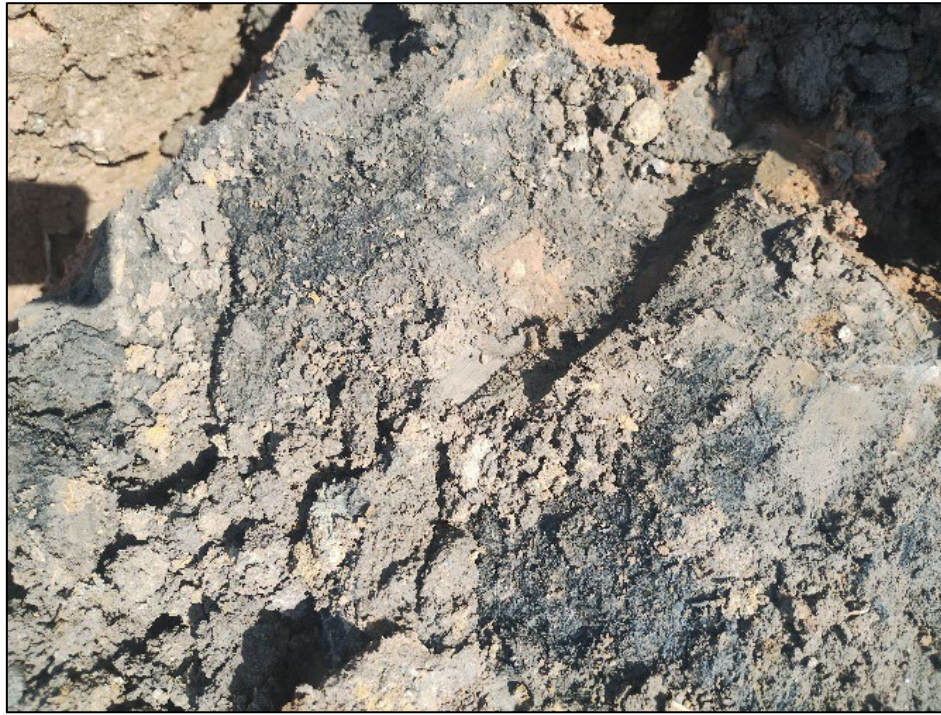
*Figure 4: Deep Made Ground with plant remains encountered within TP06 and DS06 only.*

Within DS06 and TP06 only, **Made Ground** comprising firm, orangish brown mottled grey, slightly gravelly slightly sandy CLAY was encountered to a depth of 2.00m and 2.10m bgl (31.32m and 31.19m AOD) respectively, underlain by soft, dark brown, slightly gravelly, sandy CLAY with occasional plant remains to a depth of 3.00m bgl (30.29m and 30.32m AOD). The Made Ground encountered between 2m and 3m bgl may be associated with the construction of the Former Boundary Hotel, installation of associated services in the northeastern site section or construction of the bowling greens in the southern site section.

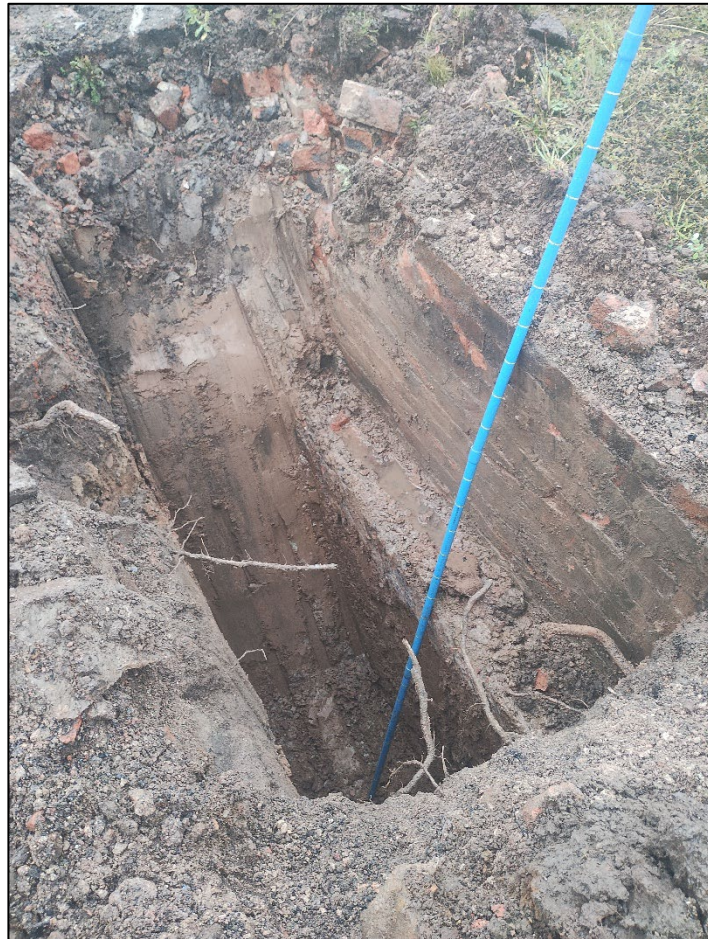
Figure 5: Footing feature encountered in TP101 in the footprint of the former boundary hotel.

Within the vicinity of the former Boundary Hotel, Made Ground comprising slightly clayey, very gravelly ashy fine to coarse SAND or sandy, angular to subangular, fine to coarse GRAVEL of red brick, concrete, yellow brick, metal shards, glass and ceramic was encountered. An obstruction was encountered within DS02 at a depth of 1.38m bgl (32.62m AOD) within the former building footprint. TP103 was undertaken in the centre of the building footprint and rebar was encountered at a depth of 2.10m bgl (32.14m AOD). As a result, the base of the Made Ground associated with the former public house was not encountered in the centre of the building footprint. Footings associated with the former building were encountered within TP101 to a depth of 1.40m bgl (33.35m AOD). The footing was underlain by firm Glacial Till, as encountered across the remainder of the site.

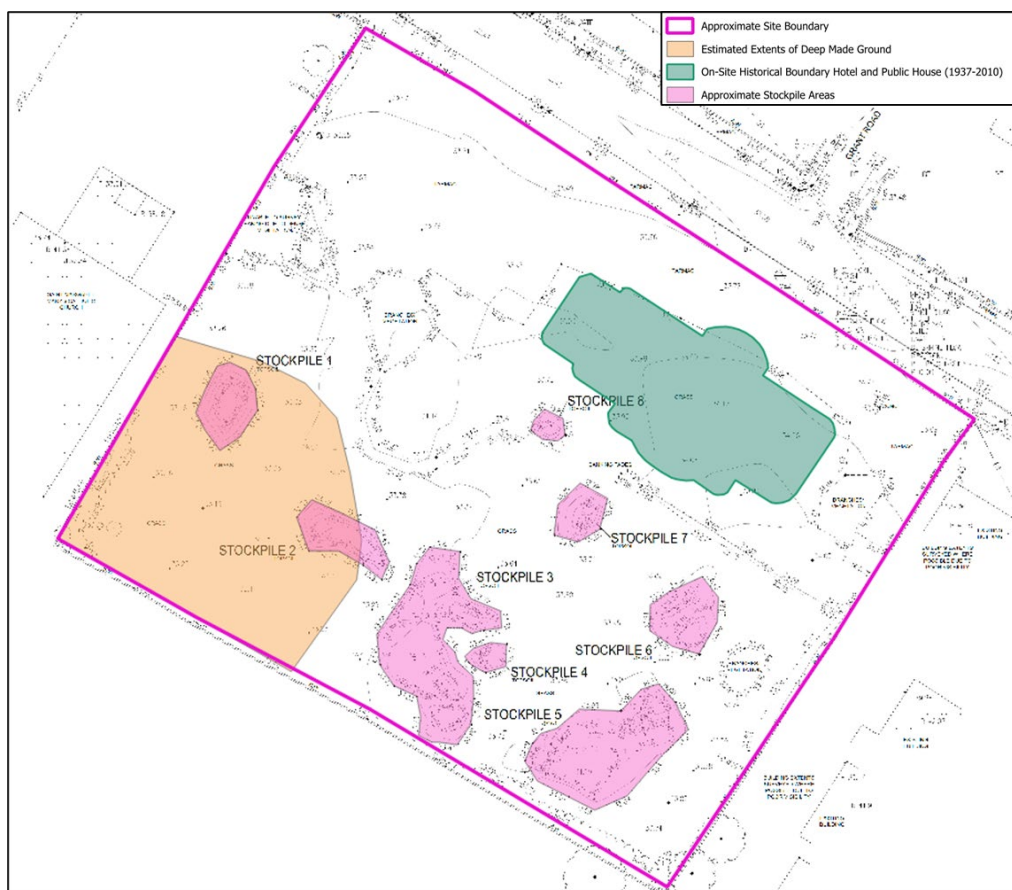
Figure 6: QGIS Extract showing the location of the stockpiles on site.

A number of stockpiles were encountered in the southeastern site section, with an estimated total volume of c. 360m<sup>3</sup>, based on an average height of 1.50m. The stockpiles were noted to contain **Made Ground** comprising dark brown, gravelly, clayey, fine to coarse SAND. 3 No. samples from the stockpiles were obtained by combining material from throughout the stockpile before sampling, ensuring a representative sample.

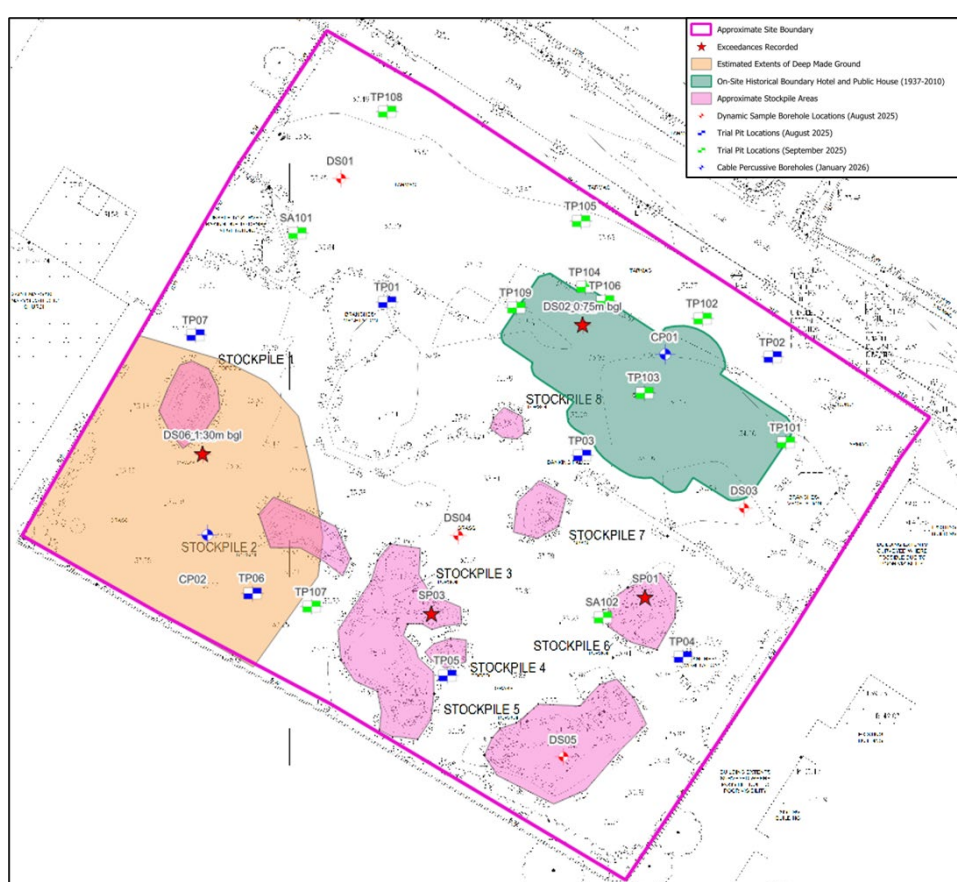
Figure 7: QGIS Extract detailing areas of exceedances: former Boundary Hotel (green), Stockpiles (pink) and area of deeper Made Ground (orange). Red stars indicate the location of exceedances encountered on site.

A number of GAC exceedances for PAHs were recorded within the Made Ground associated with the former Boundary Hotel. Within the vicinity of DS06 in the southwestern corner of the site, localised deep Made Ground was encountered and black staining and a hydrocarbon odour was observed. Exceedances of GACs for PAHs and heavy metals were recorded within this Made Ground.

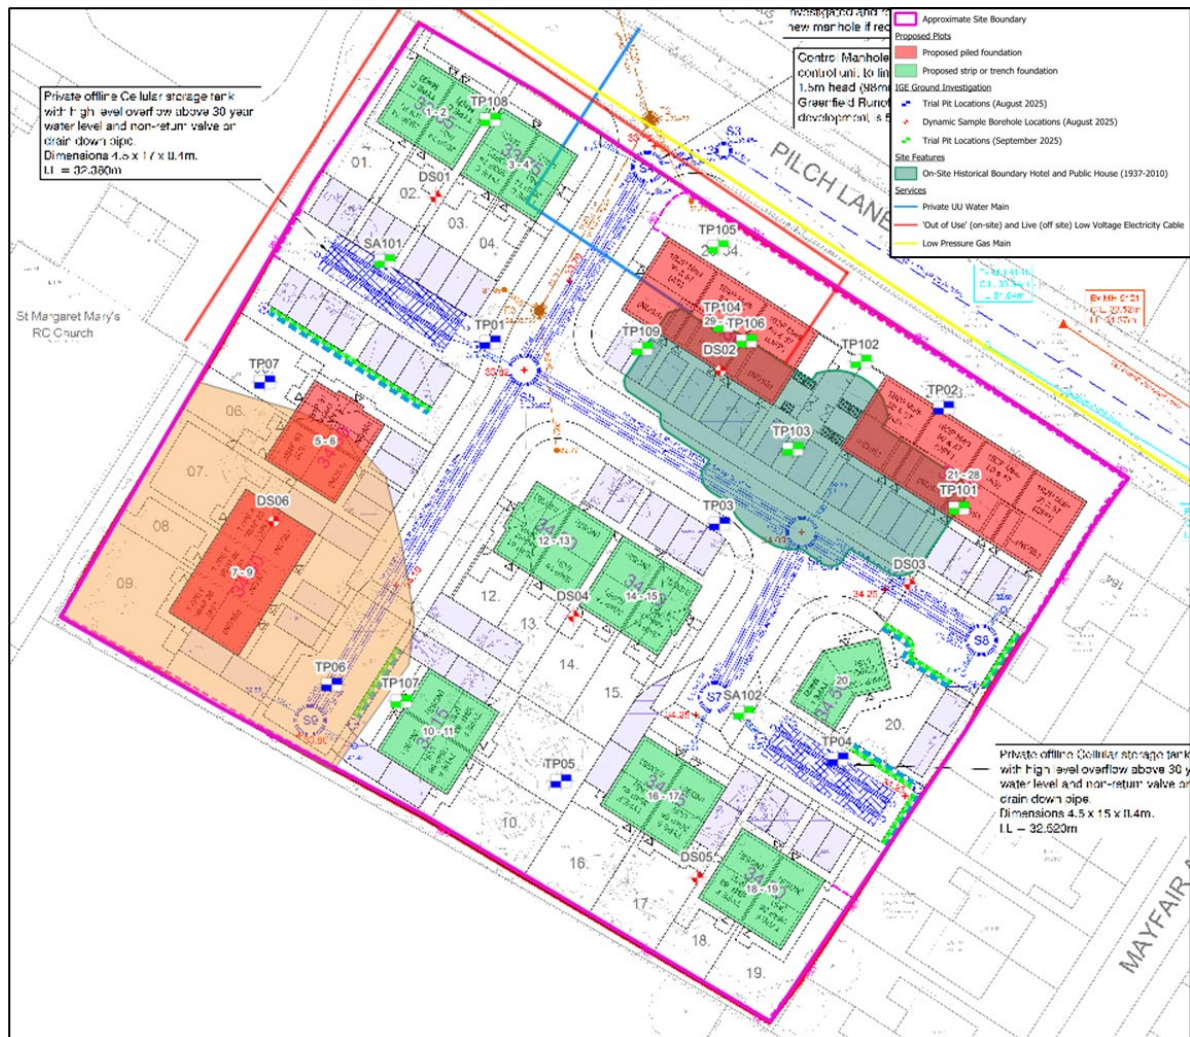
Figure 8: Extract of '30686\_100C Preliminary Drainage Layout' including services and historical features including the former Boundary Hotel extents (blue). Orange indicates the approximate area of deep Made Ground in the southwestern section.

#### Plots 1 – 4 and 12 – 20 (Green on plan)

Given that the depth of the Made Ground extends beyond 2.50m bgl, a traditional foundation solution is unlikely to be suitable for plots 7 – 12 in the southwestern site section. The underlying Glacial Till was noted to be firm to stiff with an N-value of 14 at 3.00m bgl and undrained shear strength values from hand shear vane testing of 90kPa at 3.10m, increasing to 223kPa at 3.50m bgl in TP06. Therefore, the underlying Glacial Till is deemed a suitable founding stratum for a deep (piled) foundation solution (highlighted in red above).

It is recommended that a piled foundation solution is utilised for these plots, extending into the underlying Glacial Till (highlighted in red above). Given the close

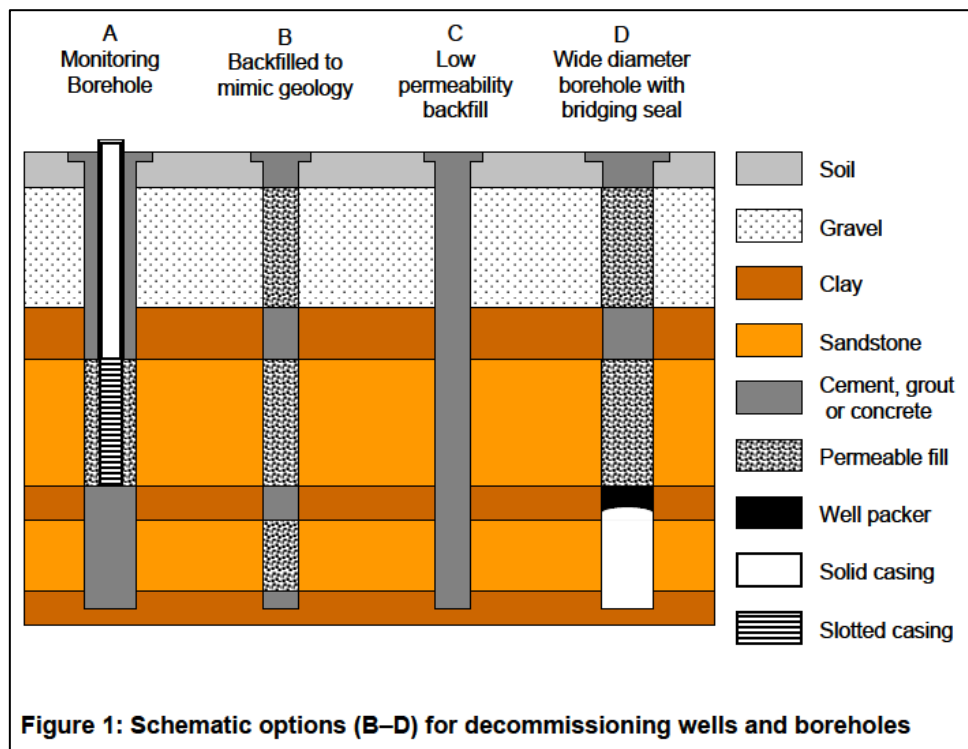
It is considered prudent to utilise Option C – low permeability backfill, shown in the diagram above, to adequately seal the borehole. The guidance recommends that ‘the backfill materials must be clean, inert and non-polluting’, e.g. bentonite. It is recommended to remove the standpipe and seal with bentonite to ground level. This will be sufficient to prevent contaminant transport.

It is imperative that all boreholes drilled into the site are located and appropriately grouted to negate any possible preferential ground gas pathways. Utilising guidance provided in the Environment Agency's '*Good practice for decommissioning redundant boreholes and wells*' (October 2012), it is prudent to secure redundant borehole to ensure that no groundwater pollution can occur. The Environment Agency (EA) offer advice on the methods of sealing wells to ensure that the preferential pathway is removed. The following diagram taken from the EA guidance shows a monitoring well (A) and 3 No. options for decommissioning (B, C and D):

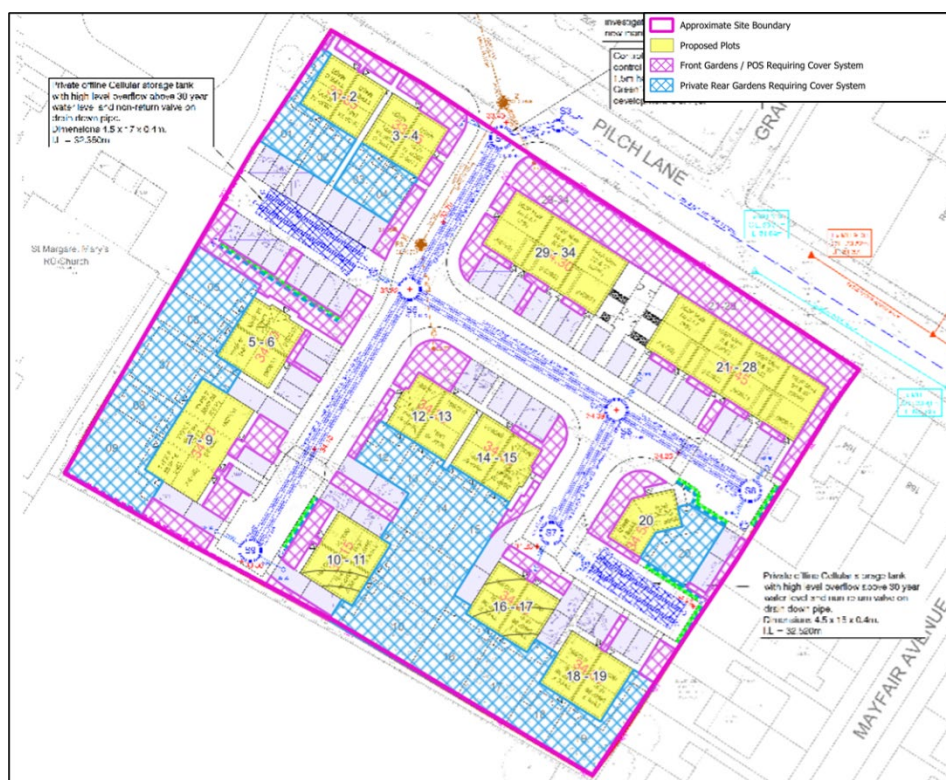
Figure 9: Extract of the Proposed Development Plan showing private gardens in blue and POS / front gardens in purple requiring a clean cover system.

The following plan details the proposed private rear gardens (blue) and front garden and POS soft landscaping (Public Open Space / POS<sub>resi</sub>) (purple) which require a clean cover system. The below remedial recommendations will refer to the landscaping designations detailed in the below extract.

The cover system for the private rear gardens is to be 600mm thick and consistent with the recommendation of the Liverpool City Council 'Requirements for Contaminated Land Validation' (2010), where Made Ground is present to greater than 600mm below finalised garden levels (300mm in areas of soft landscaping and

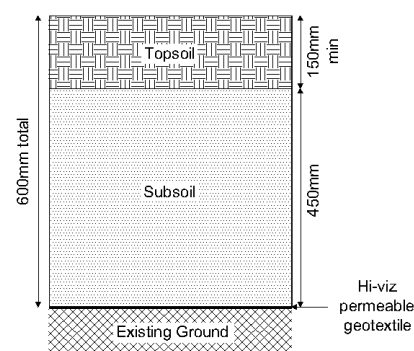
- No less than 150mm and no more than 300mm suitable topsoil, underlain by:
- Suitable subsoil to a total (topsoil + subsoil) depth of 600mm (300mm in areas of soft landscaping and front gardens), underlain by:

- A high vis geotextile marker; and
- Validated in line with the below strategy.

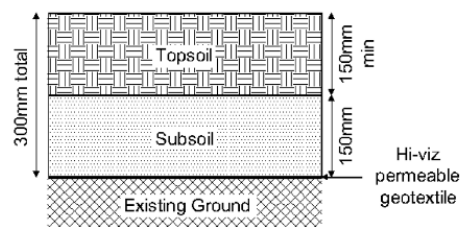
1. Excavate to the base of the Made Ground (<600mm in gardens and <300mm in soft landscaping areas public open space / front gardens). A clean cover system is not necessary.

2. Add suitable subsoil and topsoil to create a garden / soft landscaping to the client's specification.
3. Validate in line with the below strategy.

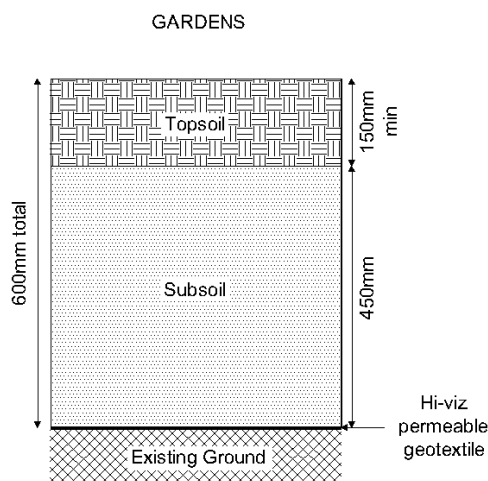
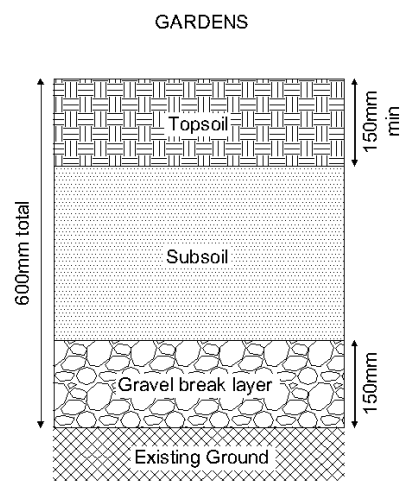
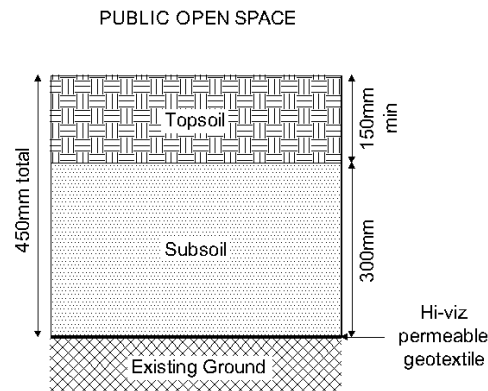
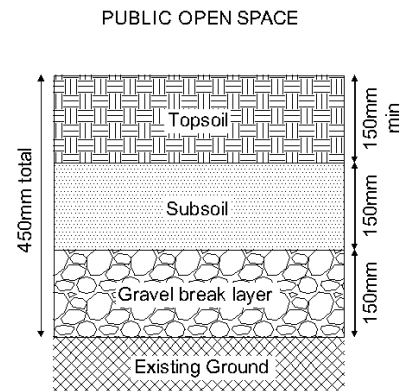
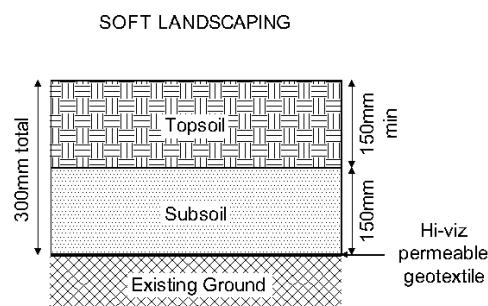
## EXAMPLE INSTALLATION OF CLEAN COVER SYSTEM

Refer to site specific Remediation Strategy for recommended installation.

It should be noted that most cover systems require **either** a gravel break layer **or** a hi-viz geotextile marker, but the below example uses both:

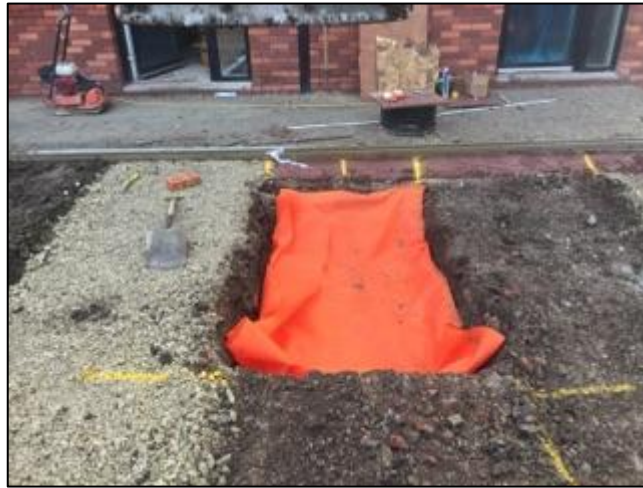
*Figure 1: First, the gardens are dug out to 600mm below FFL and lined with a hi-viz geotextile marker:*

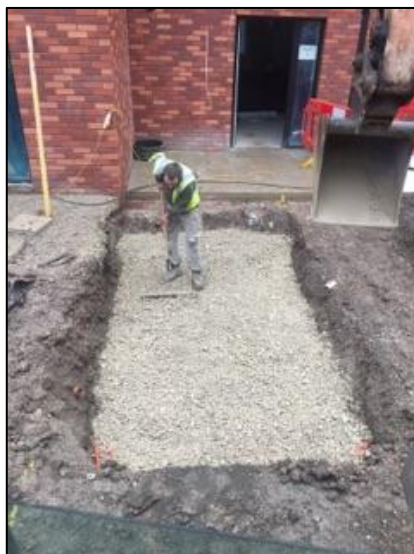
*Figure 2: The geotextile is overlain by a 150mm clean stone break layer.*

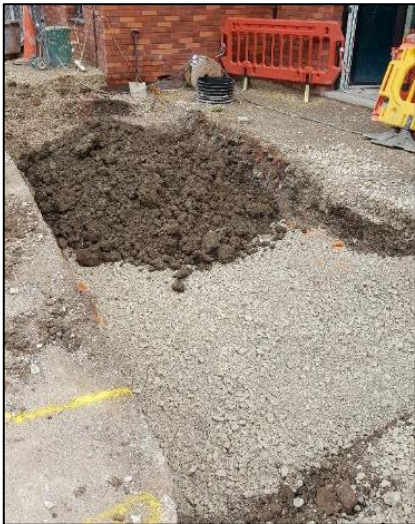
*Figure 3: The break layer is overlain by 300mm sub-soil, seen here before spreading across the garden:*

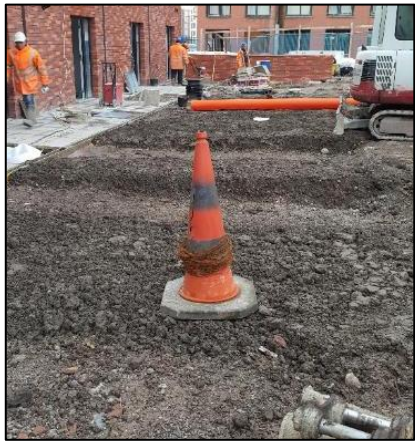
*Figure 4: The sub-soil is overlain by 150mm topsoil to FFL:*

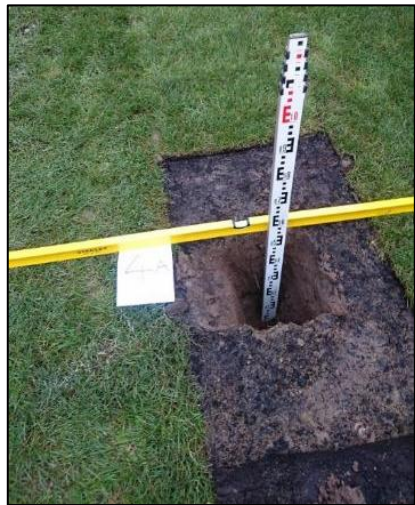
*Figure 5: The gardens are finished with turf. The overall cover system depth is 600mm:*

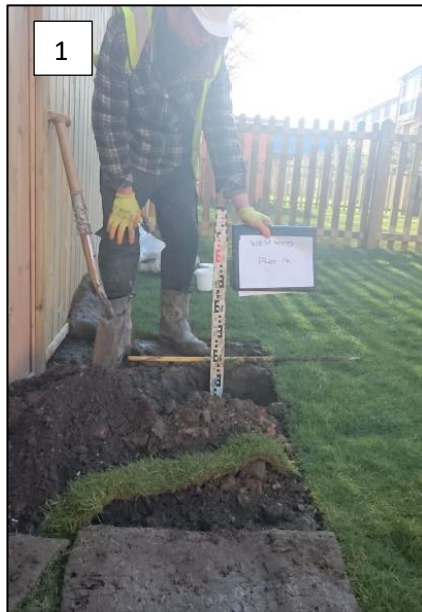
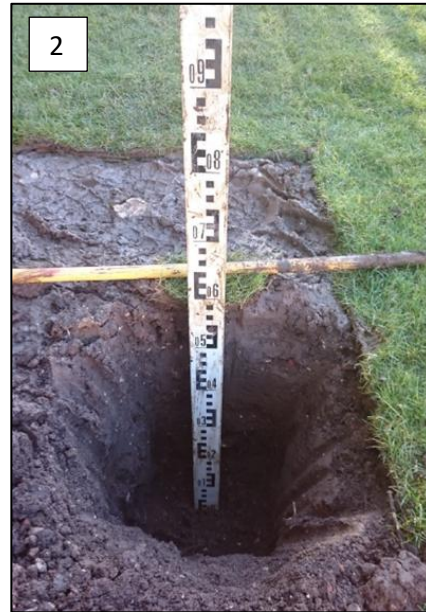
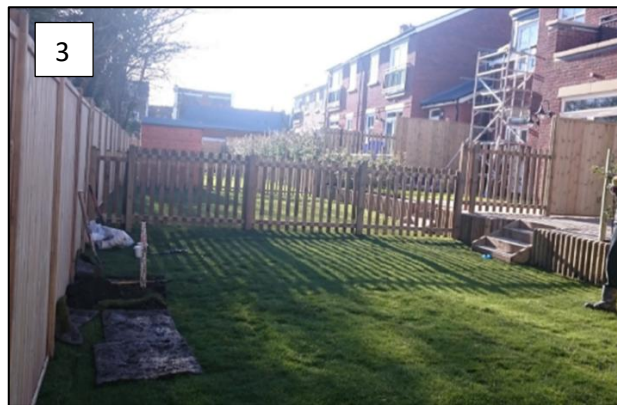
Photograph 1 – Identifies the plot number and shows the validation dig location in relation to the plot.

Photograph 2 – Shows the validation depth clearly, using a staff and a marker which crosses the hole. Shows the topsoil and subsoil, and the base of the hole.

- A 600mm clean cover system comprising:
  - A minimum of 150mm topsoil, underlain by
  - 450mm subsoil
