# The Roby Pub

## Greystone Rd, Liverpool

### Protected Species Scoping Report

30<sup>th</sup> November 2023

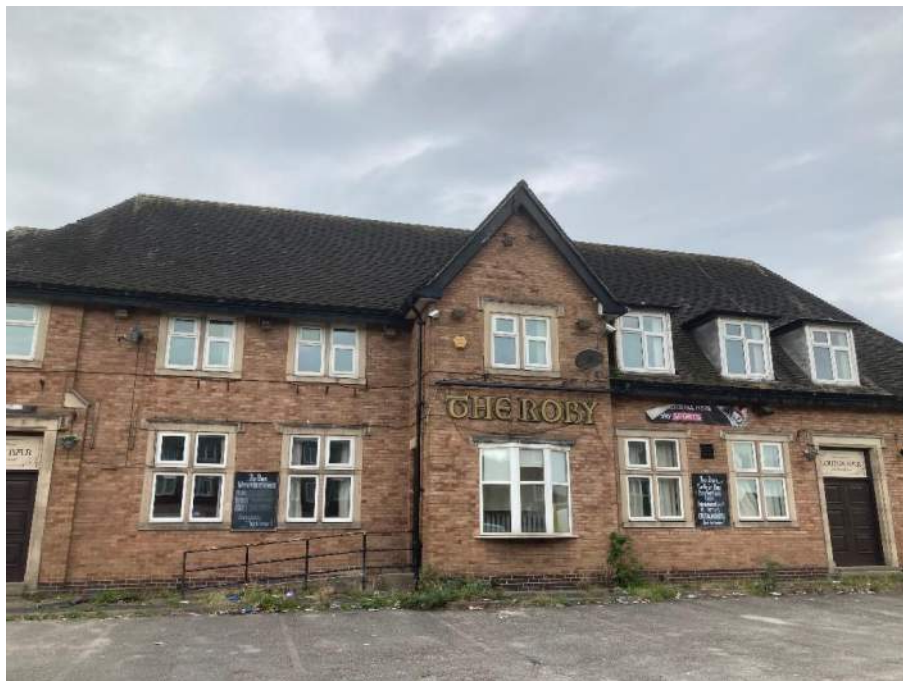
*Photograph 1 - Front of the building, east facing elevation.*

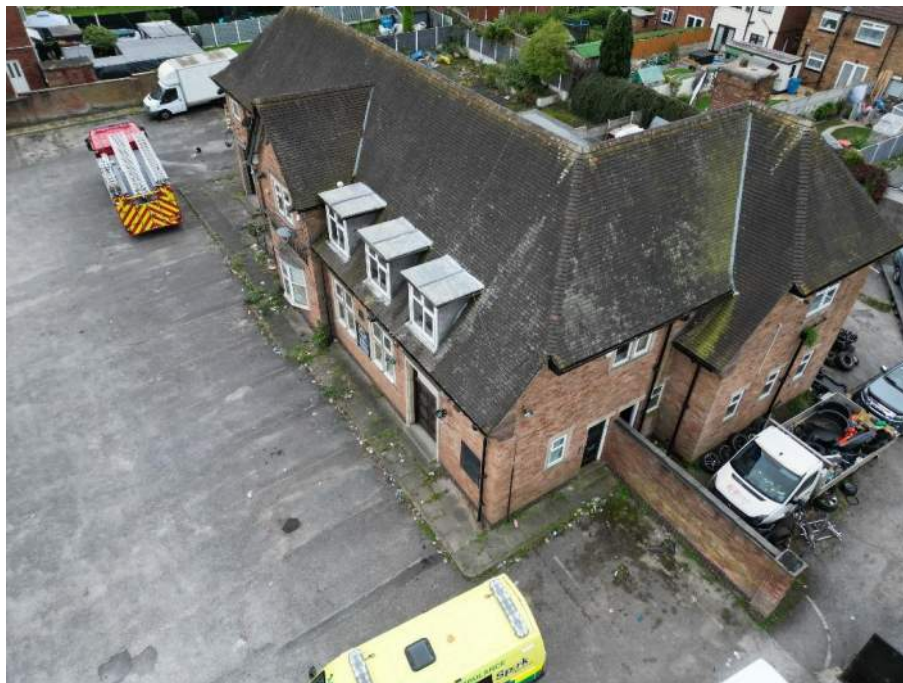
The building is generally intact and well-sealed. The soffits are fitted tightly to the external masonry and the tiles are mostly intact and in good condition. However, there is an area of missing verge mortar at the base of the east facing gable (Target Note 1 on Figure 1). There are also areas of damaged hip tile at the south-east corner of the building (Target Note 2). There are further crevices around areas of damaged verge mortar at the buildings north face (Target Note 3).

*Photograph 2 - North face of the building*

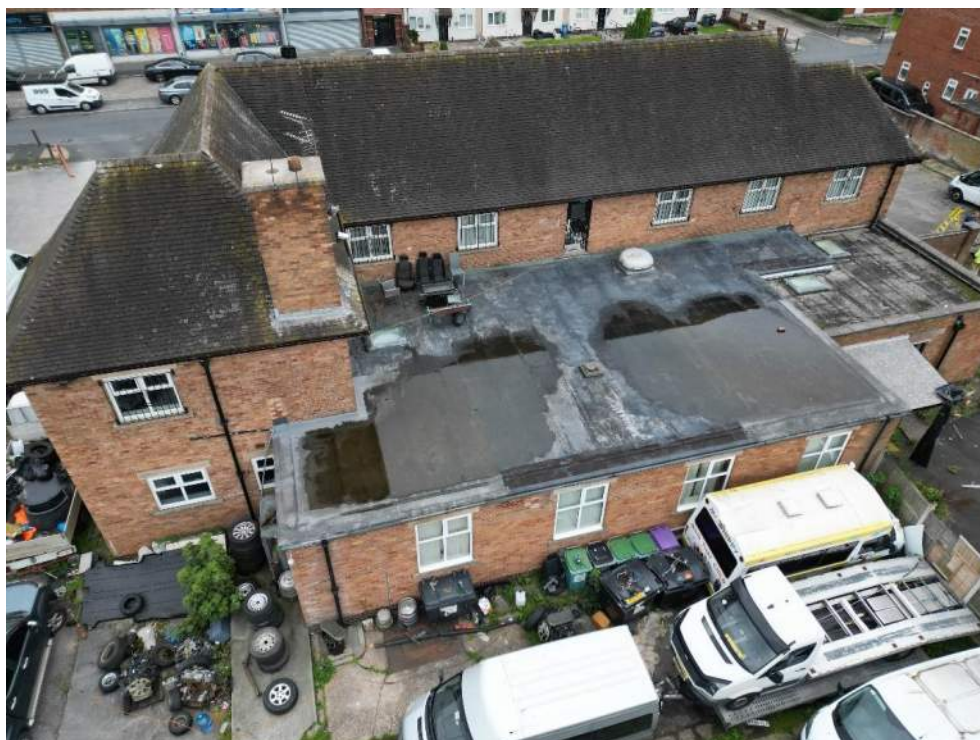
Externally, the building has a hipped roof with a gable at its east (front) face. The building has a single storey extension at its west face. The roof of the extension is clad in tightly fitted bitumen felt.

*Photograph 3 - West face of Building*

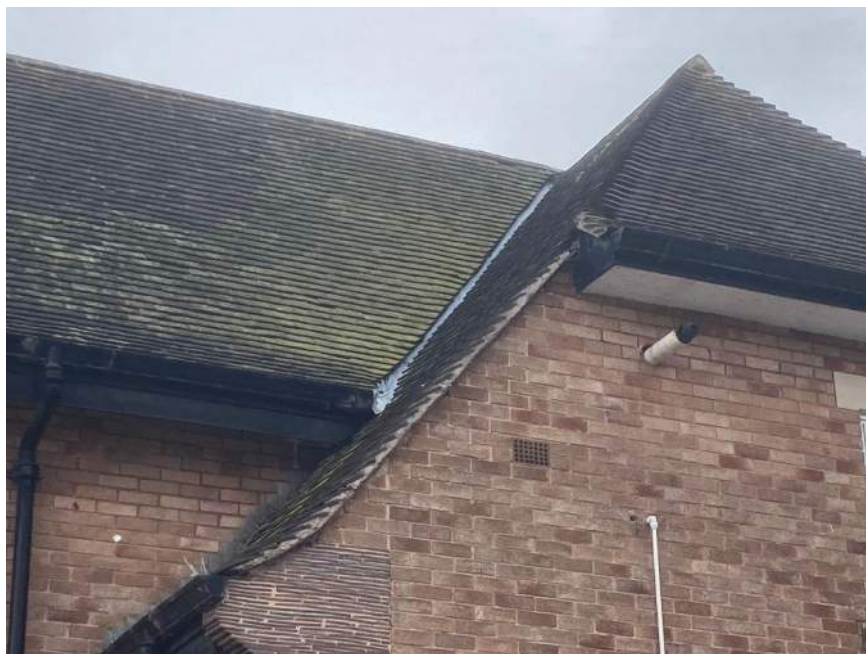
Externally, the building is generally intact and well-sealed. However, there is an area of missing verge mortar at the base of the east facing gable (Target Note 1 on Figure 1). There are also areas of damaged hip tile at the south-east corner of the building (Target Note 2). There are further crevices around areas of damaged verge mortar at the buildings north face (Target Note 3).

*Photograph 4 - Damaged hip tile at the south-east corner of the building  
(Target Note 2)*

In order to further assess the identified potential bat roosting features, it is recommended that at least one dusk bat activity surveys is carried out during the peak active bat survey season (between late May and the end of August).

The survey should use two bat surveyors so that identified potential bat roosting features can be fully assessed. The surveys would aim to confirm the presence or otherwise of any bat roosts associated with the building. Recommended surveyor locations are shown on Figure 1.

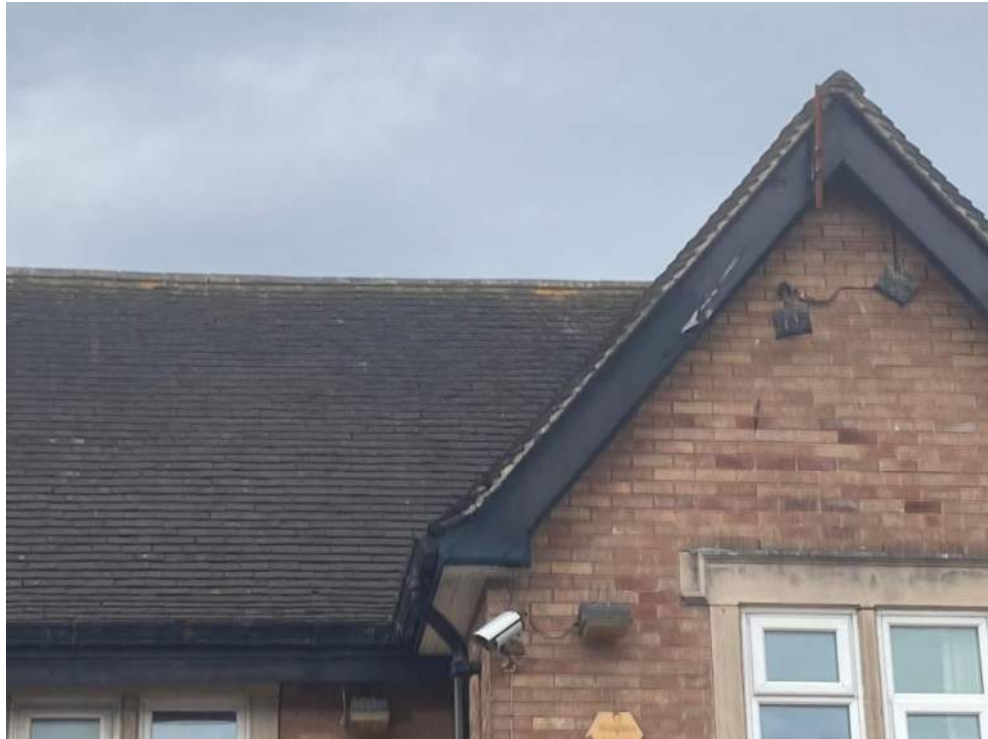
*Photograph 5 - East facing gable (Target Note 1)*

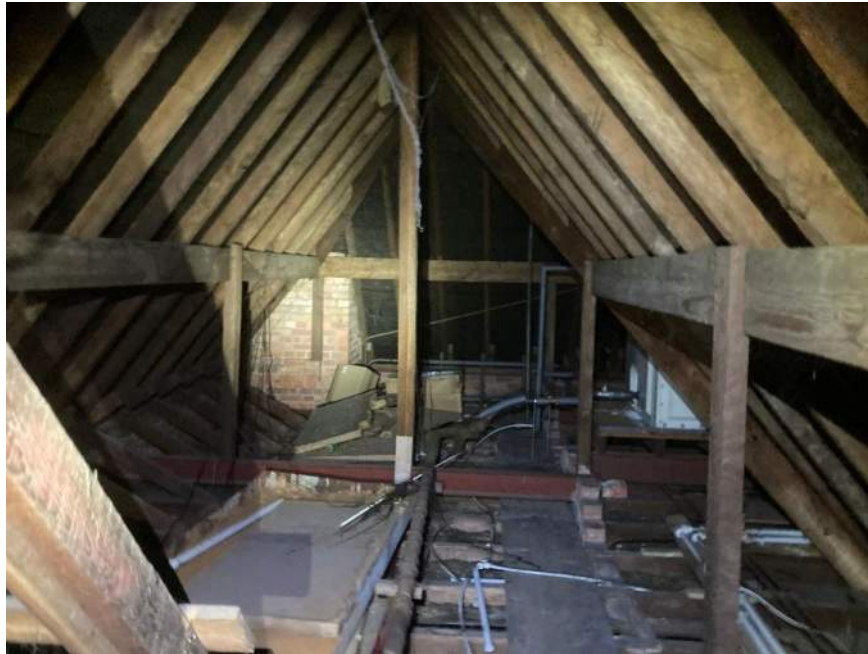
The building has a loft space which extends above the upper floor rooms. The loft space is broadly L-shaped and the roof space is approximately 3.5 m in height. The internal face of the roof is lined in tightly fitted bitumen hessian felt. The loft space is lined with old insulation felt. The loft space was observed to be cobwebbed including along the ridge and across the internal void space. The internal void is relatively cluttered with vertical posts and diagonal trusses throughout. Scattered rat droppings were identified throughout the loft space. No obvious potential bat access points to the loft space interior were identified.

The interior of the pub is largely considered to be unsuitable for roosting bats. The loft space appears to be intact and well sealed with no obvious bat access points. The loft void space was observed to be cobwebbed.

*Photograph 7 - Interior of the loft space*
