## Phase II Interpretative Ground Assessment

Cables Way,  
Prescot

Client: John F Beesley

Reference: 30259-SUT-ZZ-00-RP-G-702-0002

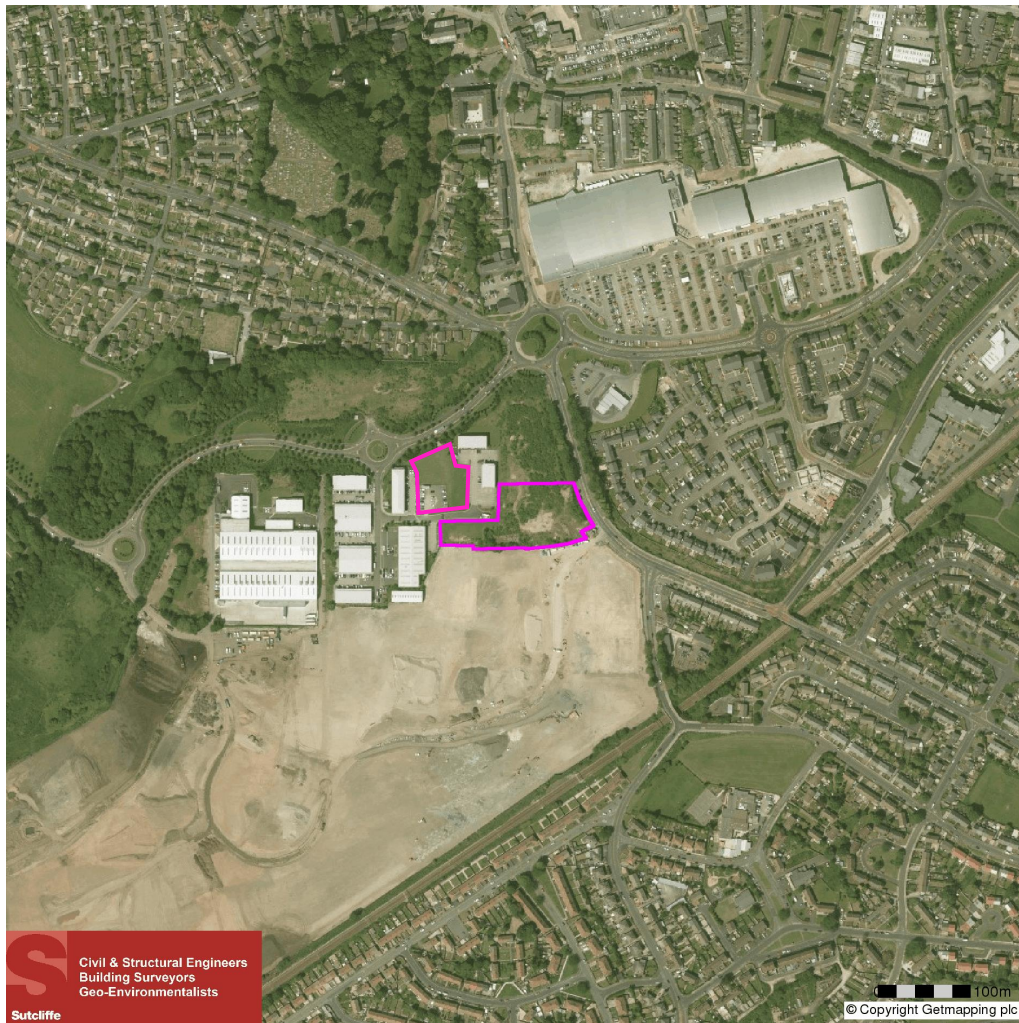
Figure 3: Aerial Photograph of the Site

The eastern section consists of a large grassed, terraced, landscaped area with saplings on the upper terrace.

The western section is currently used as contractor parking for the current residential development to the immediate south of the site, having previously being used as the construction and office compound for the construction of the fire station to the immediate north. This section is flat on a similar level to the top tier of the eastern section it is covered in various places with macadam, hardcore and rough grass.

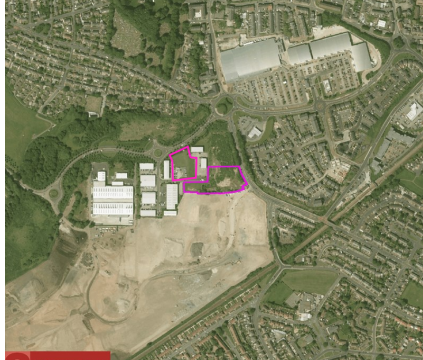
# Preliminary Conceptual Site Model (CSM)

Adjacent Site users  
RESIDENTIAL

Site users  
COMMERCIAL

| Stratum | Aquifer |
|---|---|
| TILL, DEVENSIAN | SECONDARY UNDIFFERENTIATED |
| PENNINE LOWER COAL MEASURES | SECONDARY A |

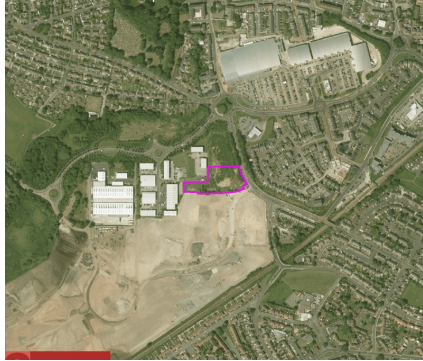
# Revised Conceptual Site Model (CSM)

Adjacent Site users  
RESIDENTIAL

Site users  
COMMERCIAL

| Stratum | Aquifer |
|---|---|
| TILL, DEVENSIAN | SECONDARY UNDIFFERENTIATED |
| PENNINE LOWER COAL MEASURES | SECONDARY A |

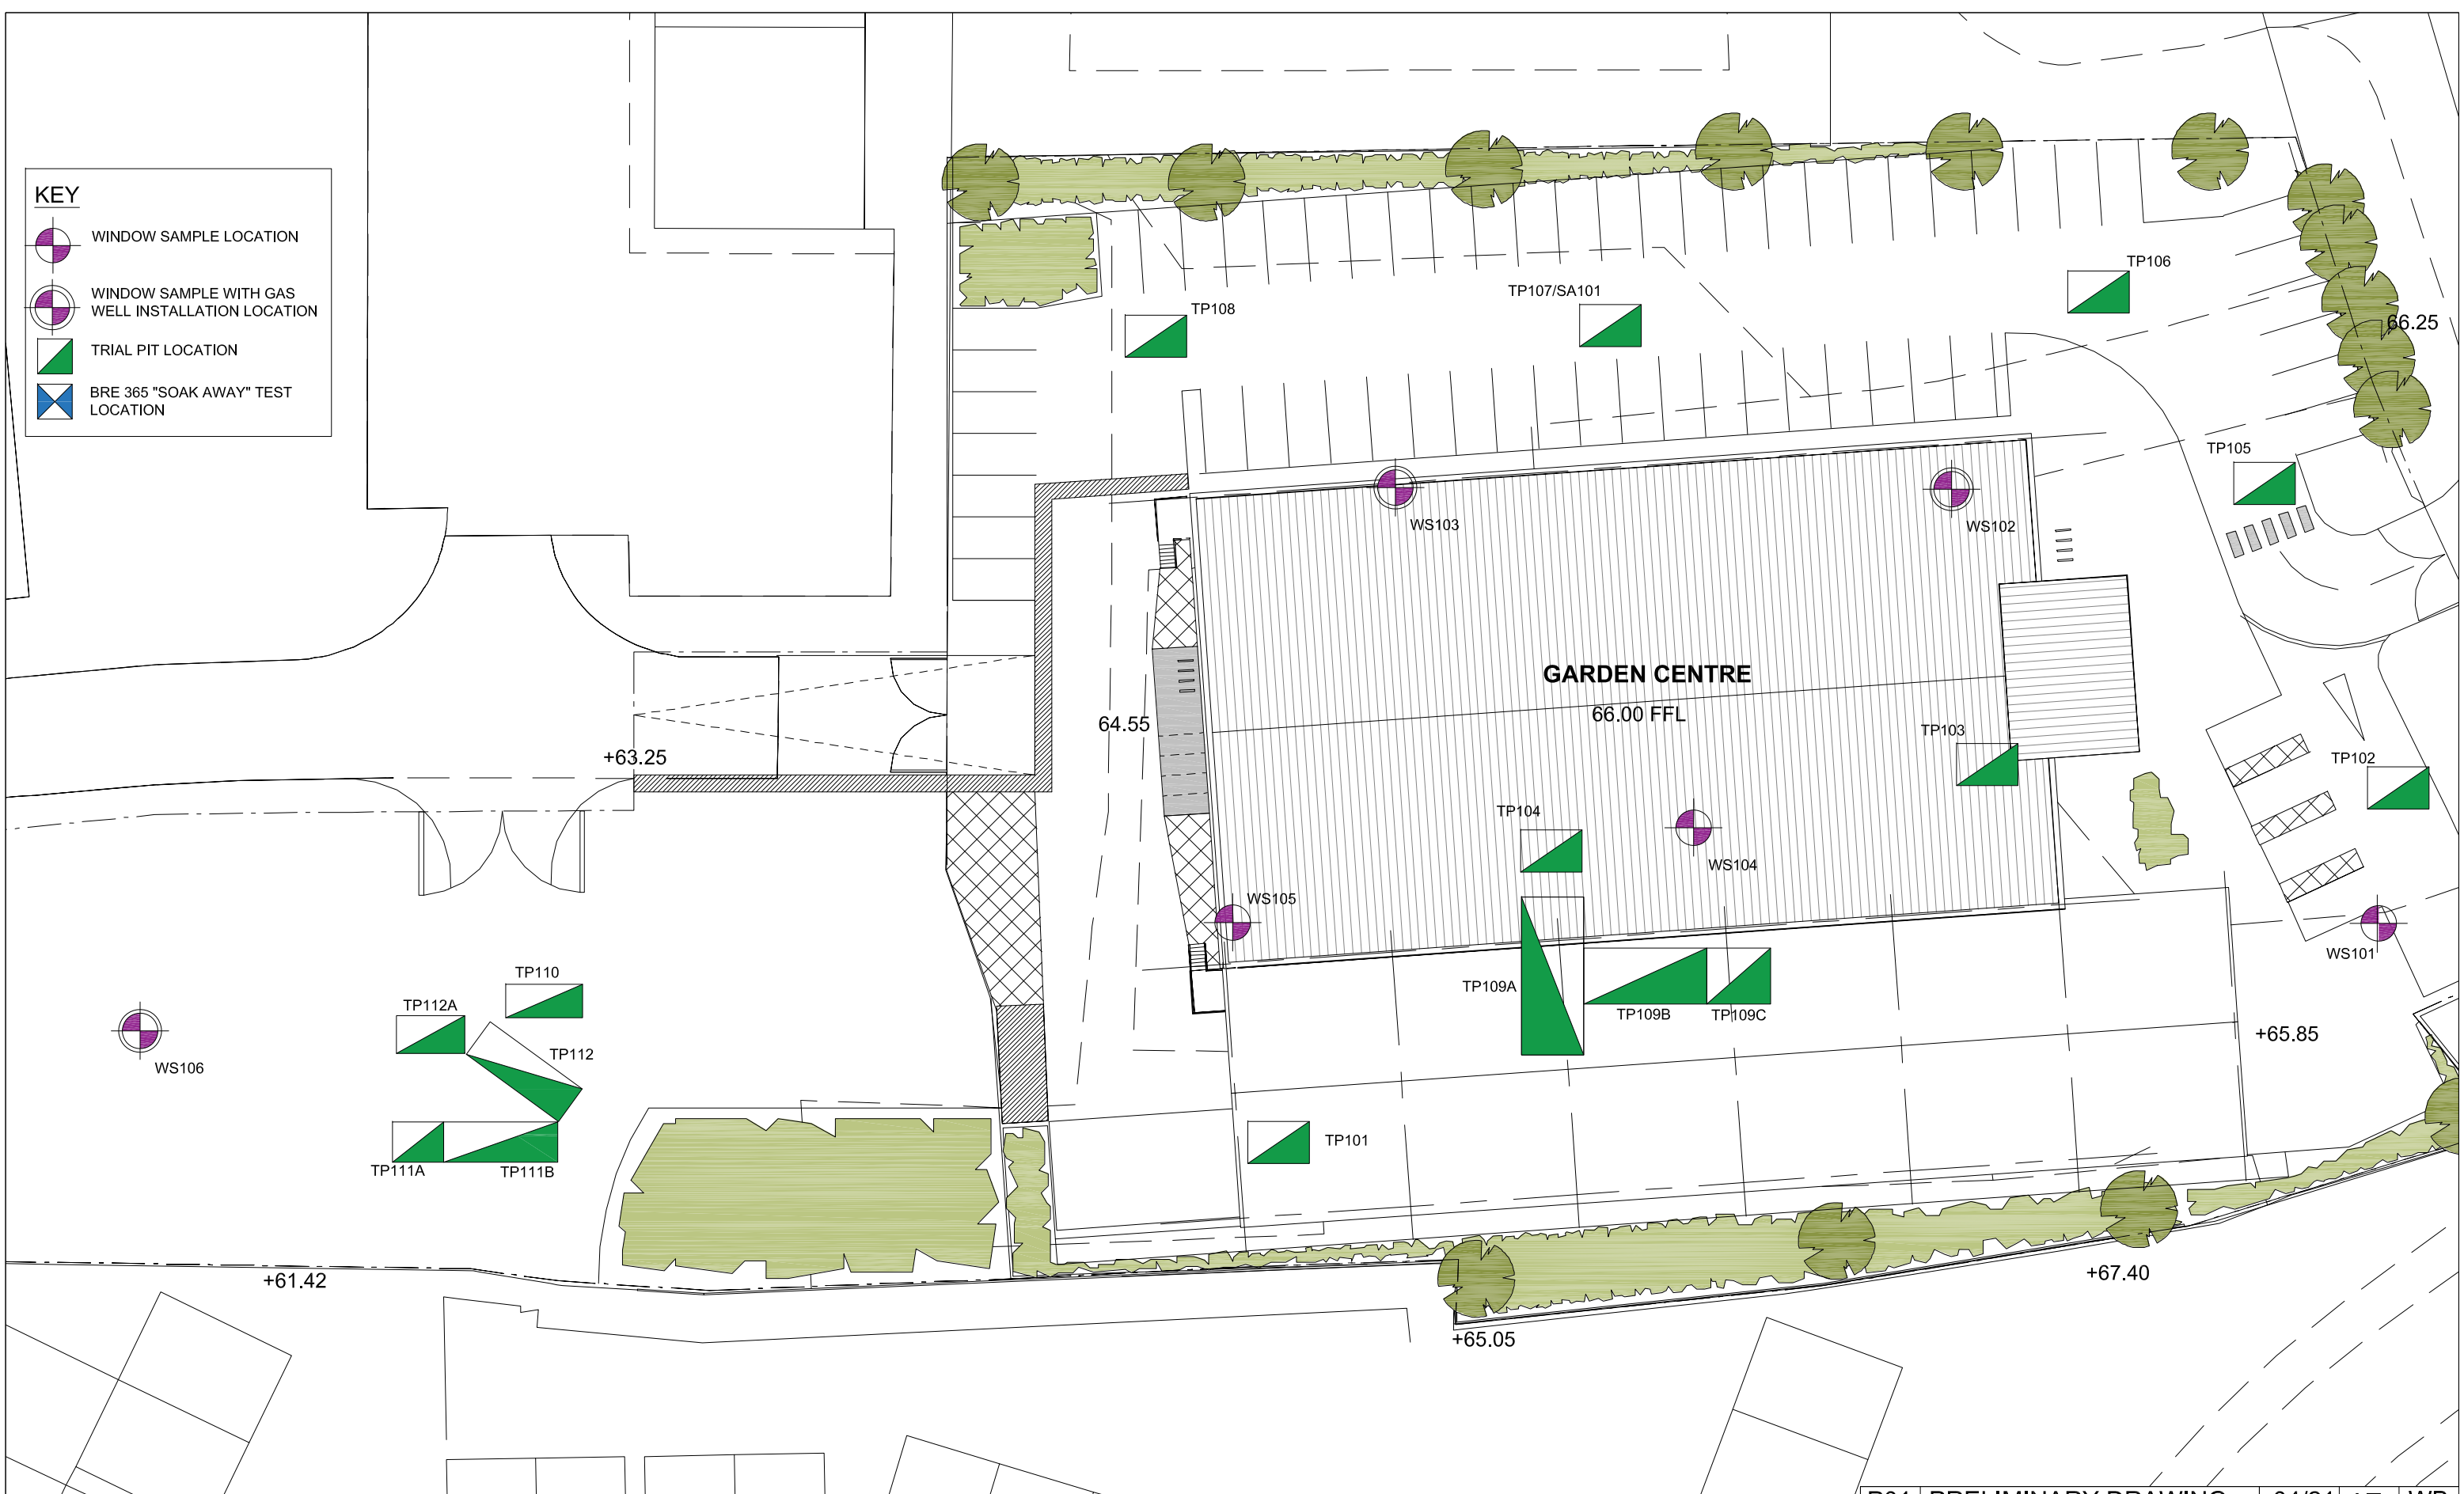
Drawing No 30259-SUT-ZZ-00-RP-G-702-0002 (Garden Centre)

1No.infiltration test (SA101) was carried out on site at TP107, shown on *Drawing No. 30259-SUT-ZZ-00-DR-G-720-0002 (Site 2)*.
