# Preliminary Ecological Appraisal and Roost Assessment

Land off Archway Road, Huyton, Metropolitan Borough of Knowsley, Merseyside

Genr8 Kajima Regeneration (Huyton) Limited

19<sup>th</sup> March 2025

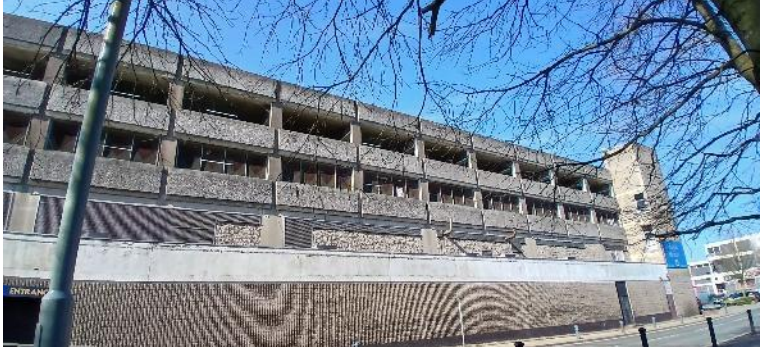
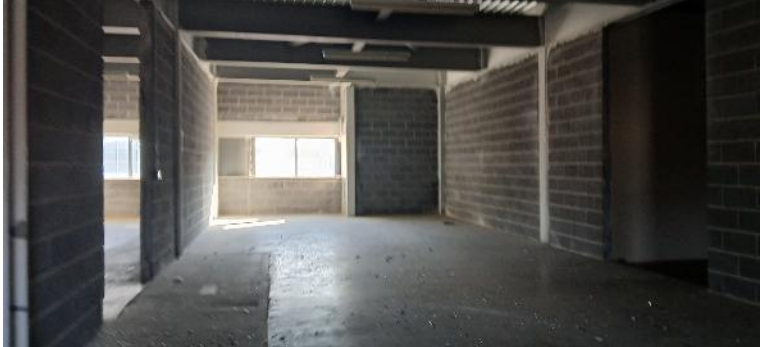
| | <p>Most notably, the hedgerows and tree lines will act as linear landscape elements for bats to commute across the site. There are train tracks situated ~80m south which will aid in commuting and foraging of local bat populations whilst travelling between roost sites. However, there is limited linear habitat which extends off site and connects the site to this feature.</p> <p><b>Roosting habitat</b></p> <p>Buildings to be impacted by the proposed development are assessed for their suitability to support roosting bats below. There are a total of five buildings on site; the former market (B1), Cavendish walk (B2), the Kwik tan building (B3), Muni tower and annex (B4) and the computer centre (B5). No evidence of roosting bats was identified on or within any of the buildings surveyed.</p> |
|---|---|
| <p><i>Summary</i></p> <p>B1 is a stone built multi-storey building utilised for car parking and recreational use. There was no damage or gaps to the stonework which could be utilised by roosting bats. The roof structure was flat. There were no loft voids within the internal space. Instead, the interior comprised of multiple rooms with vaulted ceilings. There were no crevices within the interior suitable for crevice dwelling bats and no suitable areas for void dwelling species to roost against or within. There were window shutters which were slightly ajar on the eastern elevation near where a bird's nest was identified, however as no evidence of bats was identified, nor where any suitable areas for roosting bats within the structure, it is considered that bats would not utilise this feature as an access point. Further, there is a high degree of daylight permitting through windows within several areas of the internal which further reduces the buildings suitability for bats.</p> <p>B1 is subject to demolition.</p> <p>B1 provides <b>negligible habitat value</b> for roosting bats.</p> | <p>B1 – Eastern elevation</p> <p>Internal of B1</p> |

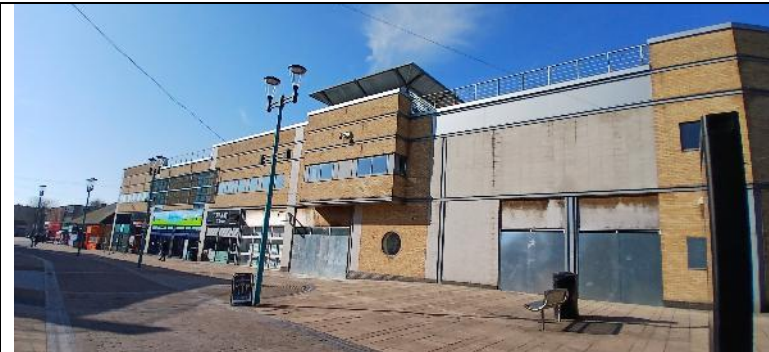
B2 – Eastern elevation

B2 is a two storey stone built structure, occupied by shops on the first floor and an empty office block on the second floor. There is metal flashing at the eaves on all elevations of which there is a slight gap behind. The interior of B2 has no loft void and instead has corrugated metal ceilings supported by metal beams. There is a high degree of daylight permitting into the internal space as the result of windows on all elevations. The roof comprises of a flat parapet roof with no areas of lifted panelling or gaps that could allow access for roosting bats into the interior of the structure. B2 is subject to internal works including the installation of new windows.

B2 is **negligible** for roosting bats.

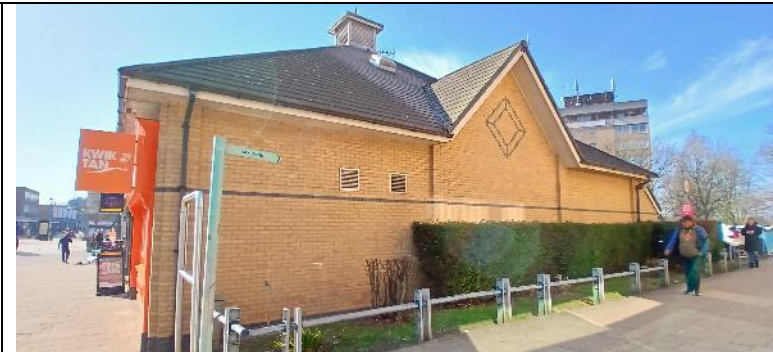
B3 – Northern elevation

B3 is single storey brick-built structure with a hipped roof structure with gabled dormers on the northern and southern elevation. The roof has cement tiles and a short bell tower like vent at the centre. The soffits are wooden and tightly sealed to the structure. There is a section of soffits at the southwestern aspect of the building with holes in it that could be utilised by roosting bats. There was a high volume of pigeons perched on the eastern aspect of the roof structure during the survey. The building is occupied by shops and has rolling shutters on the eastern elevation.

B3 has **low habitat value** for roosting bats.

| <i>Recommendations</i> | <p><b>Roosting habitat [Buildings]</b><br/><b>B3</b><br/>One bat emergence/re-entry survey is required on B3 during the active bat season (May – September) to confirm presence/likely-absence of bats roosting in or on the building. These survey visits should be completed during the optimal survey period mid-May to August inclusive. Should any bats be observed emerging from the structure during this survey, an additional two surveys will be required to characterize the roost present to inform the licence. The survey visits should be at least three weeks apart. Three surveyors equipped with infrared cameras are required to provide full coverage of the building's elevations to look for emerging/re-entering bats. Lighting mitigation may be required based on the outcome of the night bat survey(s). If any bat roosts are confirmed from this survey schedule, a bat mitigation licence would be required to demolish the buildings as it would involve the destruction of roosts. This is applied for with the help of a class 2 licensed bat ecologist after planning permission is granted, but before commencement of works.</p> <p><b>B1-2, B4-5</b><br/>In the unlikely event that a bat or evidence of bats is discovered during the development all work must stop and a bat licensed ecologist contacted for further advice.</p> <p><b>Roosting habitat [Trees]</b></p> |

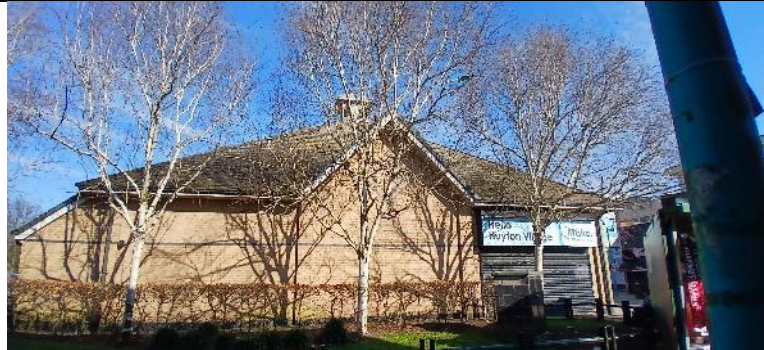
| Feature | Materials | Condition/description/suitability | Photograph(s) |
|---|---|---|---|
| Walls | Brick built | The walls of B3 are in good condition. There are no areas of damage to the mortar or gaps present on the walls of B3 which could be exploited by roosting bats. | |

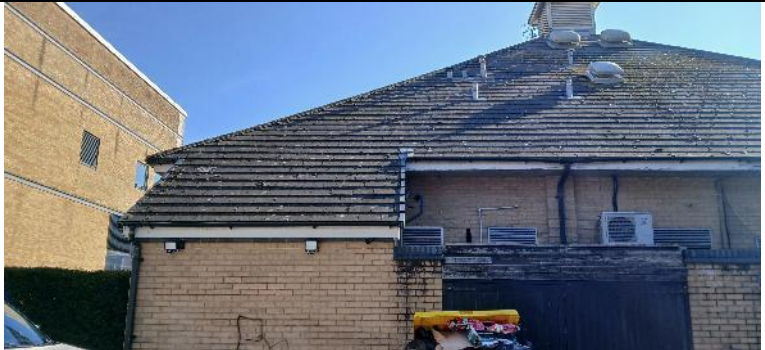
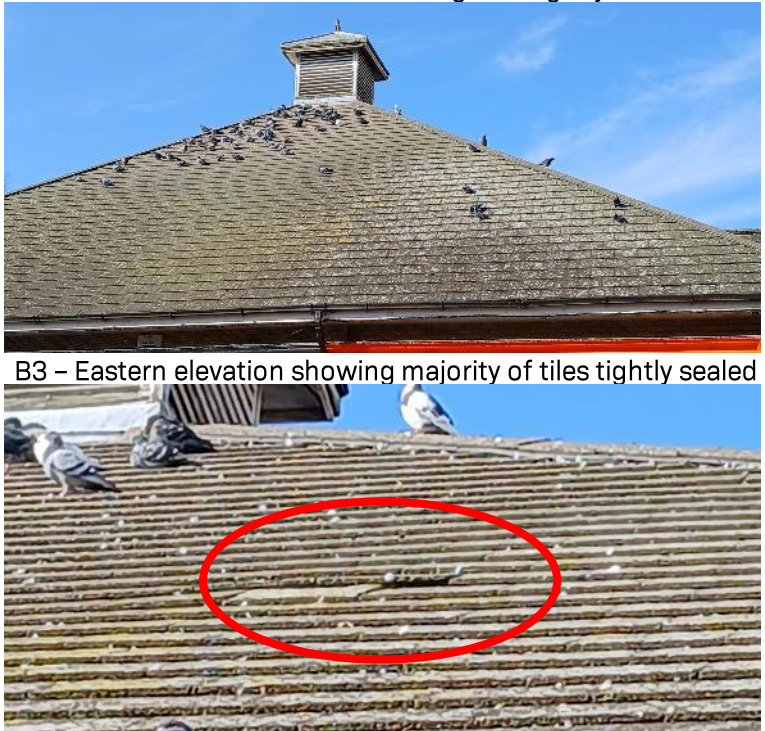
| Roof | Cement | <p>The roof structure of B3 is hipped with cement tiles. The majority of these tiles are tightly sealed with no gaps beneath.</p> <p>There is one lifted tile on the eastern elevation. This feature is suitable for crevice dwelling bat species to roost beneath in addition to potentially permitting access into the internal space.</p> <p>At the centre of the hipped structure is a bell tower-like vent which has lifted lead flashing at the eaves. This feature is suitable for crevice dwelling species.</p> | <p>B3 – Western elevation showing tiles tightly sealed</p> <p>B3 – Eastern elevation showing majority of tiles tightly sealed</p> <p>B3 – Showing lifted tile present on eastern elevation</p> |

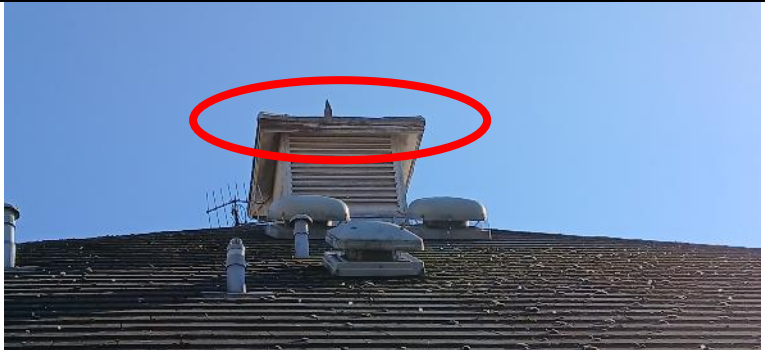
| | | | <p>Showing lifted lead flashing at tower vent</p> |

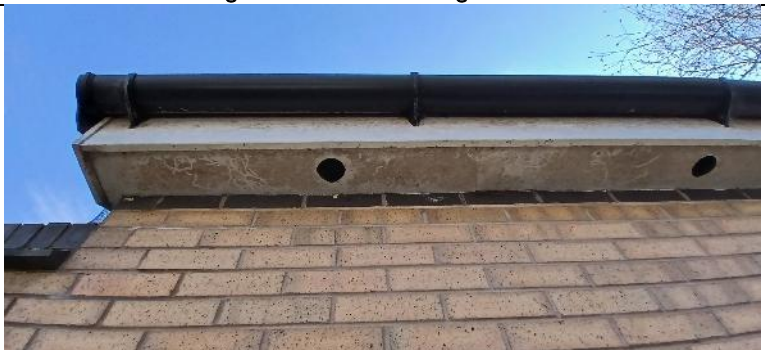
| Soffit boards | Wooden | The soffits of B3 were tightly sealed against the building on all elevations with no gaps between the soffit board and the brickwork. On the western elevation there were purpose-built holes cut into the underside of the soffit boards. These are suitable for crevice or void dwelling species to gain access. It was not possible to determine whether these holes allow access to the perimeter of the building via the soffit boards. | <p>Showing holes in soffit board on the western elevation of B3</p> |

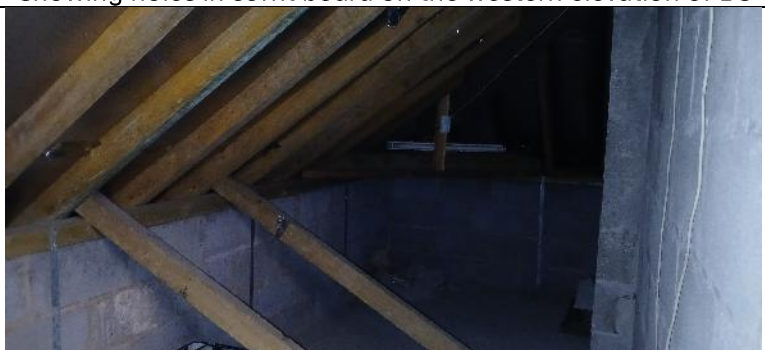
| Internal voids | Timber rafters and ridge beam. | Internal space measures ~8m L x 4m W x 2m H with the following internal conditions recorded; 15.4°C and 40.1% relative humidity. There were no visible areas of daylight permitting into the void. The roof was lined with foil insulation which had no visible areas of damage or tearing. No evidence of roosting bats including live animals, foraging remains or droppings were identified within the void. | <p>B3 - Interior</p> |

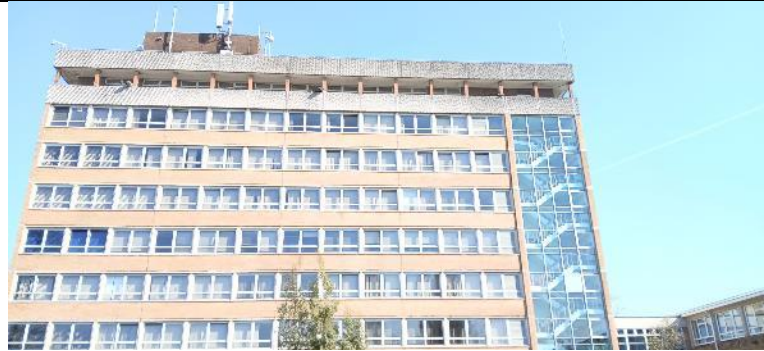
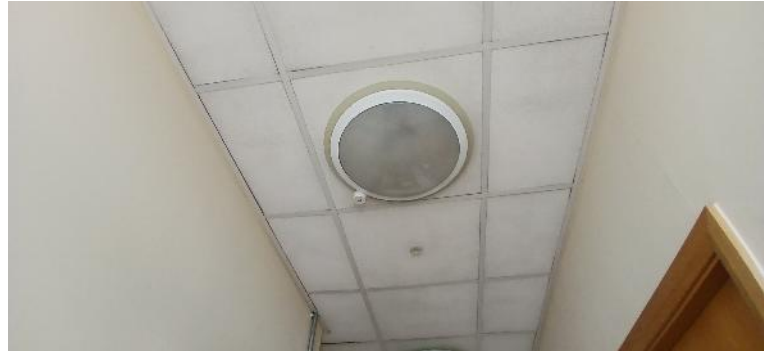
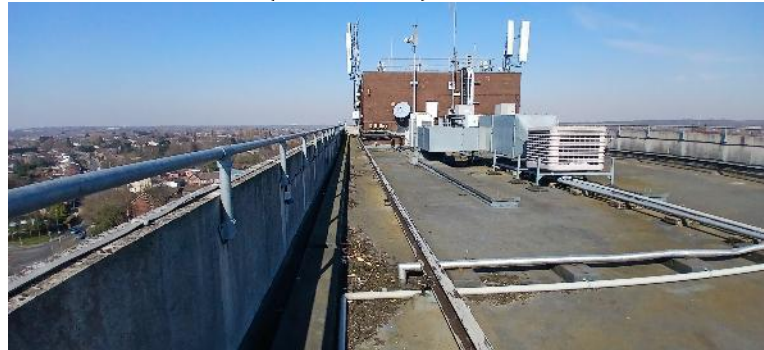
| B4 Building description | Photographs |
|---|---|
| <p><i>Summary</i></p> <p>B4 (Muni tower) is a brick-built multi storey office block utilised by the council. There are multiple windows on all elevations. There are no loft voids within B4 and instead there are suspended ceiling tiles throughout. B4 (Muni tower) has a flat roof with a parapet balcony. At the second storey of B4, the structure forms an L-shape and adjoins to the annex via the southern elevation. B4 (annex) is a two-storey brick-built structure with a gabled metal sheeting roof with solar panels. There are windows on both the northern and southern elevation. The interior void of B4 (annex) is partially boarded with areas of exposed mineral wool insulation. The roof is lined with wooden boards which showed no signs of damage. There were no areas of daylight permitting into the interior void of B4 (annex). The roof of B4 (annex) was in good condition with no apparent areas of damage, lifted sheeting or other gaps which could be utilised by roosting bats or permit access into the interior void.</p> <p>B4 is <b>negligible</b> for roosting bats.</p> | <p><b>B4 (Muni tower) – Western elevation</b></p> <p><b>B4 (Muni tower) – Interior</b></p> <p><b>B4 (Muni tower) – roof</b></p> |

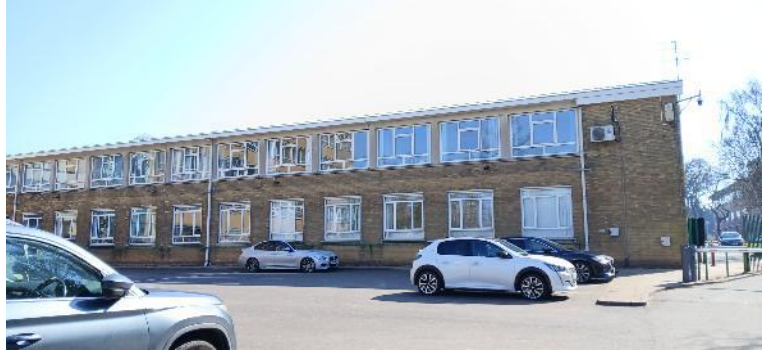
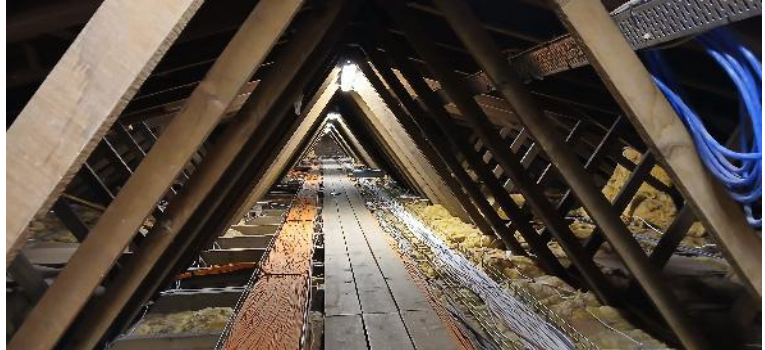
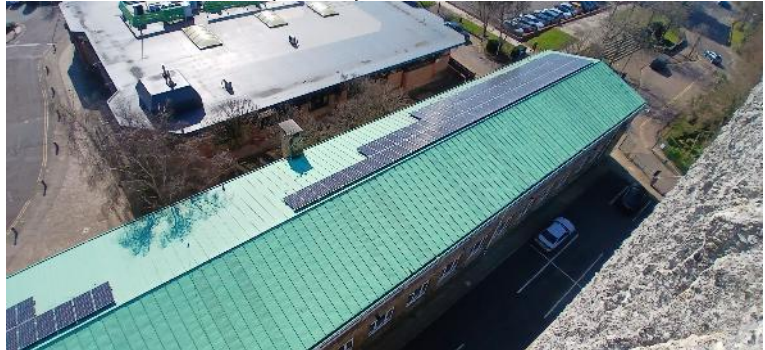
| | <p>B4 (annex) – Northern elevation</p> <p>B4 (annex) – Interior void</p> <p>B4 (annex) – roof</p> |

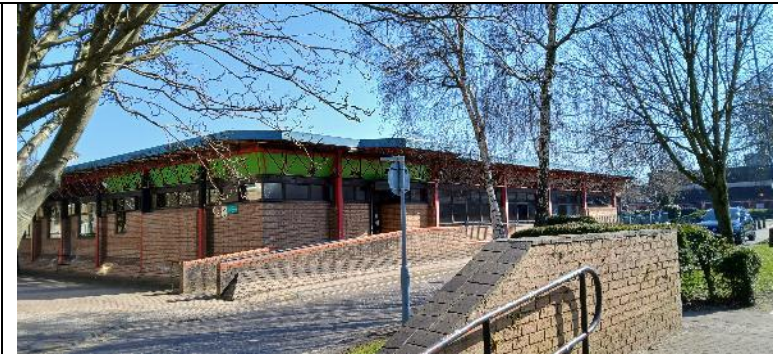
B5 – Southwestern elevation

B5, the computer centre, is a square shaped single storey office block with a flat metal sheeting roof. The lower half of the walls are brick-built, and the upper half is reinforced with metal sheets. The flashing at the eaves of B5 were tightly sealed with no apparent gaps or areas of damage which could allow ingress for roosting bats. There was no loft void within B5 and instead the interior comprised of suspended ceiling tiles.

B5 is **negligible** for roosting bats.

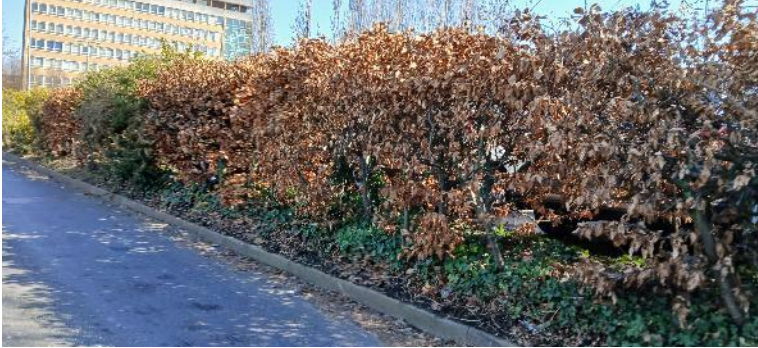
Bordering the northern site boundary and scattered throughout the site is native hedgerow comprising of beech (D), common yew (D), hawthorn (A), ivy (F), gorse (O) (Fig.7). The hedge measured ~ 1.5m H x 1m W and appeared to be subject to frequent management. This habitat was subject to a condition assessment using the Hedgerow habitat type: Native hedgerow habitat condition sheet. The results are detailed below:

It is considered that the native hedgerow is classified as **moderate** condition.

| Photograph | | Description |
|---|--|---|
| | | Figure 7: An example of the native hedgerow on site |

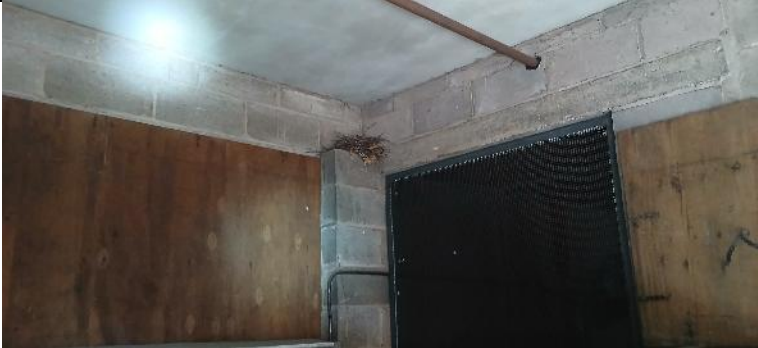
| <i>Summary of Survey Findings</i> | <p><b>Buildings</b><br/>Evidence of nesting birds was identified within B1 (Fig.8). There was a high volume of pigeons perching on the roof of B3. Additionally, the gaps in the soffit boards on the western elevation of B3 and the flat roof of B2 and B4 were considered suitable to support nesting species such as gulls and pigeons. B5 was not deemed suitable to support nesting birds due to it being single storey with a sloped roof structure and no areas of damage or gaps to the structure which could be exploited by nesting birds.</p> <p><b>Trees and vegetation</b><br/>No bird nests were identified within the scattered trees, tree lines or shrubbery on-site, however they all offer nesting opportunities and nest-building resources for birds.</p> <p><b>Barn owls</b><br/>The site does not appear to provide any suitable nesting sites for barn owls.</p> <p><b>Overwintering birds</b></p> |

| Photograph | | Description |
|---|--|---|
| | | Figure 8: Birds' nest identified within B1 |

| <i>Recommendations</i> | <p><b>Buildings/trees</b><br/>Any building or tree/shrub removal should be undertaken outside the period 1st March to 31st August. If this timeframe cannot be avoided, a close inspection of the vegetation should be undertaken immediately, by a qualified ecologist, prior to the commencement of work. All active nests will need to be retained until the young have fledged.</p> <p>Precautions should be taken with machinery and noise levels when working close to any retained nests so as not to disturb any nearby nesting birds during construction works. At least a 3-5m buffer should be created between any machinery and active nests until the young have fledged.</p> <p><b>Barn owls</b><br/>None required.</p> <p><b>Overwintering birds</b><br/>None required.</p> <p><b>Suggested biodiversity enhancements</b><br/>The installation of a minimum of four bird boxes on mature trees around the site boundaries or on newly constructed buildings will provide additional nesting habitat for birds e.g.<br/>Schwegler No 17 Swift Nest Box (buildings)<br/>Schwegler 1SP Sparrow Terrace (buildings)<br/>Schwegler 1B Nest Boxes (trees)<br/>Schwegler 2H Robin Boxes (trees)<br/>Woodstone Nest Box (buildings or trees)<br/>Or a similar alternative brand.</p> |
