Brewery House, 5 Netherley Road,  
Tarbock Green, Knowsley  
Ecological Appraisal  
2023

Project Title Brewery House, 5 Netherley Road, Tarbock Green, Knowsley

Project Reference RHE.3997

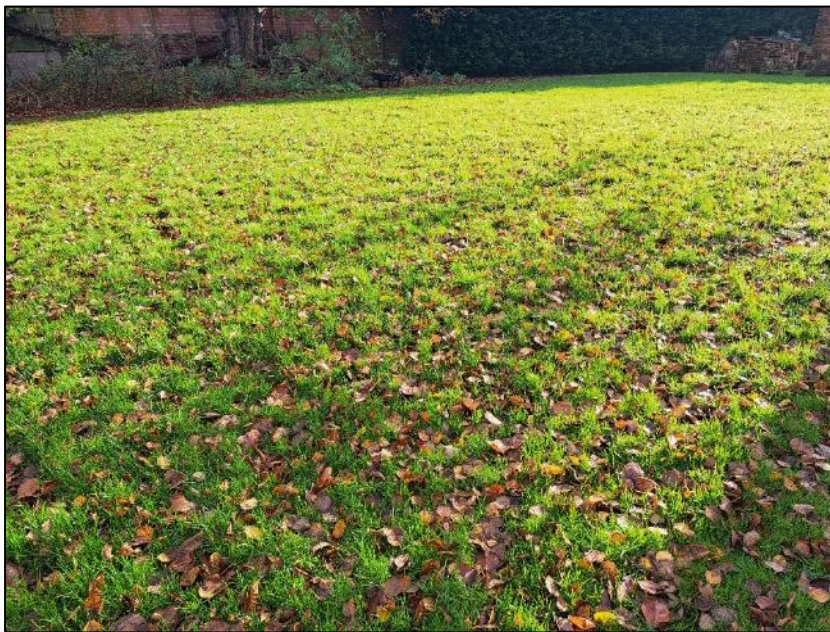
Photograph 1 showing the amenity grassland

3.3.2 A large patch of amenity-managed grassland is located to the rear of the site (see Photograph 1). Species include Perennial Rye-grass *Lolium perenne*, Yorkshire Fog *Holcus lanatus*, Creeping Buttercup *Ranunculus repens* and Dandelion *Taraxacum officinale* agg.

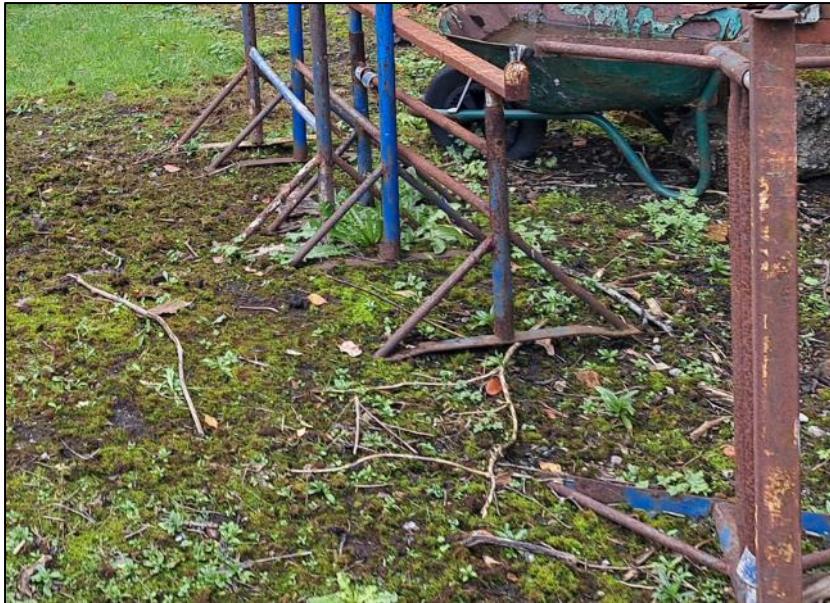
Photograph 2 showing the ephemeral/short perennial vegetation

3.3.3 Ephemeral/short perennial vegetation is present throughout the site, predominantly towards the south and centre of the site and along site boundaries (see Photograph 2). Species include, Willowherb *Epilobium* sp., Herb-Robert *Geranium robertianum*, Common Ragwort *Jacobaea vulgaris*, White Clover *Trifolium repens*, Ribwort Plantain *Plantago lanceolata*, Creeping Buttercup, Yorkshire Fog, Dandelion, Ivy *Hedera helix*, Bramble *Rubus fruticosus* agg. and Spear Thistle *Cirsium vulgare*.

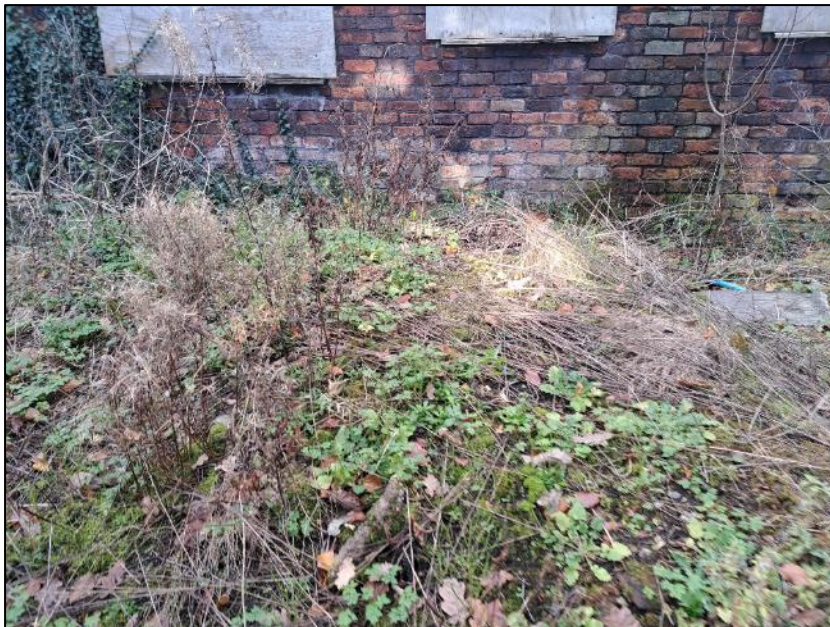
Photograph 3 showing the tall, ruderal vegetation

- 3.3.4 Tall, ruderal vegetation is present in front of the main barn, to the south and as a small patch in the northeastern corner (see Photograph 3). This habitat is dominated by a Rosebay Willowherb *Chamaenerion angustifolium* and Common Nettle *Urtica dioica*.

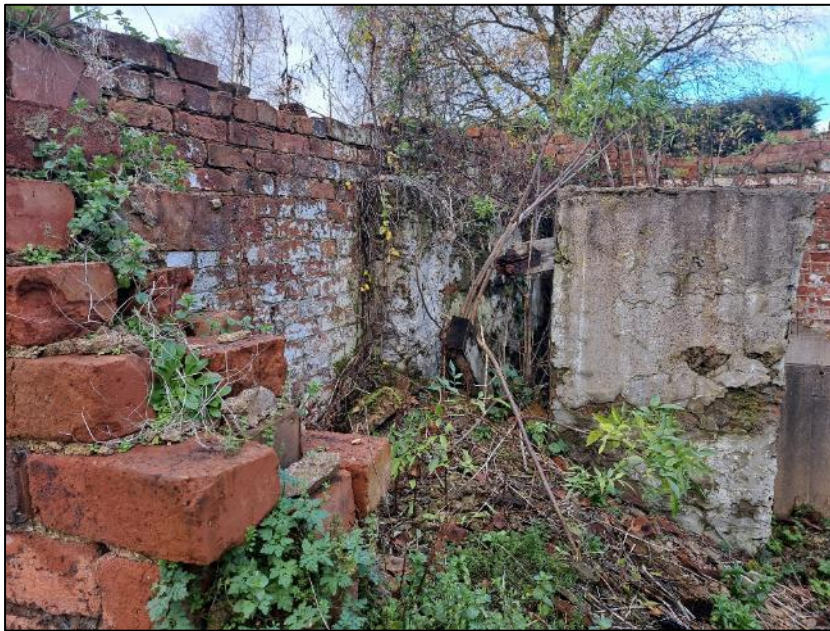
Photograph 4 showing the scattered scrub

- 3.3.5 Scattered scrub is occasional and includes Bramble and tree saplings (see Photograph 4).

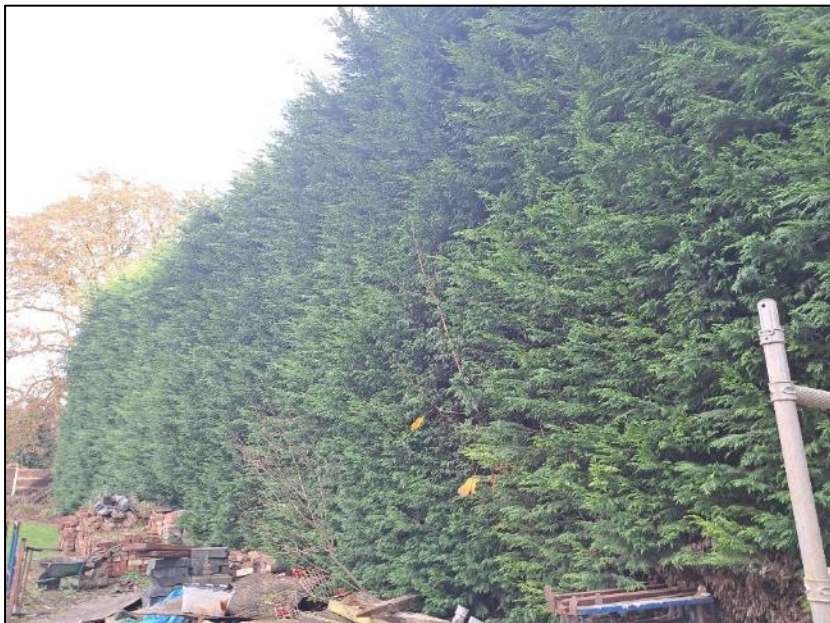
Photograph 5 showing Leyland Cypress hedgerow

- 3.3.6 The site is bordered by hedgerows to the east and south (see Photograph 5). The hedgerows are species poor, dominated by Leyland cypress *Cupressus x leylandii*.

- 4.2.1 The habitats on site are common, heavily disturbed and do not support any rare or notable plant species so they are considered to be of limited ecological interest.
- 4.2.2 Trees and hedgerows on site are assumed to be retained within the proposals. They will need to be protected from damage during the construction phase.

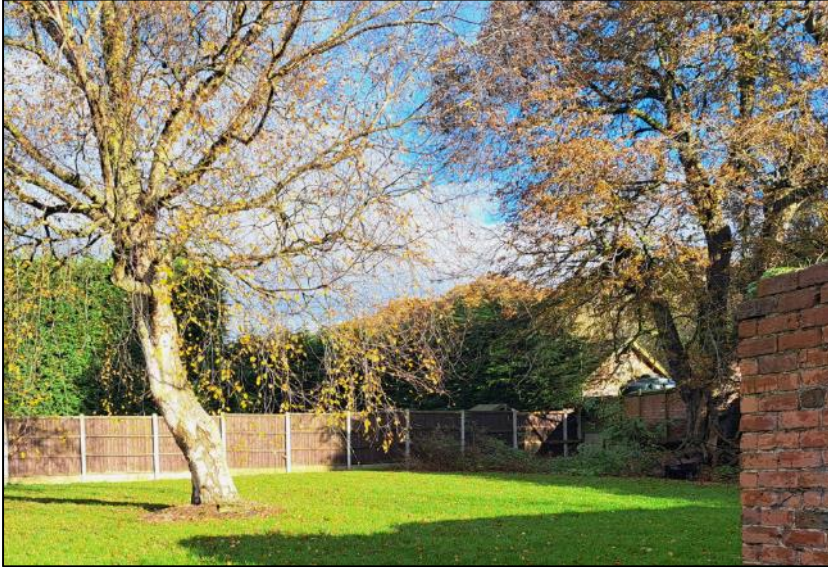
Photograph 6 showing individual trees

- 3.3.7 Several individual trees are scattered throughout the site (see Photograph 6). Species include Horse Chestnut *Aesculus hippocastanum*, Silver Birch *Betula pendula* and Pine *Pinus* sp.

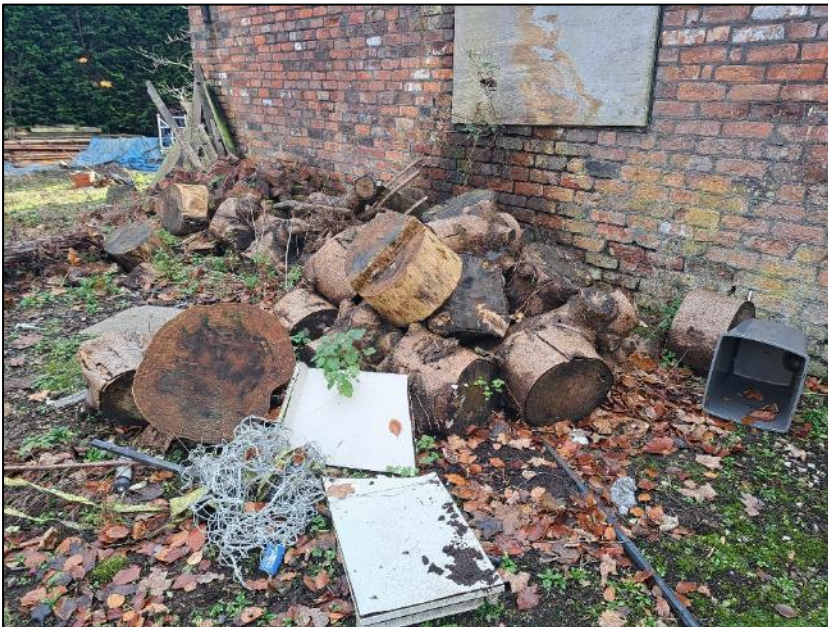
Photograph 7 showing a pile of spoil

- 3.3.8 Piles of spoil surround the main barn on site (see Photograph 7).

- 4.3.4 The site contains spoil heaps and rough vegetation that could provide suitable habitat for reptiles if they are present in the local area. Without mitigation, the proposed development has potential to impact reptiles should they be present. A Reptile Reasonable Avoidance Methods Statement (RAMS) is recommended (see Section 5).

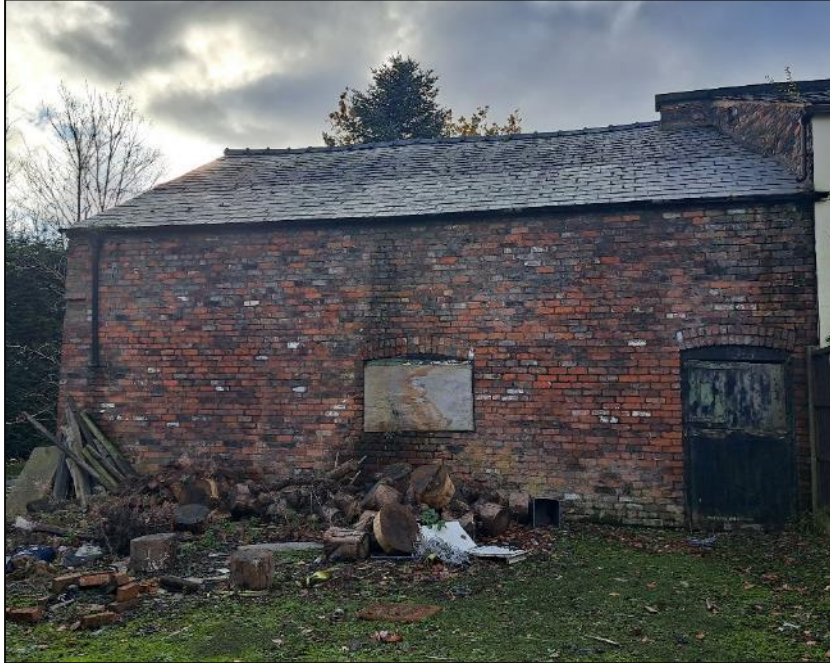
- 3.3.9 A brick barn is situated to the south of the site (see Photograph 8), and remnants of a brick structure exist to the north of the barn (see Photograph 9).

*Photograph 8 showing the main barn*

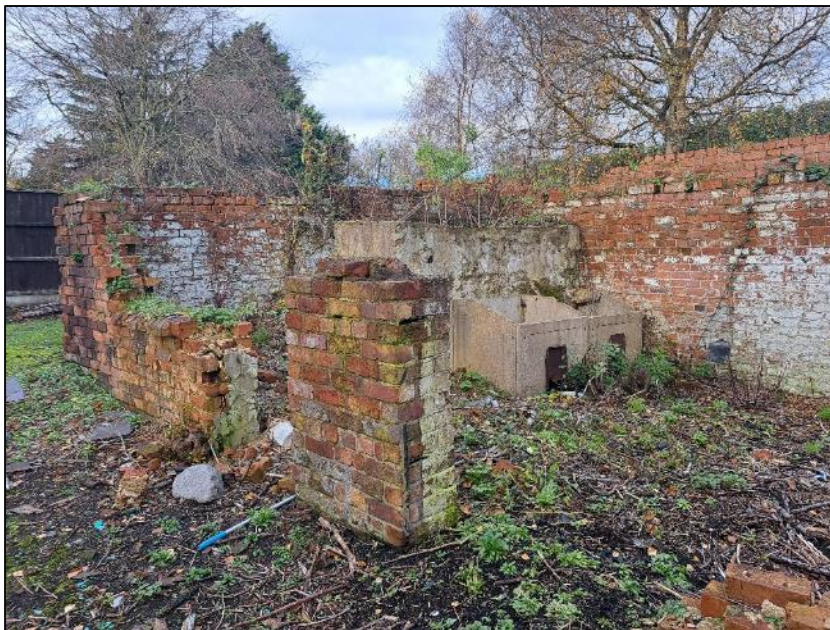
*Photograph 9 showing the remnants of a building*

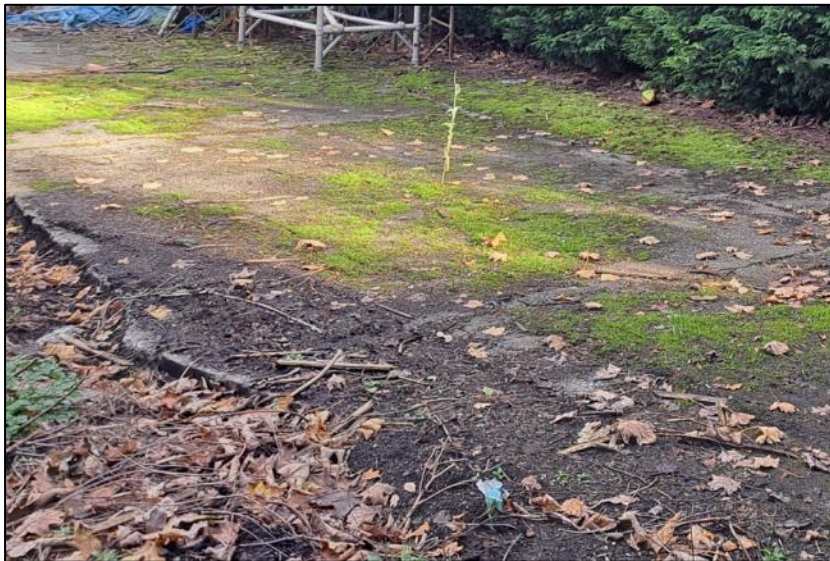
*Photograph 10 showing hard standing*

- 3.3.10 Hardstanding is situated at the southwest of the site (see Photograph 10).

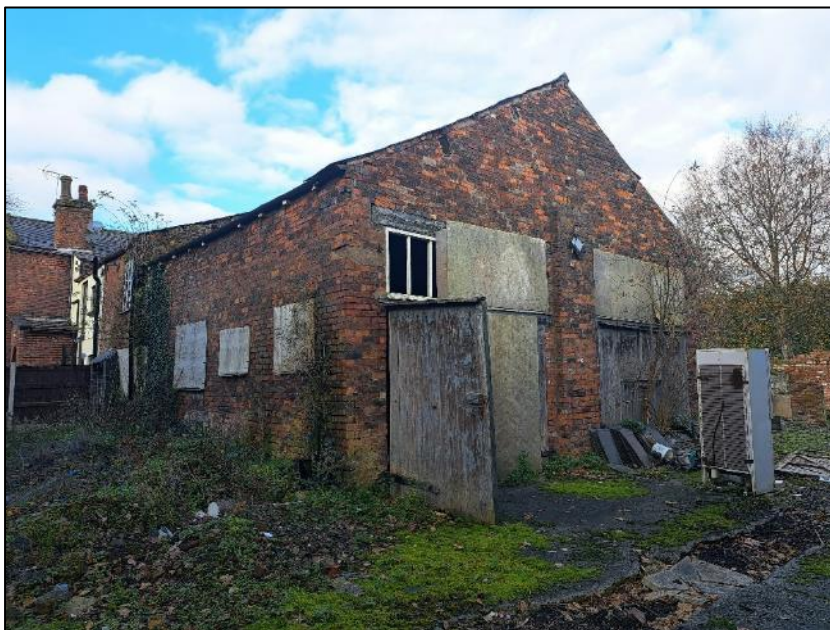
- 3.4.1 The main building on site is a two-storey barn, currently used for storage. The barn is semi-detached, with a section to the west with two levels (see Photograph 11).

*Photograph 11 showing the external masonry of the main barn*

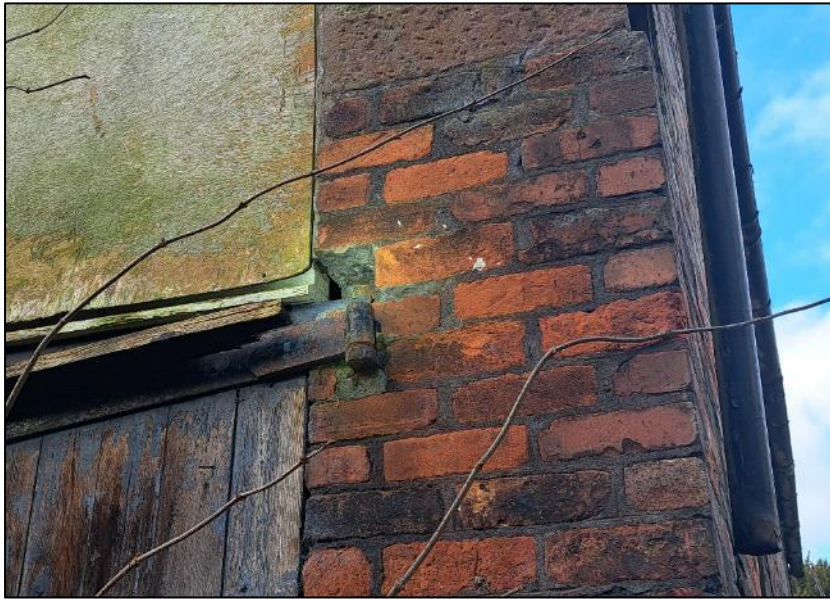
- 3.4.2 Gaps are present within the brickwork providing potential access points for bats (see Photograph 12).

*Photograph 12 showing gaps in the external brickwork*

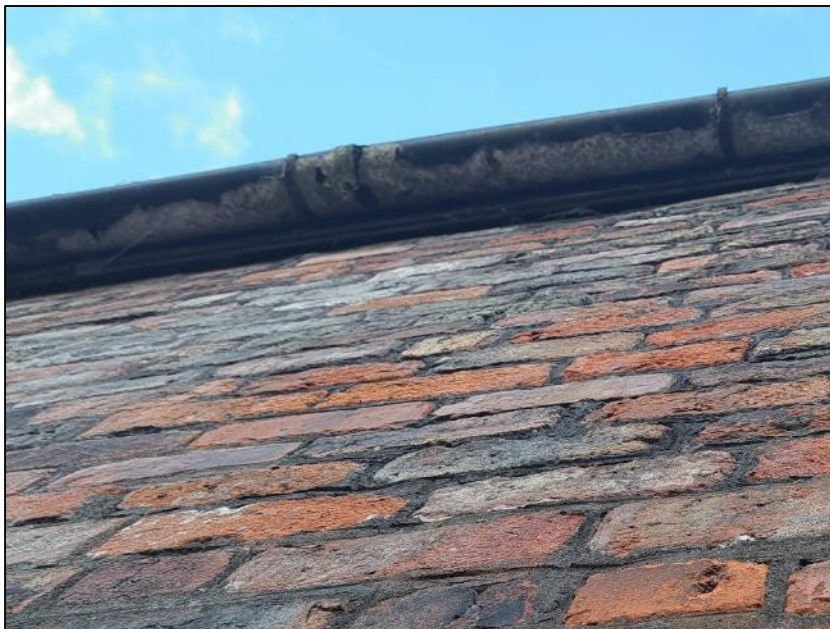
- 3.4.3 Gaps are present between the fascia boarding and brickwork providing potential access points and roosting features for bats (see Photograph 13).

*Photograph 13 showing gaps under the fascia*

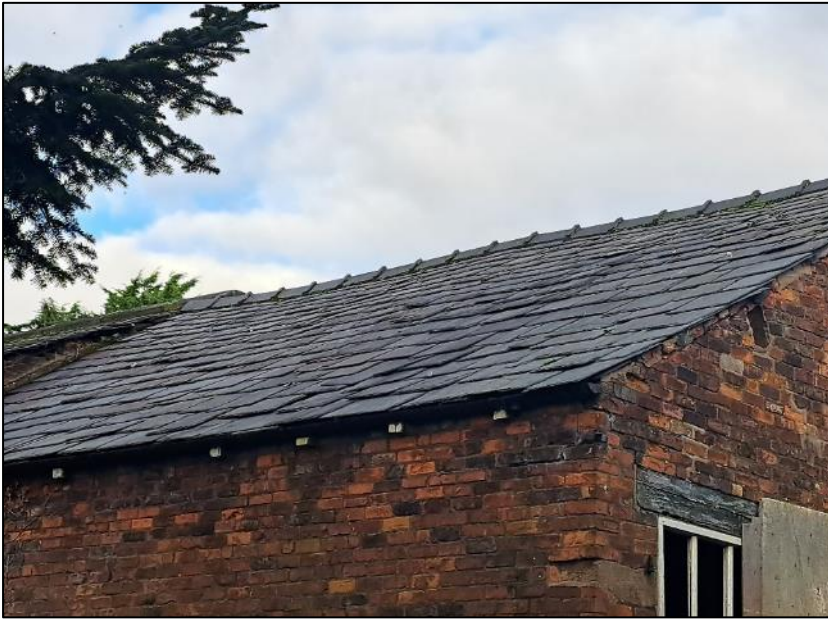
- 3.4.4 The roof appears to be intact, however slipped and missing slates are present across the entire roof (see Photograph 14). Potential roosting features exist where slates have lifted (see Photograph 15).

*Photograph 14 showing a section of roof on the barn*

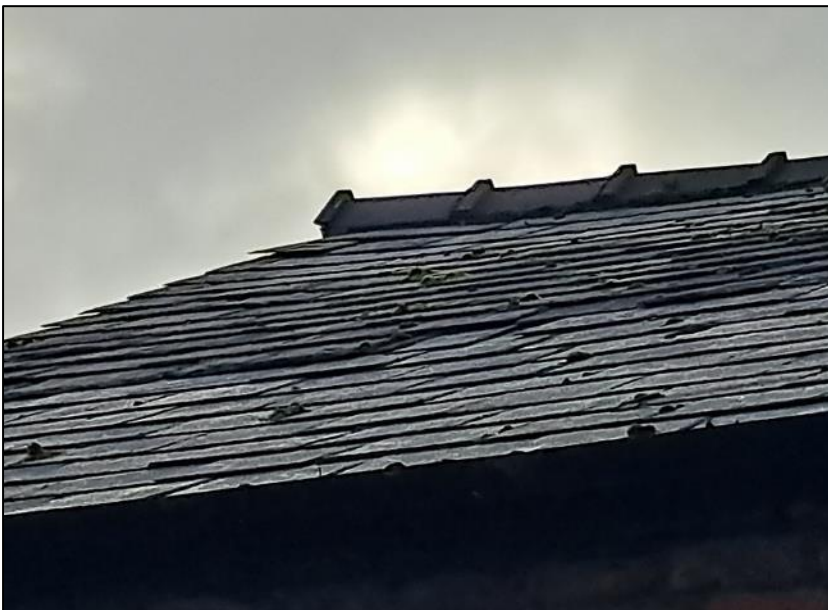
*Photograph 15 showing lifted tiles*

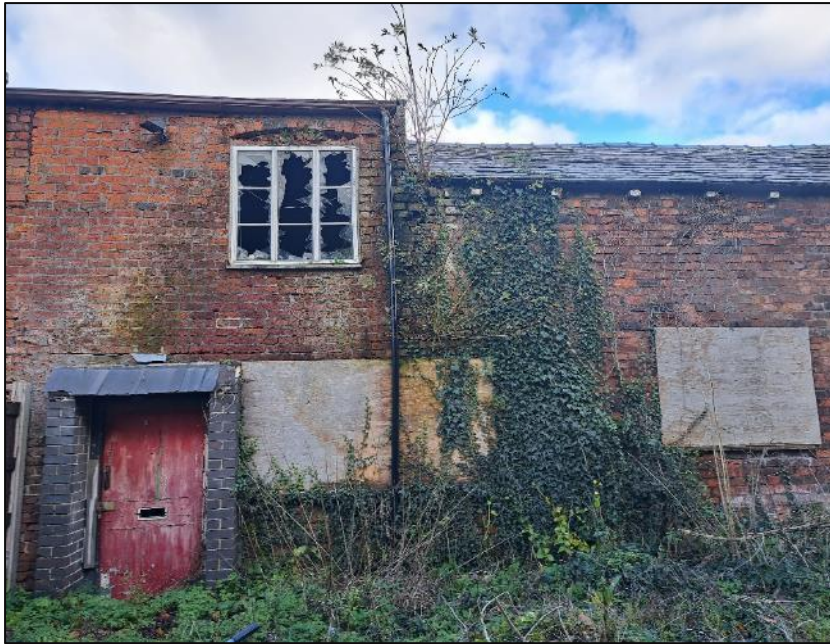
- 3.4.5 Gaps exist where wooden doors have been damaged, providing potential access points for bats. An open letterbox and a smashed window on the southern elevation of the barn to the west also provide potential access points for bats and birds (see Photograph 16).

*Photograph 16 showing potential access points on the southern elevation of the barn*

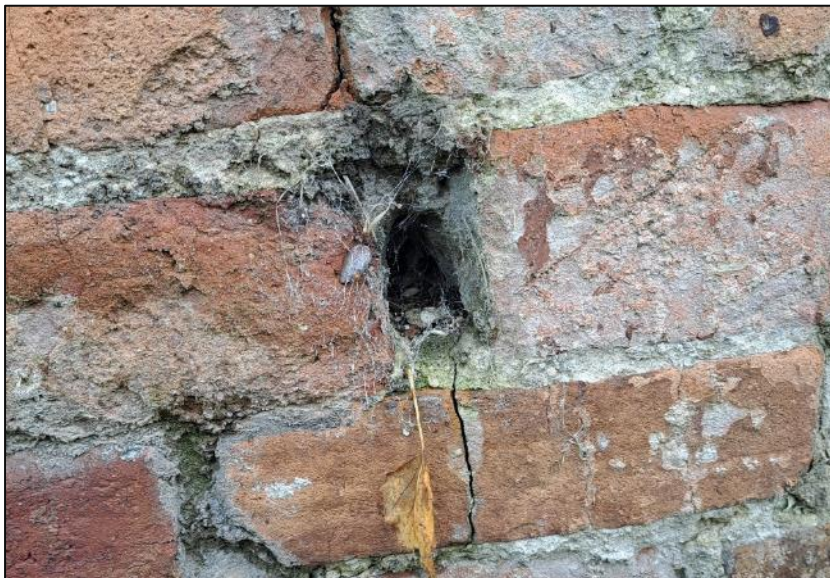
- 3.4.6 Several cavities are present within the brickwork of the building, however the cavities are shallow and cobwebbed (see Photograph 17).

*Photograph 17 showing a cavity in the wall*

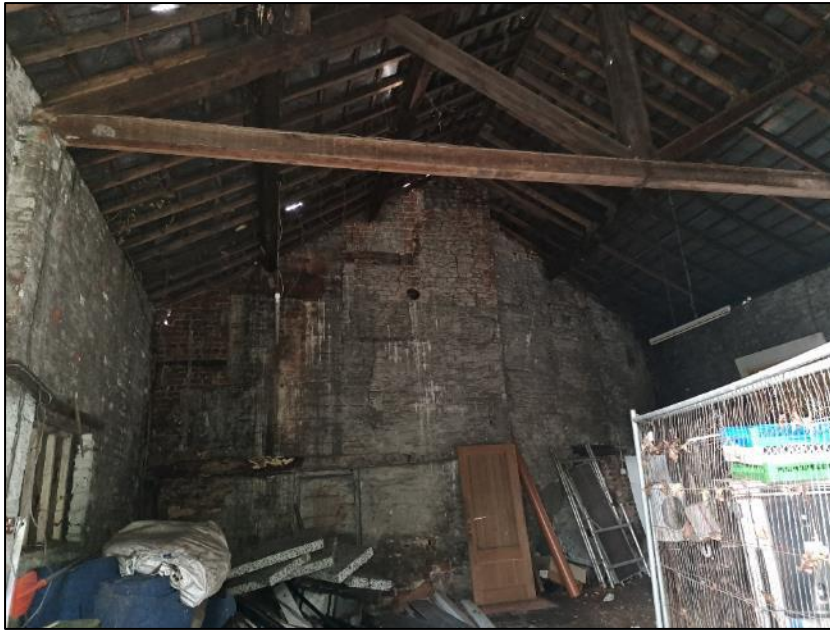
- 3.4.8 Several gaps exist within the brickwork, providing access points for bats (see Photograph 18).

*Photograph 18 showing the interior of the barn*

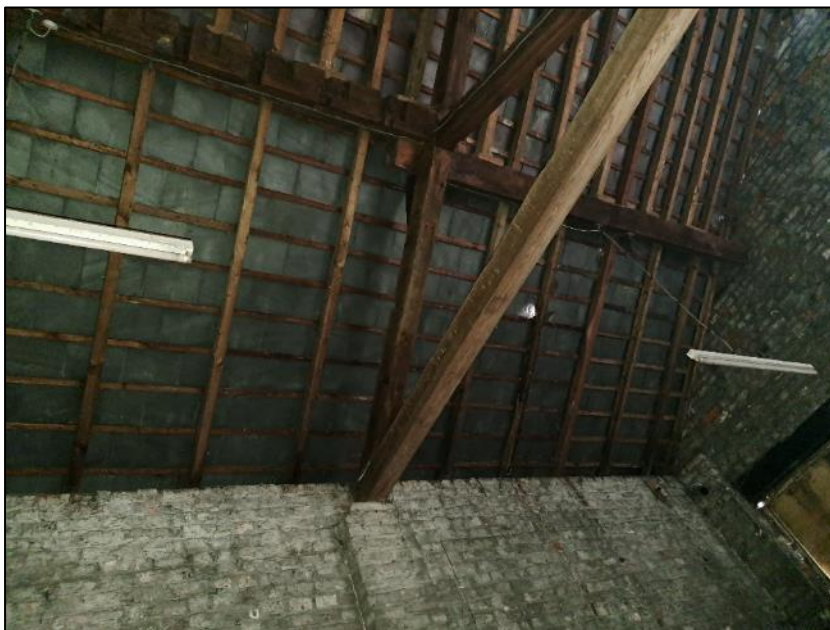
- 3.4.9 The roof of the main section of the building is open access. The roof is unlined, with several gaps between slate tiles providing potential access points for bats, the timber joists and beams are intact with minimal gaps or cracks present (see Photograph 19).

*Photograph 19 showing the underside of the roof of the barn*

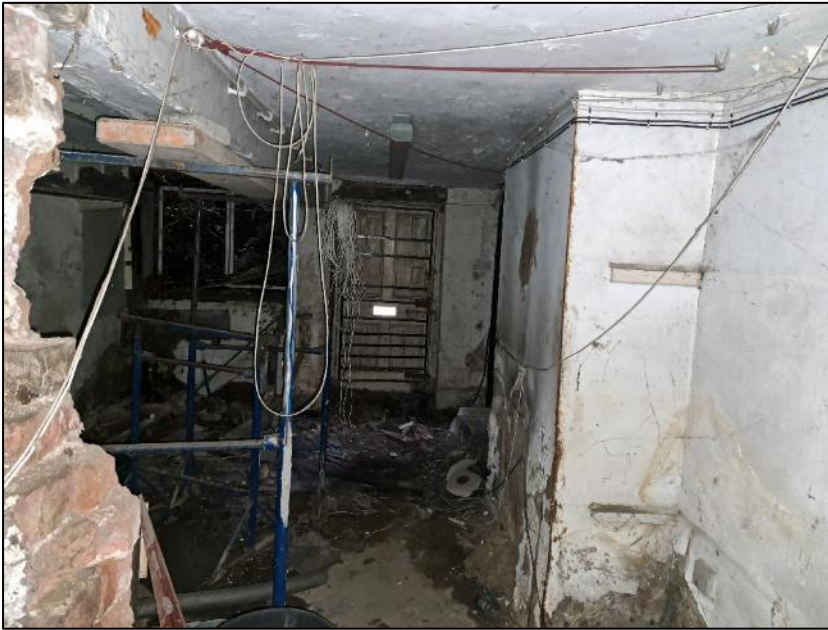
- 3.4.10 The section to the west of the building has two levels with open access between the two levels. The missing letterbox and smashed window provide potential access points for bats (see Photograph 20 and 21).

*Photograph 20 showing the lower elevation of the western section/room of the barn and open letterbox*

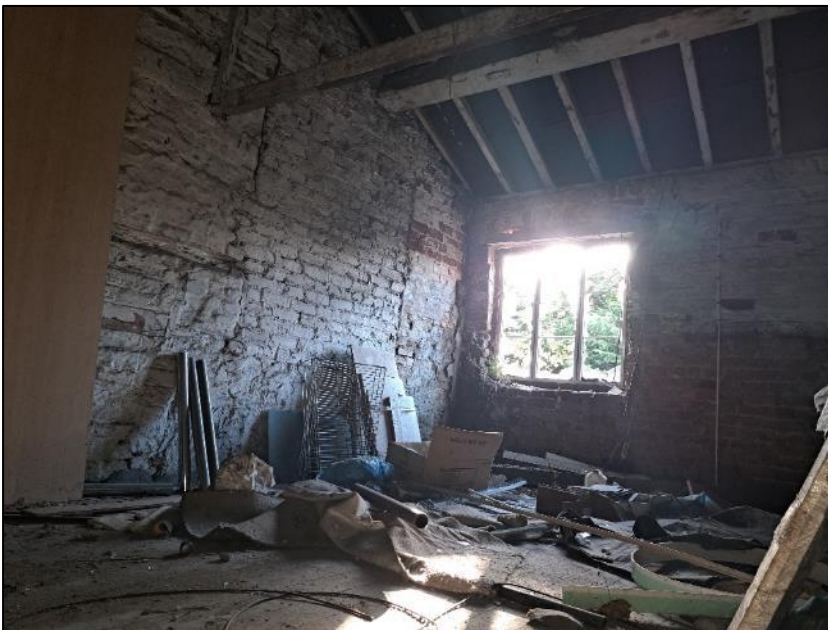
*Photograph 21 showing the upper elevation of the western section of the barn and smashed window*

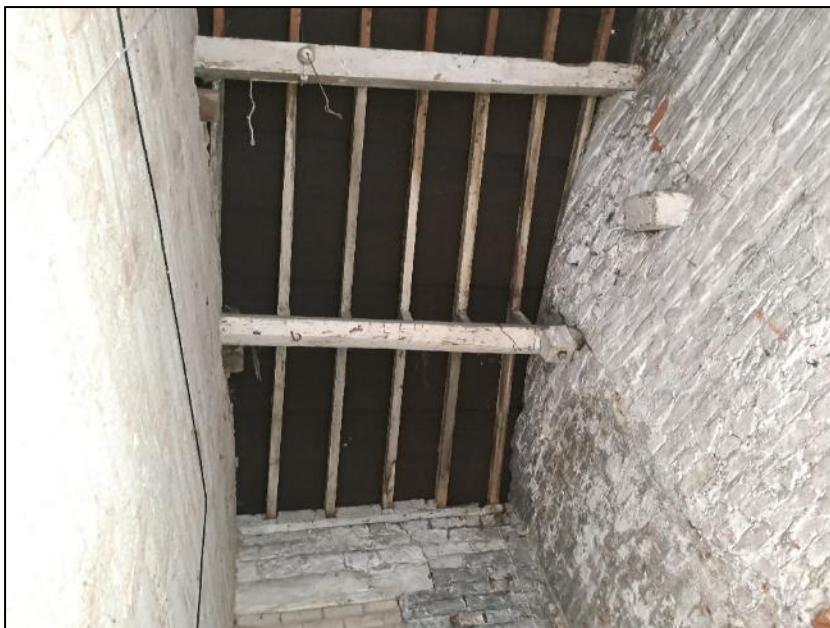
- 3.4.11 The roof of this section of the building is lined with breathable membrane with no tears or gapping within the lining (see Photograph 22). Cavities exist within the brickwork and where timber beams attach to the wall, providing potential roosting features for bats (see Photograph 23).

*Photograph 22 showing the underside of the roof in the western section of the barn*

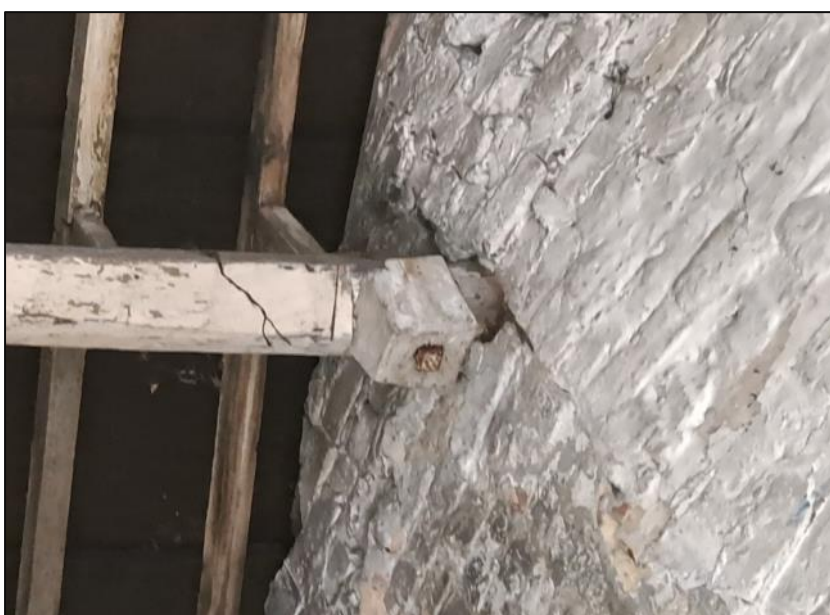
*Photograph 23 showing cavities in the brickwork*

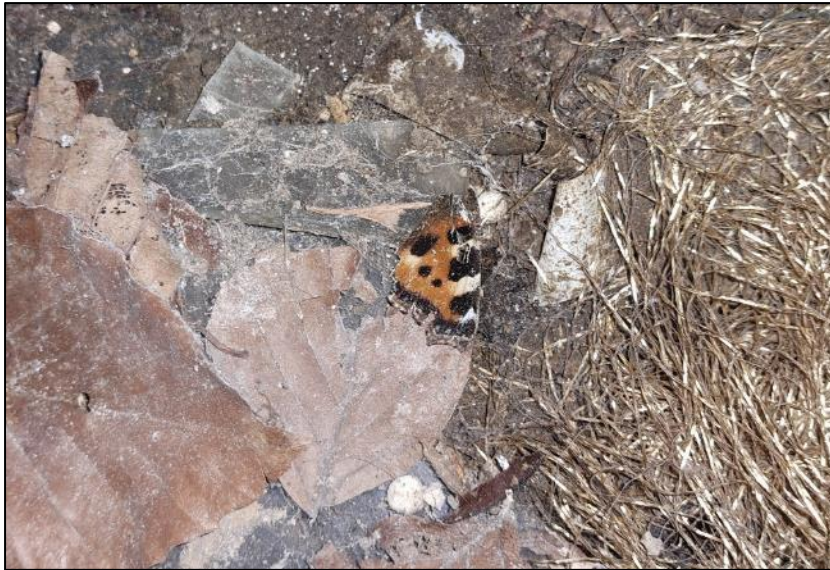
3.4.12 Feeding remains (butterfly and moth wings) were found scattered throughout both sections of the building (see Photograph 24).

*Photograph 24 showing feeding remains*

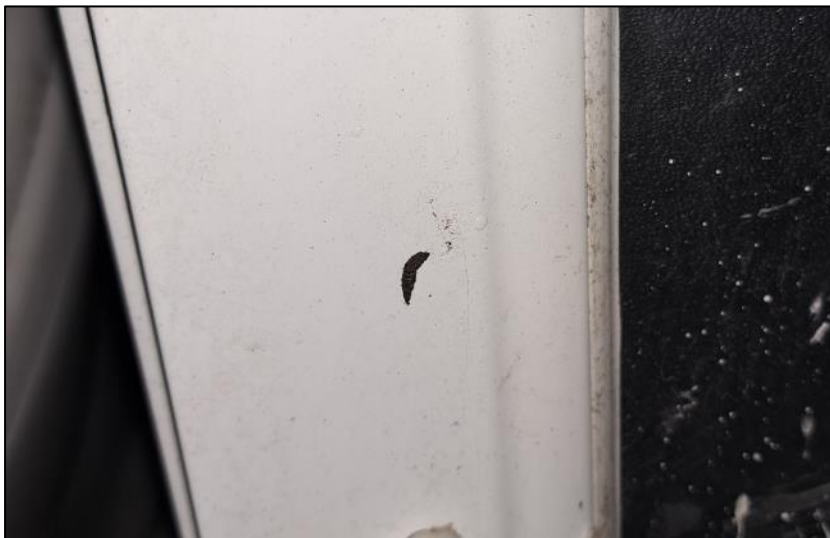
- 3.4.13 Scattered bat droppings were also found throughout both sections of the building (see Photograph 25).

*Photograph 25 showing a bat dropping*

- 5.1.1 Further targeted survey is required in order to determine the status of roosting bats at the site and inform mitigation requirements. In accordance with current guidelines, two dusk emergence surveys should be carried out on the main barn between May and September, under suitable weather conditions.

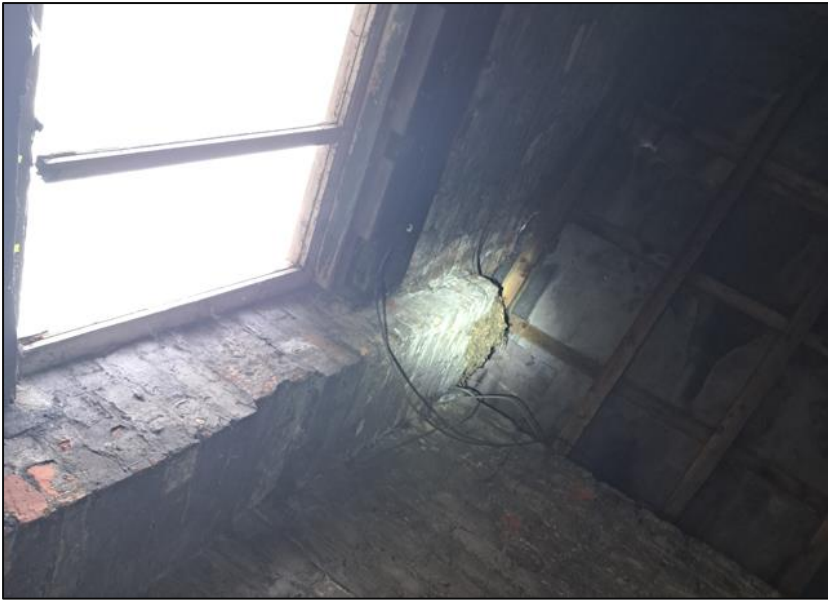
- 3.4.14 An old birds' nest was recorded within the eastern section of the building, above the main barn door (see Photograph 26). Trees and hedgerows on site also offer suitable nesting bird habitat, with a birds nest located within a tree in the north-eastern corner of the site.

Photograph 26 showing a bird's nest within the barn

- 5.2.9 Impacts on nesting birds should be avoided by carrying out site clearance and similar operations outside of the bird breeding season (March- August). Construction activities that might directly impact upon breeding birds should hence be limited to the September-February period. If vegetation has to be cleared during the bird breeding season checks immediately before clearance by a suitably qualified ecologist will be required. If nesting activity is detected work in that area will need to stop until the ecologist considers that nesting activity is finished.
