**Methodology of Works**

**Taylor Wimpey**

**FOX WOOD GARDEN VILLAGE INDICATIVE ELE/SECTION STONE WALL - FINAL**

DRAWING NUMBER 20285 IWE 04 I

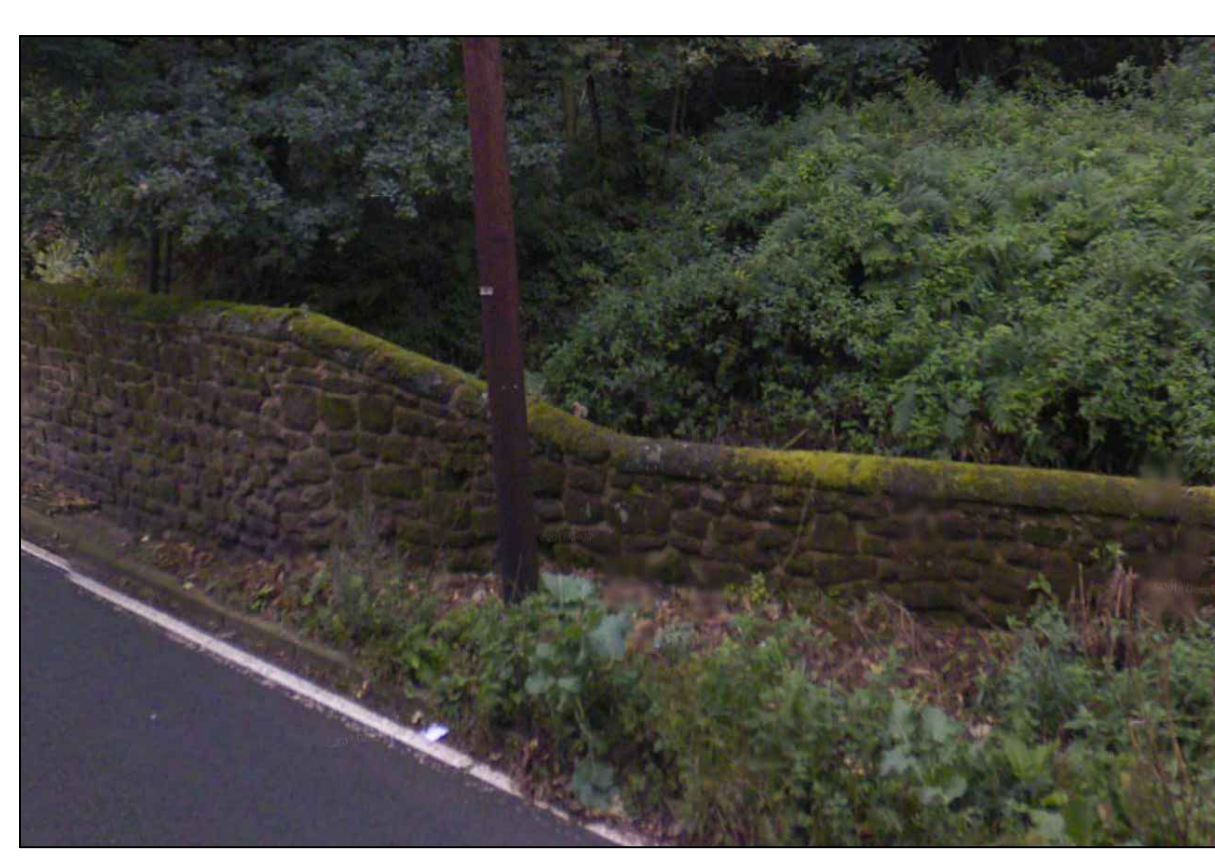
Google Street View Photographs of Sloped Coping - NTS

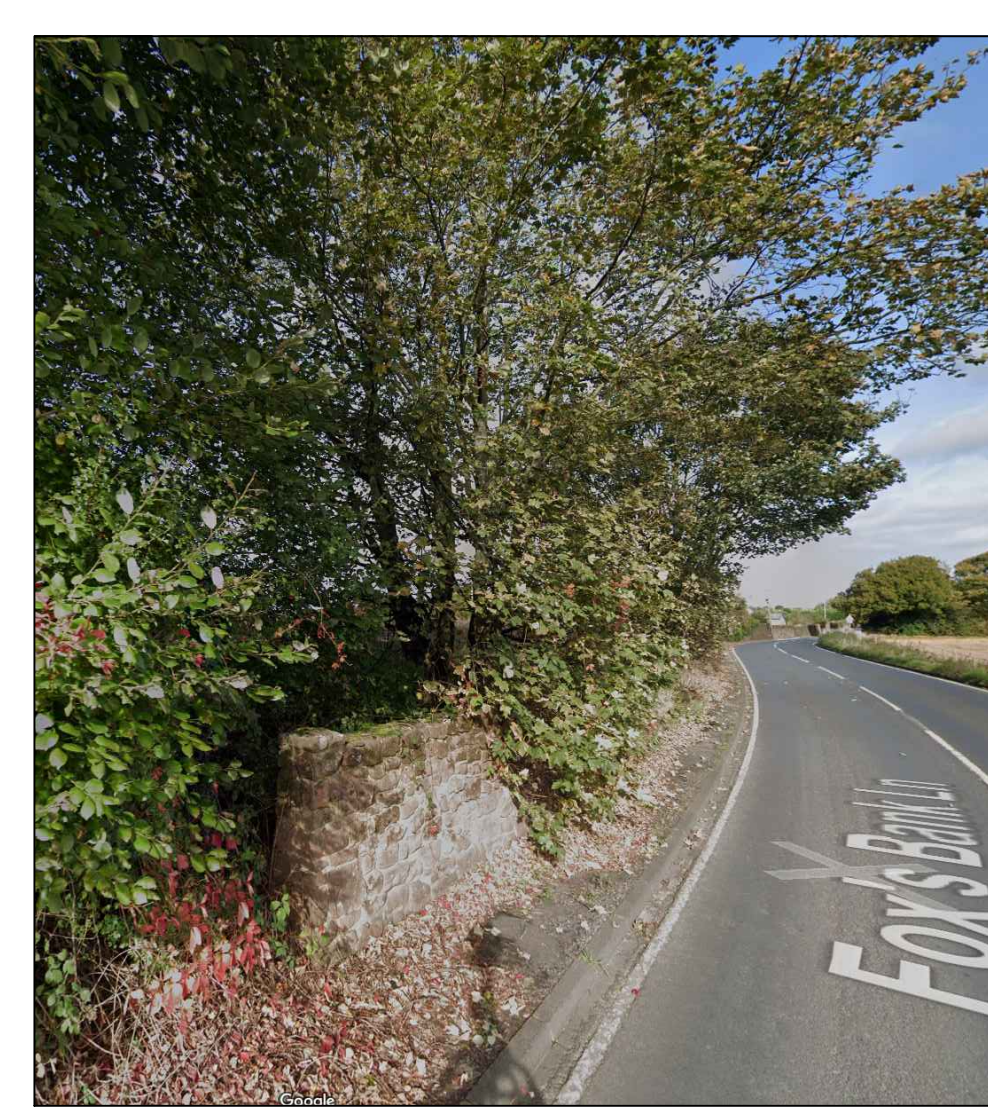
Google Street View Photographs of Low Level Wall - NTS

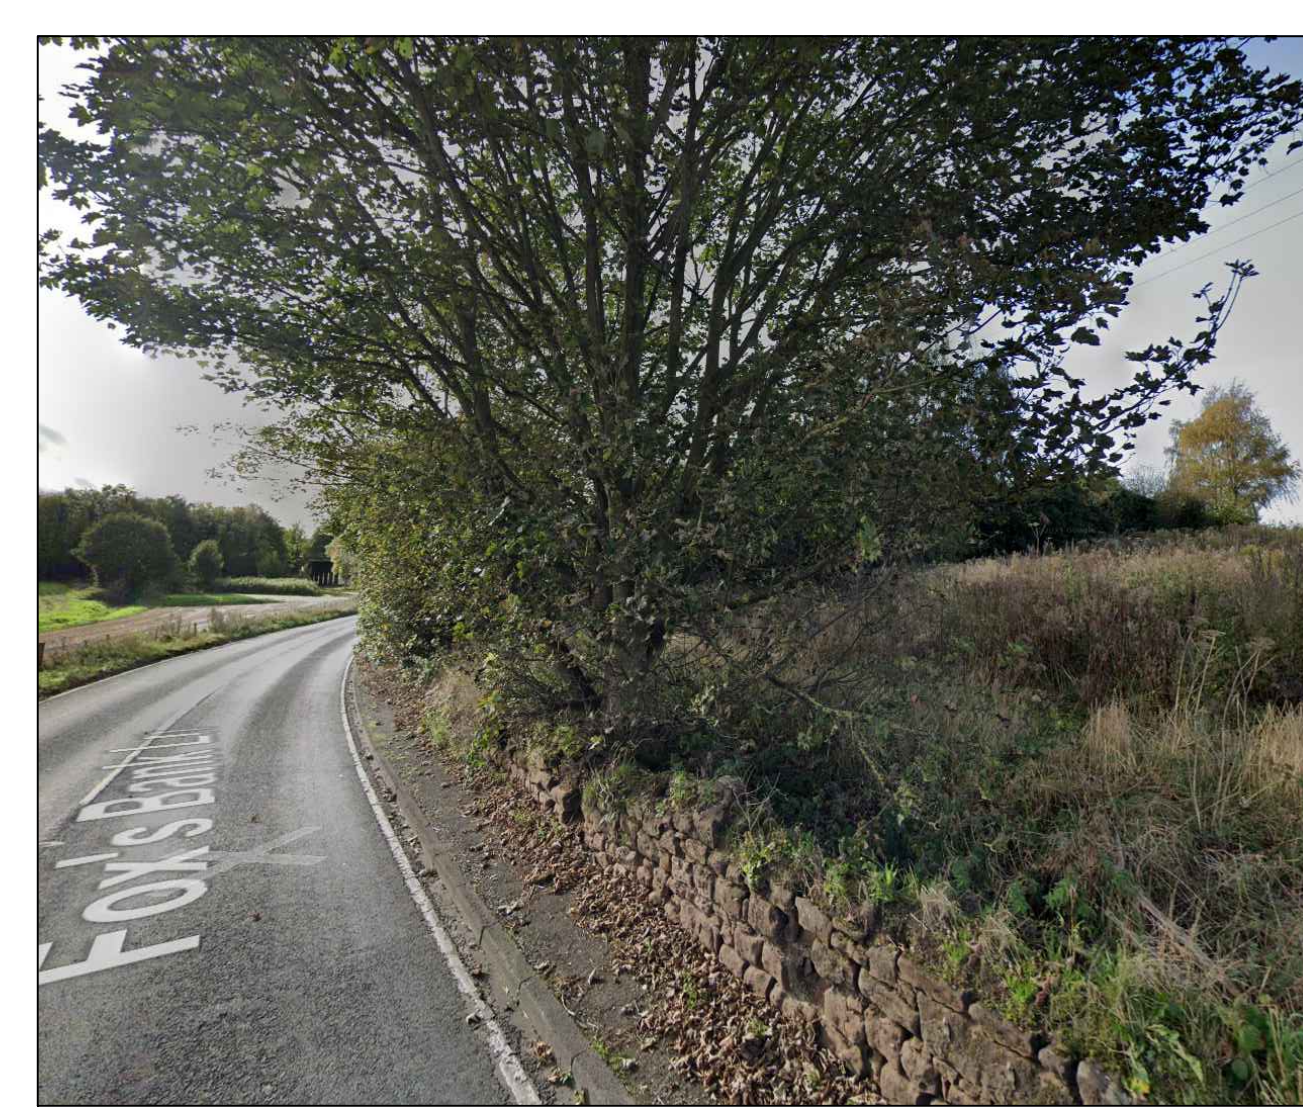
Google Street View Photographs of Low Level Wall - NTS

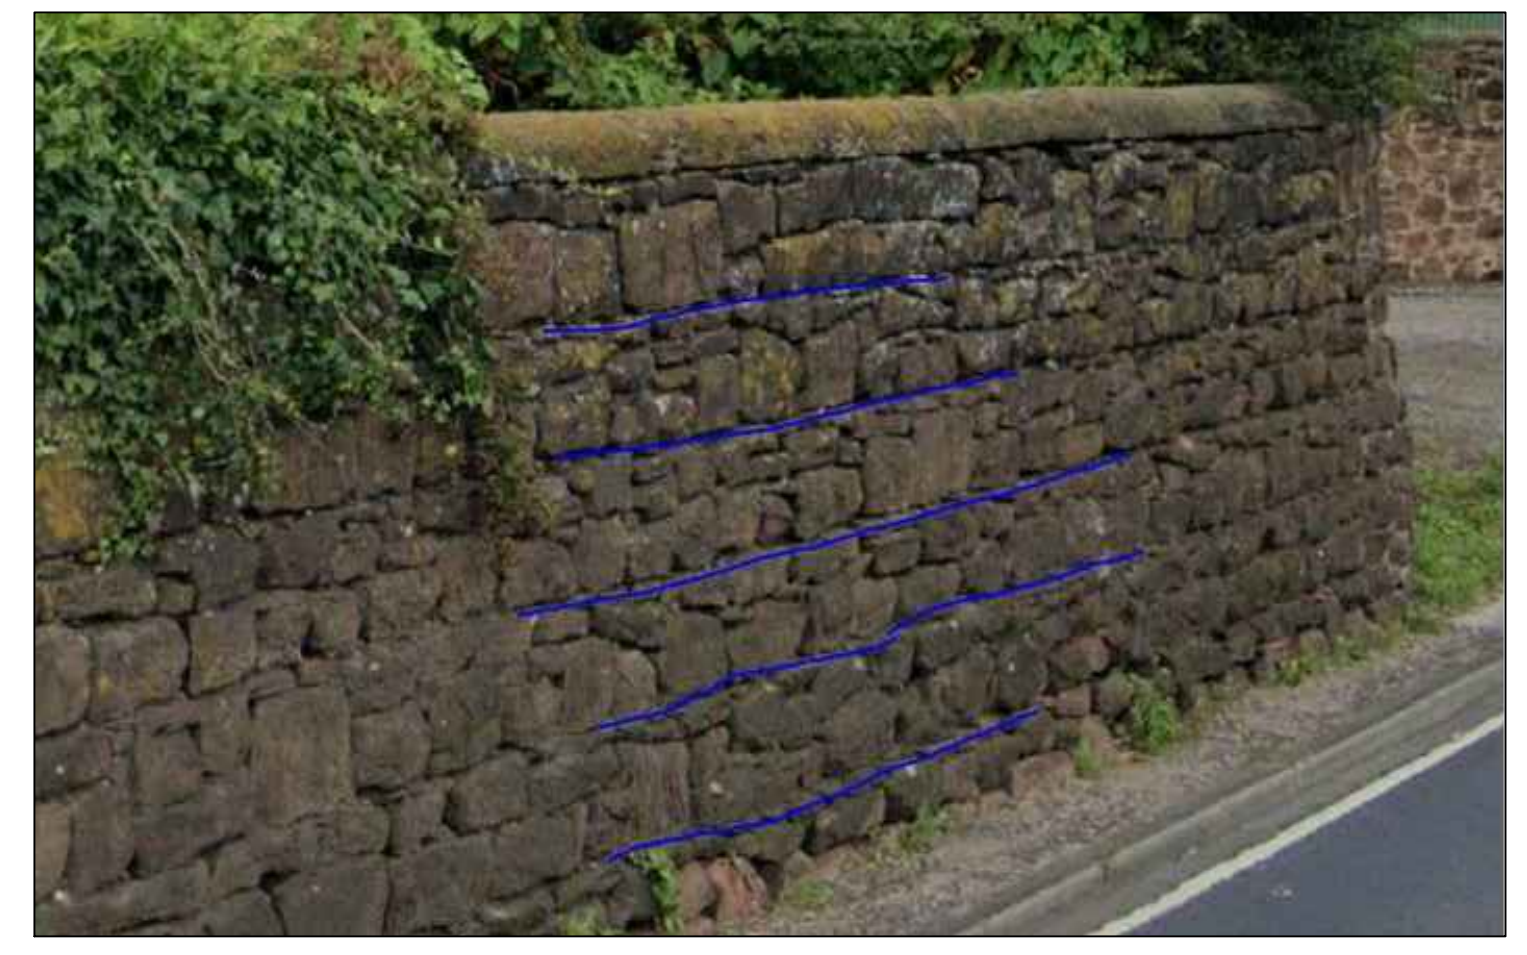
Proposed Facing Stone to be used by Stone Central (Stone Masons) where the new stone is required
