## Phase 1 GeoEnvironmental Desk Study

Land At Marl Road

Knowsley

**Report No. A7189/25/FDS**

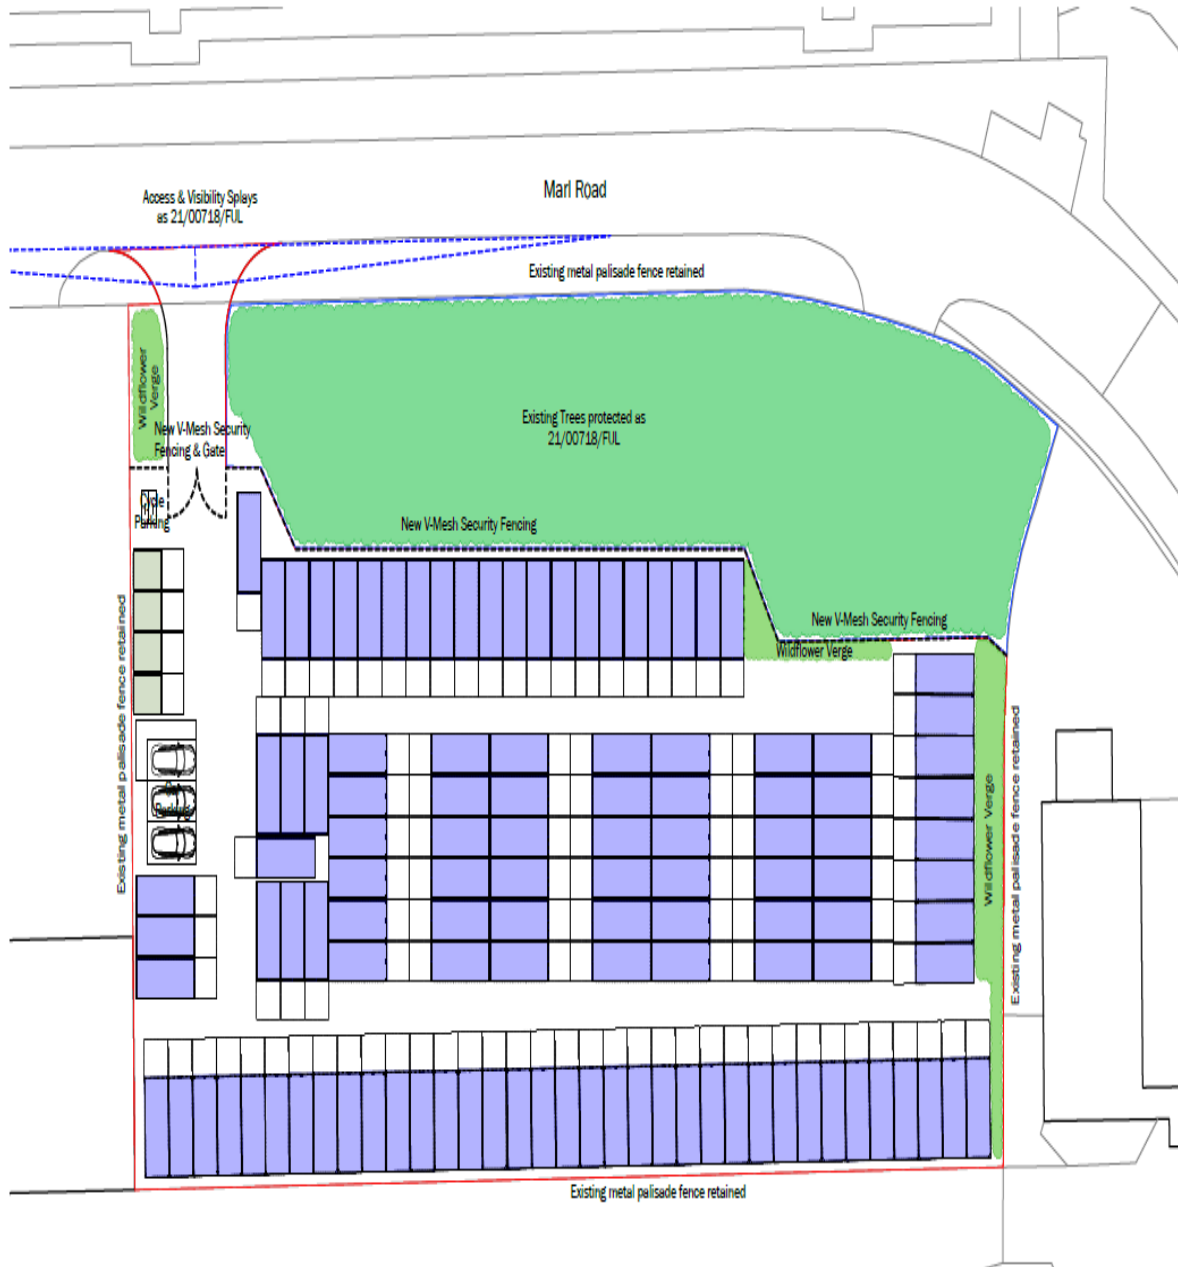
**Figure 1: Proposed Development Plan**

- 1.1 Cuboid Self Storage Ltd (the client) has commissioned Earth Environmental & Geotechnical Ltd to undertake a Pre-Purchase Phase I Environmental Desk Study for a proposed development at undeveloped land adjacent to Marl Road, Knowsley.
- 1.2 It is understood that the client intends to develop the site into a containerised self-storage facility (120 containers) with an associated car park.
- 1.3 A proposed development plan is presented in Figure 1, overleaf.

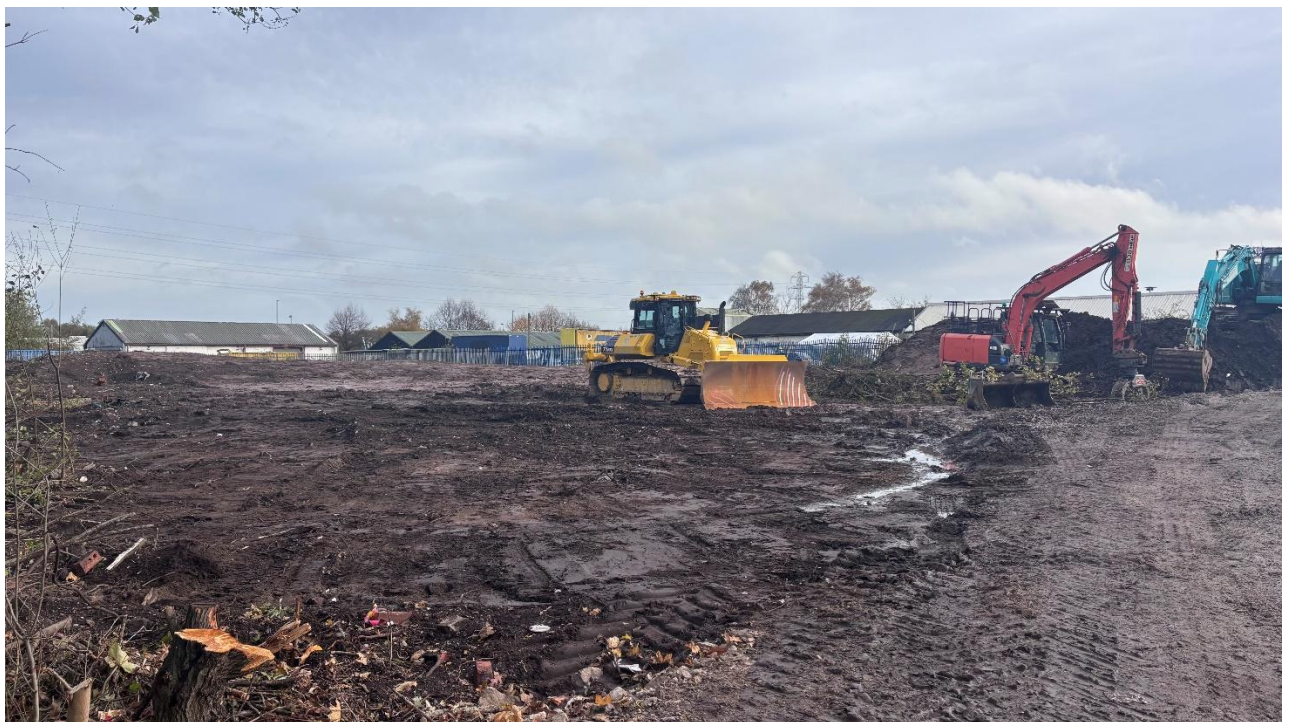
**Figure 3: Site Photograph**

- 2.3 The surface topography of the site is slightly undulating in the northern part but generally level. Additionally, the site has soil mounds from site clearing, and it slopes to the northwest.

- 2.4 The site was covered by overgrown vegetation and trees, which have been recently cleared. The site's surroundings are split between hardstanding and soft cover.

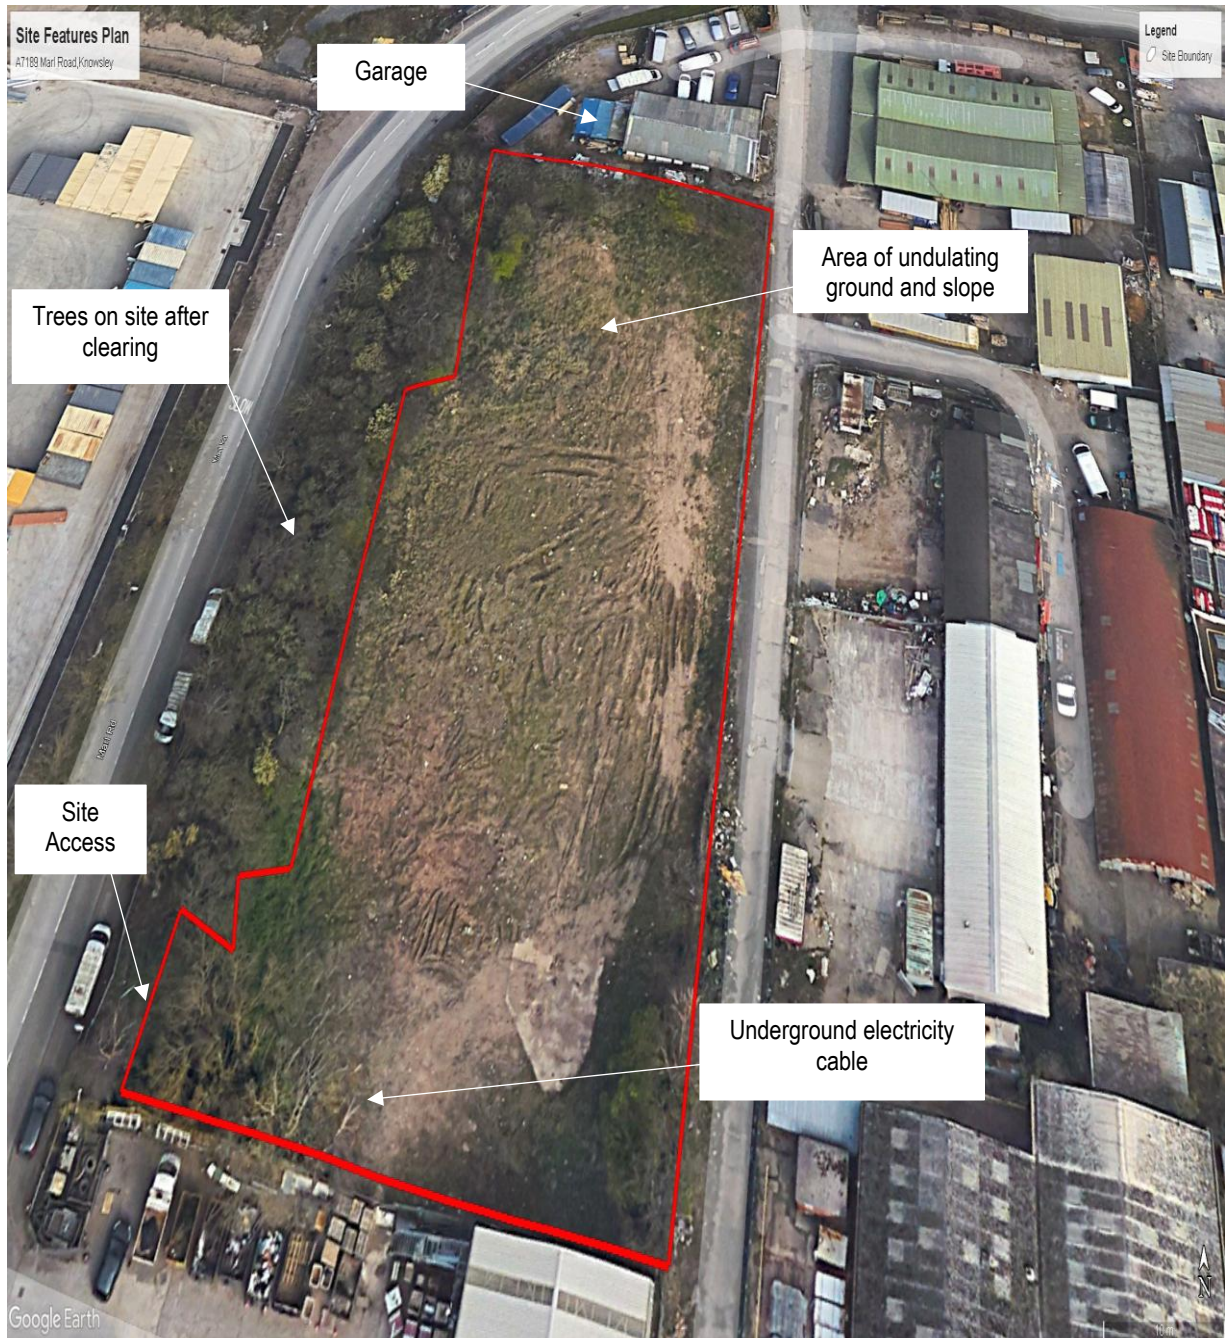
**Figure 8 Site Features Plan**

- 5.4 A repaired underground electric cable using a low-voltage cable joint was seen at the southern end of the site.
- 5.5 The site was covered by overgrown vegetation and trees, which have been recently cleared. The site's surrounding area is split between hardstanding and soft cover.

- 5.9 Trees border the site and Marl Road to the west, and across the road is the Amazon depot.
- 5.10 A garage is at the northern boundary of the site, and unknown industrial buildings are on the east and south borders of the site.

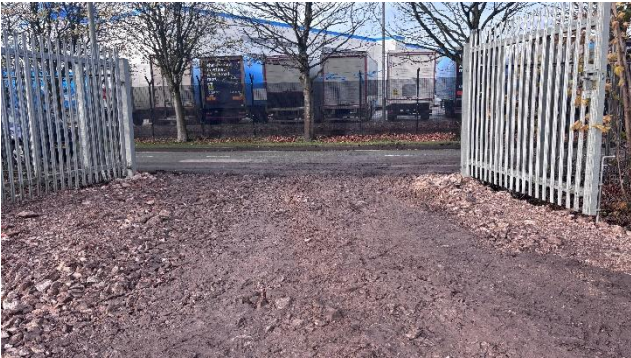
| <b>Plate 1 View facing west showing site entrance</b> | <b>Plate 2 View facing northeast into the site</b> |

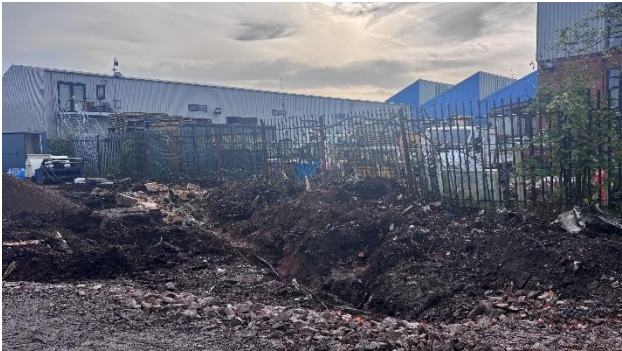
| <b>Plate 3 View facing east showing the site from the southern corner</b> | <b>Plate 4 View facing west showing trees at the western boundary of the site</b> |

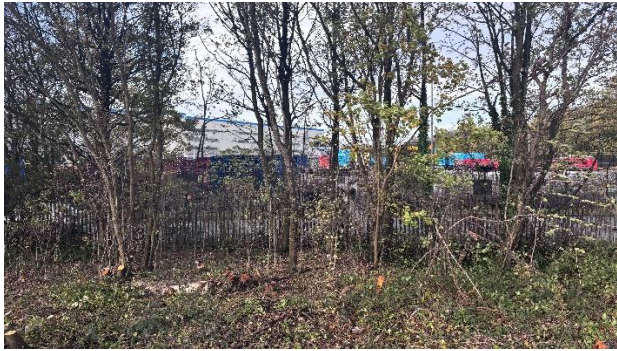
- 2.5 Mature bushes and trees are located on site on the western end of the site, adjacent to Marl Road. However, the trees are not within the proposed site development boundary.

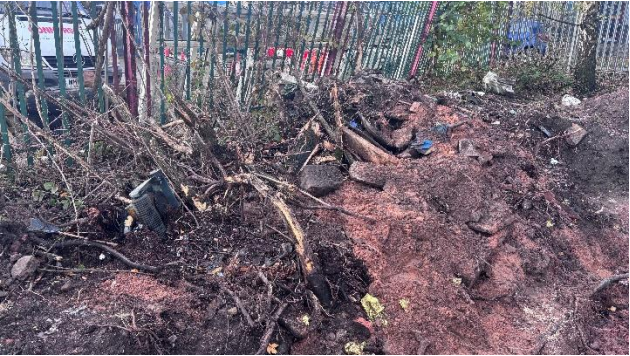
| <p><b>Plate 5 View facing southwest showing stockpile on the site</b></p> | <p><b>Plate 6 View facing the western boundary showing fly tipping evidence on the site</b></p> |

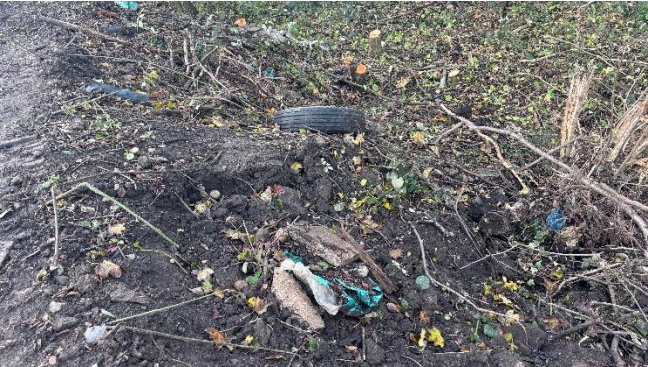
| Source | Pathway | Receptor | Probability | Consequence | Risk | Comment |
|---|---|---|---|---|---|---|
| | | Construction Workers | Low Likelihood | Moderate | Moderate to Low | Given the site's history, deep-made ground is likely to be anticipated. Construction workers may be exposed to ground gas / depleted oxygen conditions in excavations; however, the exposure will be short-term. The risk to construction workers from ground gas is considered <b>MODERATE to LOW</b> . |

| <p><b>Plate 7 View facing northwest showing evidence of made ground</b></p> | <p><b>Plate 8 View facing east, present made ground</b></p> |

- 8.12 A further intrusive investigation should be undertaken to establish geotechnical parameters for the design of foundations for the storage containers.
- 8.13 As part of the geotechnical investigation, it is recommended that samples of soil and groundwater be recovered for contamination testing to allow for a more detailed assessment of the risk and allow for an evaluation of potential surplus off-site soil disposal.
- 8.14 Monitoring wells also need to be installed to confirm the risk of contamination from potential ground gas.

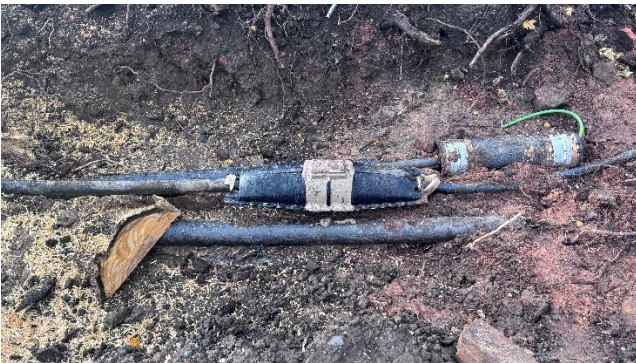
**Plate 9 View showing repaired electrical cable in the southern area of the site**

| Desk Study features checked during site visit | Feature and Information required | Present | Description / Comments |
|---|---|---|---|
| Electrical Equipment | Are there any electricity substations on or adjacent to the site? Are there any electrical transformers, capacitors, pylons etc on site? | Yes | A repaired underground electrical cable was seen at the southern end of the site. |

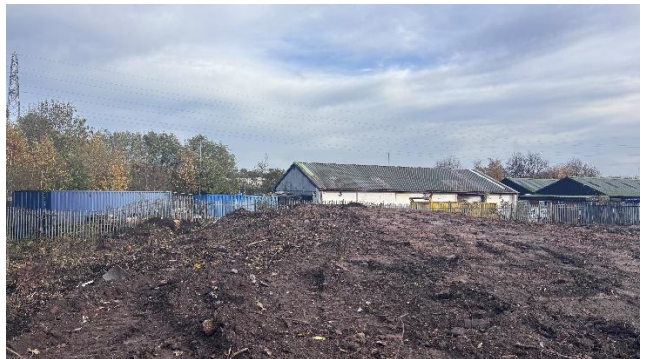
**Plate 10 View showing the undulating ground condition of the site and slopes in the northwest end of the site**

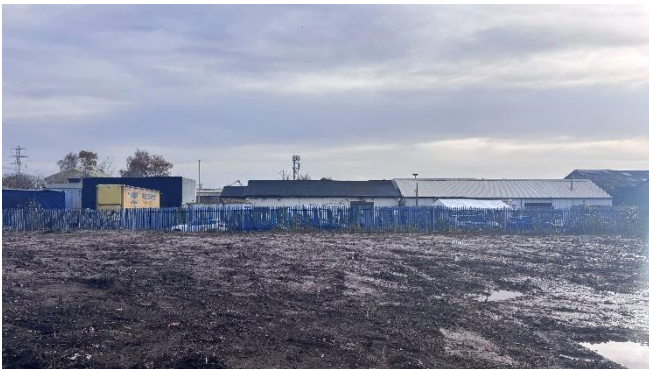
**Plate 11 View showing the eastern boundary of the site**

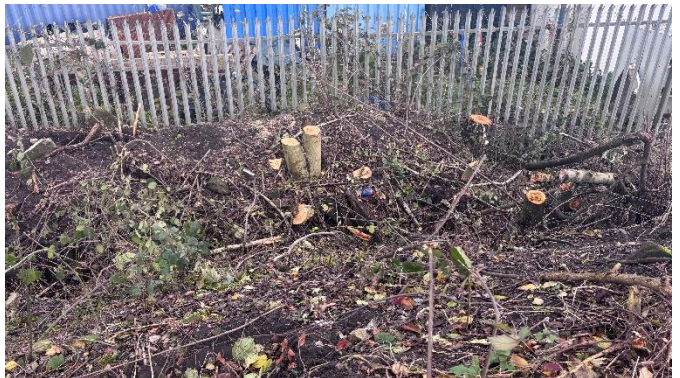
**Plate 12 View showing the northern boundary of the site and slope**

| Desk Study features checked during site visit. | Feature and Information required | Present | Description / Comments |
|---|---|---|---|
| Ground Conditions | Is there any evidence of:<br><br>Mining, Mine entries<br>Subsidence<br><br>Landslip/slope erosion<br><br>Former investigation works | No<br><br>Yes<br><br>No | No evidence of negative ground conditions nor a previous ground investigation within the site.<br><br>The site slopes slightly to the north. |
