# Dusk Survey Results

**22 Archway Road**  
Huyton  
Liverpool  
L36 9XB

**22 Archway Road, Huyton, Liverpool, L36 9XB**  
**Dusk Survey Results**

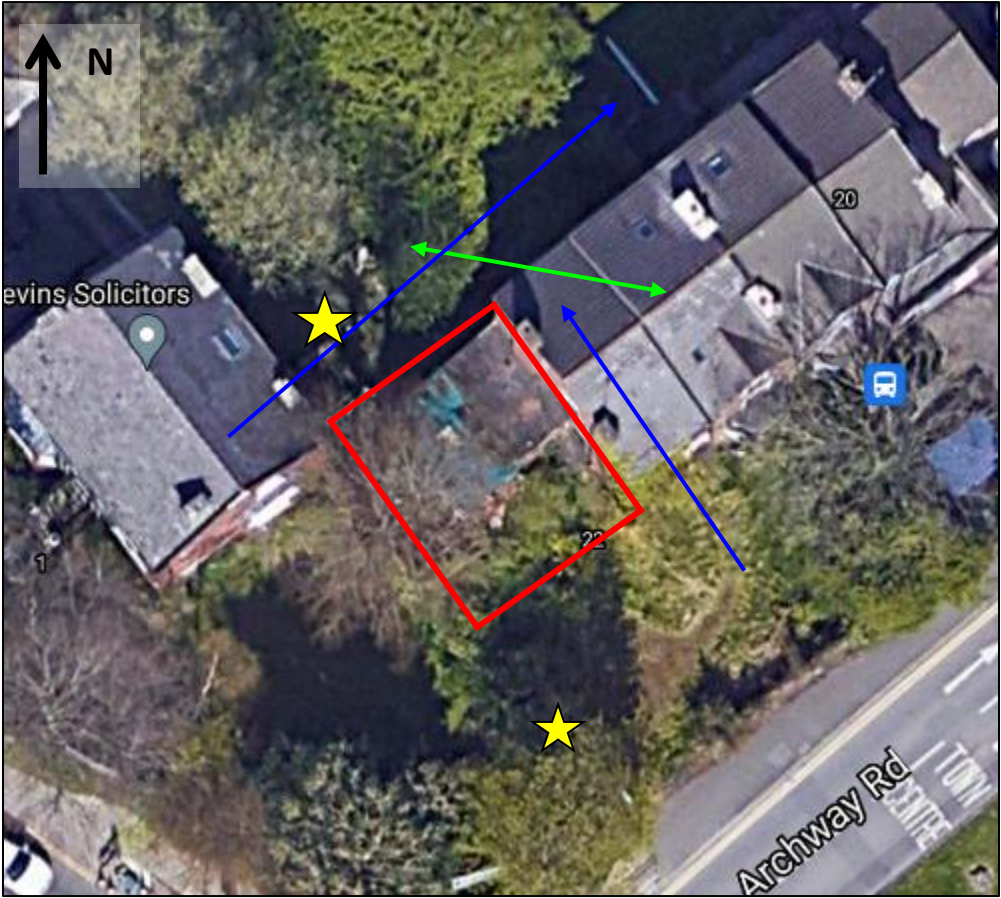
Figure 5.1: Dusk Survey Results 13/05/2021 (adapted Google 2021)

| <b>Dusk Survey</b> | <b>Time</b> | <b>Activity</b> |
|---|---|---|
| 13/05/2021 | 2042 - 2220 | <p><b>Summary: No bat emergence for the duration of survey.</b></p> <p>2123 hrs: Common Pipistrelle foraging in the back garden at the north of the property.</p> <p>2124 hrs: Common Pipistrelle foraging round the north of the building.</p> <p>2133 hrs: Common Pipistrelle commuting round the north of the building.</p> <p>2150 hrs: Common Pipistrelle commuting round the north of the building and limited foraging.</p> <p>General activity comprised of regular foraging by Common Pipistrelle bats and minimal passes.</p> |

- 6.1 From the two dusk survey results, it can be concluded that whilst using best practice survey methodology, emergence of bats was absent at 22 Archway Street over the survey effort; activity was limited to occasional foraging and commuting activity by a maximum of one Common Pipistrelle (*Pipistrellus pipistrellus*) bat at a time during the combined survey effort.
- 6.2 Bats are a highly transient species with multiple roosts in an area, and can use buildings that offer potential roost features at any time of the year, therefore despite no roost behaviour being observed it should be stated that if bats, or evidence of bats (see Figure 6.1), is found at any stage during work schedule, then as a legal requirement the work at the site should immediately cease and a Bat licenced ecologist should be contacted for further advice.
