## LIVERPOOL FC ACADEMY PHASE 2 GROUND INVESTIGATION REPORT

**Curtins Ref: 088269-CUR-XX-XX-T-GE-00005**

Client Name: Liverpool FC

Site Address: Liverpool FC Academy, The Liverpool Way, Liverpool, L33 7ED

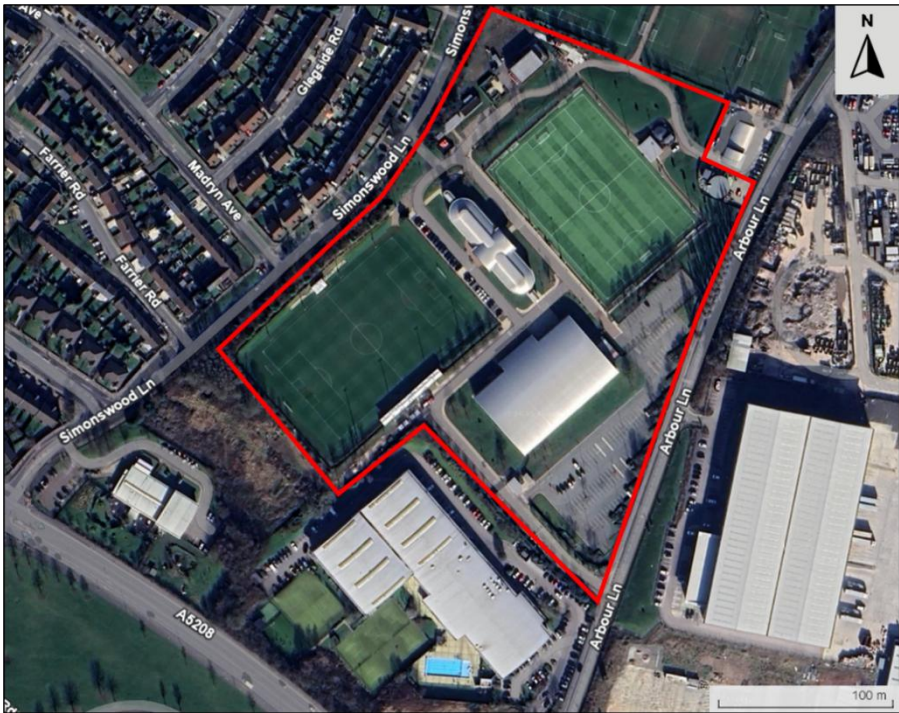
Figure 1 – Site Location Plan (site boundary shown in Red)

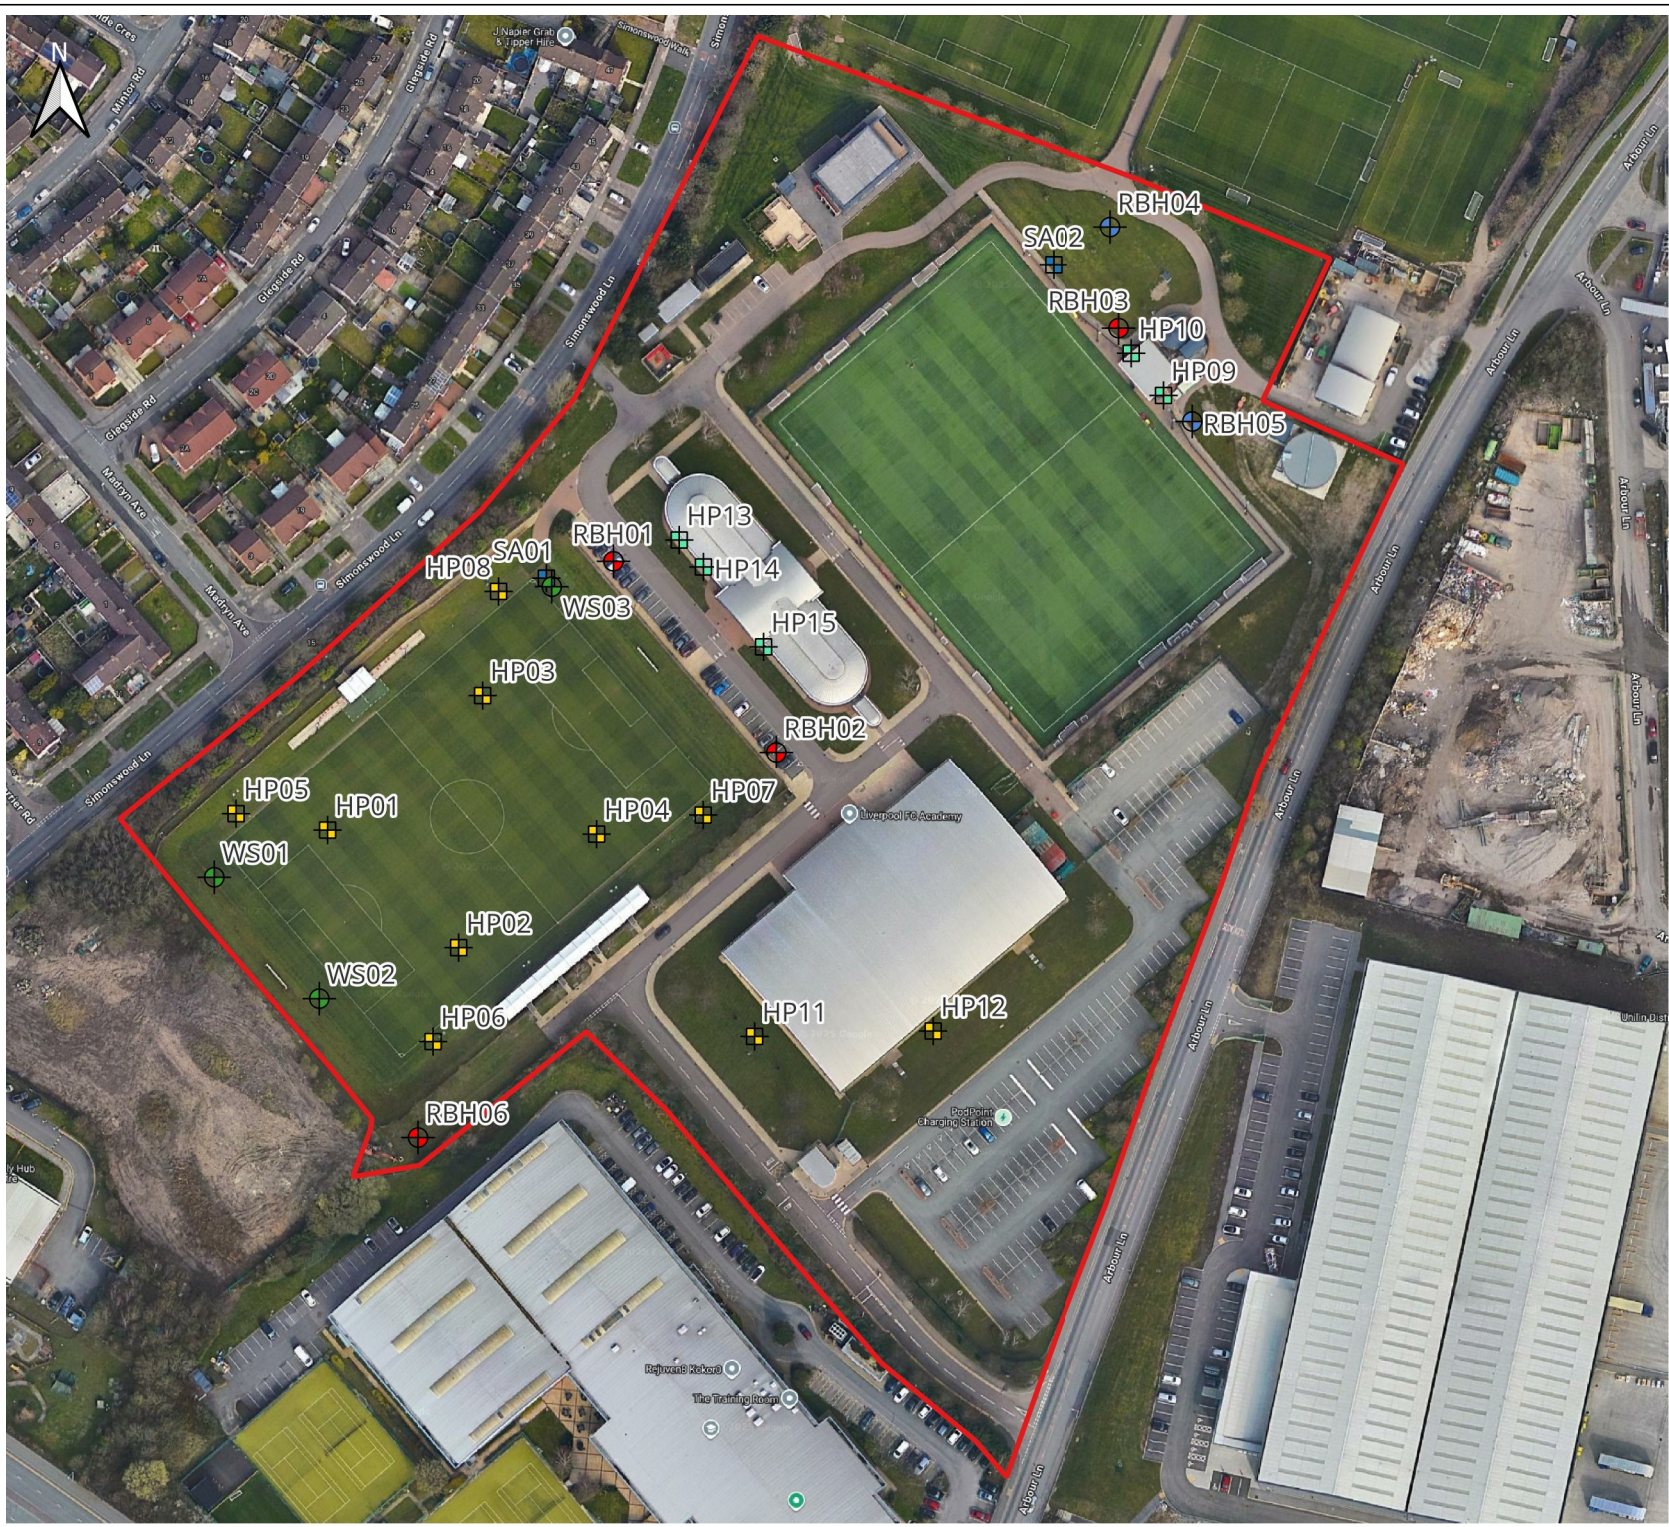
**Exploratory Holes**

- Hand Pit
- Foundation Pit
- Soak Away Trial Pit
- Dynamic Sample Borehole
- Rotary Cored Borehole
- Window Sample Borehole
- Red line boundary

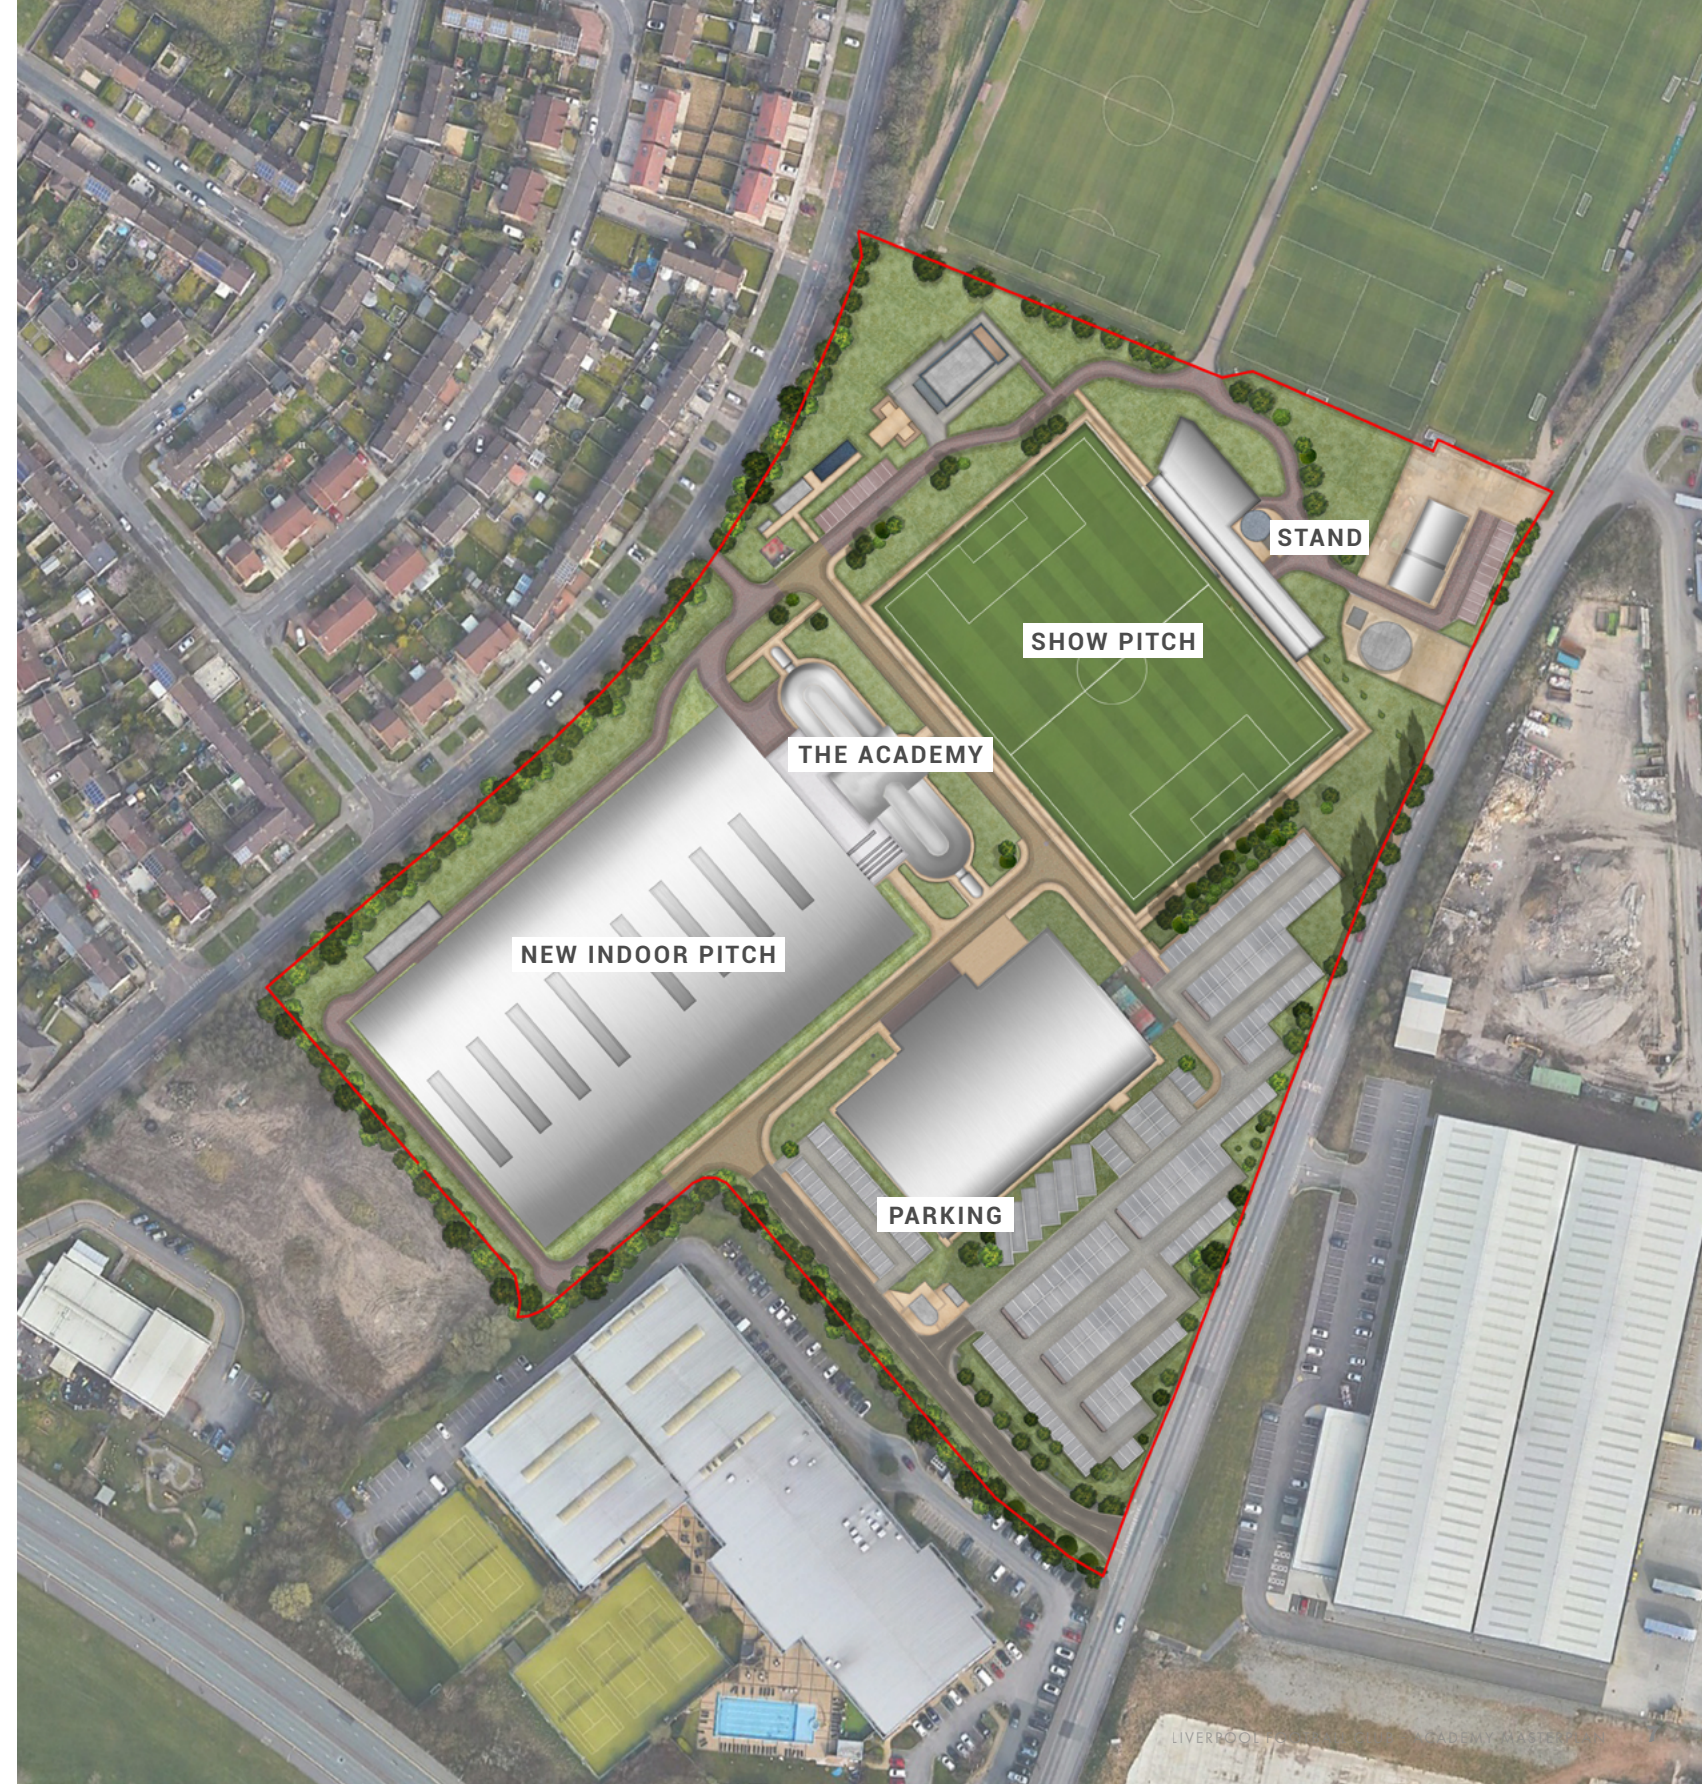
- Extending and refurbishing the academy building
- A new full-size artificial indoor pitch
- A new full-size show pitch
- A 499 (maximum) seat spectator stand and associated accommodation such as changing rooms, officials rooms and spectator facilities.
- Replacement of lost parking spaces and some additional parking spaces with coach and mini-bus parking.
- Landscaping, pitch access, and replacement trees.

— SITE BOUNDARY
