## BS5837 Tree Survey, Arboricultural Impact Assessment & Method Statement

**Site:** Old Sports Hall off Land at The Orchard Huyton  
L36 5SU

**Ref:** 19115/A2\_AIA AMS rev A

Drawing Number  
19115/TPP/01

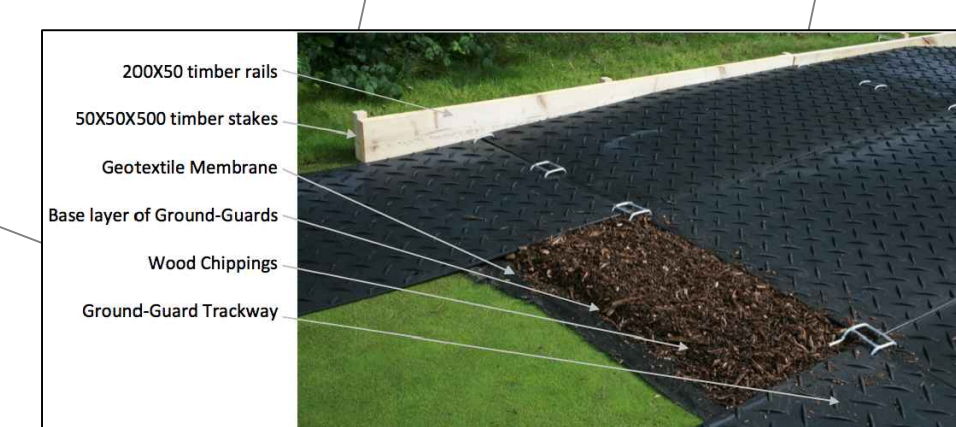
Figure 3. - Scaffolding within the RPA

- 4.3 It is anticipated that the working distance required (Scaffolding, access etc) for construction of the proposal will incur into the RPA's of T1, T2, and T8. Ground protection will be required in these areas as denoted (in brown) in the plan 19115/TPP/01 rev A. It is intended to use ground protection and scaffolding compliant with BS5837 in these areas
