# **ARBORICULTURAL IMPACT ASSESSMENT**

Woodlands, Lodge Lane, Widnes

Ref: 21/00064/AIA  
Author: Jonathan Henderson  
Qualifications: B.Sc Hons, TechArborA

## Arboricultural Impact Assessment – Woodlands, Lodge Lane, Widnes

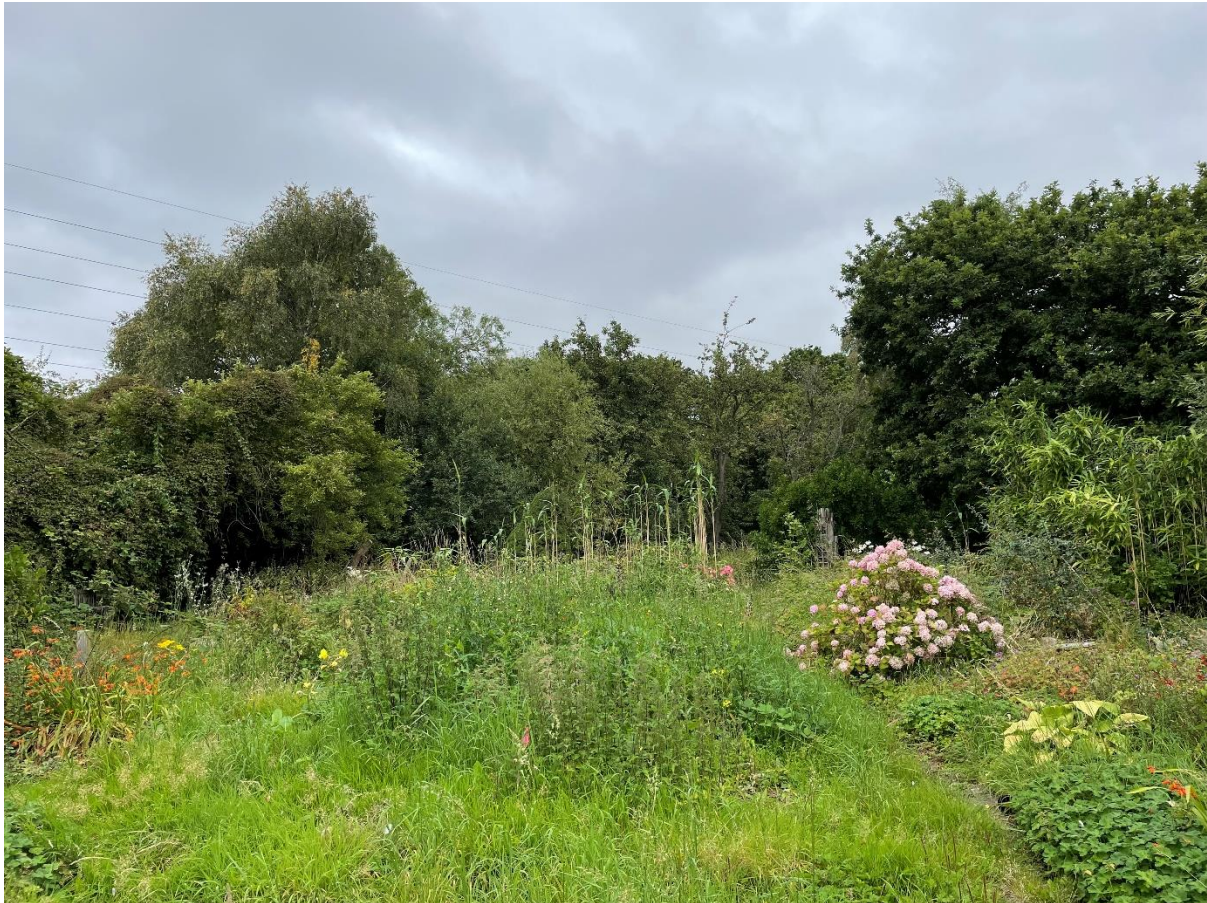
A northern view of the site showing G3 (Left), G5 (Central) and part of G6 (Right).
