**DESK TOP STUDY**

**SANDY BROW LANE, KNOWSLEY**

**BALANCE POWER**

August 2023

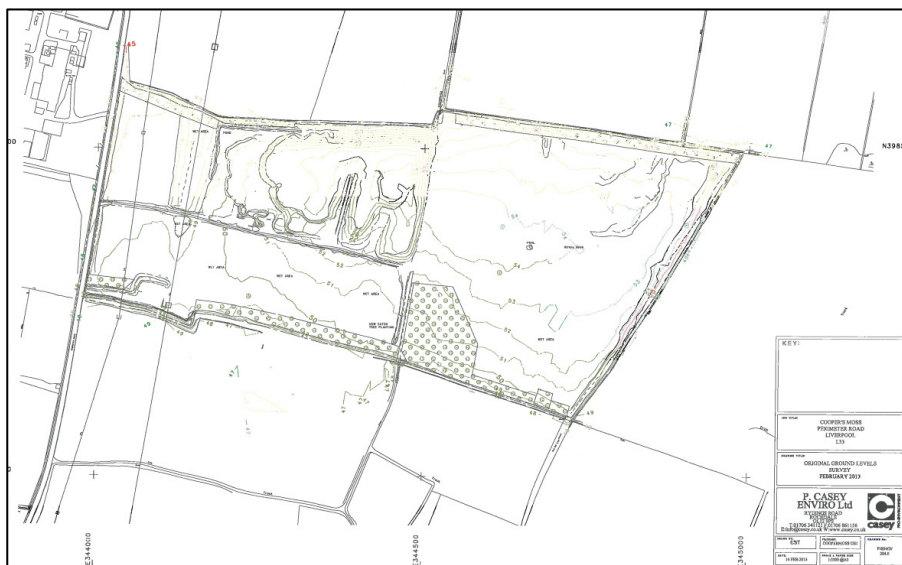
*Extract 2.1: Topographical Survey*

A topographic survey for the site has been produced, extract below. Site levels vary between 48-54mAOD although in the north-west portion, where waste was deposited, ground levels are up to 59mAOD. In general there is a relatively steep peripheral slope to the northern, eastern and southern boundaries and thereafter gradients are quite shallow. There is a 2m deep valley feature trending south to north across the north-western part of the site.

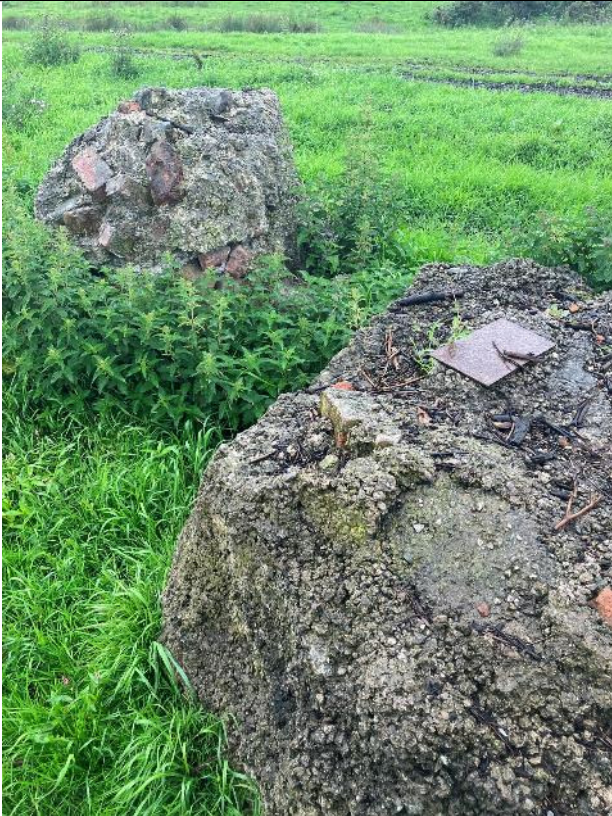
| Photo No. | Date | |
|---|---|---|
| 8 | 18 July 2023 | |

| Photo No. | Date | |
|---|---|---|
| Evidence of historical on site structures. | | |

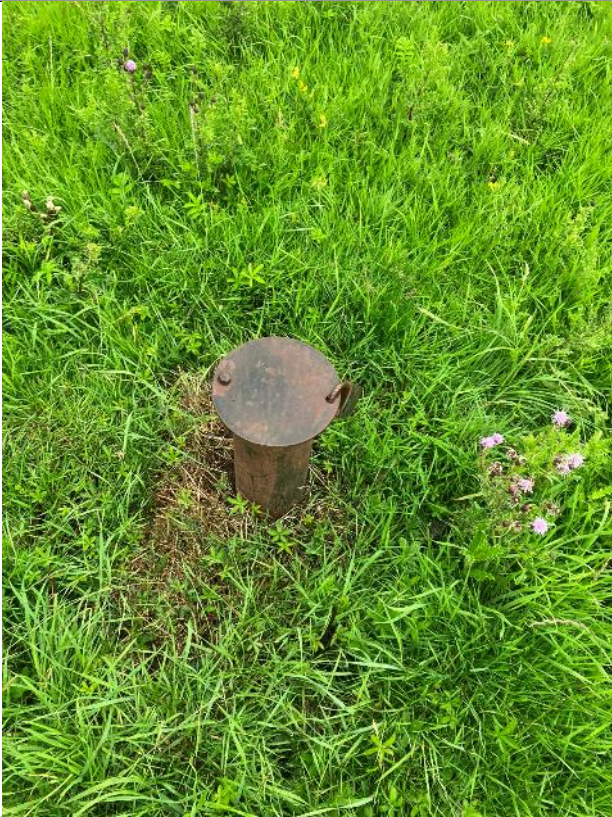
| Photo No. | Date | |
|---|---|---|
| 9 | 18 July 2023 | |

| Photo No. | Date | |
|---|---|---|
| On-site monitoring well. | | |

2no. monitoring wells with locked upright covers were noted in the centre of the site, one of which was located within the raised area.

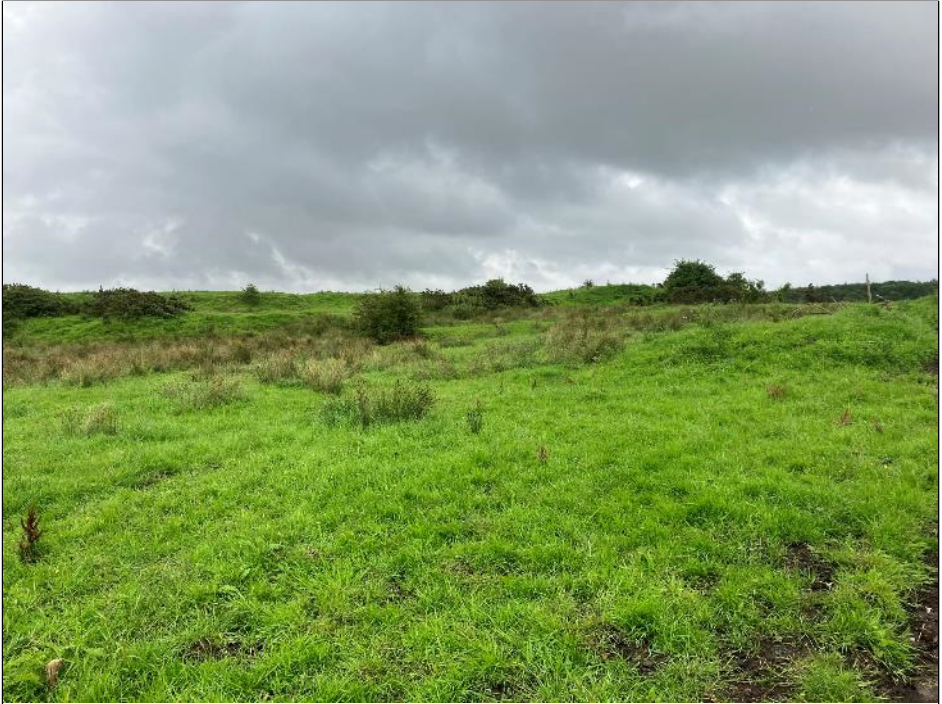
| Photo No. | Date | |
|---|---|---|
| 13 | 18 July 2023 | |

| Photo No. | Date | |
|---|---|---|
| View of the illegally deposited waste. | | |
