# PHASE II GEOENVIRONMENTAL SITE ASSESSMENT

| Site: | Glen Dimplex, Prescot |
| References: | 17-500-R2-1 |
| Client: | Glen Dimplex Home Appliances Ltd |

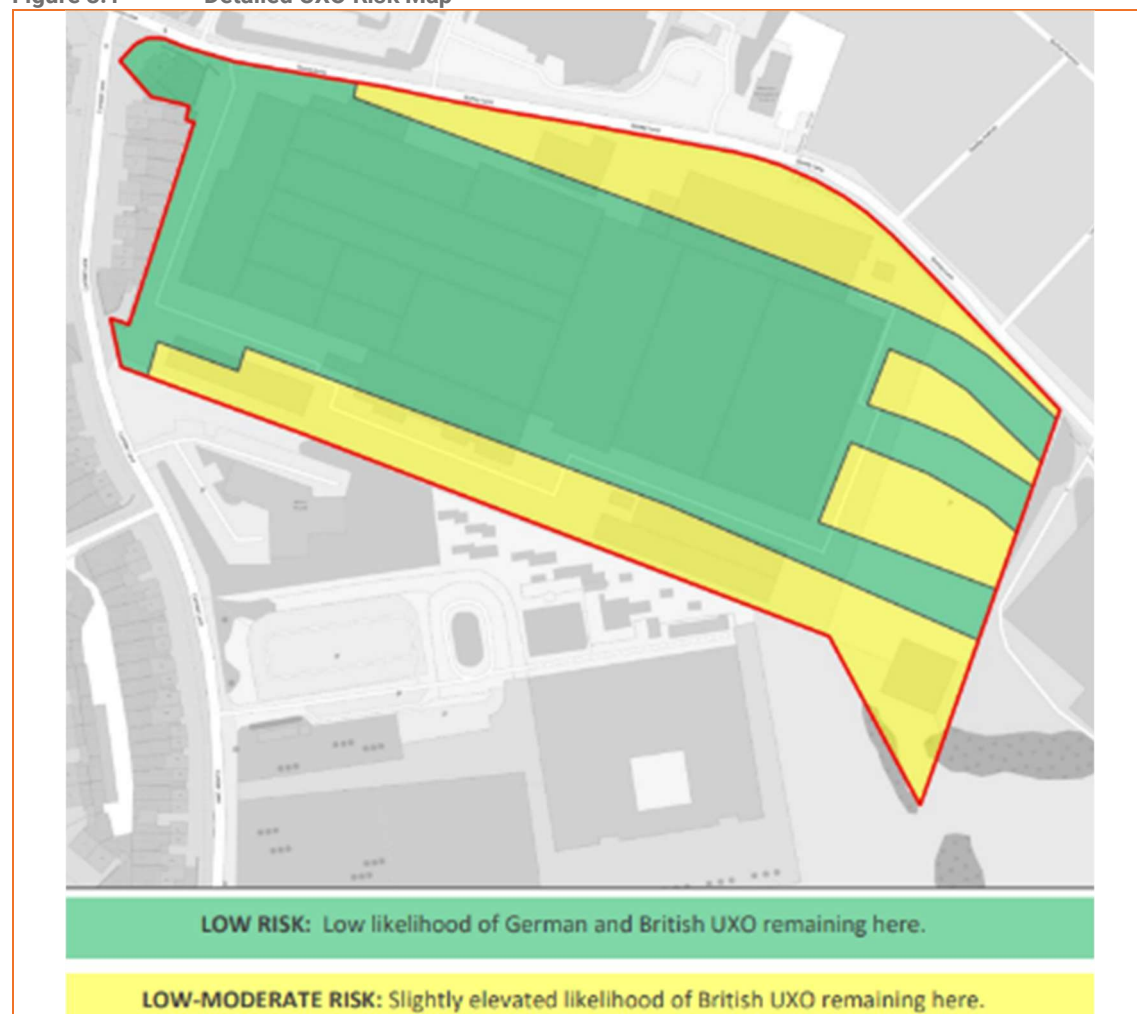
Figure 3.1 Detailed UXO Risk Map

- ✳ The site is assessed as containing a Low risk from German UXB and a Low to Moderate Risk from Allied UXO. The areas surrounding the factory structure are noted to contain a higher moderate risk of British UXO, however these are noted to be likely present within the upper shallow 2.00 m bgl of ground deposits if present.

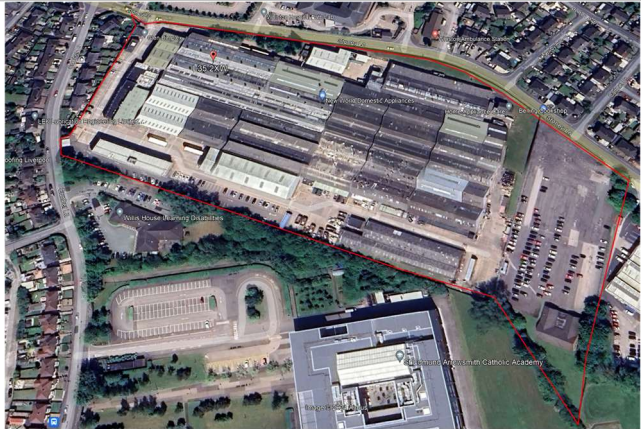
| FEATURE | DESCRIPTION | PHOTOGRAPHIC EVIDENCE |
|---|---|---|
| Occupancy/Use | <p>The site is an irregularly shaped parcel of land situated to the south of Stoney Lane in Rainhill, Prescott. The site is formerly occupied by the Glen Dimplex Home Appliances manufacturing factory, which predominantly comprises a large factory structure with associated smaller buildings and infrastructure, including a gas governor to the north and two electricity substations to the west and south. Surrounding the main factory structure, a service road is present to the south and the west, connecting to Stoney Lane at the north.</p> <p>Whilst the site was active, the main factory structure was internally segmented into multiple smaller subsections pertaining to various elements of the manufacturing process. The area highlighted in blue pertains to the assembly area including freestanding, with area to the right highlighted in red pertaining to the press/technology area. Both the enamel area (purple) and paint shop (pink) noted all machinery remained in-situ and had not yet been deconstructed. Access was not granted into the Polystyrene Plant (yellow) or Aluminum Shop (Grey) at the time of investigation.</p> <p>An area of hard standing car parking is also noted at the east of the site. At the time of the internal investigation, all site activities have ceased with only security personnel remaining permanently on-site.</p> | |

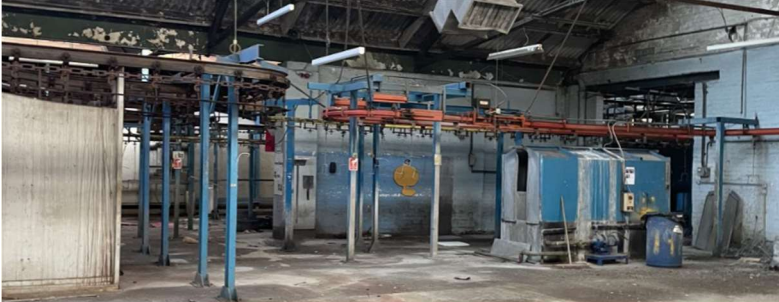
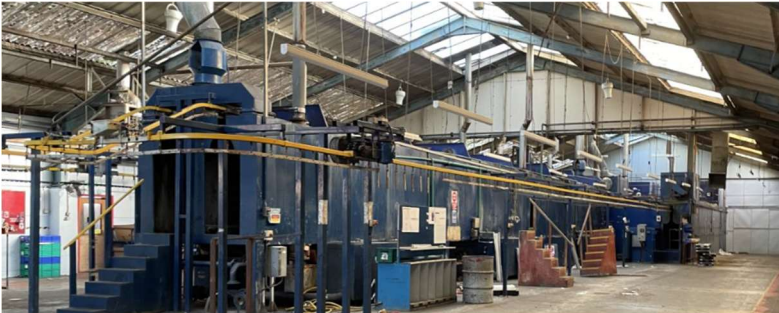
| FEATURE | DESCRIPTION | PHOTOGRAPHIC EVIDENCE |
|---|---|---|
| <b>Relict Machines</b><br><i>Continued...</i> | <p>Machinery associated with the construction of equipment, paint and lacquering, cleaning and priming, and subsequent movement were identified through the factory. Scarring surrounding the structures indicated below ground infrastructure are likely present. Above ground infrastructure including vents to outside the factory were still present connected to the machinery.</p> <p>Free standing machinery was present in the Strut/Robot area in the far eastern part of site, and compressors remained towards the centre of the factory, however, these were not operational at the time of the walkover.</p> | <br> |

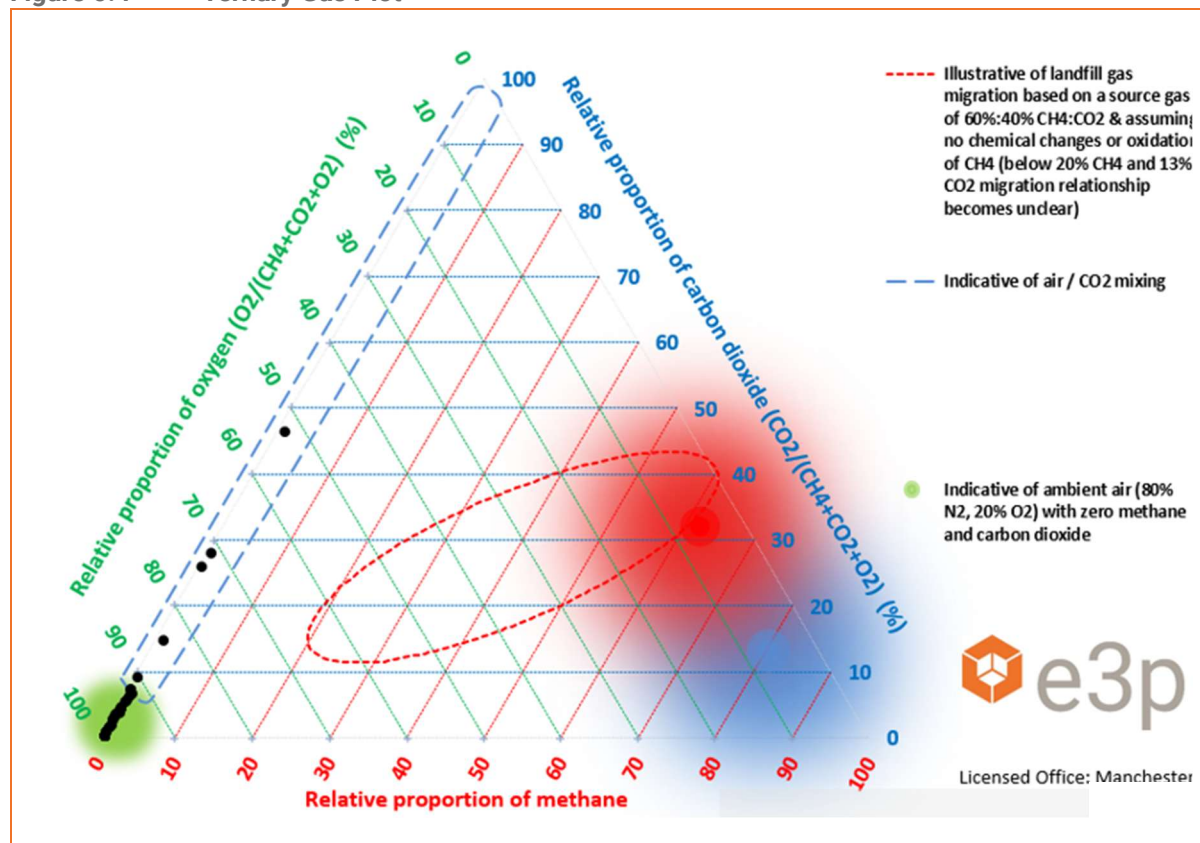
Figure 6.4 Ternary Gas Plot

The ternary gas plot indicates the majority of the ground gas monitoring results have standard oxygen and generally low carbon dioxide concentrations with limited occasions of carbon dioxide concentrations above 5%, and no elevated methane, which is indicative of natural sources (green area on the ternary plot).

On three occasions within WS103, WS105 and WS107, elevated carbon dioxide and partially depleted oxygen were recorded, which could indicate organic material, Made Ground or organic contamination undergoing anaerobic degradation.

Figure 6.4 shows the ternary gas plot for the gas monitoring data.

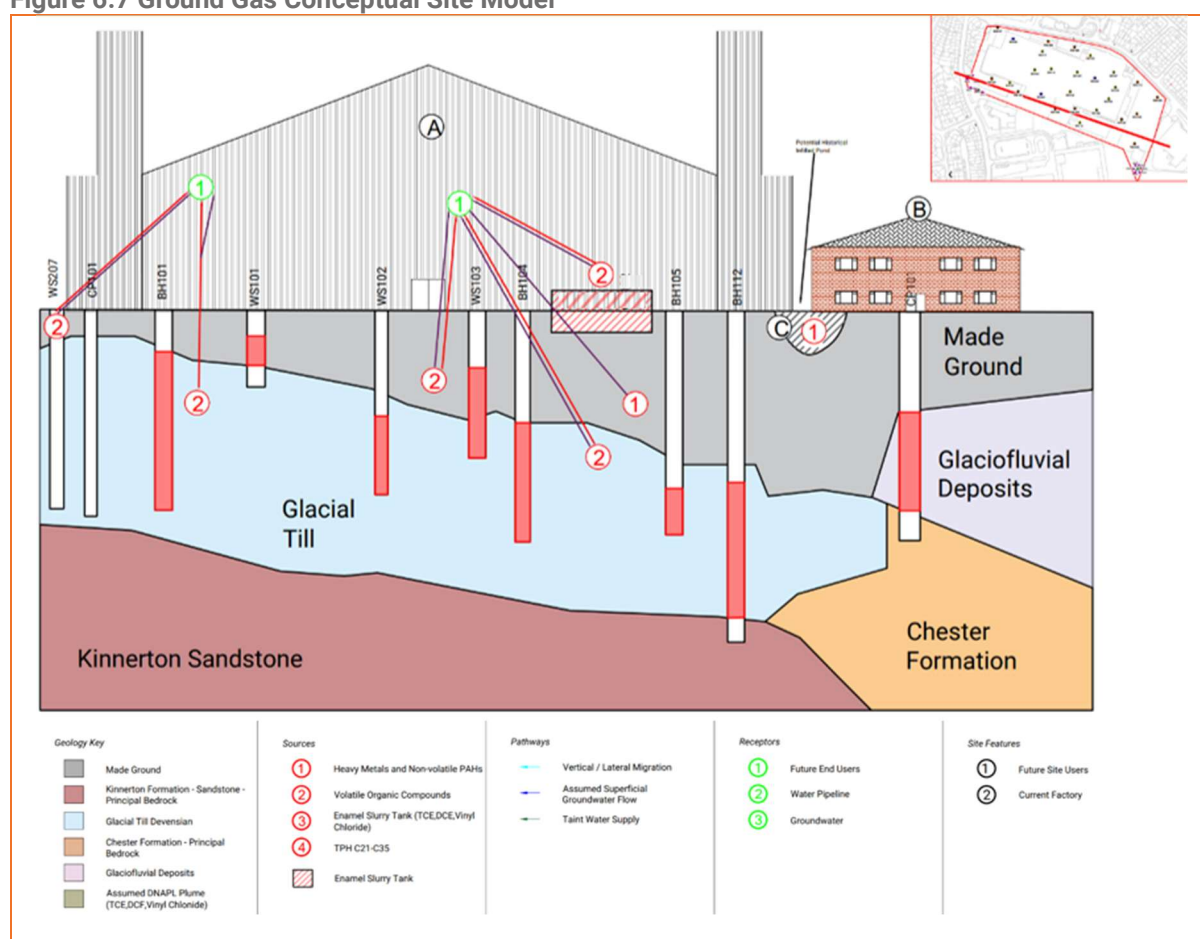
**Figure 6.7 Ground Gas Conceptual Site Model**

A Gas Protection Design Report (GPDR) will be required to be read in conjunction with this report. This is suggested to be completed following a full assessment of ground gas monitoring data to ensure a representative assessment can be achieved.

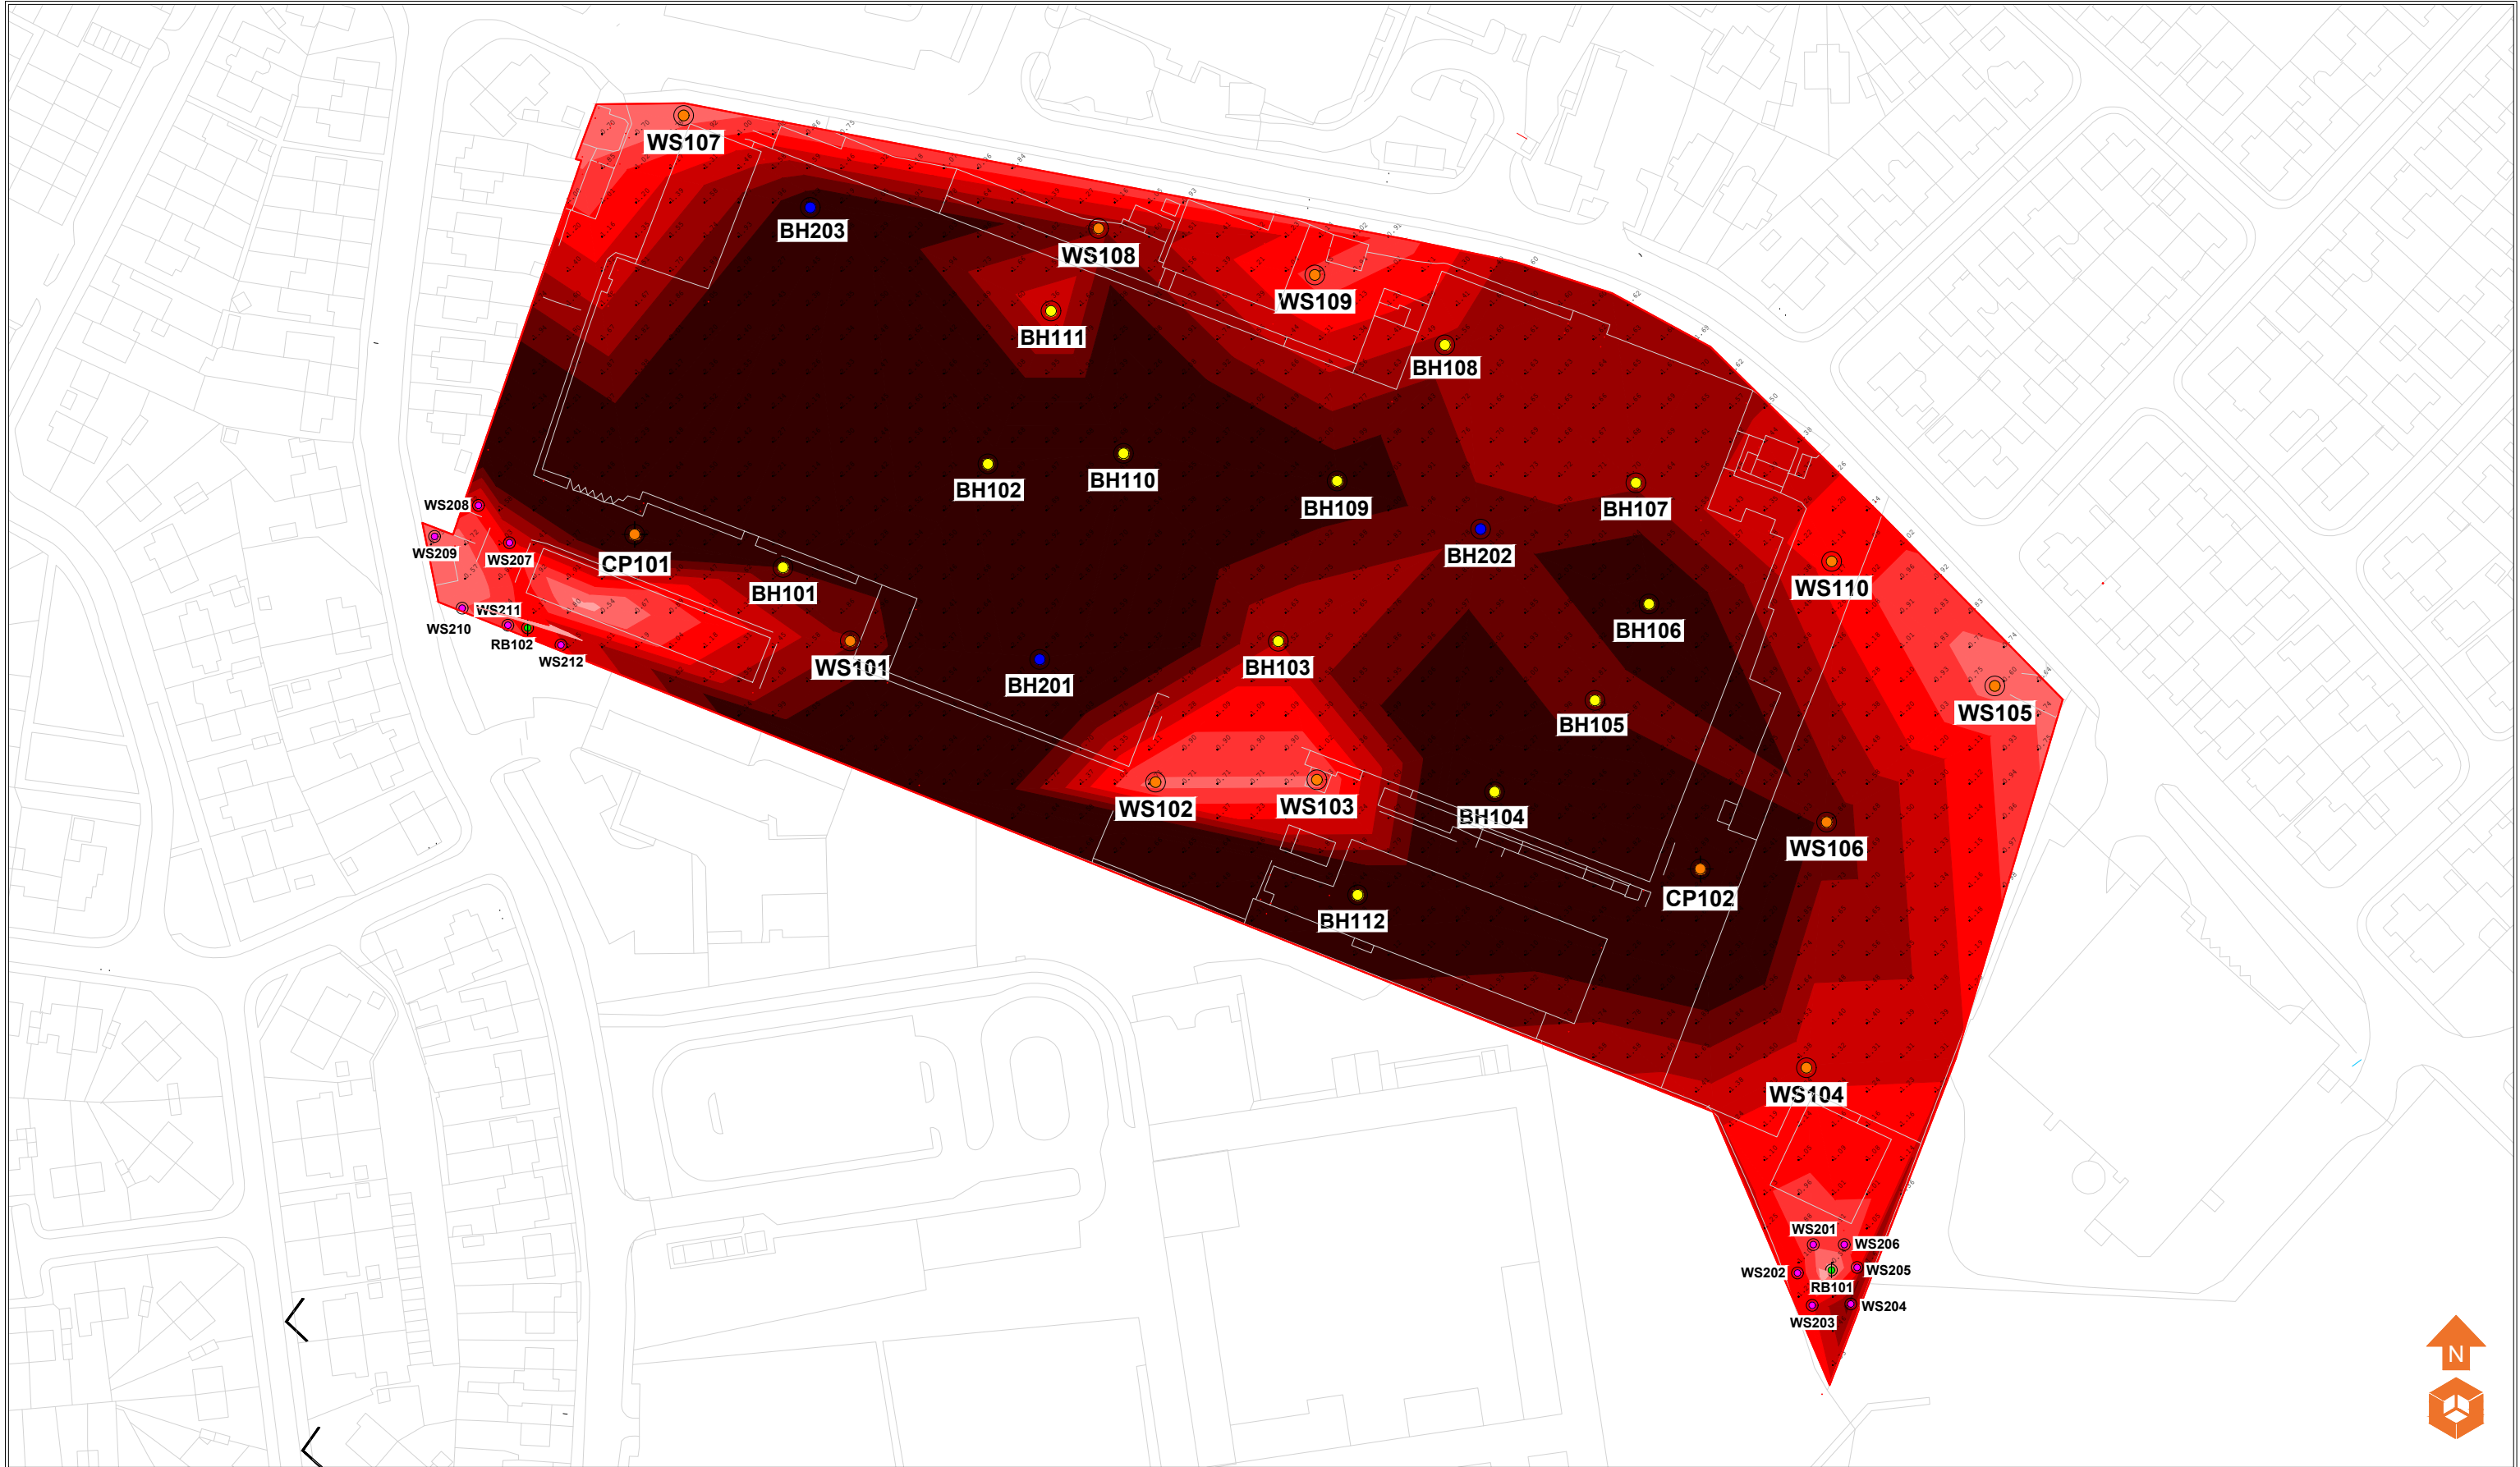
- Made Ground Depth (m)**
- Depth of Made Ground 0.50 - 0.74m
  - Depth of Made Ground 0.75 - 0.99m
  - Depth of Made Ground 1.00 - 1.24m
  - Depth of Made Ground 1.25 - 1.49m
  - Depth of Made Ground 1.50 - 1.74m
  - Depth of Made Ground 1.75 - 1.99m
  - Depth of Made Ground >2.00m

Made Ground deposits were generally noted to be deeper within the southernmost boreholes, including BH201, BH102, BH104, and BH112, which were noted to extend from ground level to between 2.00–3.00 m bgl.

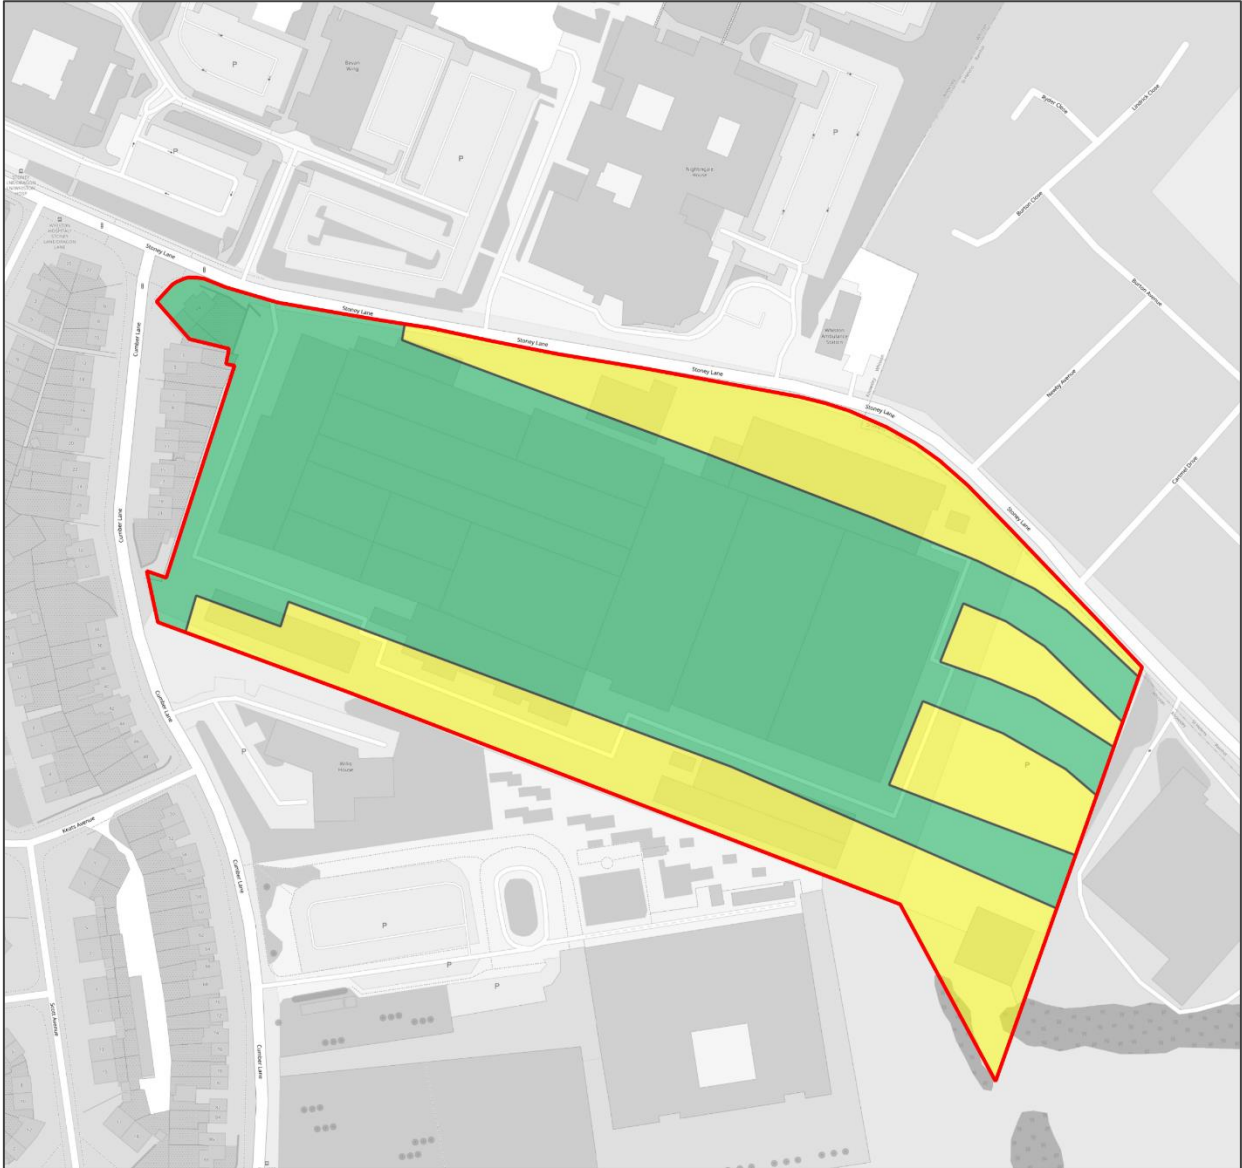
**Risk Map**

**LOW RISK:** Low likelihood of German and British UXO remaining here.

**LOW-MODERATE RISK:** Slightly elevated likelihood of British UXO remaining here.

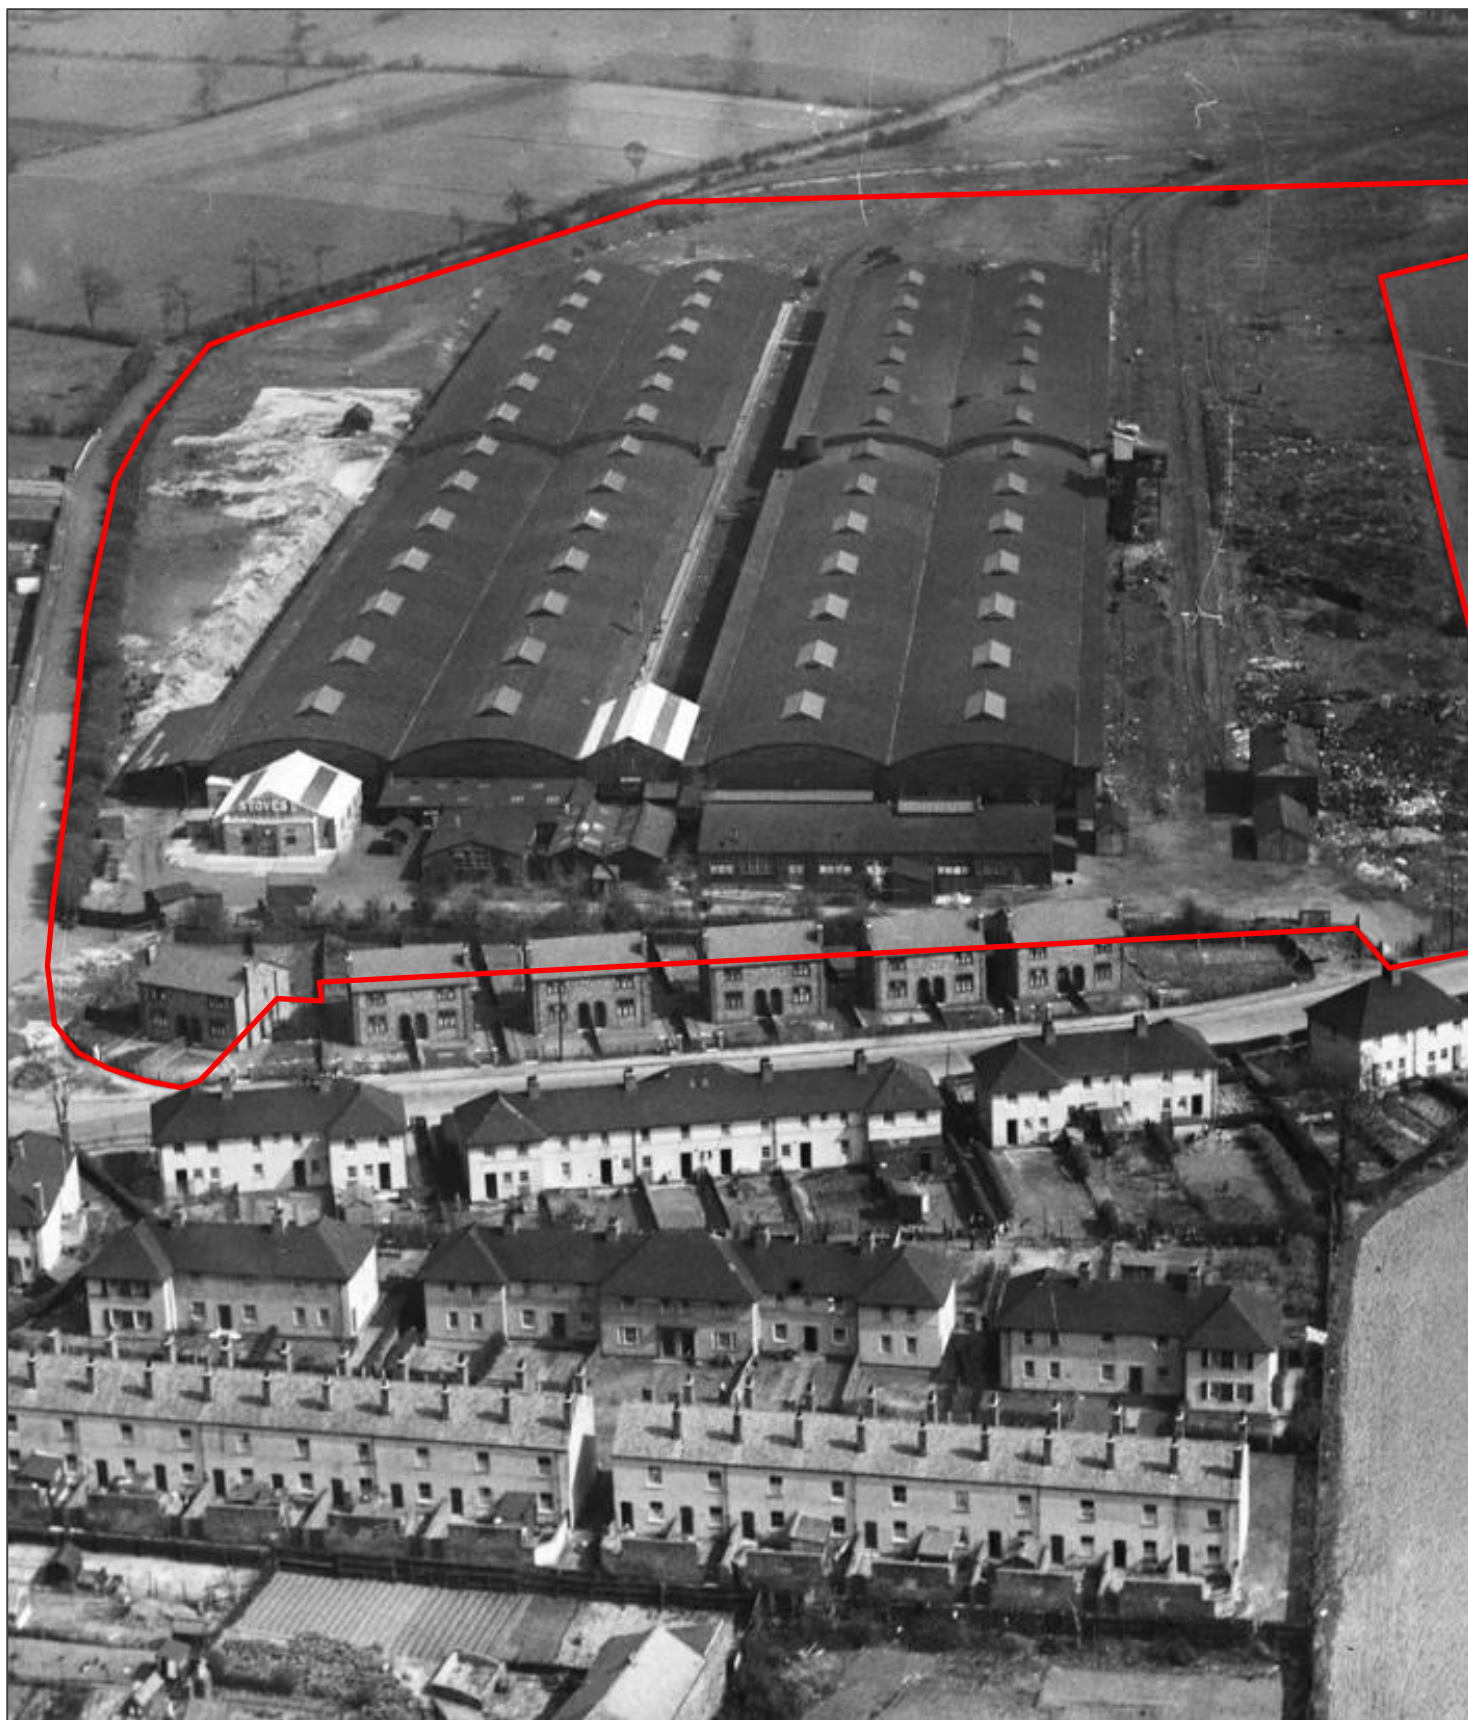
FIGURE: 5.1

| Period | Photo Date | Review |
|---|---|---|
| Pre-WWII | 28 <sup>th</sup> April 1935 | <b>FIGURE 5.1:</b> This oblique image, taken in the inter-war period, displays the majority of the Site from the north-west.<br>The composition of the Site matches that displayed in pre-WWII OS mapping, with the large industrial structures occupying a majority of the Site, along railway lines and peripheral areas of open, undeveloped ground.<br>The areas of open ground do not appear to have an obvious purpose and appear to be poorly maintained. |

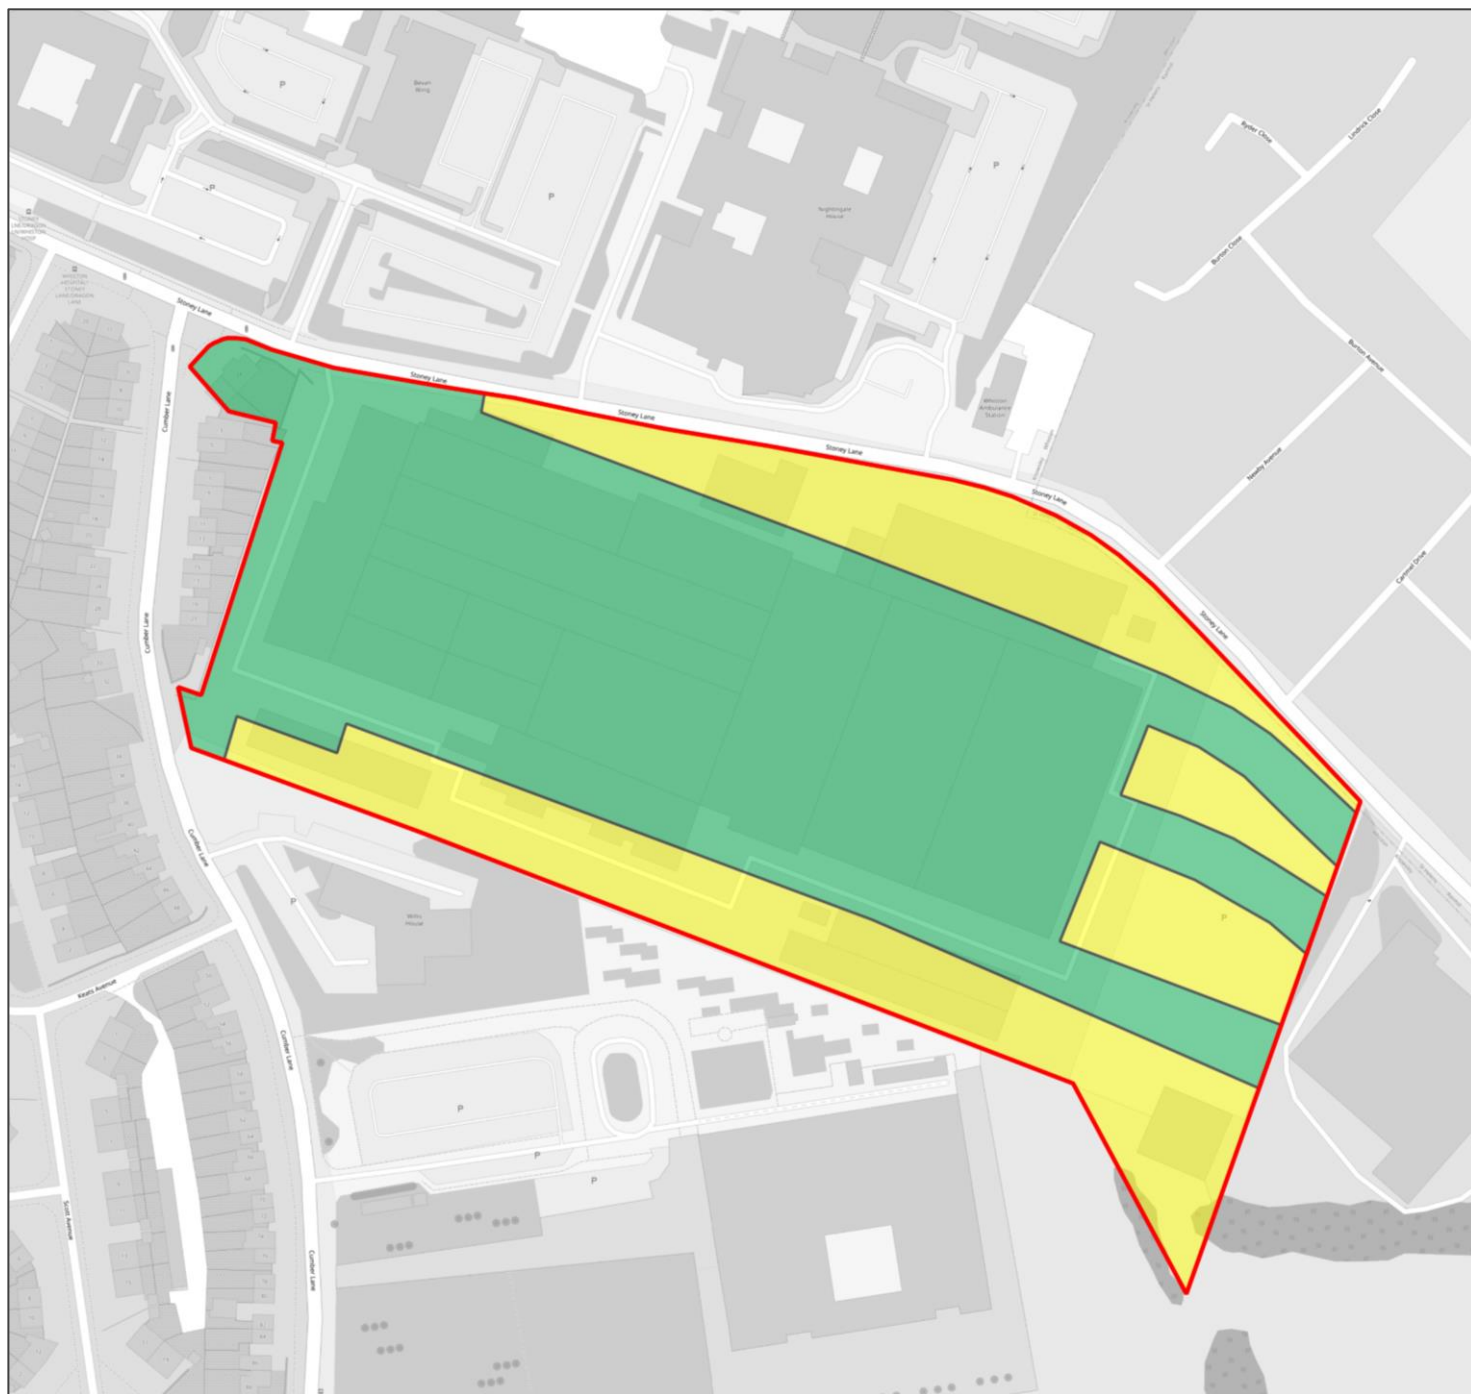
FIGURE: 7.1

**LOW RISK:** Low likelihood of German and British UXO remaining here.

**LOW-MODERATE RISK:** Slightly elevated likelihood of British UXO remaining here.

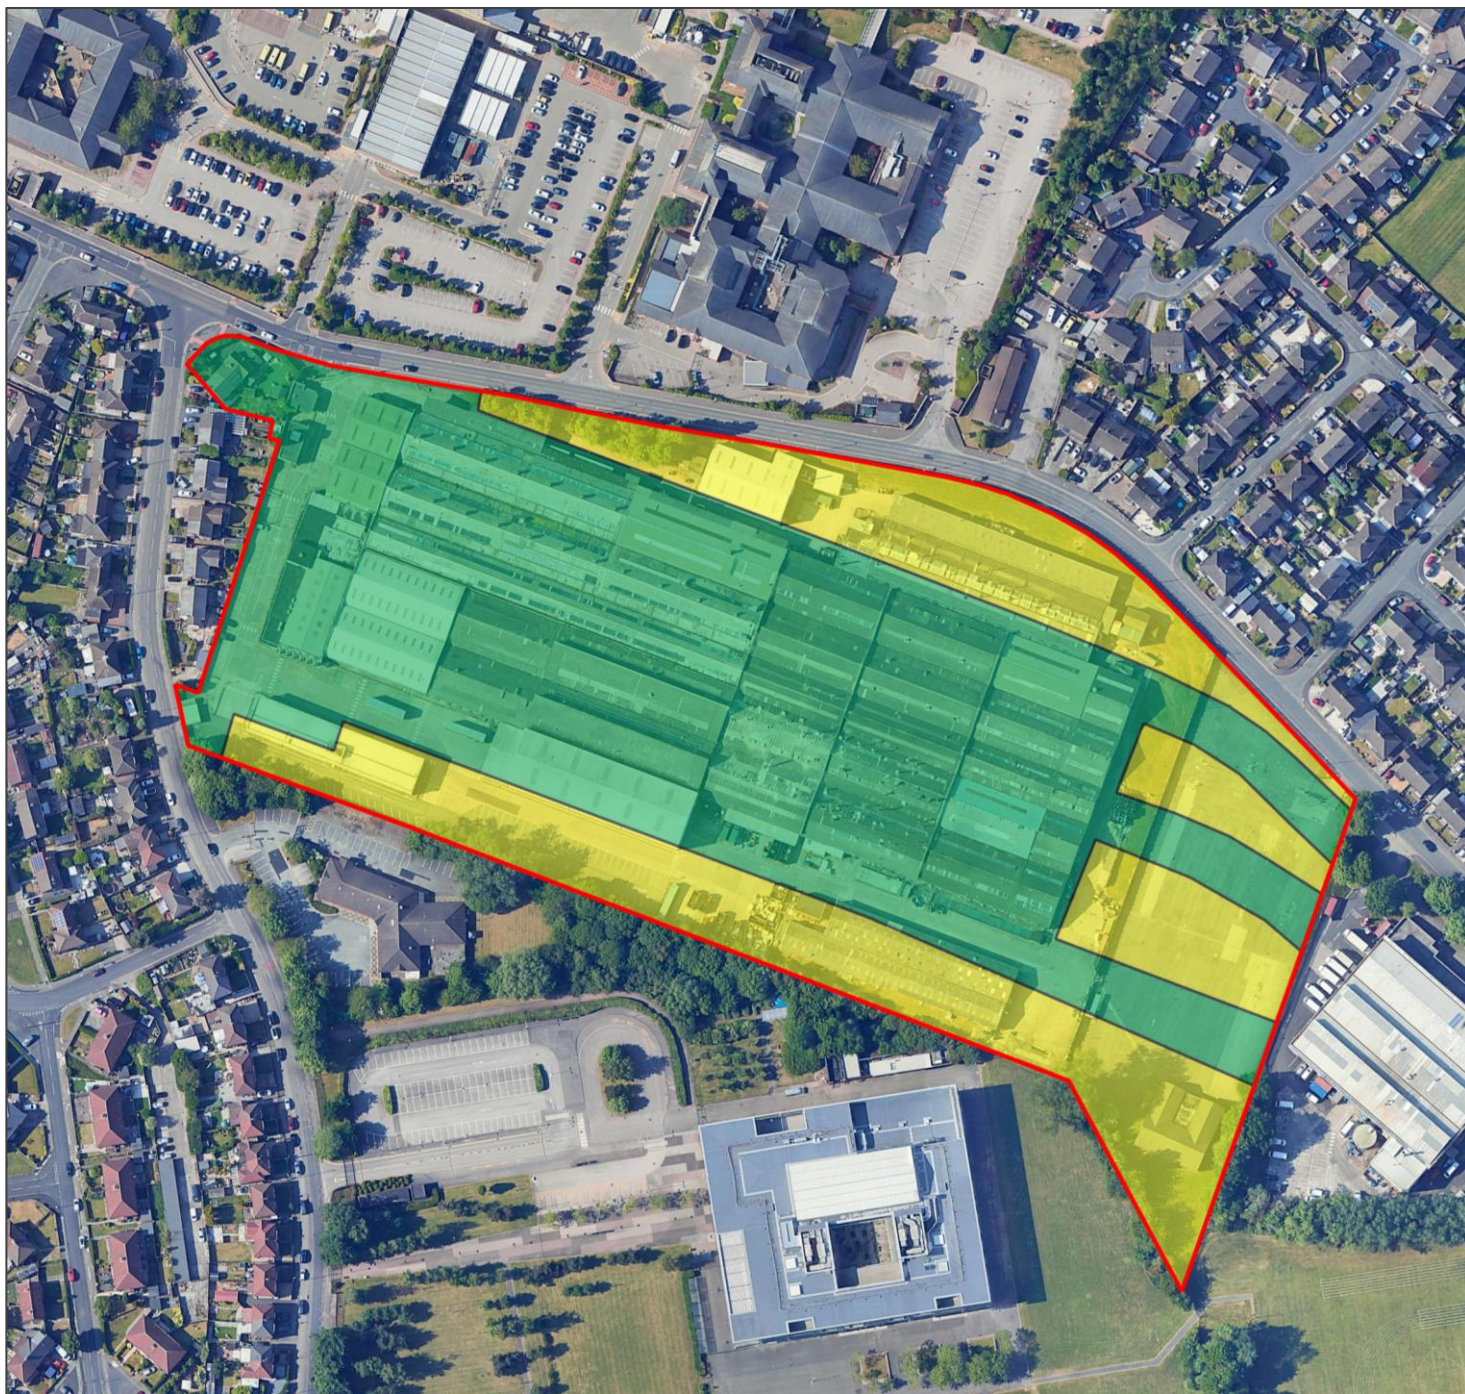
FIGURE: 7.2

**LOW RISK:** Low likelihood of German and British UXO remaining here.

**LOW-MODERATE RISK:** Slightly elevated likelihood of British UXO remaining here.
