# ARBORICULTURAL IMPLICATIONS ASSESSMENT

PROPOSED DEVELOPMENT

THE POOLHOUSE  
FLUKERS BROOK LANE  
KNOWSLEY

Author: C. Salisbury  
Date: 3 April 2023  
Ref: TRE/TPFBLK

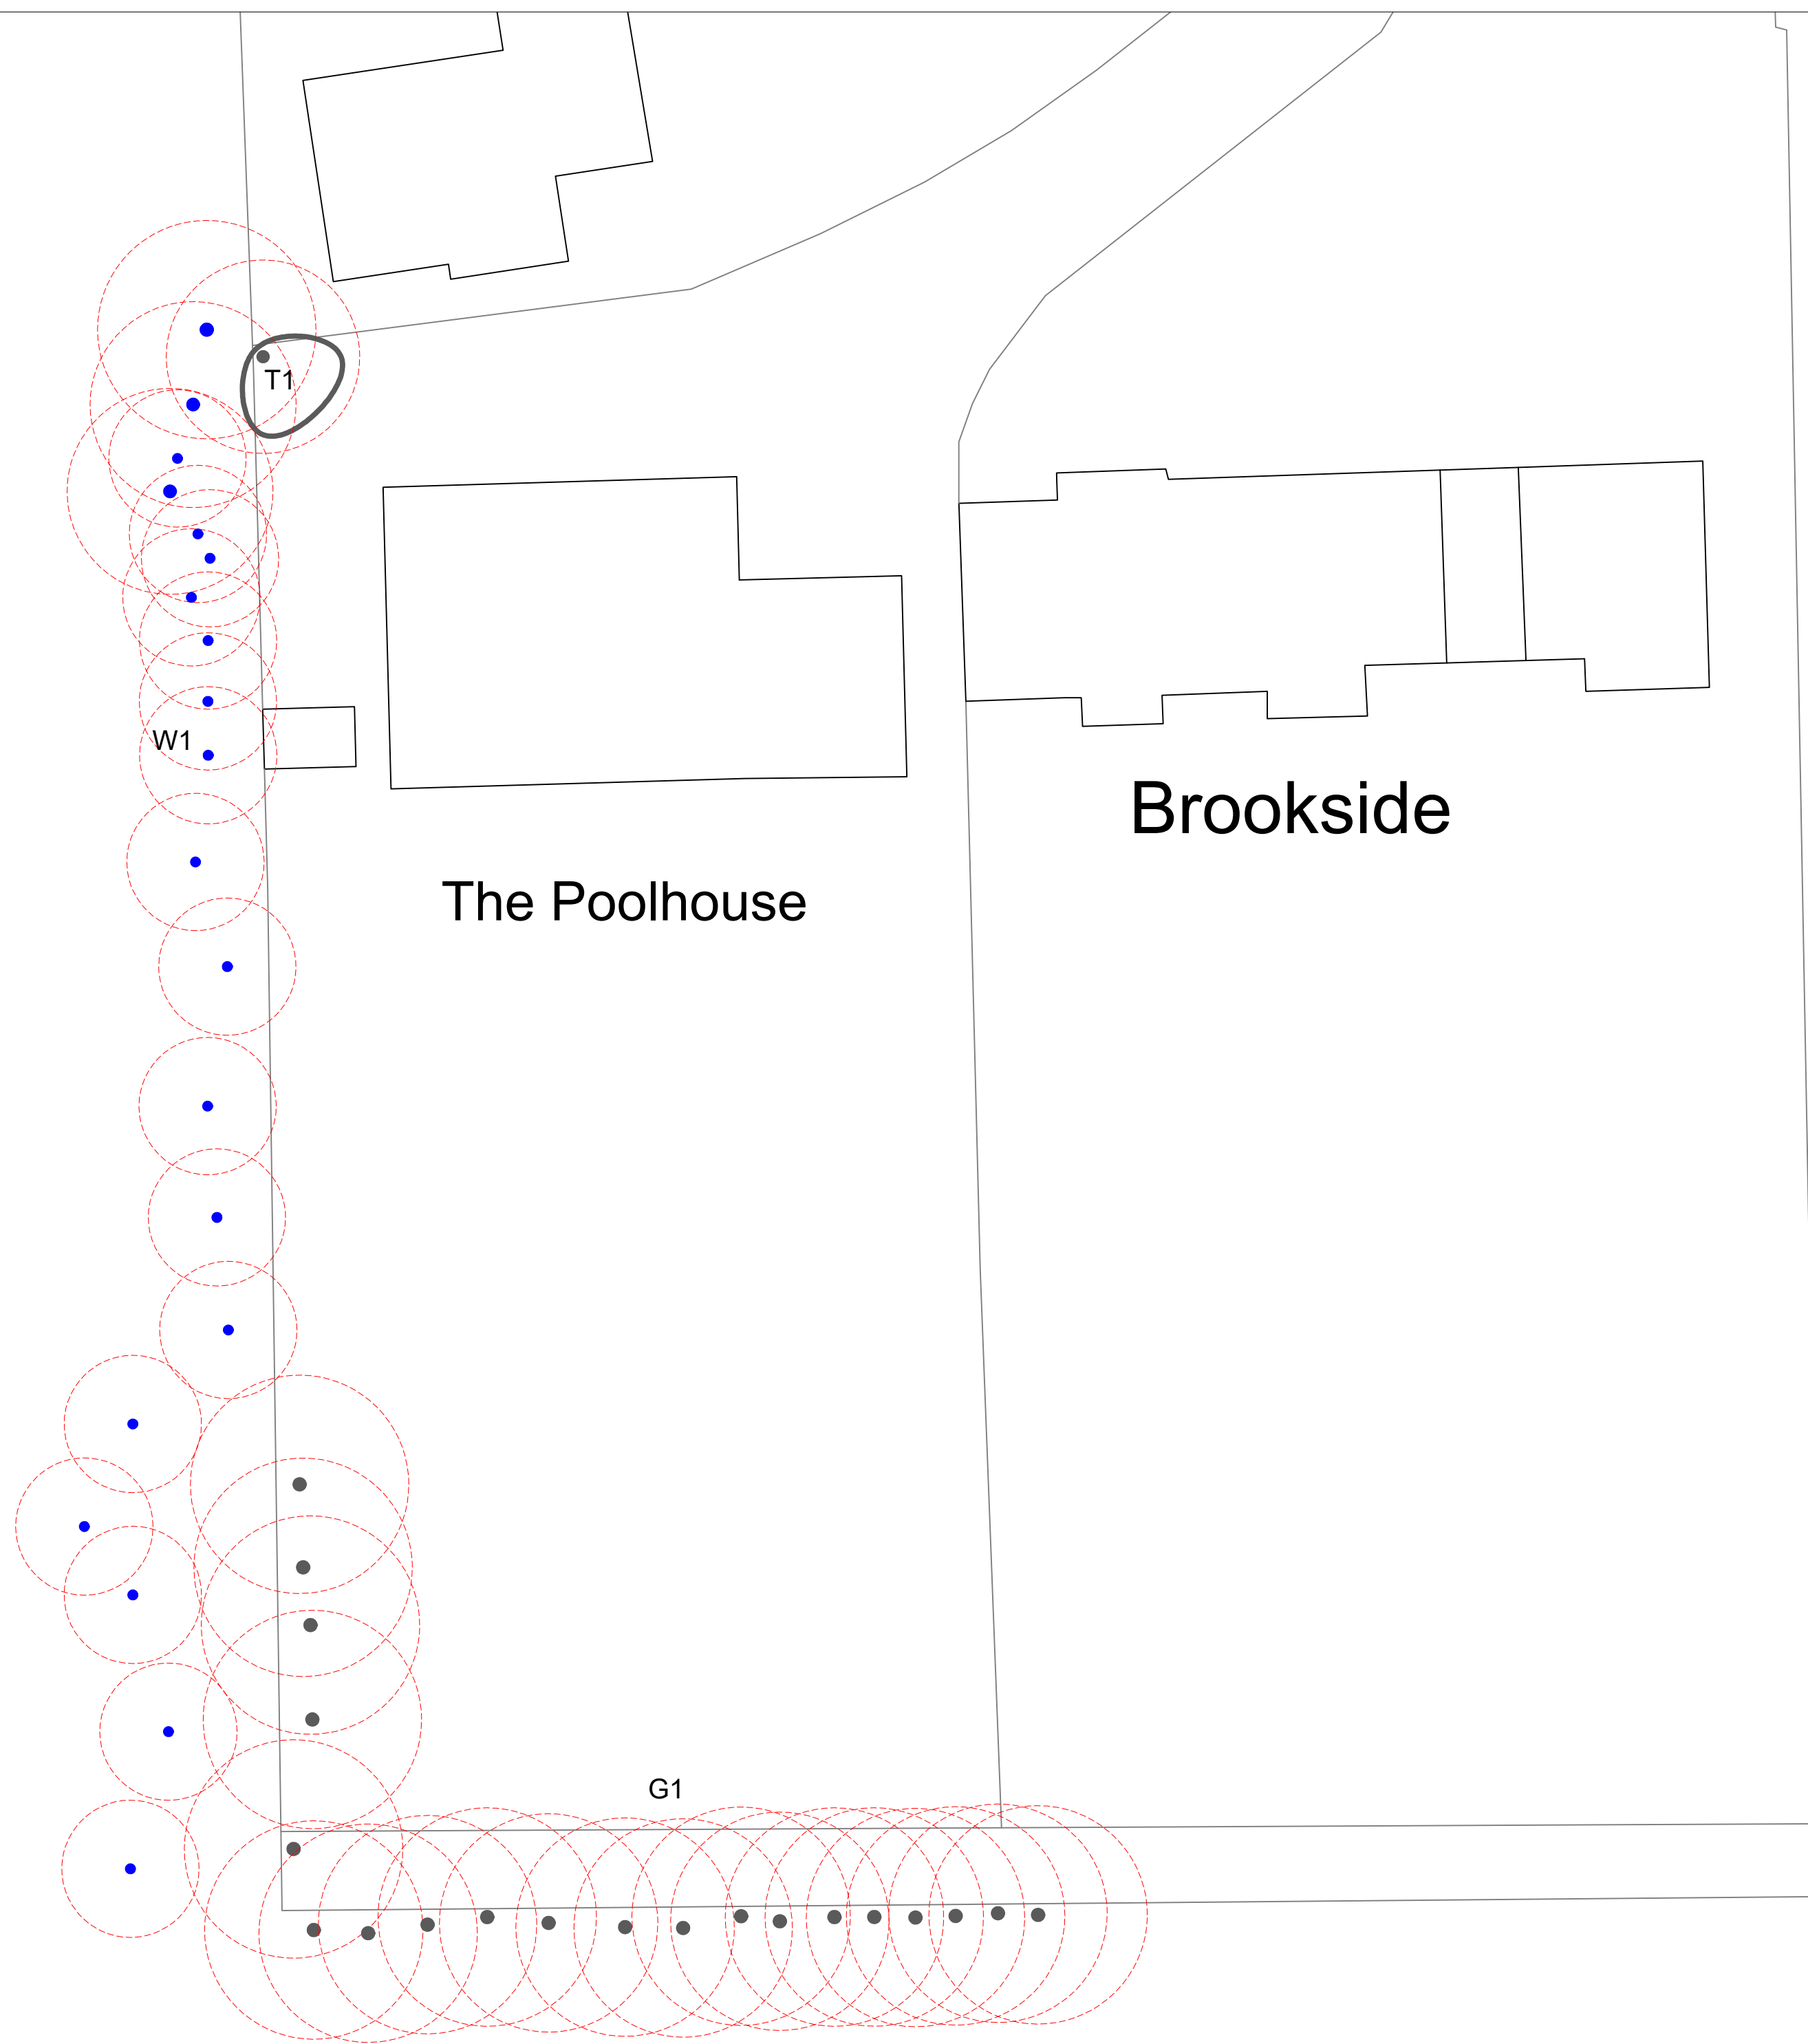
Drawing Title:  
BS5837 Plan

Drawing No:  
TPFBL/BS/01

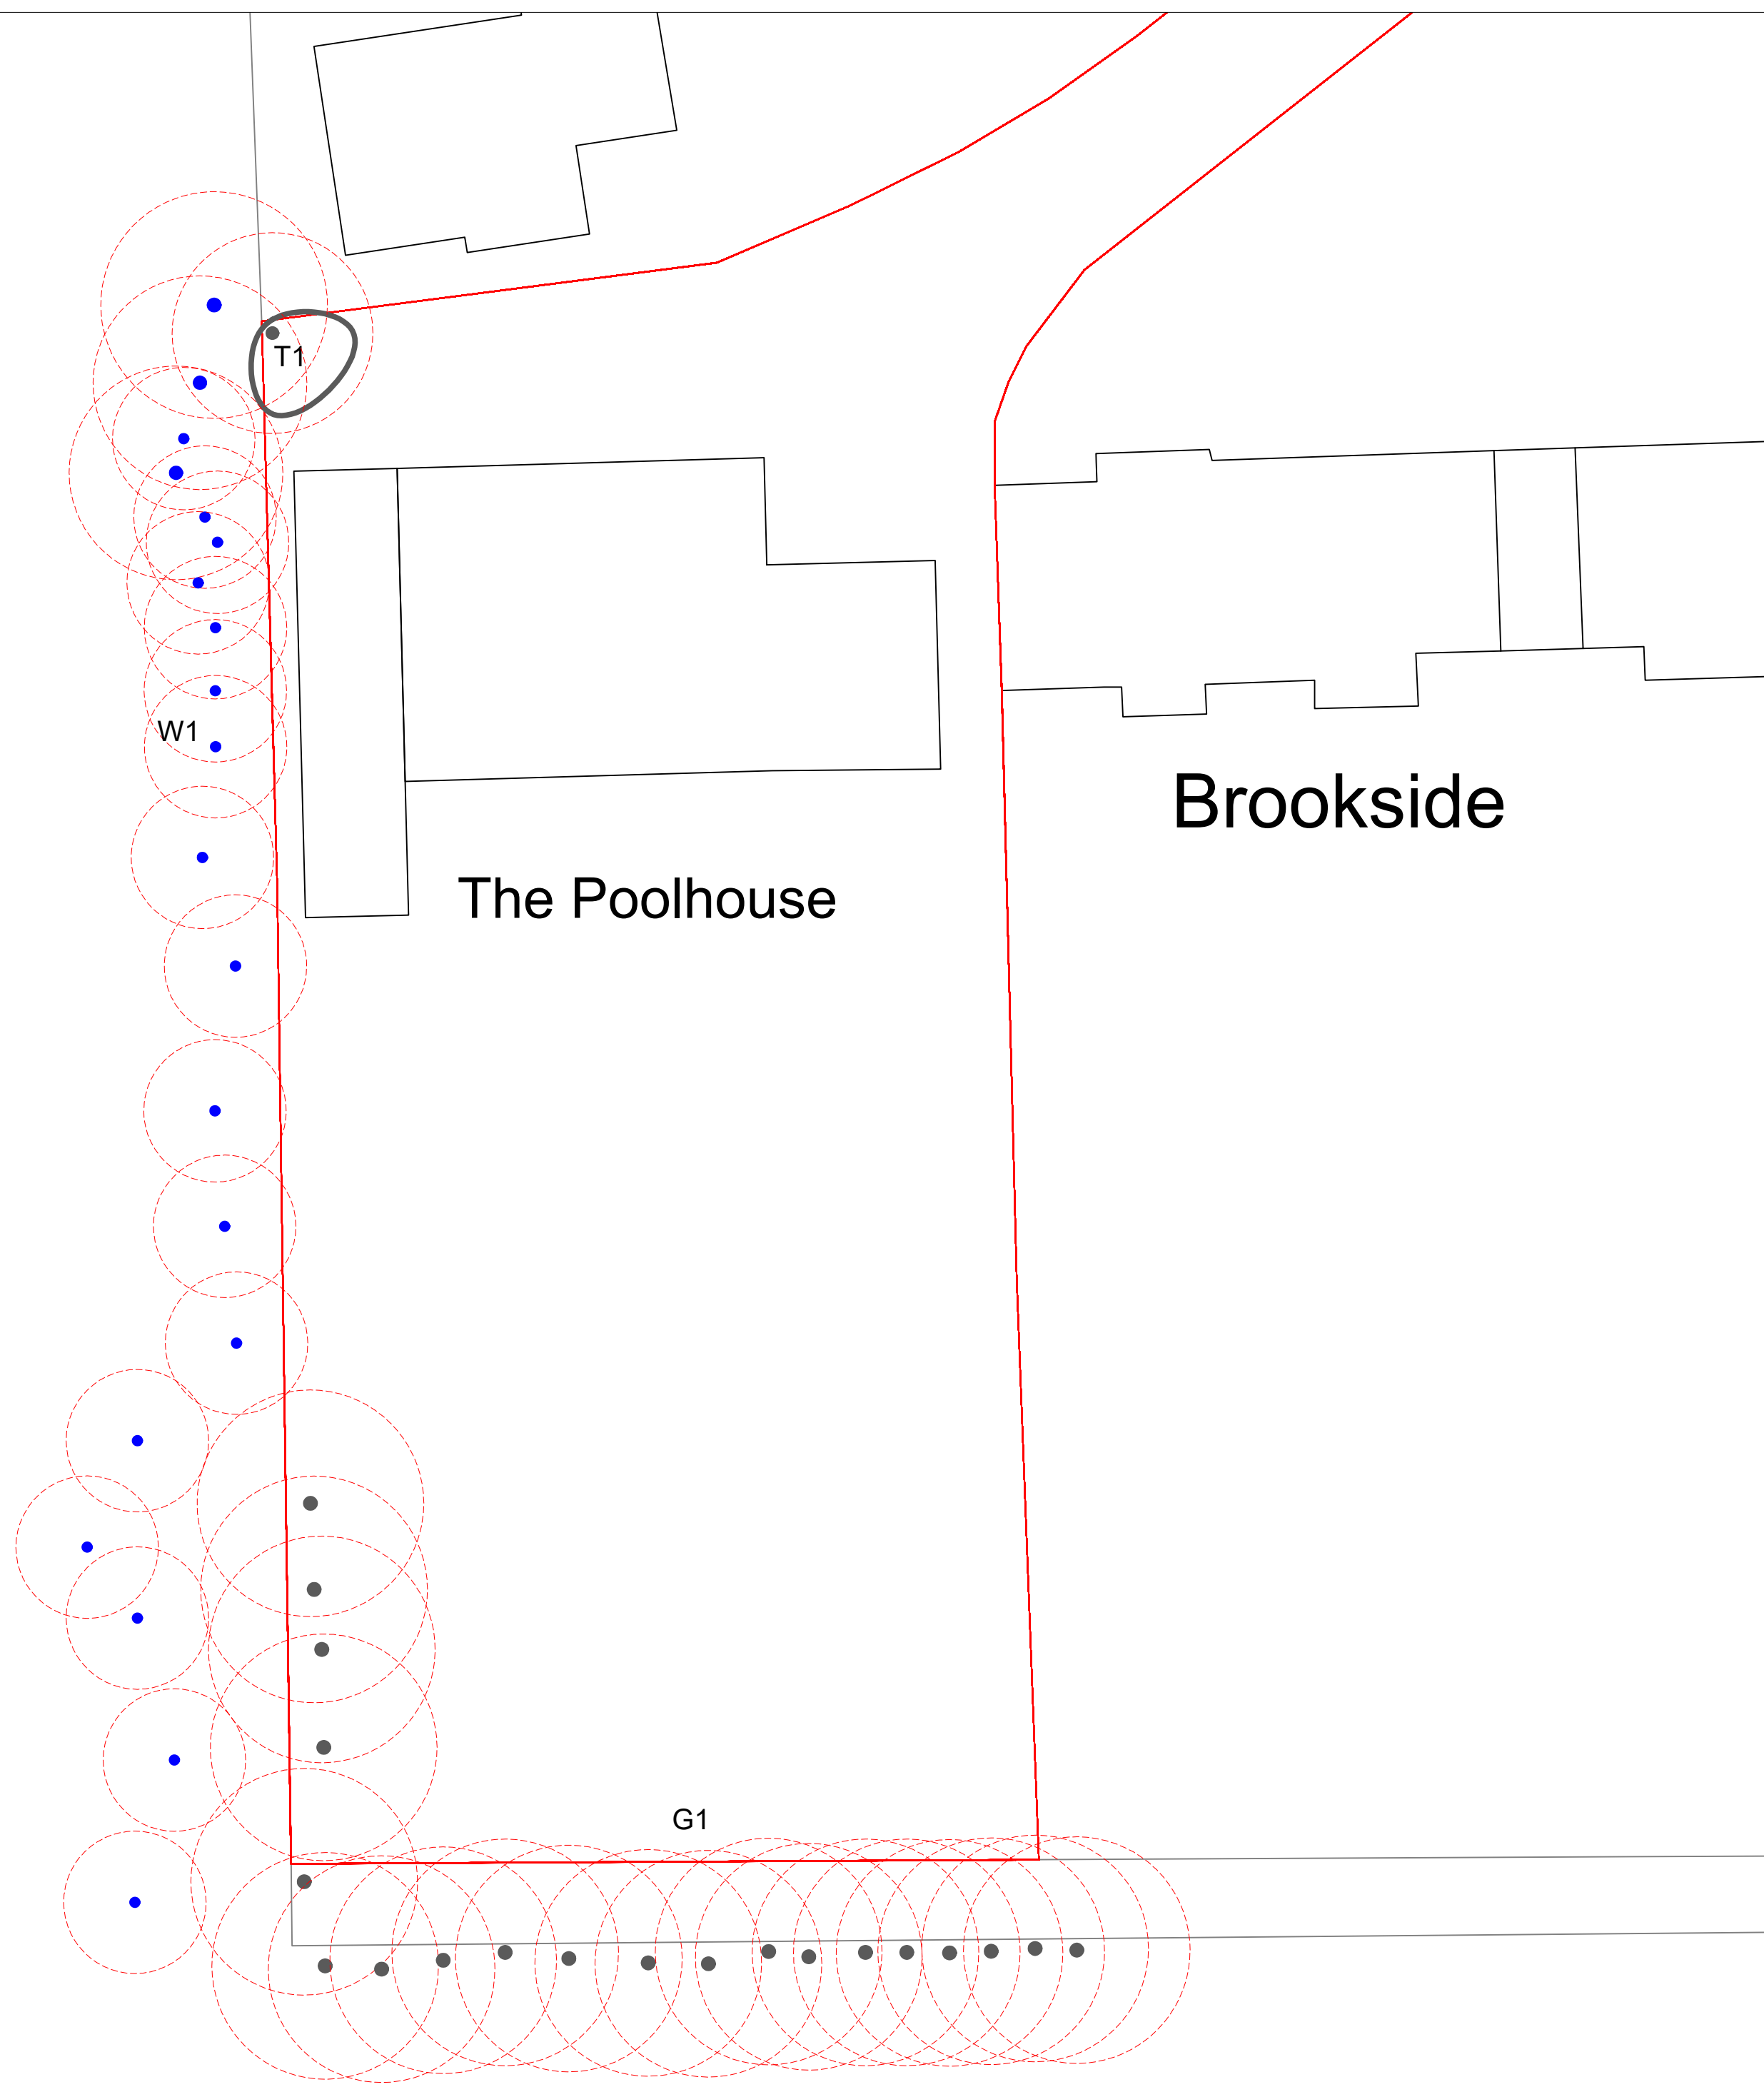
Drawing Title:  
AIS Plan

- 3.1 Due to the proposed development and its associated infrastructure there are a number of locations where the proposals are in close proximity to the trees surveyed. The Site Layout Plan within appendix three identifies the trees in relation to the proposed development.
- 3.2 In order to fully assess the impact of the proposals an Impact Table has been created detailing each tree, which shows the proximity of the associated works to the tree.
- 3.3 This can then be assessed in accordance with BS 5837:2012 to determine whether the development will have a detrimental impact on the health of each tree. Once this has been determined remedial measures can be detailed to reduce the impact the proposals will have on the treescape.
