# **A PRELIMINARY RISK ASSESSMENT FOR THE FORMER CRONTON COLLIERY**

**TE1163PRA1**

**13 AUGUST 2020**

Tritax Symmetry Ltd

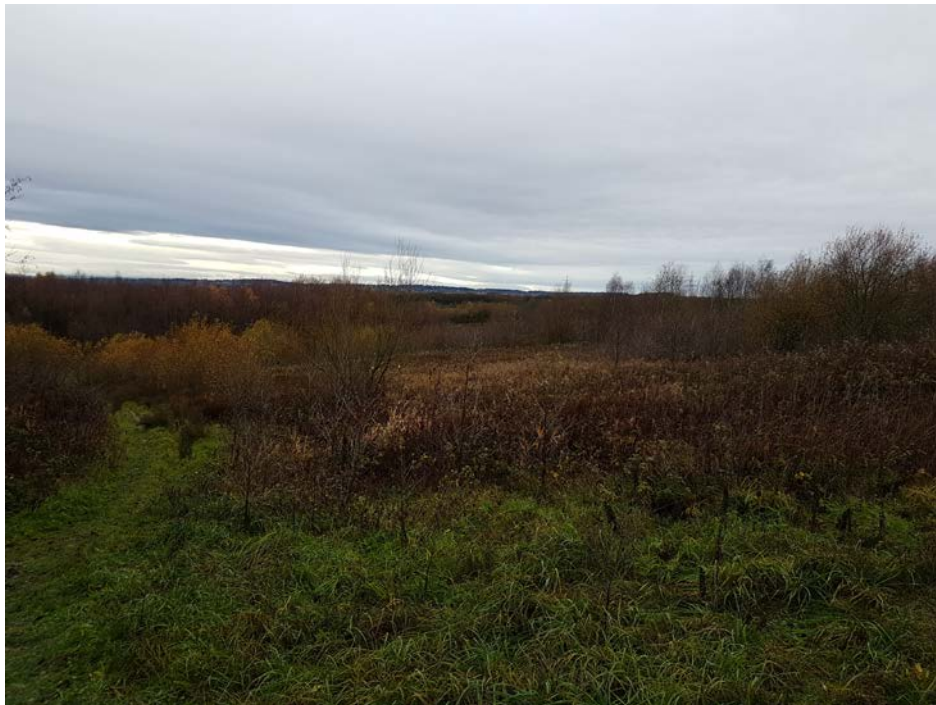
Photograph 4: Vegetated and sloping ground in the southwest of the site (proposed DBS2).

| Slope stability | <p>The regrading works are likely to result in slopes integrated into the development layout, notably to the west of unit DBS1 and to the south of DBS2.</p> <p>It is recommended that slope stability analyses are undertaken during the design phase; the results of the analyses may affect the unit dimensions, foundation solutions and floor slab designs for the proposed units. Retaining structures may also be required locally, notably to the west of unit DBS1 to maximise the floor area of this unit and minimise potential impact on the adjacent 'ancient woodland'.</p> |

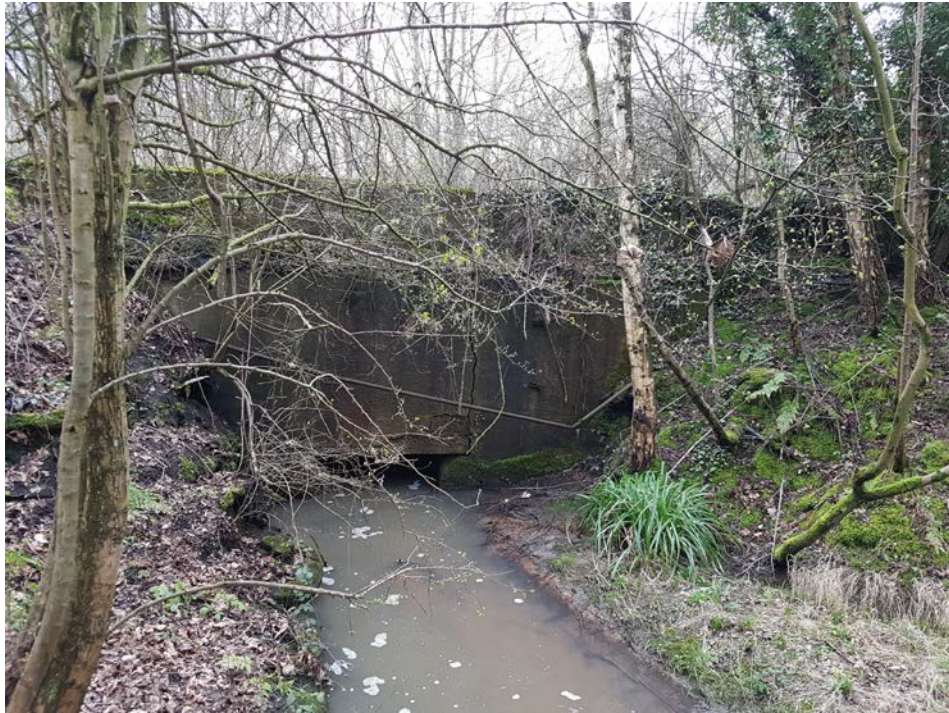
Photograph 5: Bridge/embankment structure with vertical crack along the line of the potential southern access road.
