## **Barn at Brook House Farm, Lower Road, Halewood, L26 3UB.**

### **Bat Activity Survey Report**

Report number: HALEW2/2022

Date: 18<sup>th</sup> July 2022

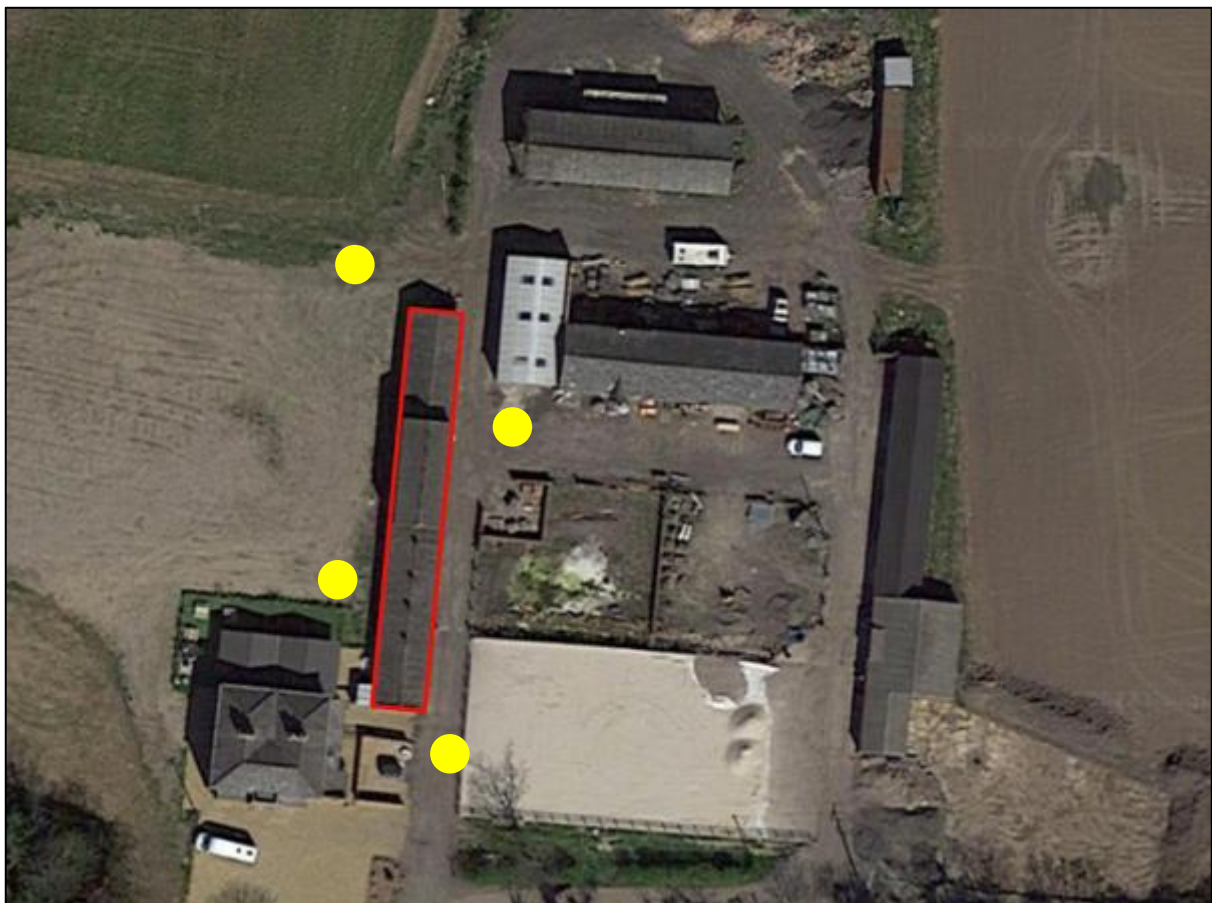
**Figure 1 - Surveyor Positions.**

The surveyors were positioned at each face of the dwelling in order to view the elevation, and roof, and gain full coverage simultaneously (see surveyor location plan below).

The surveyors used Wildlife Acoustics Echometer/IPAD 4 and EMT pro bat detectors to record the echolocations of active bats. The surveyors were positioned as shown in figure 1, to ensure full coverage of the dwelling, in order to view the elevation, and roof, and gain full coverage simultaneously.
