For: NEXUS ST.MARKS CHURCH LTD

TERM Engineering Ref: 1064/1

**Brook Hey Drive, Knowsley**

**Phase 1 Geo-Environmental Investigation**

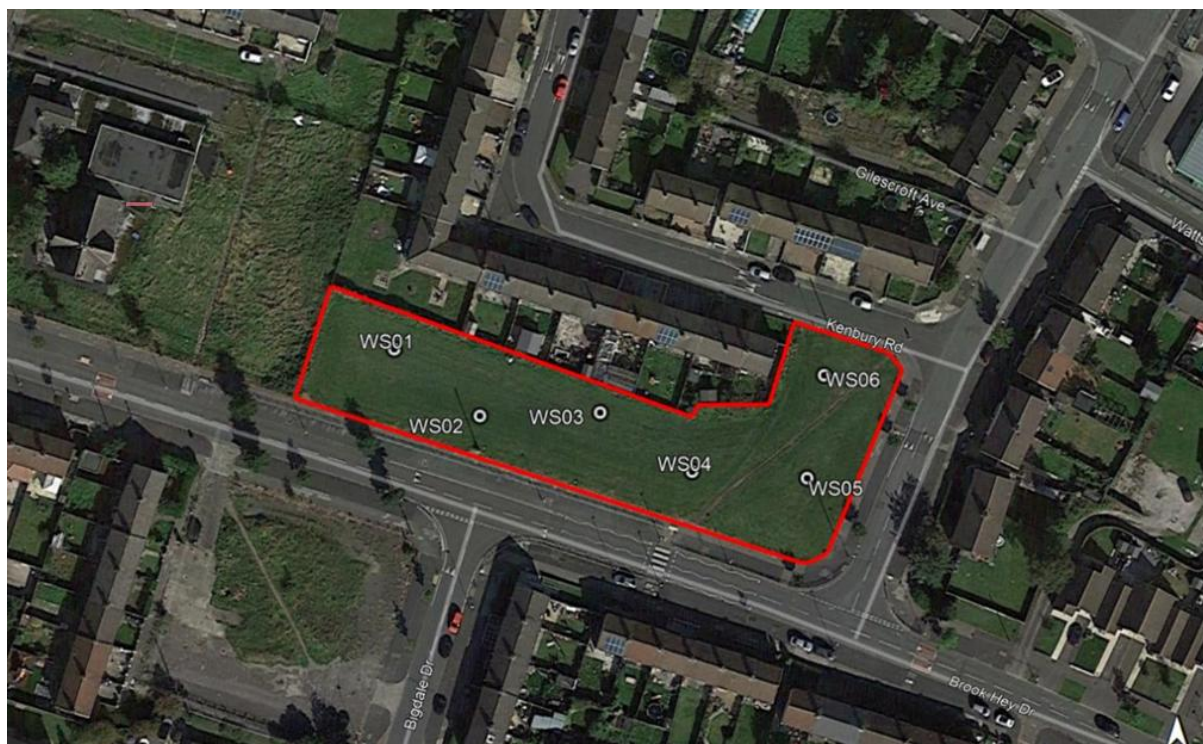
Locations of window samples carried out in 2020

A site investigation comprising 6 No. 6m deep window samples was carried out on the Eastern end of the site, and it was found that there were varying layers of made ground, sands, and peat overlaying a layer of Clay. See the location plan and table below.

No ground water was encountered in any of the window samples during the investigation. The environmental chemistry of the ground was investigated by specialist chemical analysis of samples from the site investigation.

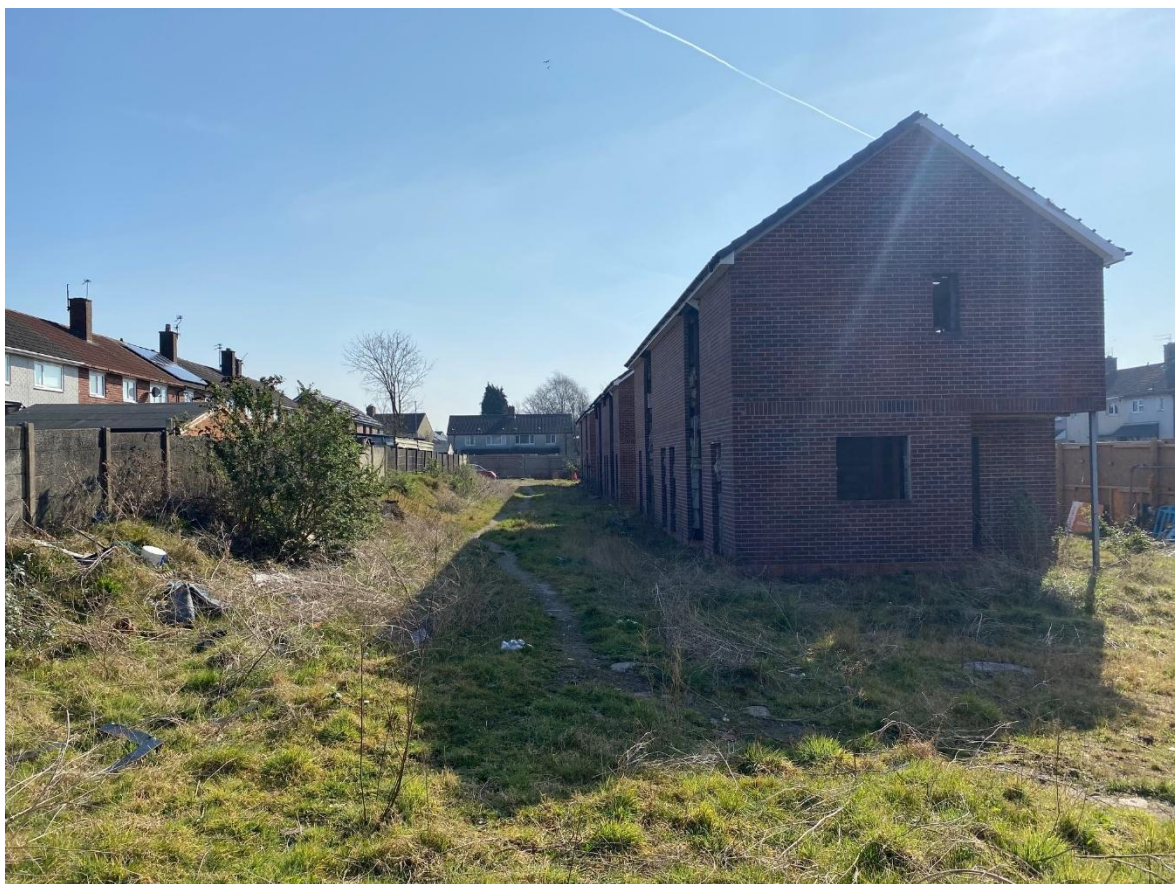
**Photo 1**

The site is generally flat. There are areas of concrete hardstanding in the location of the former church on the Western end of the site. No external hardstanding appears to have been completed for the 5 partially constructed buildings to the East of the site.

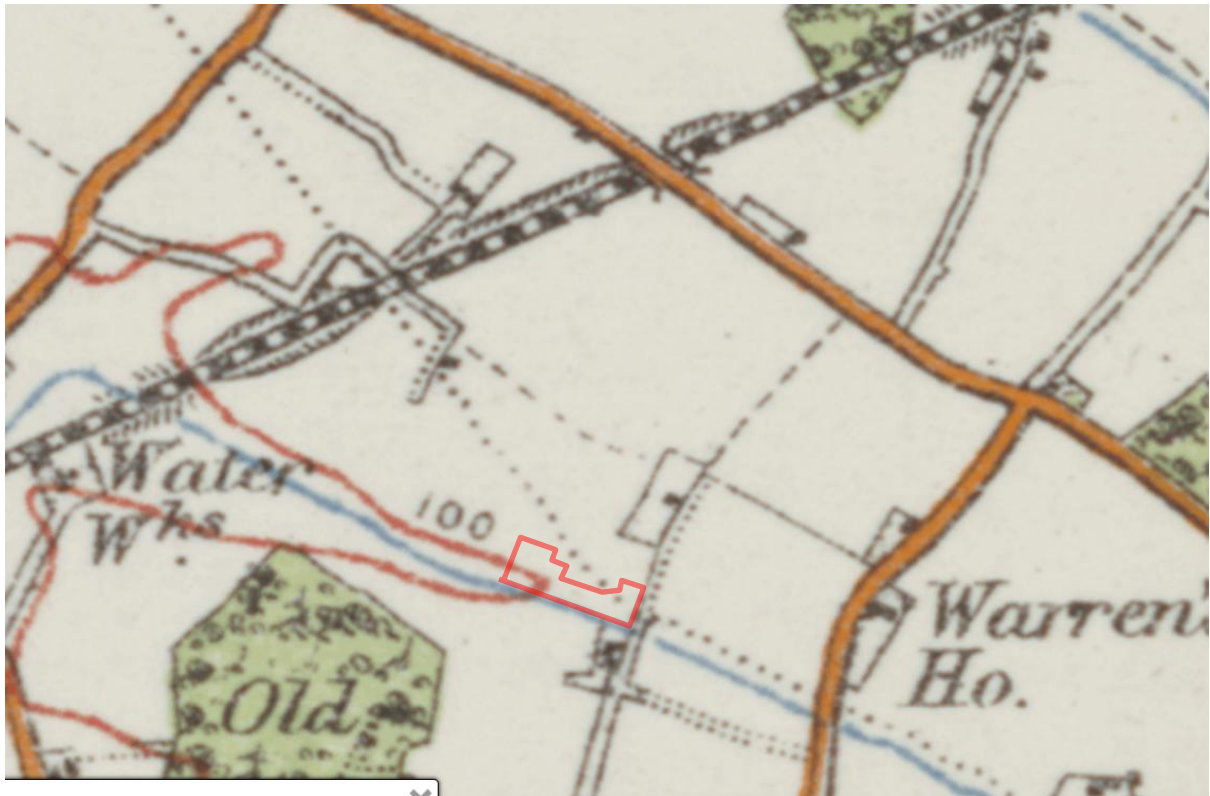
1917

| Dates | On-Site history | Off-Site History |
|---|---|---|
| 1849 | The site forms part of the farmland associated with a farm building to the North. There is an open watercourse to the South, in the current location of Brook Hay Drive, flowing to the West. The Railway line to the North has been constructed | There is an open watercourse to the South, in the current location of Brook Hey Drive, flowing to the West. The Railway line to the North has been constructed. A Water Works (identified as a pumping station as part of the St Helens Corporation Water Works on later maps) is shown around 500m West of the site. |

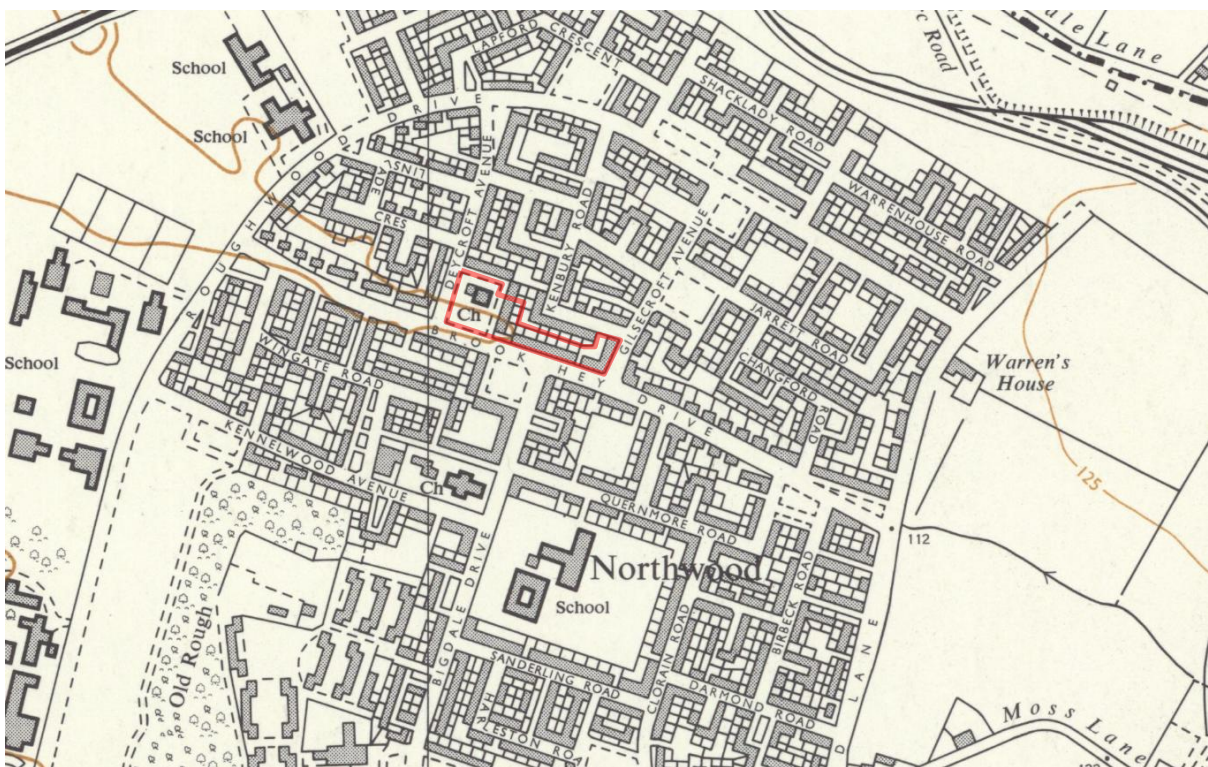
| Dates | On-Site history | Off-Site History |
|---|---|---|
| 1966 | The site remains unchanged | The site remains unchanged |
