# Desk Based Ground Gas Risk Assessment

Hilcrest House, Thingwall Hall

Report Ref: GR00215-GGRA-1.0

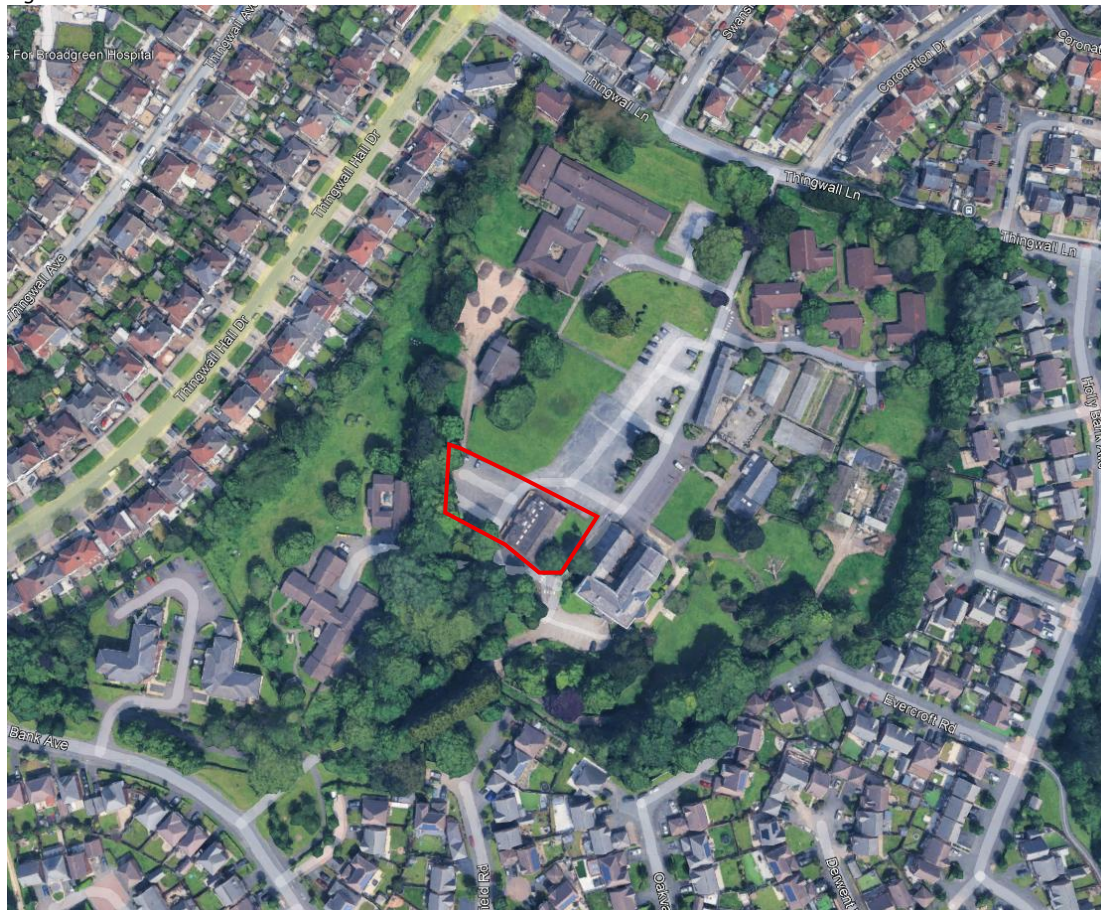
Figure 1.1 Site Location

| Location description | The site is located within the centre of the wider Thingwall Hall estate in the Broadgreen suburb of Liverpool, approximately 6km east of Liverpool City Centre. |

Ground Risk Ltd were commissioned by CUBE Architects on behalf of Brothers of Charity Services to undertake a Desk Based Ground Gas Risk Assessment for a site referred to as Hilcrest House, Thingwall Hall (the "site"). The site comprises an individual single-storey structure and nearby external areas within a limited area of the wider Thingwall Hall estate. The site location is indicated in Figure 1.1.
