# LAND AT ACORNFIELD ROAD, KNOWSLEY

GEOENVIRONMENTAL  
APPRAISAL  
(PHASE 2 ASSESSMENT)

S2405/02, FEB 2025  
FINAL, ISSUE 1.0

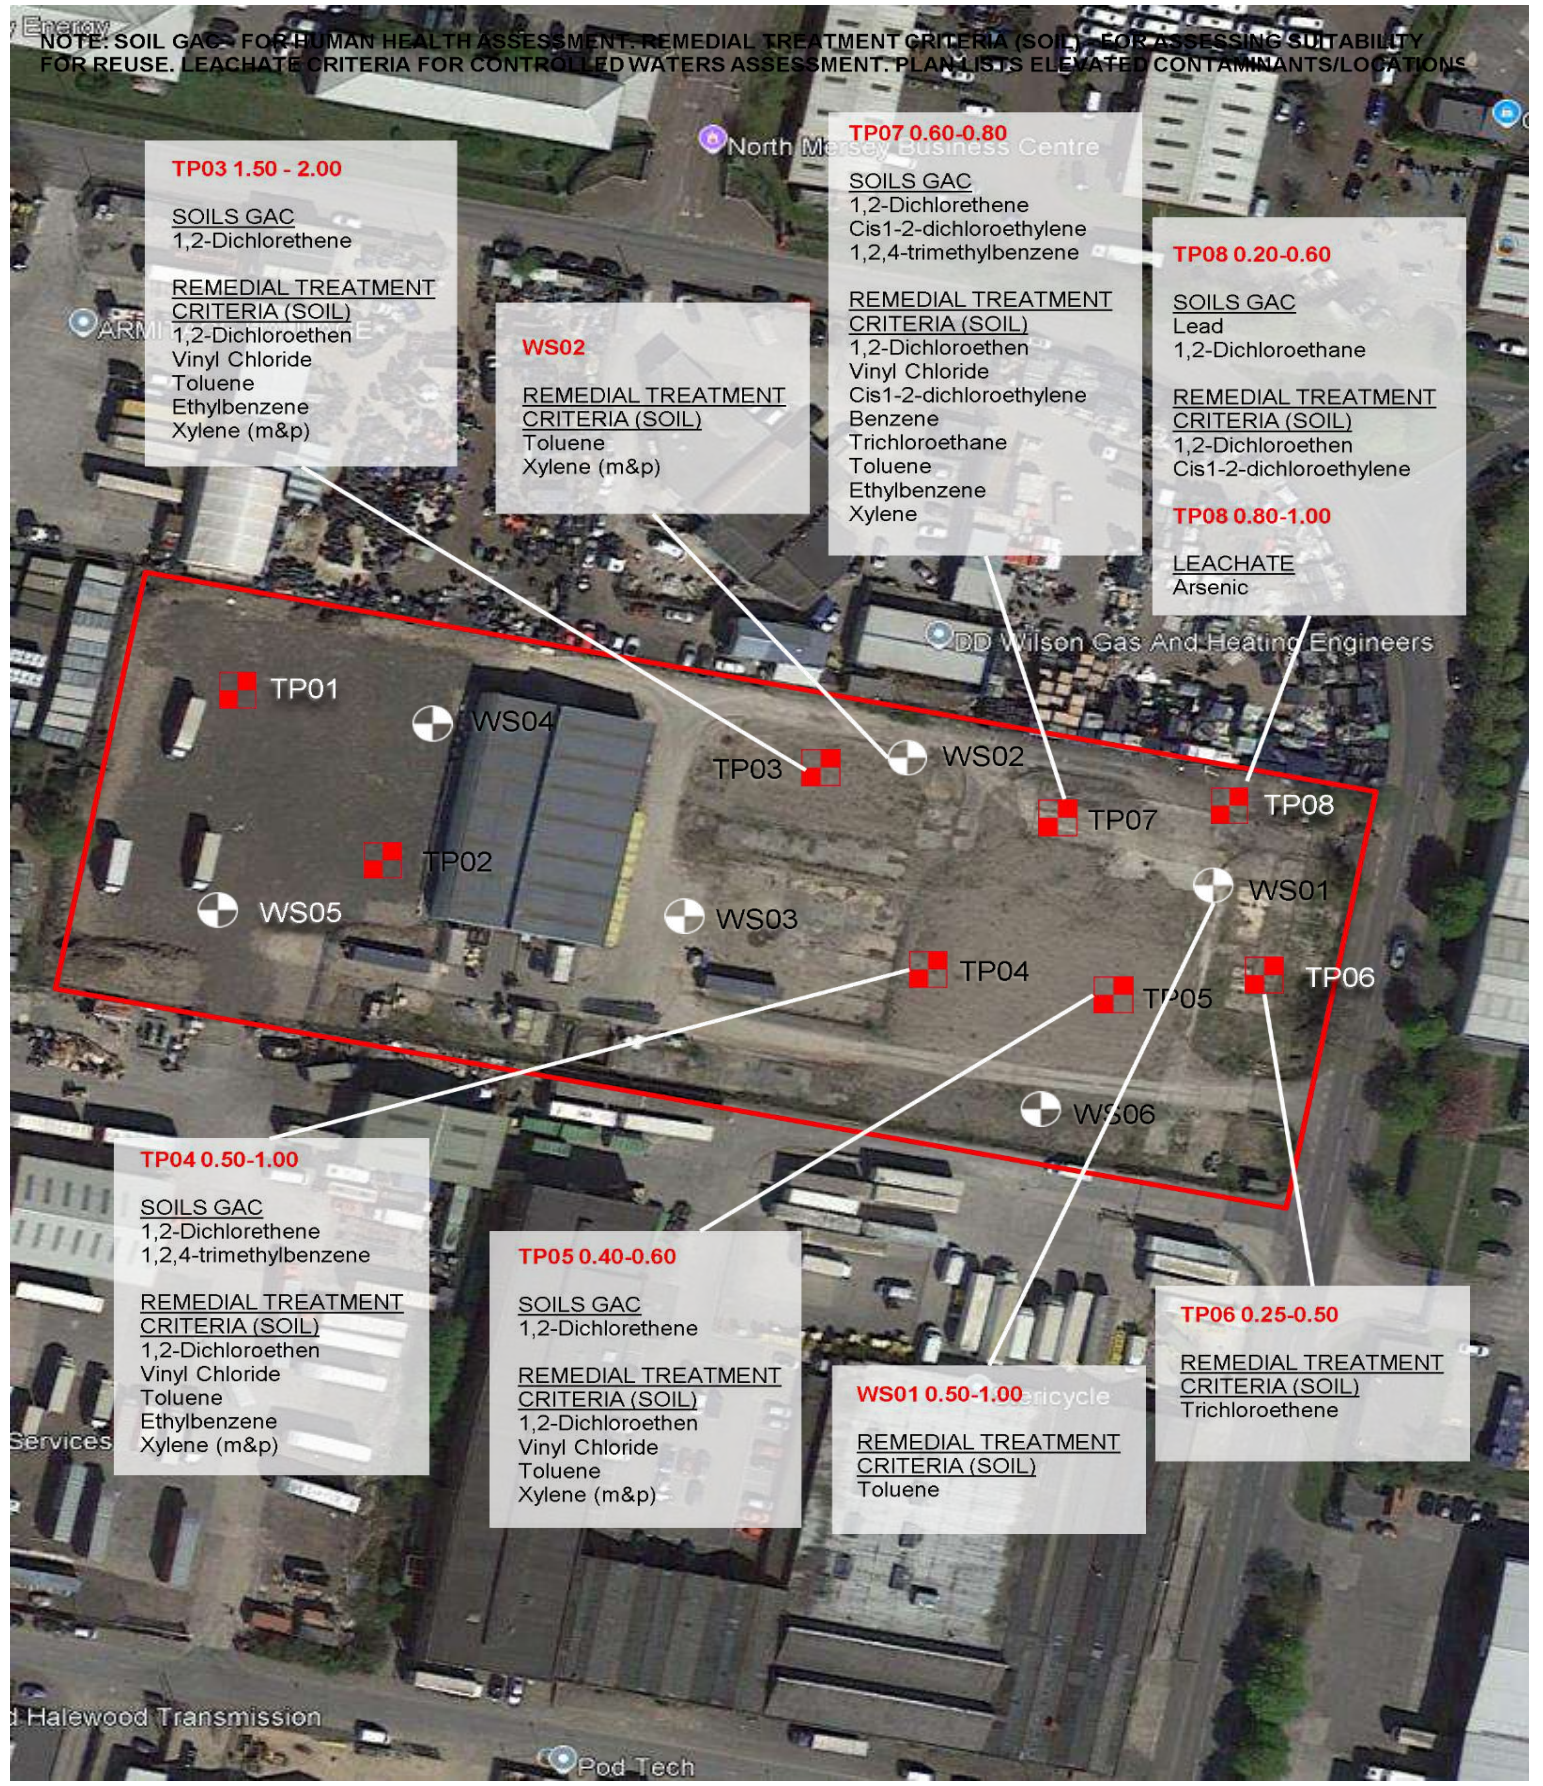
| <b>SPIRE<br/>GEOTECHNICAL</b><br><br>SPIRE GEOTECHNICAL LTD<br>NORTH SANDS BUSINESS CENTRE<br>ROKER SUNDERLAND SR6 0QA<br><br>hello@spire-geo.com spire-geo.com<br>0191 549 7384<br><br>Company No.: 15969735 | DRAWING TITLE<br>"HOT-SPOT" LOCATION PLAN | |

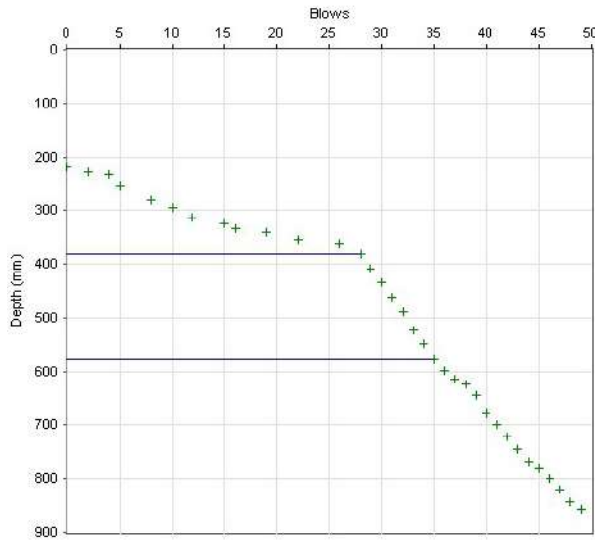
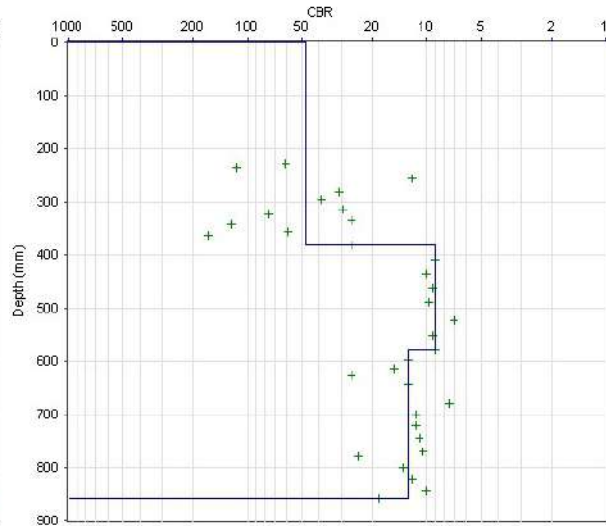
Layer Boundaries: Chainage 1.000

Layer Boundaries Chart

CBR Chart

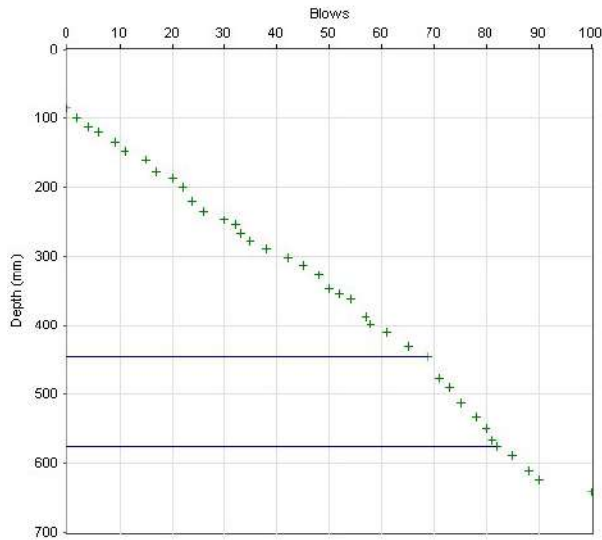
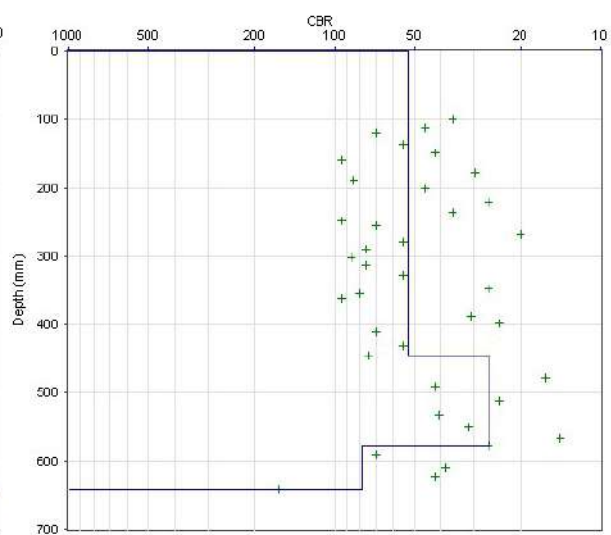
Layer Boundaries: Chainage 2.000

Layer Boundaries Chart

CBR Chart

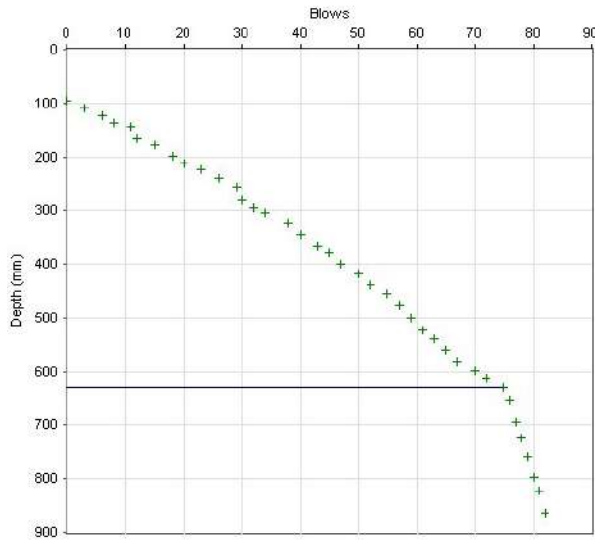
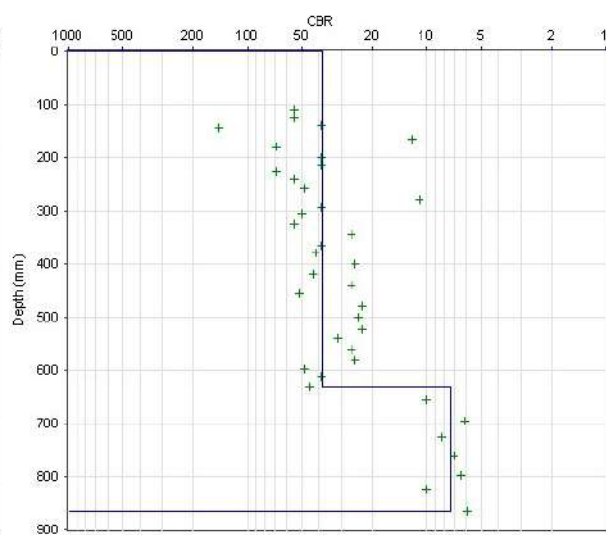
Layer Boundaries: Chainage 4.000

Layer Boundaries Chart

CBR Chart

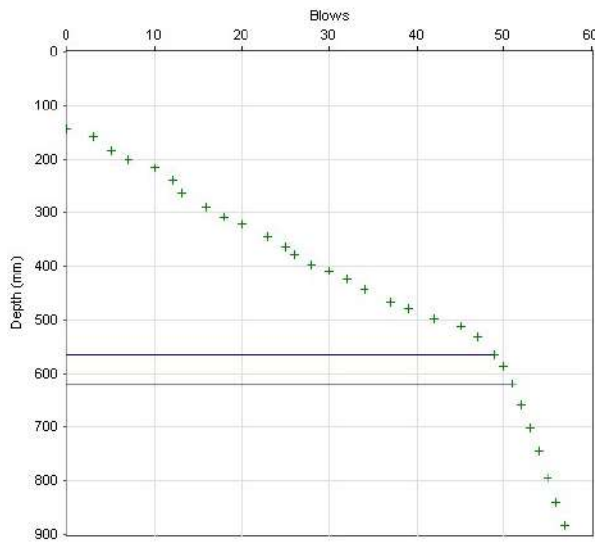
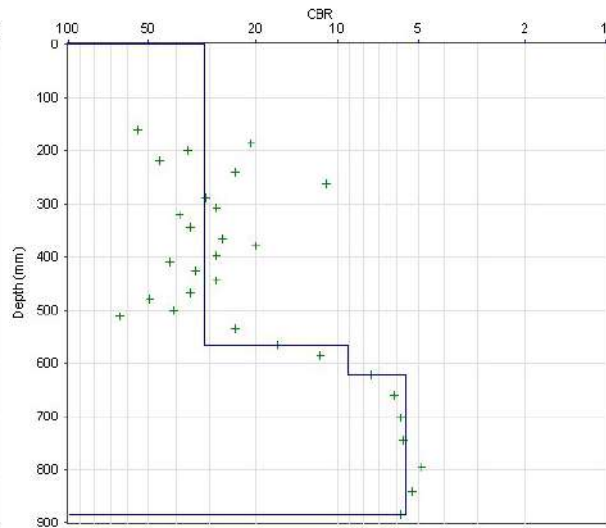
Layer Boundaries: Chainage 5.000

Layer Boundaries Chart

CBR Chart
