**BAT SCOPING SURVEY**

**Glen Dimplex Factory**

Stone Lane  
Whiston  
Knowsley  
L35 2XW

UES05069/03

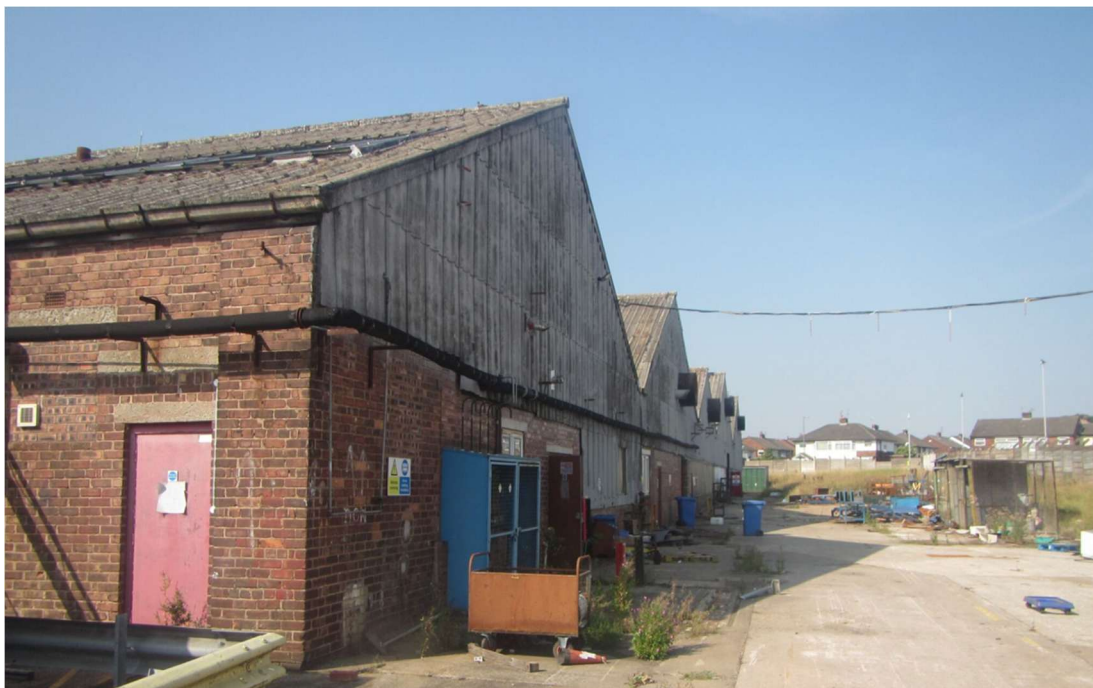
**Building 1** is the main factory building located within the centre of the development site (see Appendix 3 – Photographs, Photograph 1). It is a complex series of industrial units with a combination of pitched and flat roofs constructed from corrugated asbestos, sheet metal or bitumen felt (Photographs 1 to 4). The eaves of the building consist of wooden or asbestos fascia boards, and gaps were identified beneath the eaves, where it connects to the wall plate, which may provide a potential roosting features (PRF) for bats (Photographs 7 and 8).

Photograph 1 – The eastern aspect of Building 1, showing the pitched roofs.

**Building 1** was assessed as having low potential to support roosting bats. Due to the large size of the building, two bat back tracking surveys are considered to be more appropriate than individual bat presence / absence surveys. These surveys should be undertaken during the bat survey season (May to September inclusive), with at least one of the surveys undertaken during the peak season of May to August inclusive. Surveyors should be positioned sufficiently to cover the proposed development site footprint.

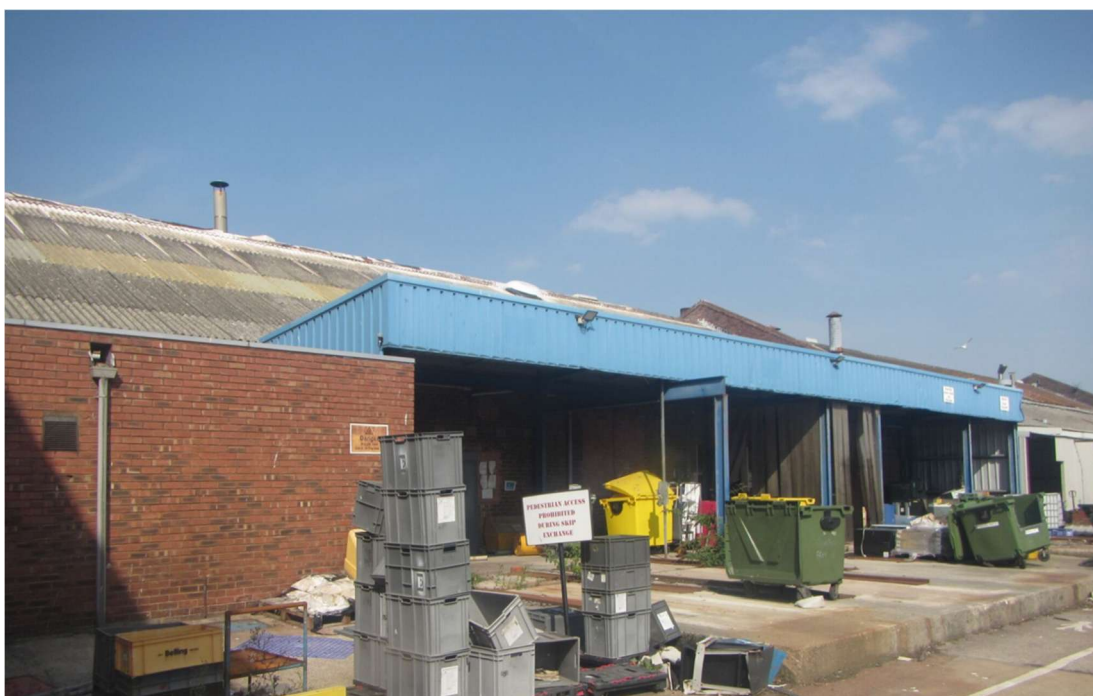
Photograph 2 – A flat roof located along the southern aspect of Building 1.

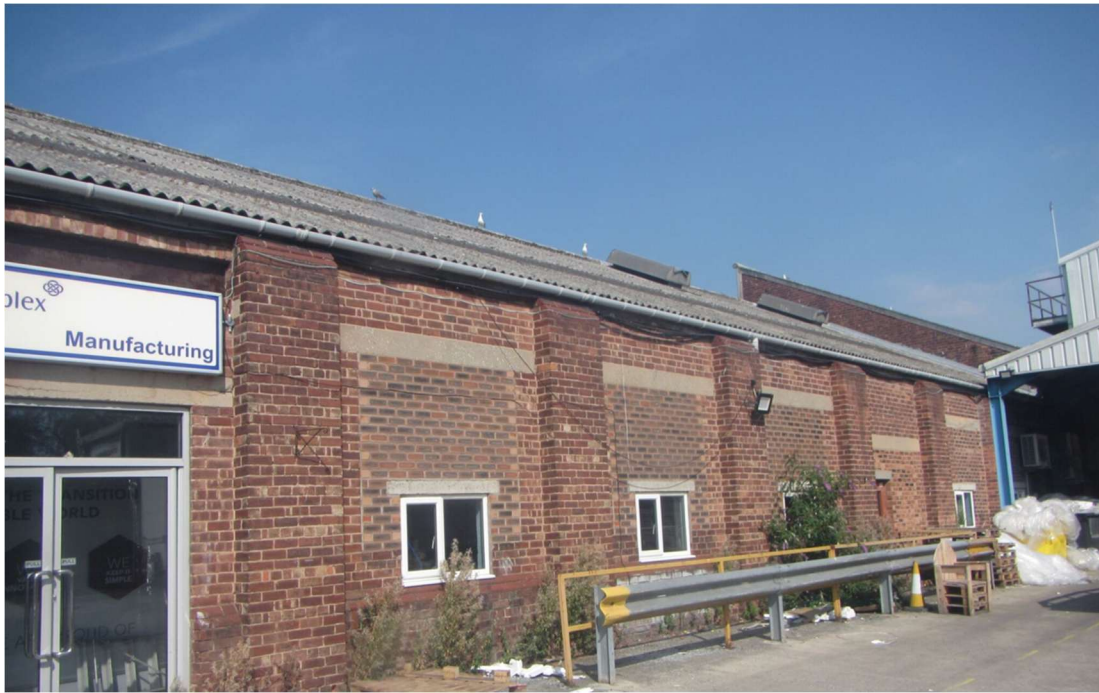
Photograph 3 – Corrugated asbestos roof on Building 1.

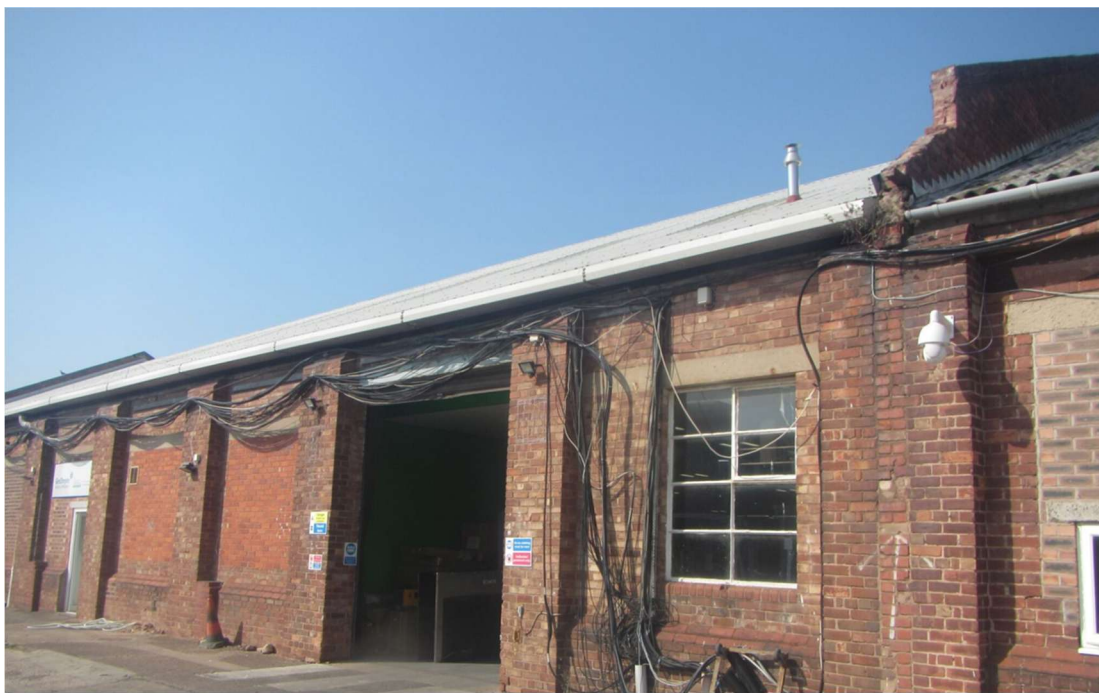
Photograph 4 – Sheet metal roof on Building 1.

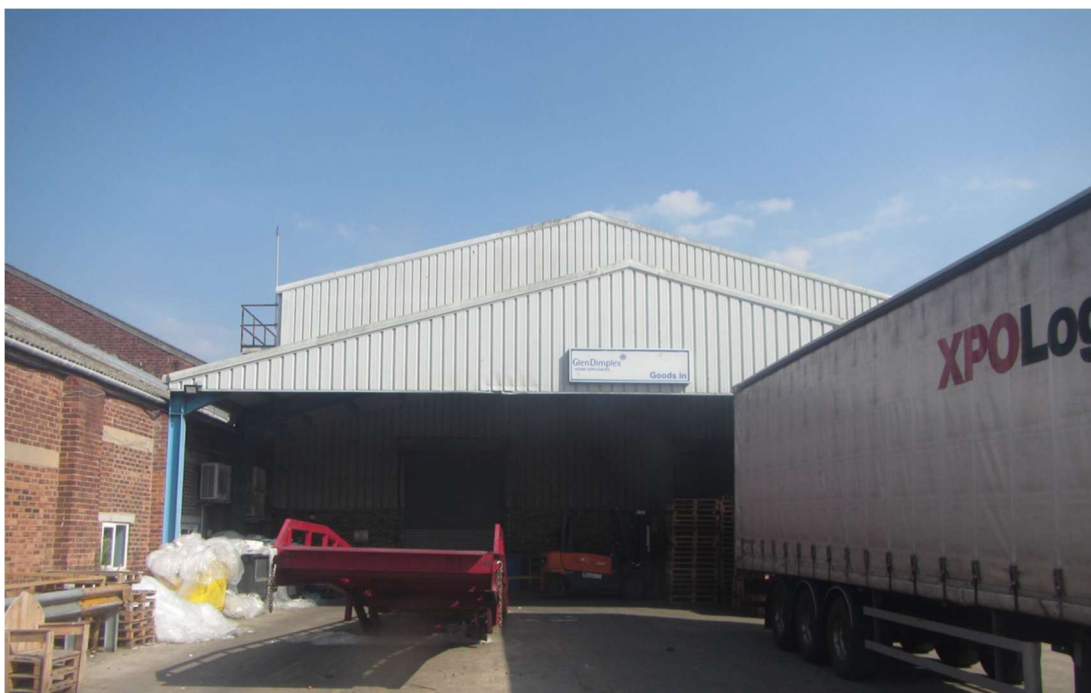
Photograph 5 – A section of Building 1 which is constructed from metal cladding.

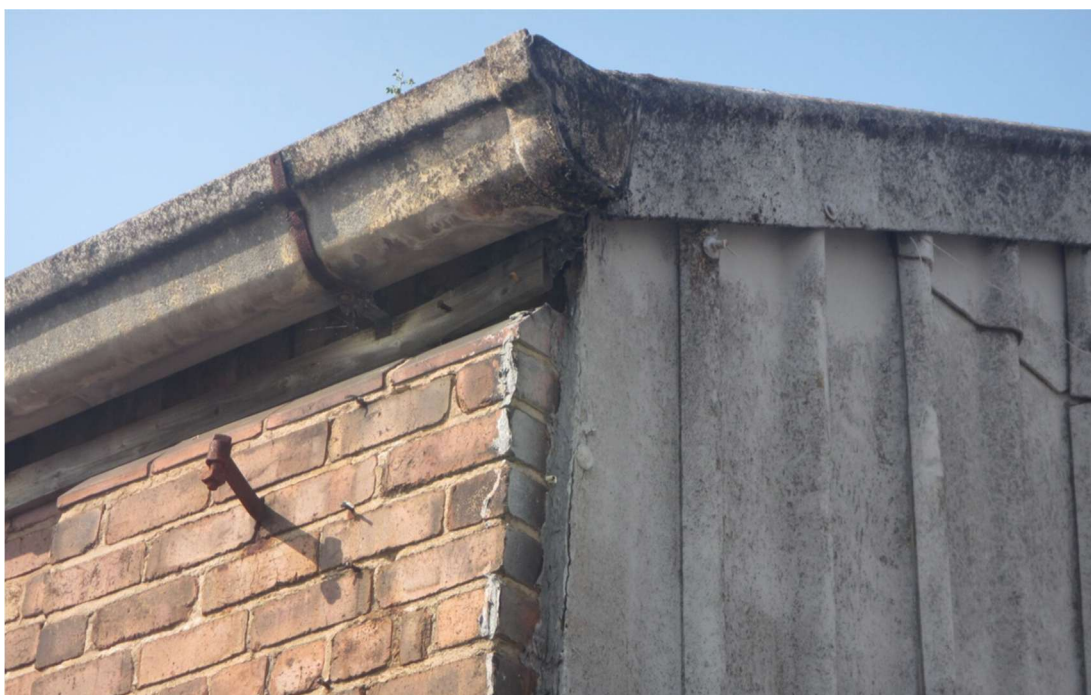
Photograph 6 – Wooden fascia boards located along the eaves of Building 1.

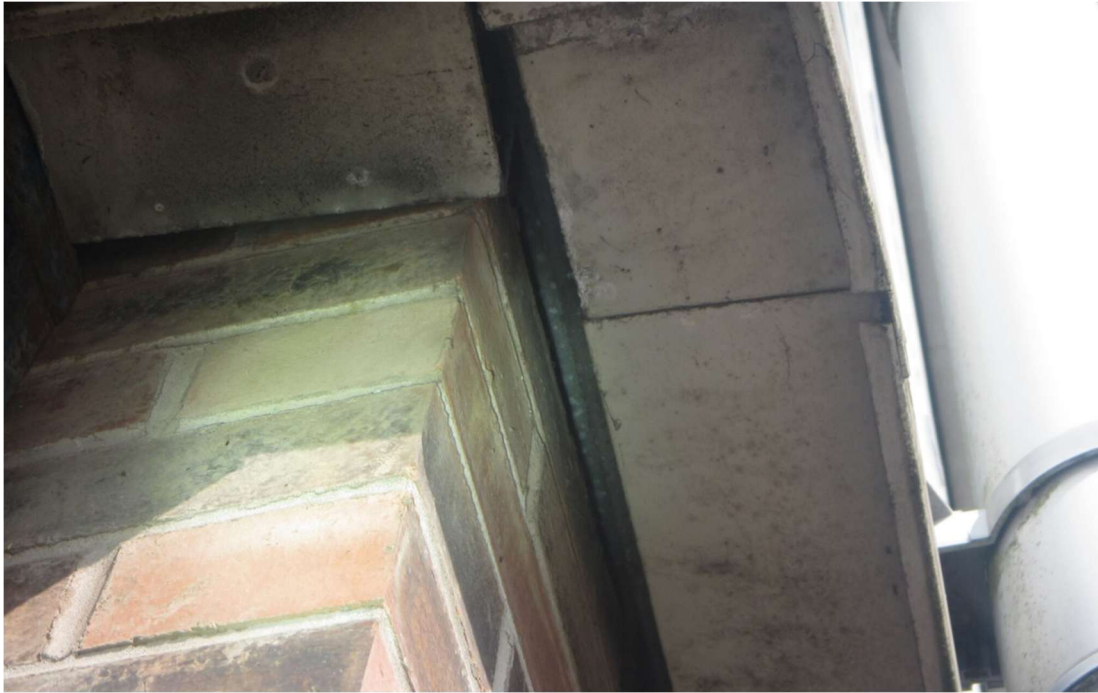
Buildings 1, 2 and 3 were assessed as having low potential to support roosting bats due to the presence of predominantly external PRFs including gaps underneath the eaves and cavities within the brickwork. No evidence of roosting bats was identified within these buildings during the internal and external building inspections.

Photograph 7 – A gap between the eaves and external wall on Building 1.

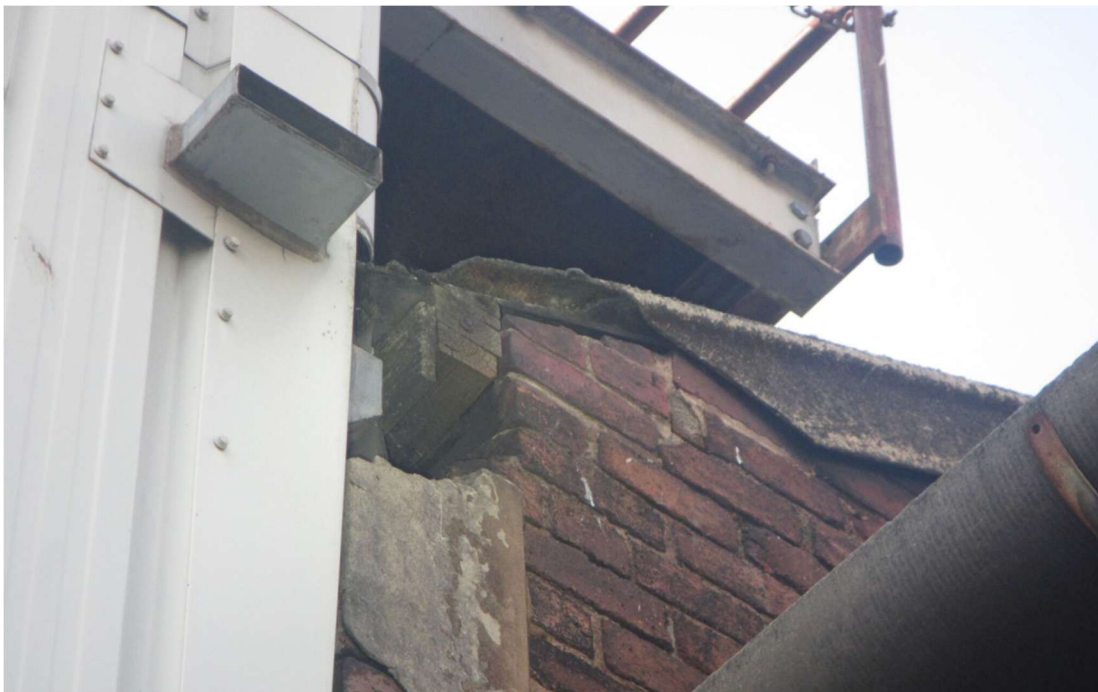
Photograph 8 – A gap between the top of the wall plate and the eaves of Building 1.

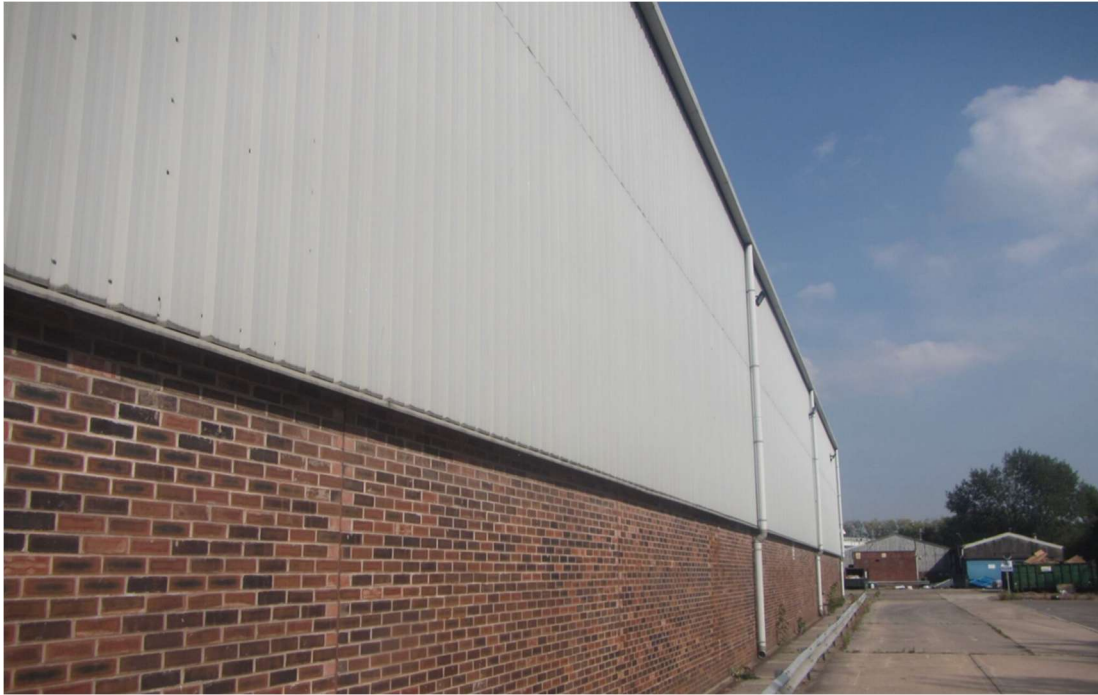
The external walls are constructed from a combination of materials including redbrick, breezeblock and metal cladding. Cavities were identified within the brickwork, and where the cladding connects to the external wall, which may also provide a PRF for bats (Photograph 9). The western-most section of the building is an openly accessible loading area covered with a corrugated roof. Feral pigeons *Columba livia* were observed within this section of the building.

Photograph 9 – Gaps are present underneath the metal cladding and external walls on Building 1.

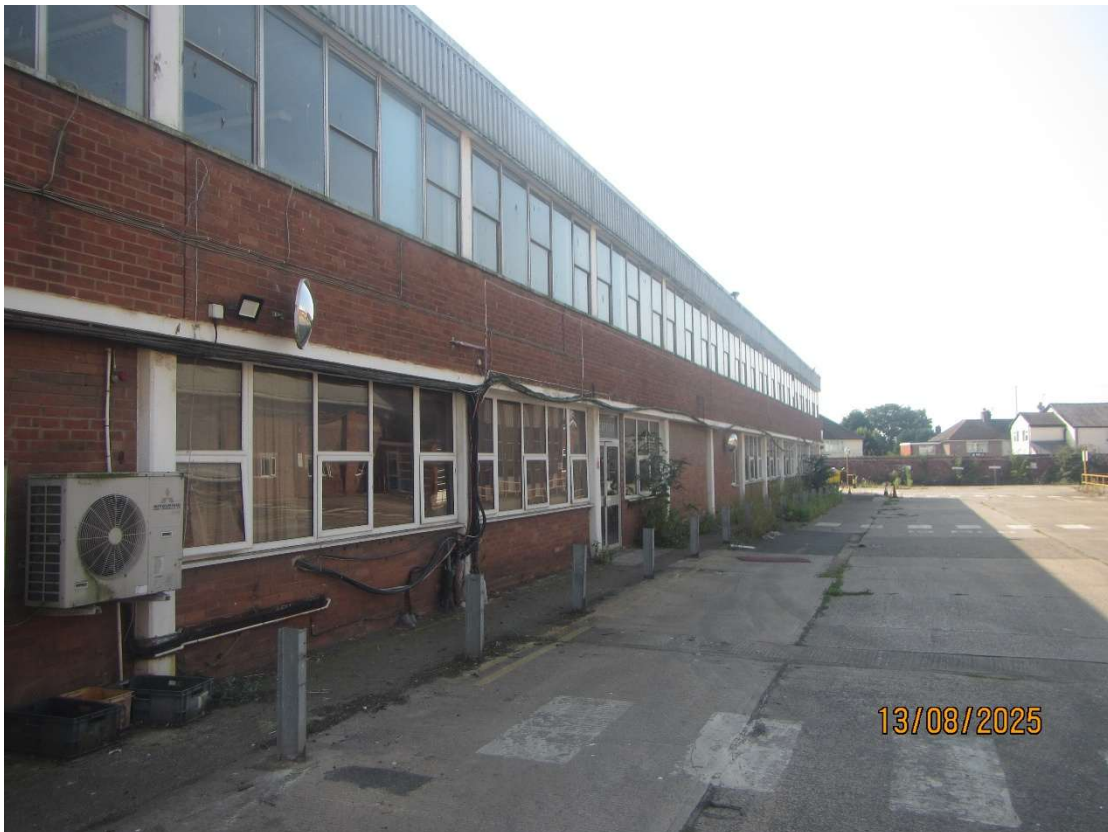
**Building 2** is a disused office building with a flat roof covered in metal sheeting (Photograph 10). The lower half of the external walls are constructed from redbrick, whilst the upper half of the walls primarily comprise PVC windows with metal cladding directly above (Photograph 11). Gaps were identified where the eaves of the building connect to the cladding, which may provide a PRF for bats, and cavities were also identified within the brickwork.

Photograph 10 – The northern aspect of Building 2.

**Buildings 2 and 3** were assessed as having low potential to support roosting bats and as such, a single further bat presence / absence survey is required during the peak bat survey season of May to August inclusive.

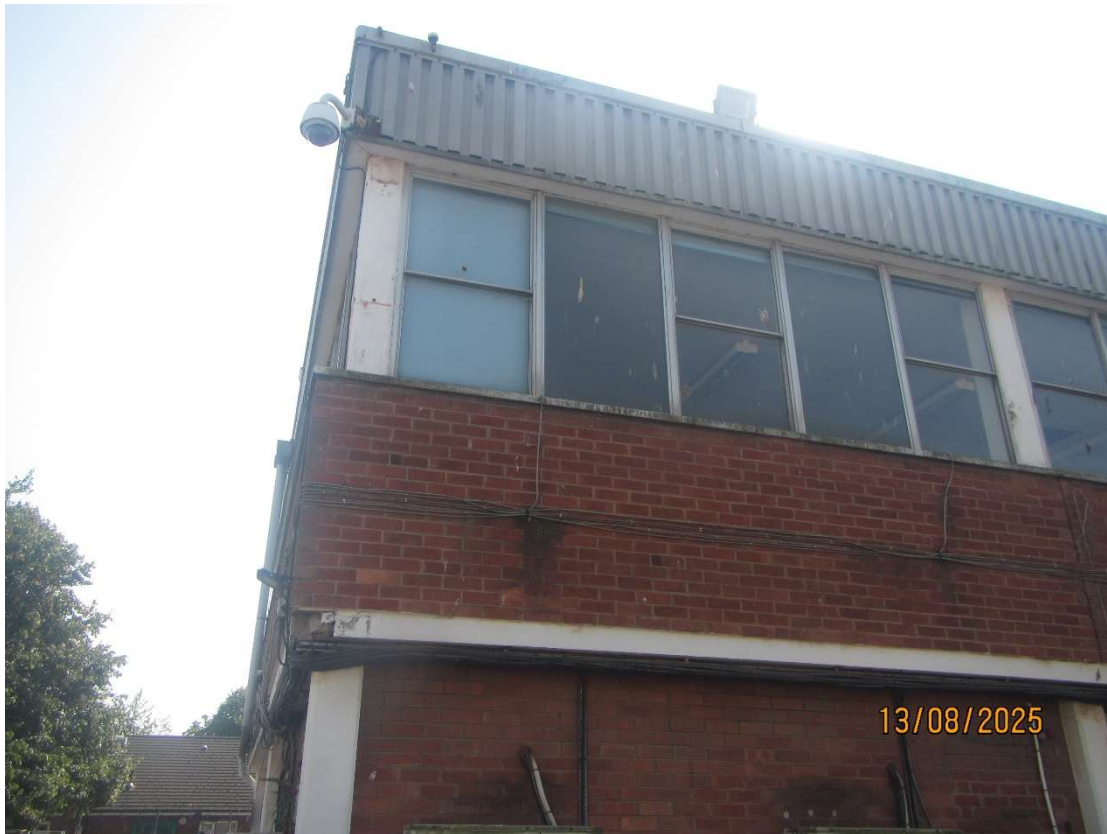
Photograph 11 – Showing the external structure of Building 2, including the cladding, redbrick walls and windows.

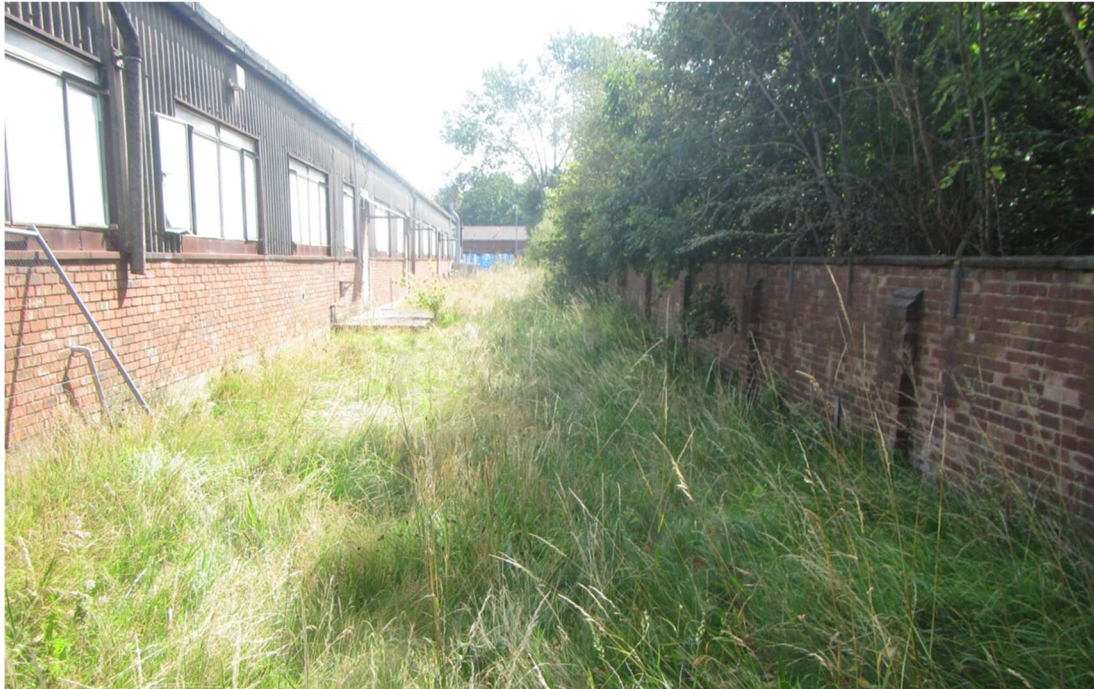
**Building 3** is a disused industrial building with a multi-pitched roof constructed from corrugated asbestos. The external walls are a combination of redbrick with corrugated asbestos cladding (Photograph 12). PRFs were identified during the bat scoping survey but were limited to gaps between the cladding and external walls, and cavities within the brickwork.

Photograph 12 – The southern aspect of Building 3 which is constructed of red brick with asbestos cladding.

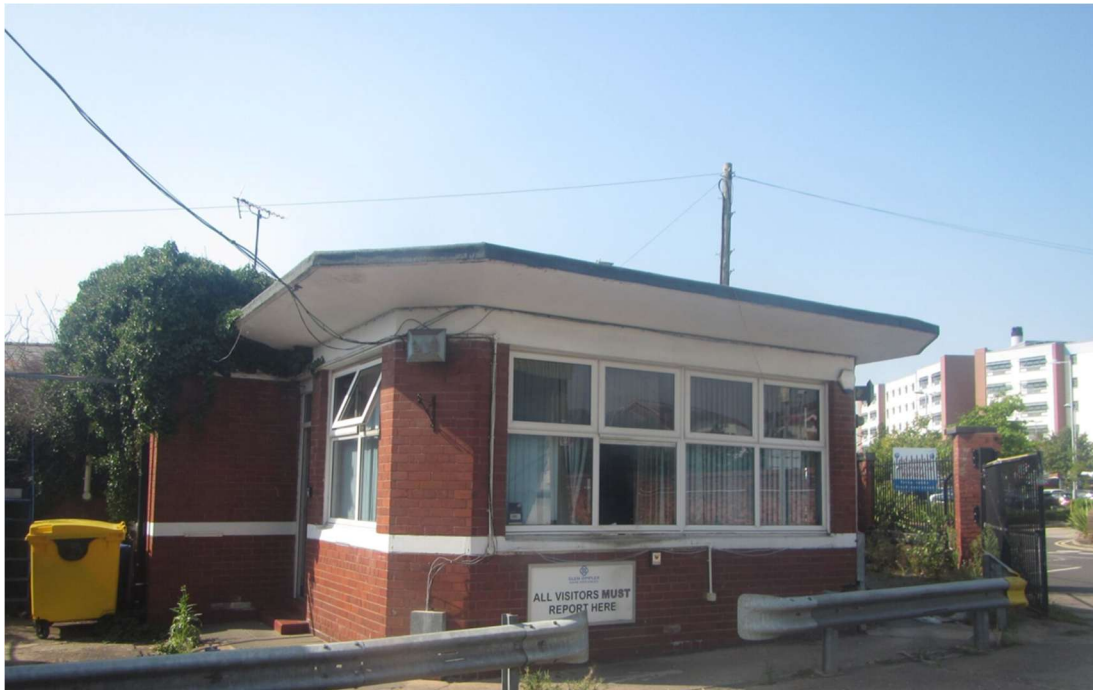
**Building 4** is a single-storey security office. It has a flat roof which is covered in a bitumen felt, and the roof extends beyond the eaves of the building to form an overhang (Photograph 13). The external walls are constructed of redbrick and no suitable PRFs were identified during the bat scoping survey.

Photograph 13 – Building 4.

**Buildings 4, 5 and 6** were assessed as having negligible potential to support roosting bats and as such, no further surveys or mitigation measures are required for these buildings, with regards to bats.

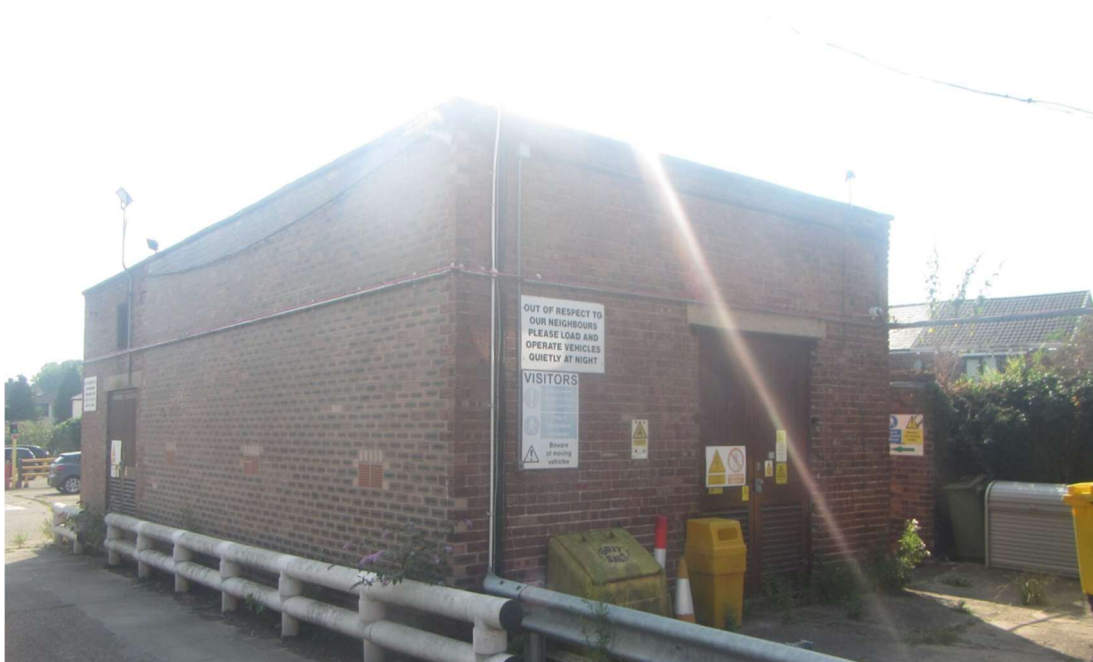
**Building 5** is a single-storey substation. It has a flat roof which is covered in a bitumen felt, and the external walls are constructed of redbrick with stone lintels present above the doorways (Photograph 14). No suitable PRFs were identified during the bat scoping survey.

Photograph 14 – Building 5.

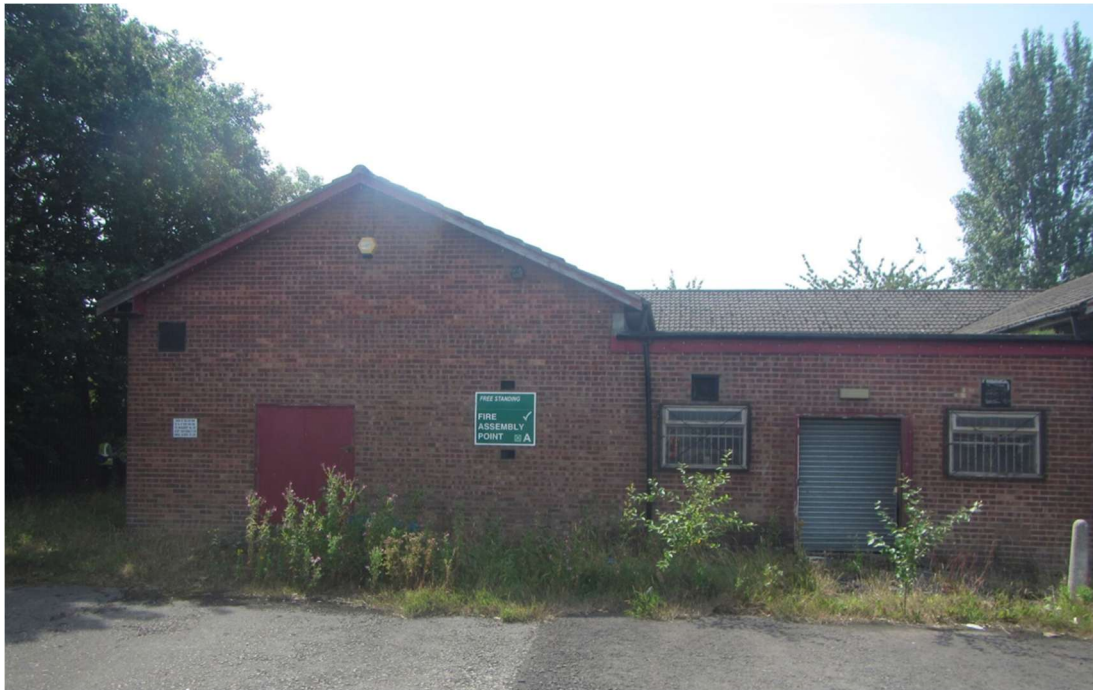
**Building 7** is a disused social club with a multi-pitched roof constructed from interlocking concrete roof and ridge tiles (Photograph 15). PRFs were found to be associated with the roof of the building due to the presence of raised or missing roof tiles, and gaps within the mortar of the verge pointing (Photographs 16 and 17). The eaves of the building consist of wooden boxed soffits and barge boards, which are damaged in places with gaps identified between the soffits and the gable end walls, and holes within the soffits (Photograph 18). The external walls are constructed of redbrick, and a hole was identified within the brickwork on the eastern aspect of the building.

Photograph 15 – Building 7 which contains a multi-pitched roof and external redbrick walls.

**Building 7** was assessed as having moderate potential to support roosting bats and as such, two further bat presence / absence surveys should be undertaken from May to September inclusive, with at least one of the surveys undertaken during the peak bat survey season of May to August inclusive.

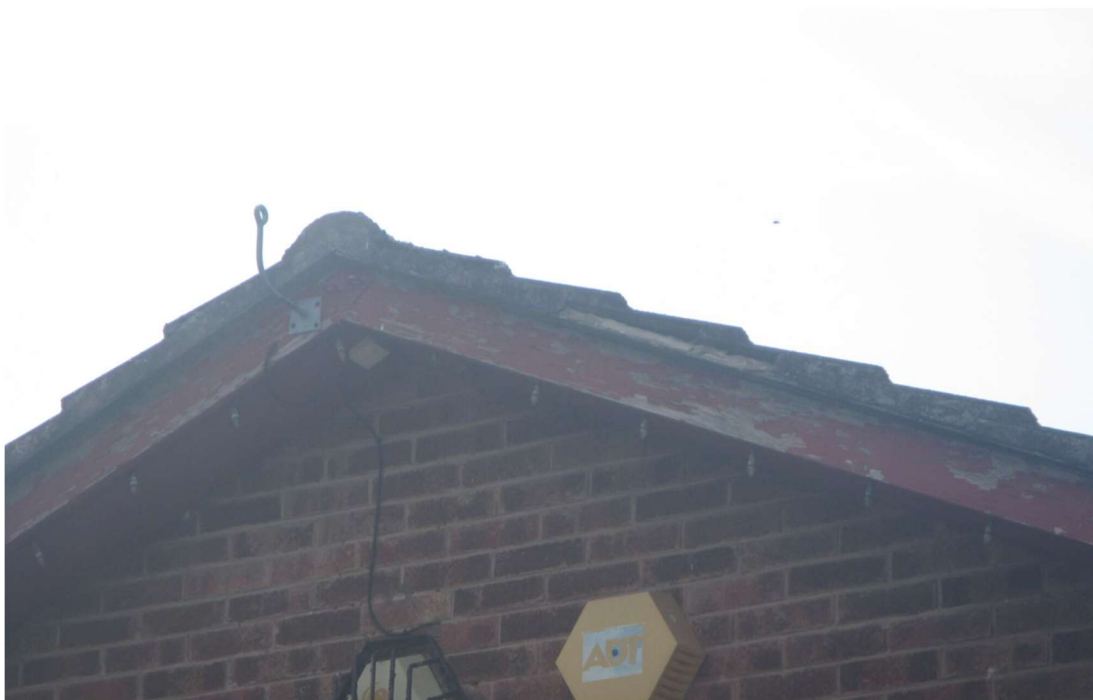
Building 7 was assessed as having moderate potential to support roosting bats due to the presence of both internal and external PRFs, such as missing or raised roof tiles, gaps within the verge pointing, cavities within the redbrick walls and gaps beneath the soffits. No evidence of roosting bats was identified within these buildings during the internal and external building inspections.

Photograph 16 – Missing mortar in the verge pointing of Building 7.

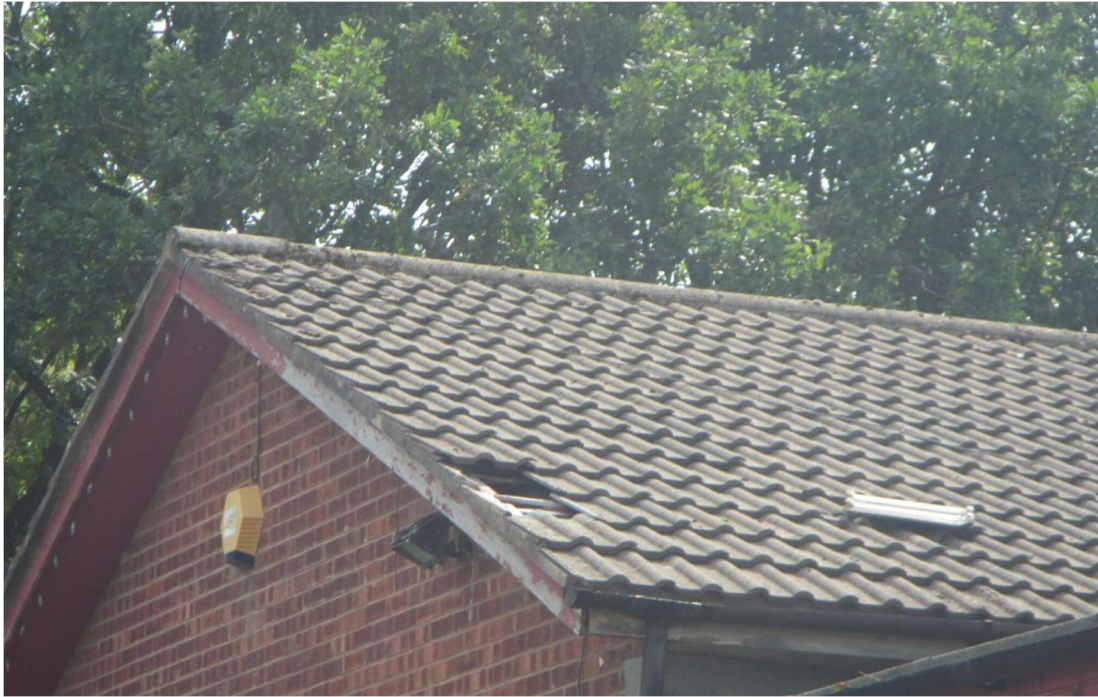
Photograph 17 – Missing tiles on the roof of Building 7.

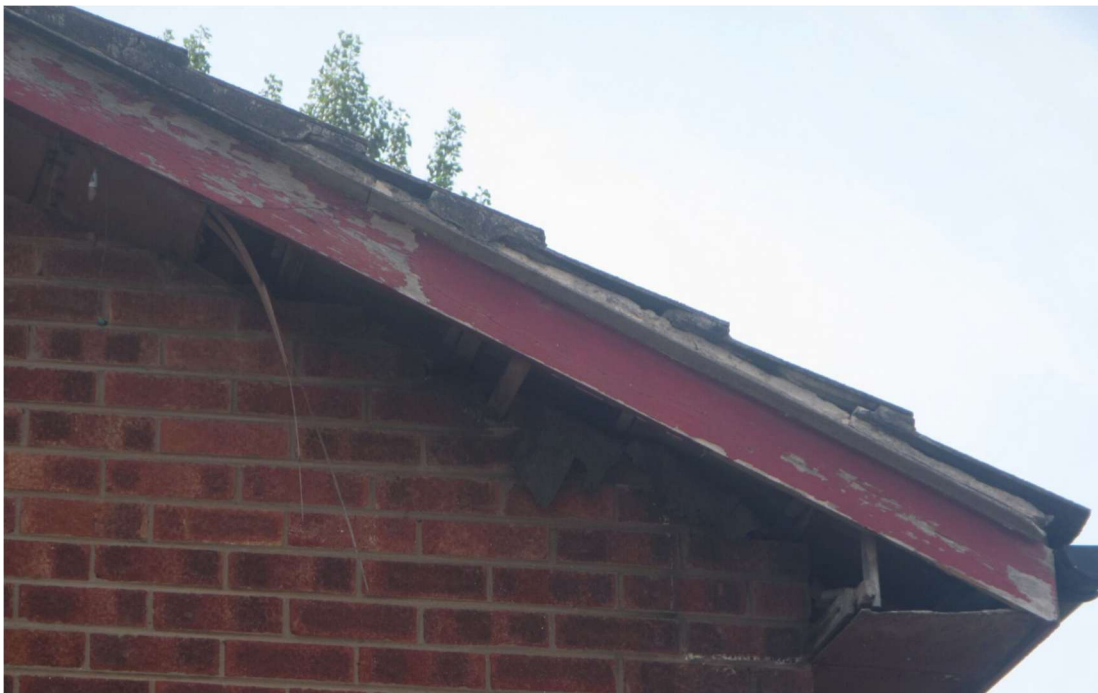
Photograph 18 – Damaged boxed soffits along the eaves of Building 7.

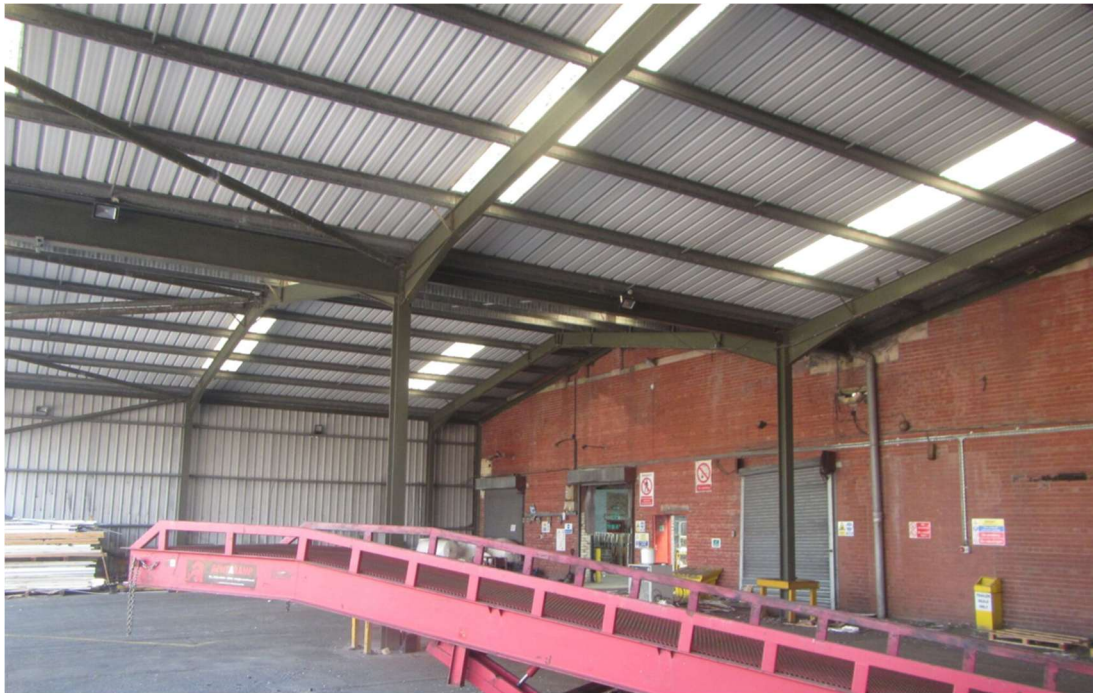
**Building 1** contains no loft void and is open from floor-to-ceiling (Photograph 19). It is a disused factory building consisting of a complex series of industrial units and as such, there is a large amount of storage and equipment present throughout. Due to the number of windows, the building is well-lit. Since there is no loft void, internal PRFs are limited to cracks and cavities within the brickwork. No evidence of roosting bats was identified within the building, but feral pigeons were observed within the building (Photograph 20).

Photograph 19 – Large open interior of Building 1.

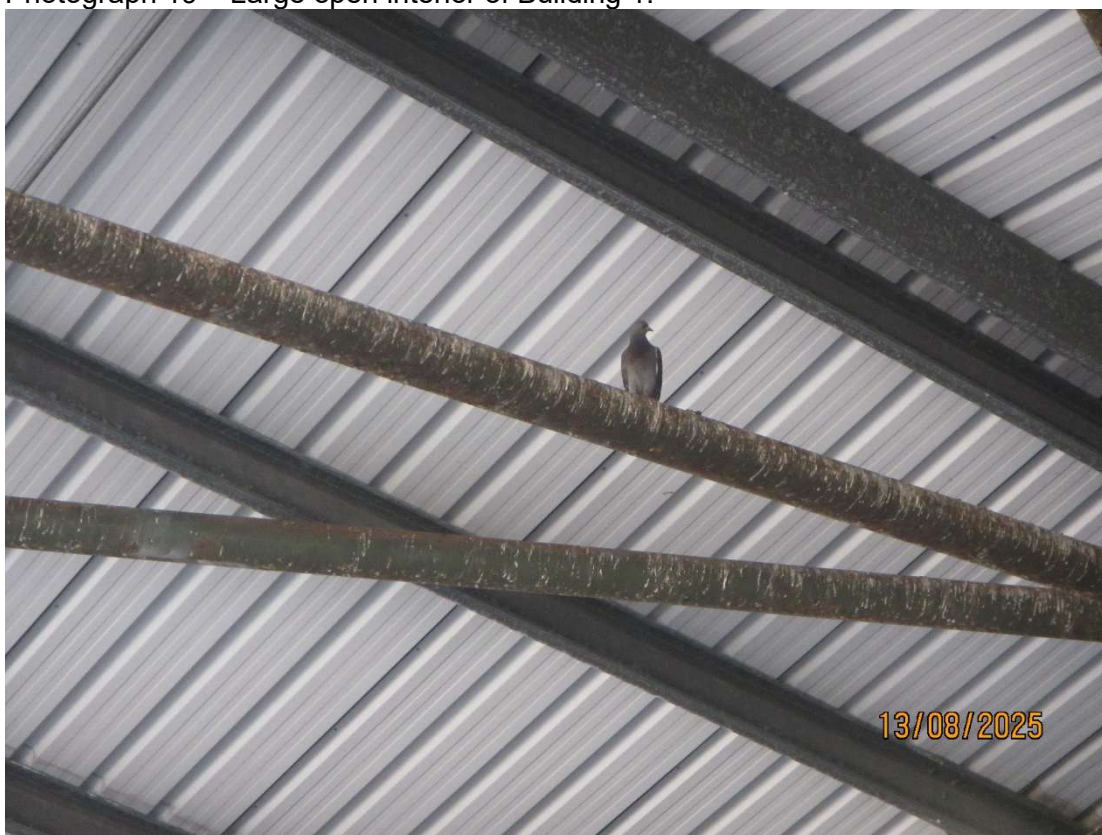
Photograph 20 – A feral pigeon within Building 1.

Feral pigeons were identified within the buildings onsite and feral pigeons are known to breed all year round. Given the number of pigeons present and the potential for birds to be nesting at the time of the proposed works, it may be necessary to engage the services of a pest control contractor who may be able to remove the feral pigeons under general licence, provided that all the necessary criteria have been met.

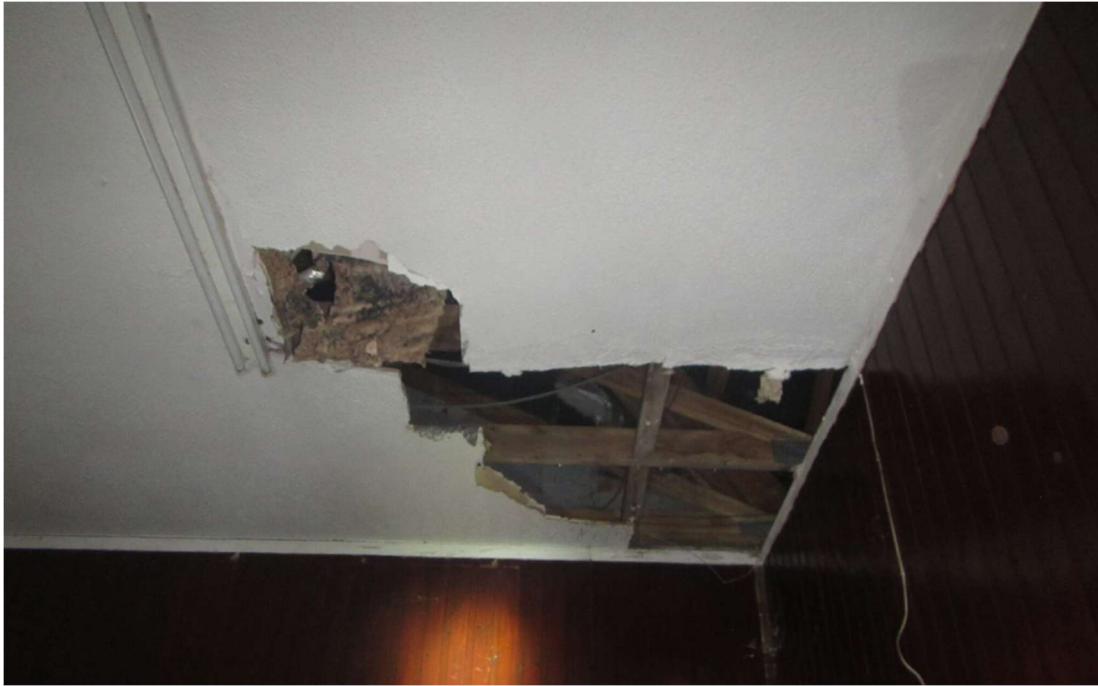
**Building 7** is a disused social club with false ceilings (Photograph 21). There is a large loft space within the building which is separated into two sections by a dividing wall. The loft has a traditional timber rafter and purlin structure, with exposed wooden joists indicating possible removed floors (Photograph 22). The roof is lined with a bitumen felt which is damaged within the western section of the roof and there is light ingress associated with the damaged felt, indicating potential access points into the building (Photograph 23). In addition, gaps were identified within the soffits along the eaves of the building which may provide further access points into the loft void. The gable end walls are constructed of redbrick and breezeblock, and PRFs were also found to be associated with these areas due to the presence of gaps above the wall plate (Photograph 24). No evidence of roosting bats was identified within the building.

Photograph 21 – A damaged false ceiling within Building 7.

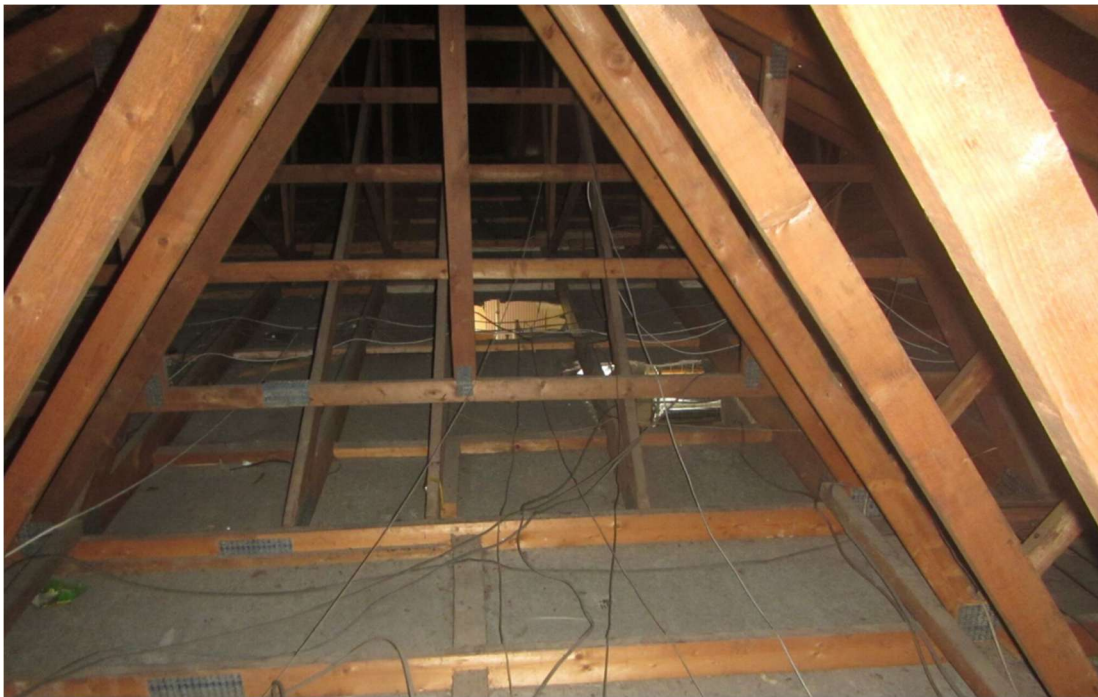
Photograph 22 – Traditional timber rafter and purlin structure within Building 7.

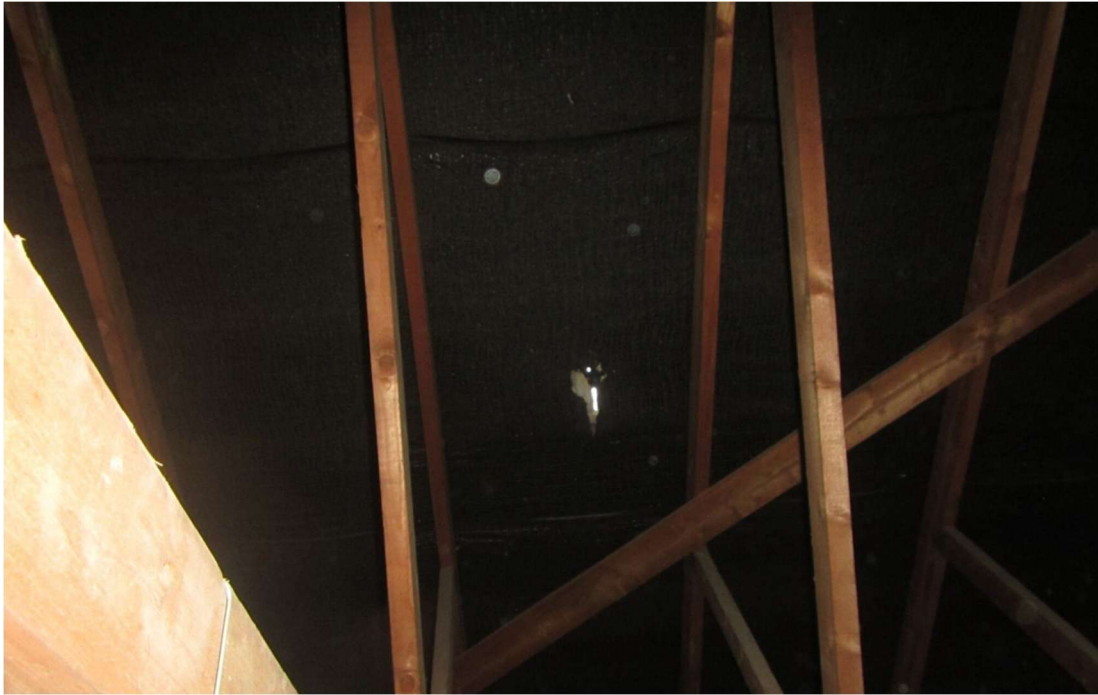
Photograph 23 – Damaged bitumen felt lining the roof of Building 7.
