# **Foxhill Farm, Ecological Impact Assessment**

**FINAL REPORT**

**Date: May 2023**

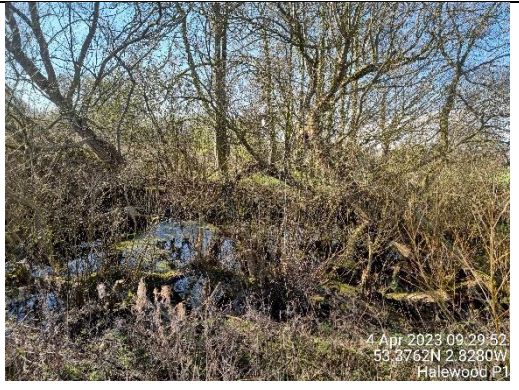
| Pond ref | Description | Photograph |
|---|---|---|
| P1 | Irregular shaped pond at the southern end of a ditch network. The water is 10 cm deep at the margins, to no more than 1 m at the centre. The pond is brown tinged with signs of nutrient enrichment (algal blooms) and slight turbidity (2/5). Several mature and dead willows sprawl across the water. The drawdown area is approximately 1-2m wide and the | |

| | margins feature willowherbs ( <i>Epilobium</i> spp.), creeping buttercup ( <i>Ranunculus repens</i> ) and yellow flag iris ( <i>Iris pseudacorus</i> ). No macrophytes other than algae were noted. The banks are gradually sloping and support bramble and willow scrub with brash and log piles. The wider area is wet, and cattle poached. | |

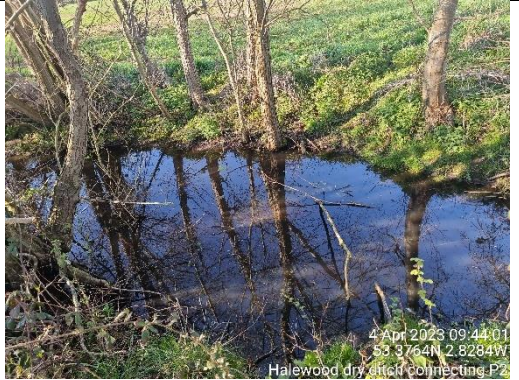
| P2 | A second pond located along the dry ditch network. The water is 20 cm deep at the margins leading to no more than 1 m at the centre. The water has a brown hue and is turbid (3/5). Marginal vegetation is sparse and limited to creeping buttercup and grasses; no macrophytes were noted. Some small algae blooms are indicative of nutrient enrichment. Willow saplings are present in the water and mature willows occur along the bank edge. The banks are steep and vegetated by common nettle, ivy, cleavers ( <i>Galium aparine</i> ), broadleaved dock and perennial rye grass ( <i>Lolium perenne</i> ). | |

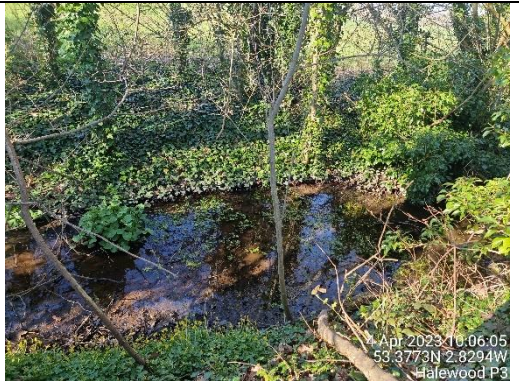
| P3 | A third pond located along the same ditch system. The water depth is 10 cm at the margins to 1 m at centre. The water has a milky hue and is turbid (3/5), but clearer at the margins. The substrate comprises thick organic matter and marginal species include marsh marigold ( <i>Caltha palustris</i> ), watercress ( <i>Nasturtium officinale</i> ) and creeping buttercup. The banks are steep, with mature oak ( <i>Quercus robur</i> ), willow, ivy, lesser celandine ( <i>Ficaria verna</i> ) and bramble scrub. | |

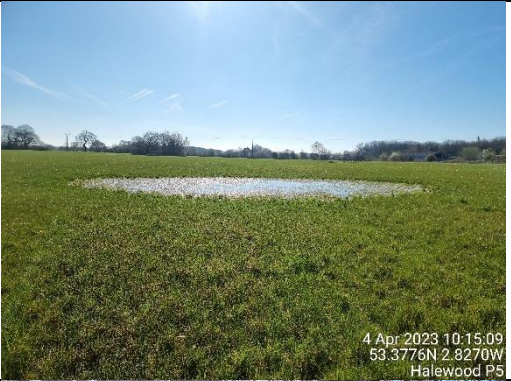
| P5 | A shallow depression within heavily poached wet grass ley. The pond is likely ephemeral, with a water depth of 1 cm at the edge, to no more than 20 cm at the center. The water is clear (1/5 turbidity) and abundant grass is present. | |

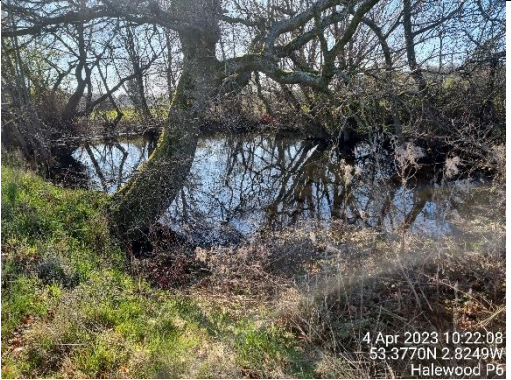
| P6 | A larger pond located in the centre of an adjacent field. The water is 20 cm at the margins, extending to approximately 1.5 m deep in the middle (it appears deeper and more permanent than the other ponds). The water is slightly turbid (2/5). No macrophytes were noted, and the marginal vegetation comprises grasses and willowherbs. Mature willows are present on banks and over hanging the pond. The banks are steep with trees and bramble scrub. The wider area is wet and cattle poached. | |

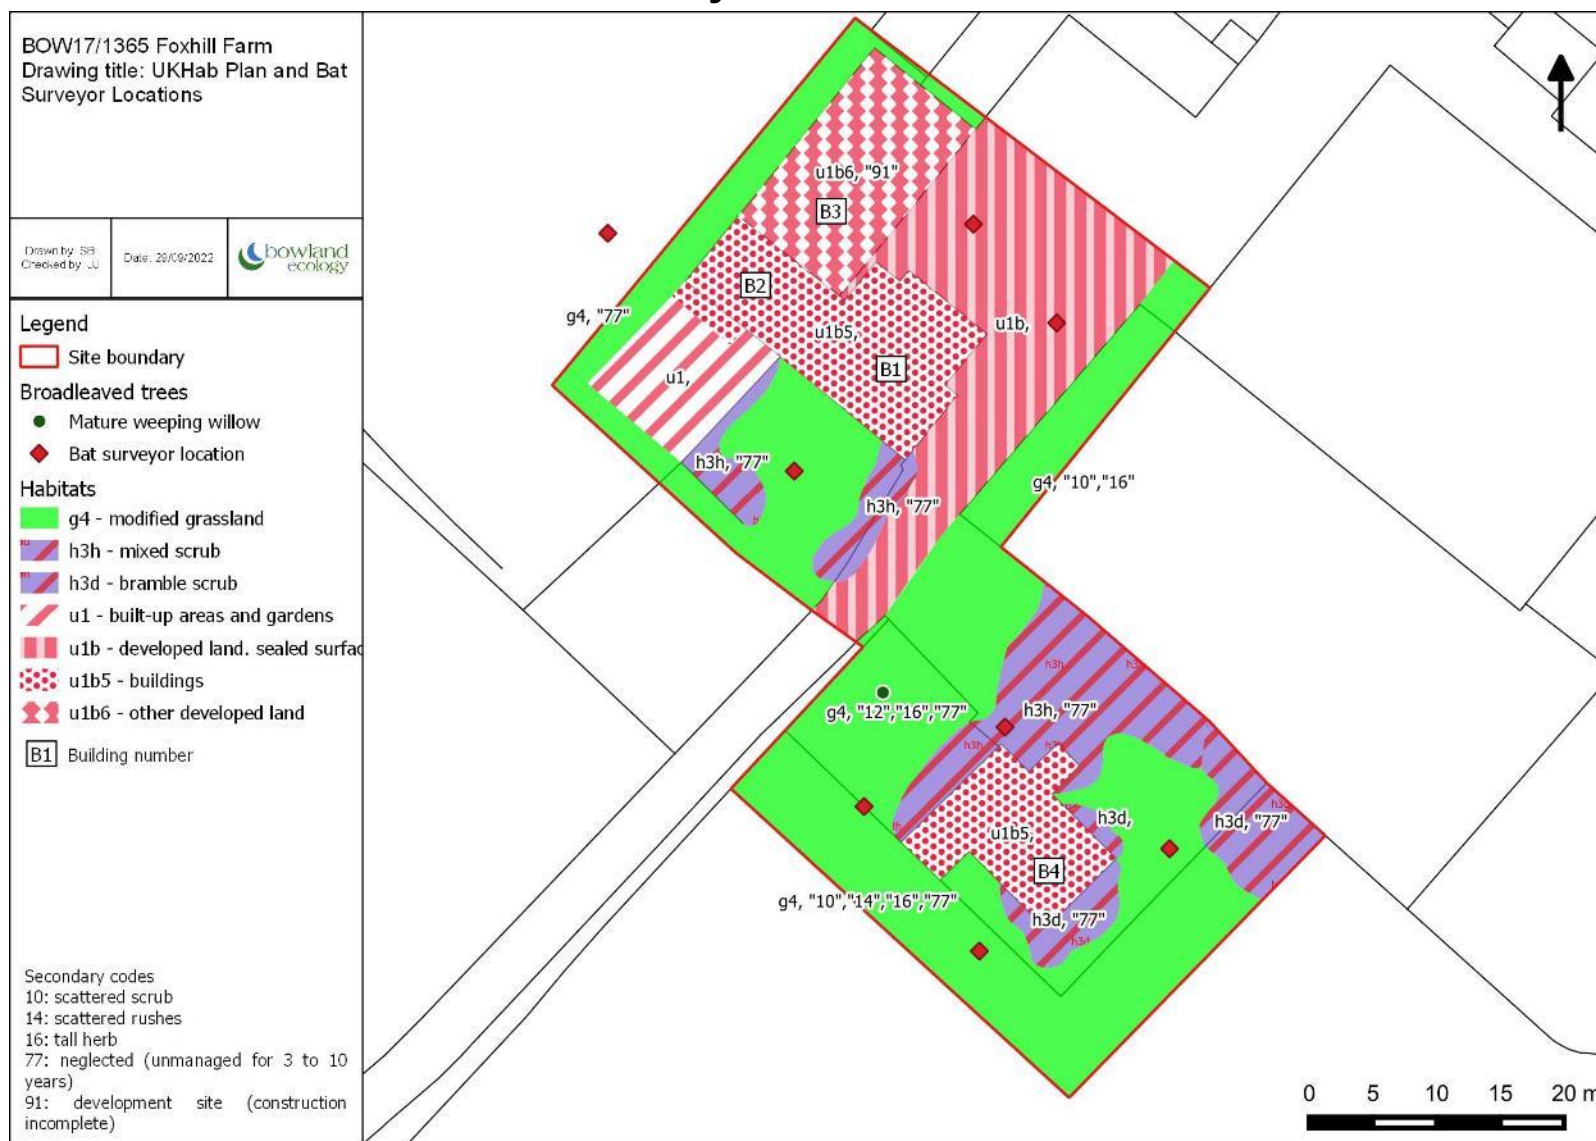
## Appendix C – UKHab Plan and Bat Surveyor Locations

- 2.16 Buildings assessed as having high suitability for roosting bats (B1 – farmhouse and B4 - bungalow) received three survey visits in total, and low suitability buildings (B2 – cottage and B3 – partly built barn) received one survey visit. The survey methodology followed the guidelines as described in Collins, 2016. Table 2 below outlines the survey dates, timings and weather conditions. Surveyors positioned themselves to get the best coverage of the buildings during the surveys and focused in on those areas with the most potential as roosting habitat (see Appendix C for bat surveyor locations).

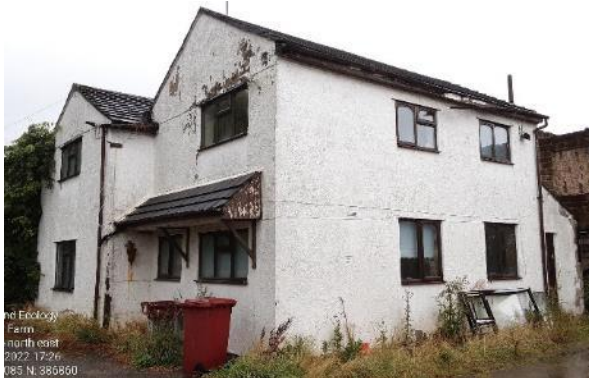
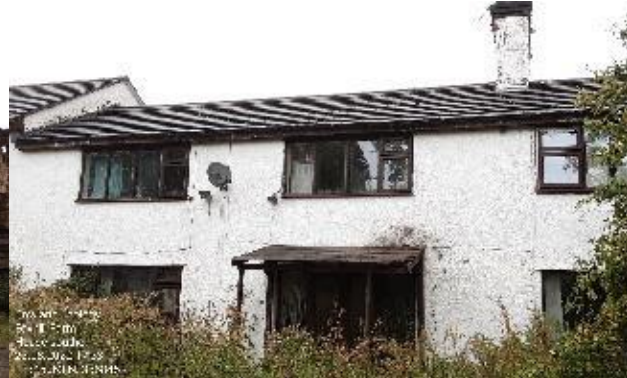
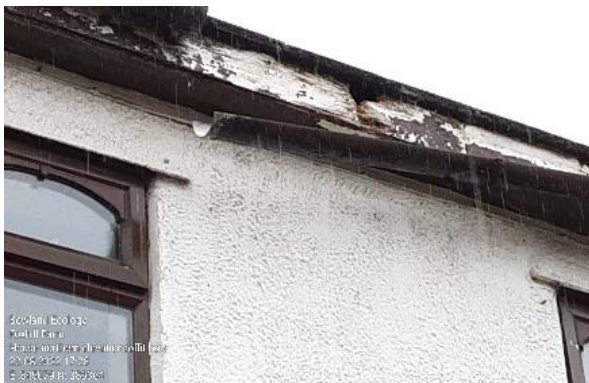
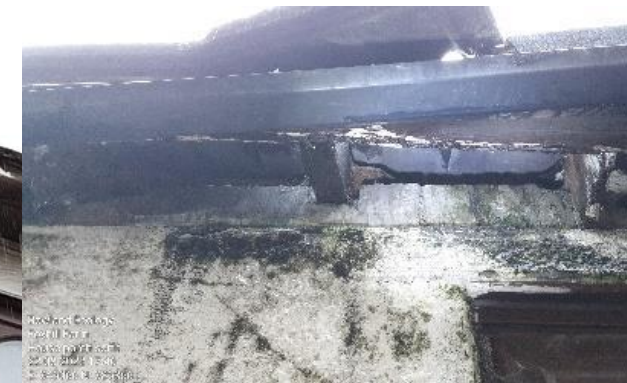
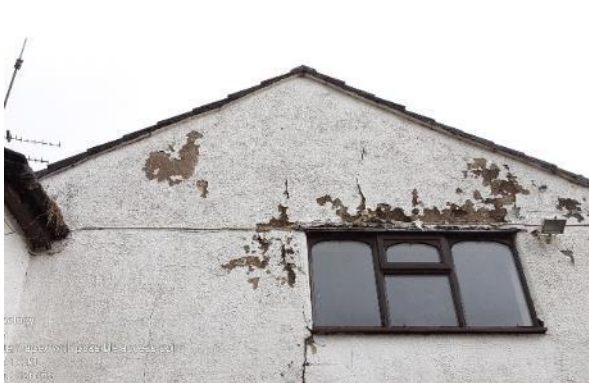
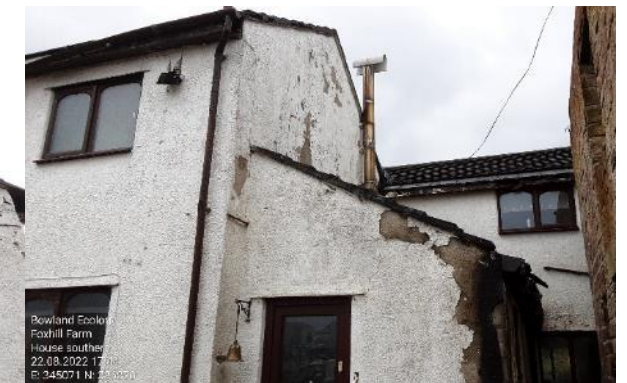
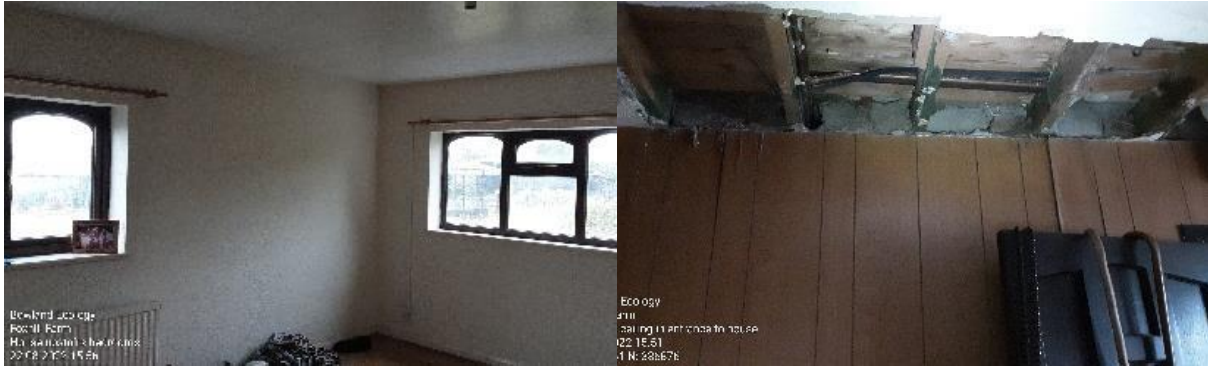
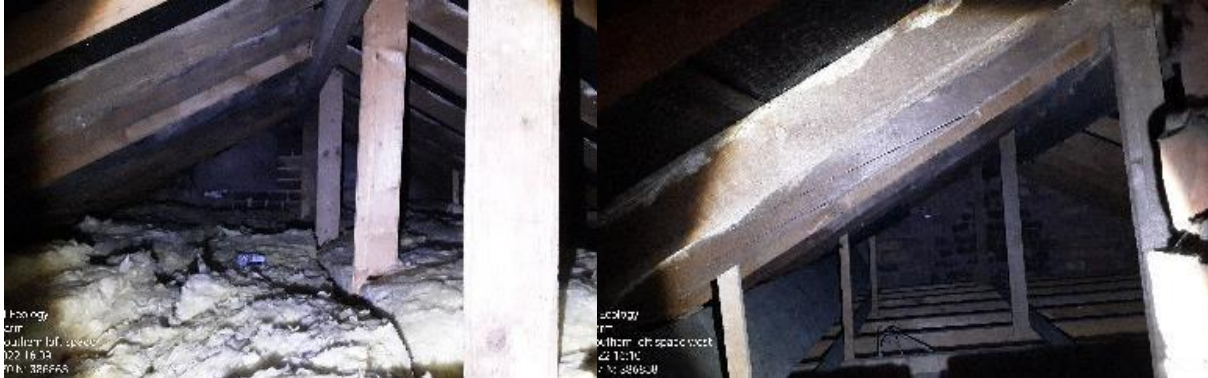
| Building Number | Description | Photographs |
|---|---|---|
| B1<br>(unoccupied) | <p><u>Overview</u></p> <p>A large two-storey neglected farmhouse with rendered breeze-block walls and two parallel double-pitched roofs, both orientated north-west to south-east (Plate 1). Both roofs are covered with interlocking tiles over a bitumen felt liner. The southern part of the farmhouse adjoins the cottage (B2) and the northern part has a lean-to extension located on its north-western elevation. The building has UPVC windows and features a small mono-pitched roof over the ground floor windows on the south-west elevation and a mono-pitched porch at the rear (Plate 2). A heavily degraded timber soffit box and associated guttering lines the roof verge along the north-east and south-west elevations. The gables are mortared and lack barge boards.</p> <p><u>External Inspection</u></p> <p>The ridge along the northern elevation appears to be well sealed, although there are some gaps beneath the roof tiles close to the roof verge, where bats could potentially roost under or gain access to the loft void. The soffit is also rotten in many places along the roof verge, with large gaps creating potential access points for bats along the main roofs and the lean-to extension (Plates 3 and 4).</p> <p>At the apex of the south-eastern gable there is a gap below the ridge tile, providing a PRF (potential roosting feature) for bats (Plate 5). The wooden porch on the same elevation is rotting, and the gaps between the wood and tiles may provide opportunities for crevice dwelling bats. Similar gaps are present at uncovered gable verges and the edge of the lean-to roof along the north-western elevation (Plate 6).</p> <p>The roof tiles on the south-western elevation are generally well sealed, although the soffit is very rotten in places with large gaps. There is a brick chimney with lead flashing surrounding the base, which has a small gap in the brickwork towards the base. Viewed from the north, there are also several small gaps along the ridgeline and the soffit above the alleyway between the two buildings is very rotten with large gaps (Plate 6).</p> <p><u>Internal Inspection</u></p> <p>Internally, the ground floor appeared to have been recently used. All the doors and windows across both floors are well sealed and in good condition (Plate 7). At the entrance of the building, the ceiling joists are exposed, however no obvious gaps with suitability for bats were present (Plate 8). The lean-to extension of the north-western elevation has a pitched ceiling and does not feature a roof void. On the first floor, there is a small hole in the ceiling above the hot water tank, potentially providing an access point from the loft space above. However, as the building is unoccupied and likely unheated, this would be unlikely to attract bats. In general, the interior space across both floors is well lit from uncovered windows and is unlikely to provide suitable roosting opportunities or access points for bats.</p> <p>There are two access hatches into the roof voids on the first floor; both voids could not be accessed fully as they were not boarded. Insulation was present between joists across the majority of the visible loft space. The southern (larger) loft void above the bedrooms is divided into sections by brick walls. A small hole was noted along the ridge with some light ingress just above the ridge beam, which may provide possible access for bats. The roof is lined with traditional bitumen felt, which is generally well-sealed although some sections are starting</p> | <p>Plates 1 and 2: External views of the farmhouse (front and rear elevations)</p> <p>Plates 3 and 4: Degraded soffit box along main roof and lean-to extension</p> <p>Plates 5 and 6: Gap at south-eastern gable end below ridge tile gaps at roof verges on north-west elevation</p> |

| | <p>to degrade and there are minor gaps between overlapping sections, which could be used by roosting bats. Rat and mouse droppings were observed around the loft hatch. The northern loft void above the bathroom leads to a similar space, with more cross trusses present and is only partly insulated. The felt lining is in good condition and tightly overlapped at the apex. Mouse droppings were observed across the floor of the roof void. No bats or signs of roosting bats were observed in either loft void.</p> <p>Overall, the farmhouse (B1) is assessed as providing <b>high suitability</b> for roosting bats. The building provides multiple PRFs, primarily associated with exterior features, which have developed due to lack of repair work and maintenance to the building.</p> | <p>Plates 7 and 8: Internal space and stripped area of ceiling on ground floor</p> <p>Plates 9 and 10: Internal loft spaces</p> |

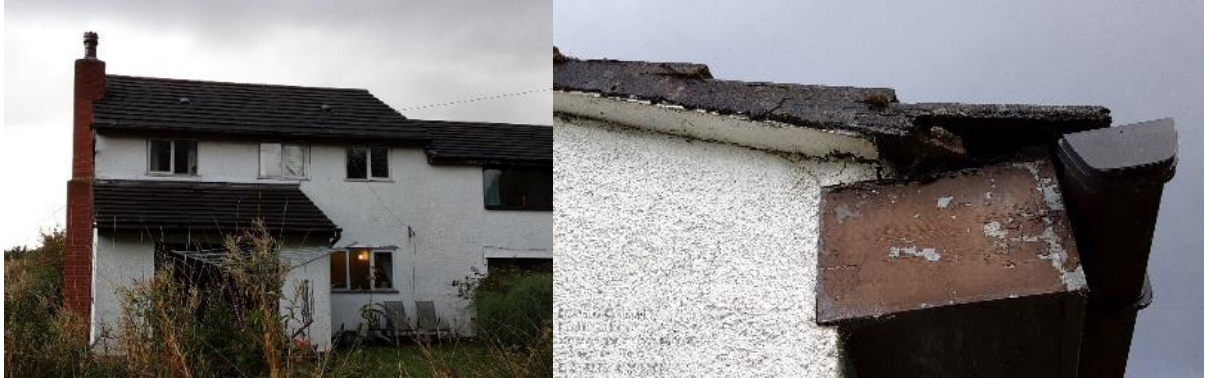
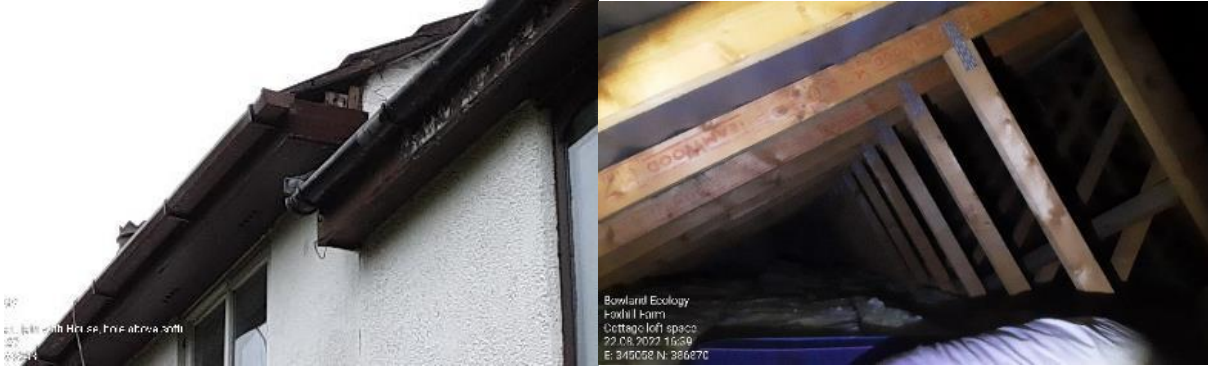
| B2 (currently inhabited) | <p><u>Overview of building</u></p> <p>A smaller two storey property (referred to as the cottage) adjoins onto the north-western elevation of the farmhouse (B1) (Plate 11). The cottage is of a similar construction to the farmhouse but is in a much-improved state of repair and is currently inhabited by site owners. The building has a mono-pitched extension to its south-western elevation. A red brick chimney protrudes from the north-western elevation. The main roof is double pitched and covered with interlocking tiles, with a timber soffit box along the eaves. The cottage adjoins the wall of B3 along the north-eastern elevation.</p> <p><u>External Inspection</u></p> <p>The cottage features timber framed windows which appear to be well sealed with no potential access for bats. The interlocking roof tiles are flush with no gaps between them or along the ridge line. The soffit boxes (to the main roof and lean-to extension) are generally in good condition, although a gap was noted between the soffit box and roof tiles on the lean-to extension (Plate 12). A similar gap is also present at the southern corner of the main roof, where it adjoins B1 (Plate 13). These gaps may provide access into the loft void if suitable gaps are present under the tiles.</p> <p><u>Internal Inspection</u></p> <p>The building is warm and well-sealed internally. The single main (not boarded) loft void could be viewed from a loft hatch on the first floor. A plastic roof lining appears new and is well sealed. There is no ridge beam, but cross trusses are present every 0.5m and there is thick insulation across the floor of the void (Plate 14). No light</p> | <p>Plates 11 and 12: Exterior view from the rear garden; gaps at roof verge to lean-to extension</p> <p>Plates 13 and 14: Potential access gap at southern corner of main roof; internal loft void</p> |

| | <p>ingress, including from the corners of the loft (corresponding with gaps observed during the external inspection) was observed. Mouse droppings were evident surrounding the loft hatch. No bats or signs of roosting bats were recorded.</p> <p>Overall, the cottage (B2) is assessed as providing <b>low suitability</b> for roosting bats. The building is in good condition and PRFs are limited to open gaps at the corners of the roof which may not provide access to suitability sheltered roosting locations.</p> | |

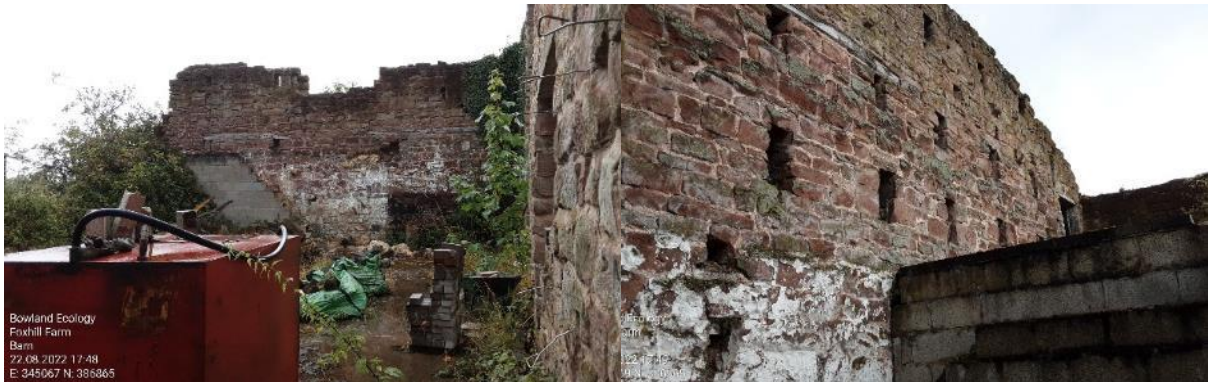
| B3 | <p><u>Overview of building and external inspection</u></p> <p>A partially converted barn is essentially the shell of a building with solid red sandstone walls and no roof (Plates 15 and 16). Construction ceased several years ago and never re-commenced; scaffolding is still installed around part of the barn. Some breeze block walls are present towards to southern part of the barn and metal and concrete lintels for windows/doors have been installed along the south-east and north-western elevation. There are no windows or frames currently installed. The inspection found no evidence of bats. Potential roosting features for bats include gaps and crevices in the stone walls and gaps in lintels on the south-eastern elevation. However, the building is not watertight and is exposed to the elements, which reduces the suitability of these PRFs. Overall, the barn is considered to have <b>low suitability</b> for roosting bats.</p> | <p>Plates 15 and 16: External views of partly completed barn</p> |

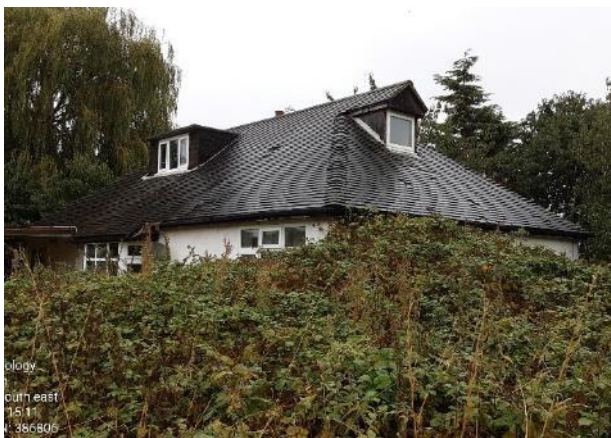
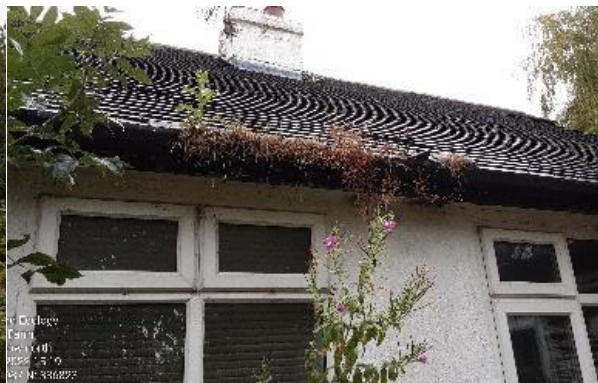
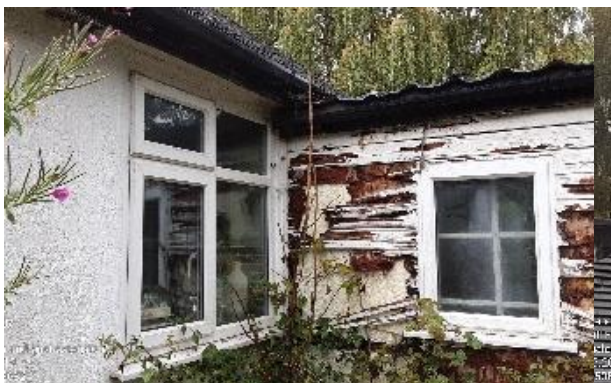
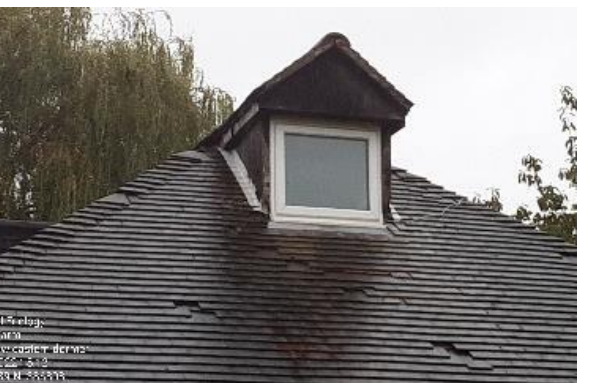
| B4<br>(Bungalow) | <p><u>Overview of building</u></p> <p>A dormer bungalow is located to the south of the other properties within the site, surrounded by dense scrub and unmanaged grassland (Plate 17). The bungalow has not been occupied for several years and is in a poor state of repair. The main roof is hipped and covered with interlocking tiles; it features three dormers and a chimney on the north-eastern pitch. A corrugated extension is also present on the north-eastern elevation and a porch overhangs an area of decking extending from the south-western elevation.</p> <p><u>External Inspection</u></p> <p>The small flat roofed (corrugated metal) extension to the northern elevation has timber panelling across the external walls, many areas of which are rotting and falling loose which could offer PRFs for crevice dwelling bats. The main roof verge along the northern elevation is generally well sealed, however there are some gaps present in the lead flashing around the chimney.</p> <p>Across all elevations of the main roof there are several missing/slipped roof tiles, including ridge tiles at adjoining sections (Plate 20). The majority do not appear to create suitable access gaps for bats, however where tiles are missing completely there may be access underneath adjacent tiles or the liner and potentially into the loft void. The two dormers at either end of the main ridge feature gaps at the verge and apex of their pitched roofs and possible gaps between timber and lead flashing and around the UPVC window, where external timber structure has degraded over time (Plate 20). The flat-roofed dormer on the south-western elevation has sections of hanging felt, which has come loose and may offer suitable PRFs for roosting bats (Plate 21).</p> <p>The south-western elevation also features bay window with a short section of roof extending over it. Timber at the roof verge is rotten and there are large gaps at either side of the bay window, providing potential access and roosting opportunities for bats (Plate 22). Along the north-western elevation, a large hole is present in the soffit box, however elsewhere the boarding is relatively well sealed. There is also an air vent lacking any mesh,</p> | <p>Plates 17 and 18: External views of bungalow and surrounding dense vegetation</p> <p>Plates 19 and 20: Degraded timber cladding on extension and slipped/missing tiles across main roof</p> |

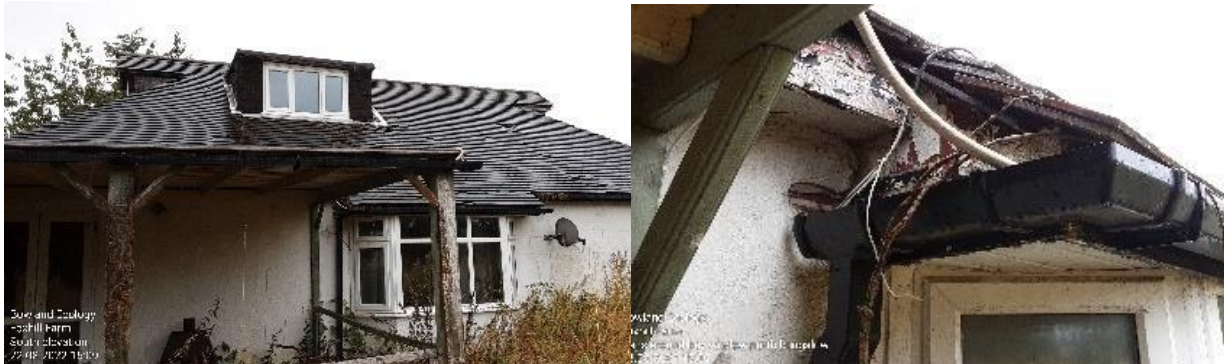
Plates 21 and 22: Dormer on south-western elevation and gaps at adjacent bay window

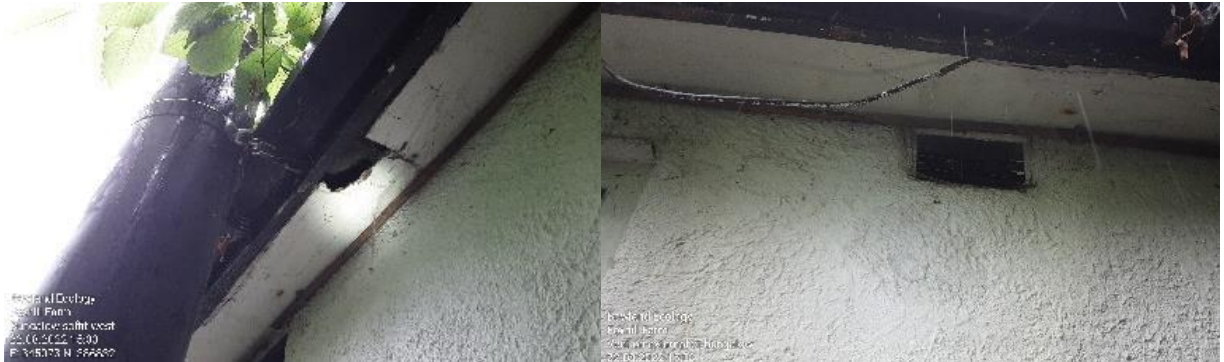
which may provide a potential access point (Plate 24).

Plate 23 and 24: Eastern elevation hole in soffit box and air vent

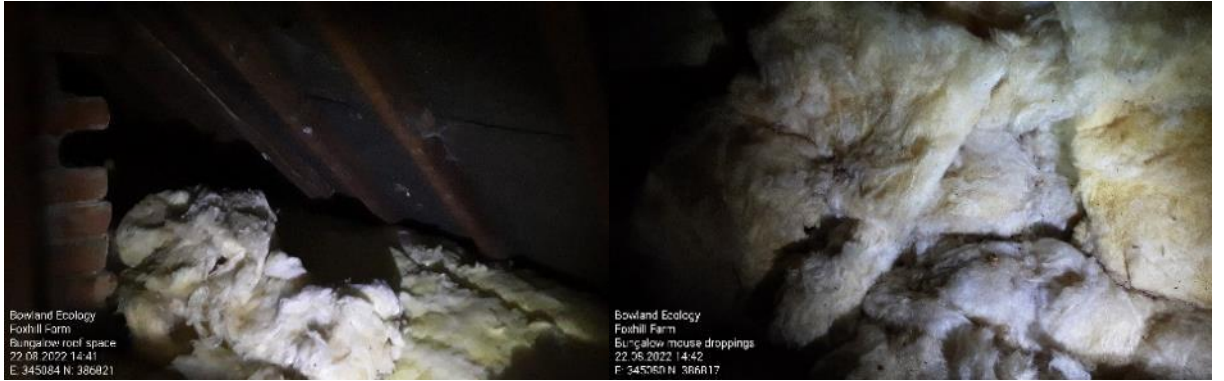
On the first floor there are two rooms, surrounded by a sloping roof void which was be viewed through open hatches (Plates 27 and 28). It was noted that the upper rooms were significantly warmer than the rooms on the ground floor. The underside of the main roof is lined with tradition bitumen felt which was degraded in some areas, with torn sections and gaps between overlapping layers. Wooden rafters extend to meet large wooden beams with trusses where they meet the internal walls. No light ingress could be seen, although insulation covered the floor of the void. Mice droppings were observed within the crawl space. No bats or evidence of bats was observed.

Plates 27 and 28: Loft voids (crawl space around upper rooms)

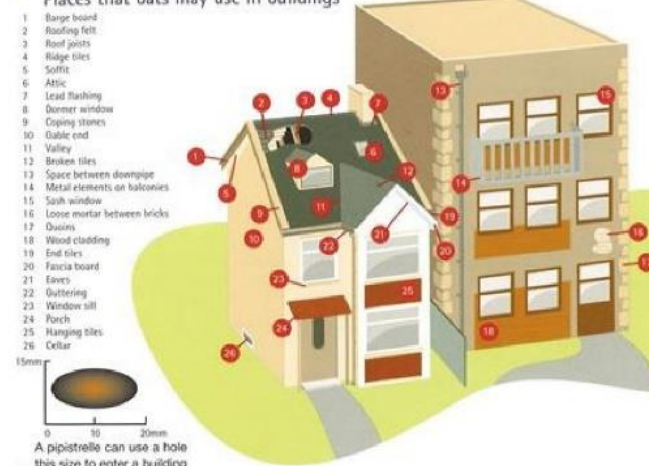
### Places that bats may use in buildings

Schematic from [www.bats.org.uk](http://www.bats.org.uk)

- The top of gable end or dividing wall;
- The top of chimney breasts;
- Ridge and hip beams and other roof beams;
- Mortise and tension joints;
- All beams/ceilings/pipework (free hanging bats);
- The junction of roof timbers, especially where ridge and hip beams meet;
- Behind purlins;
- Between tiles and the roof lining;
- Under flat felt roofs;
- Under barge boards;
- In cavity walls;
- In cracks in stone or concrete;
- Behind peeling paint/wall coverings;
- Gaps behind window and door frames;
- Between window panes and timber boarding.
- In trees (cracks/holes/ivy cladding).
