## **BAT PRESENCE / ABSENCE SURVEY**

### **Huyton Cricket Club**

Huyton Lane  
Huyton  
Liverpool  
L36 7XD

| UES reference: | UES04790/03 |

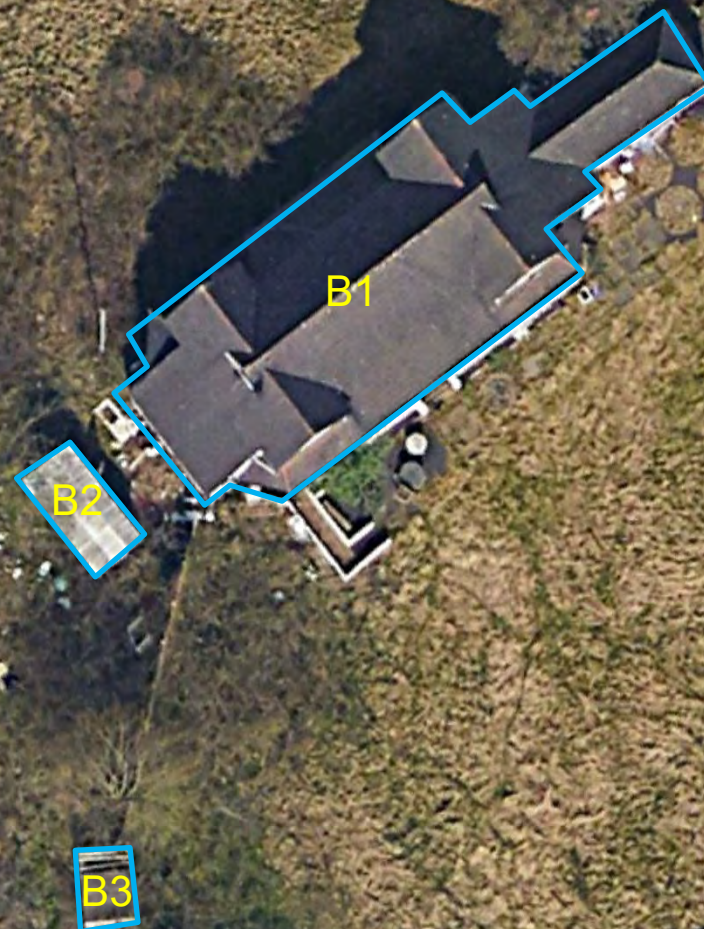
## Site plan

There are three buildings at Huyton Cricket Club, these buildings have been numbered for the purposes of the report (see Appendix 1 – Site plan).

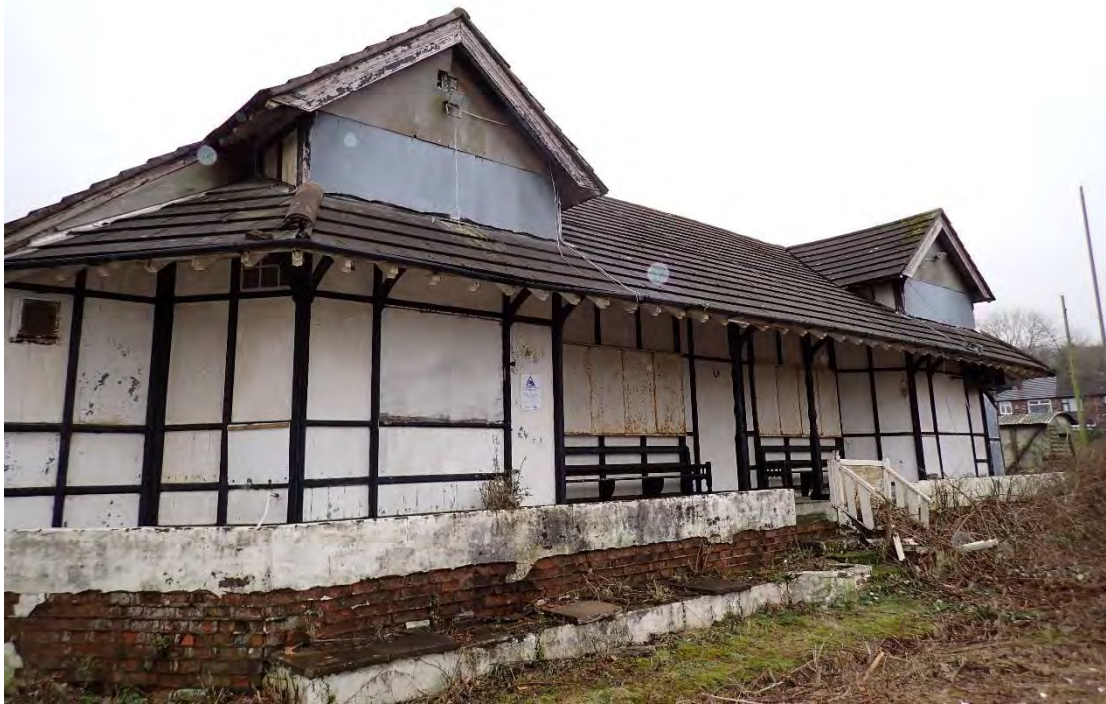
**Building 1** is the pavilion building, which is generally in poor repair. It is of dormer bungalow construction, with a total of 6 dormers (on all aspects). The building features numerous PRFs which may be used by bats:

Photograph 1 – Southwestern aspect of *Building 1*

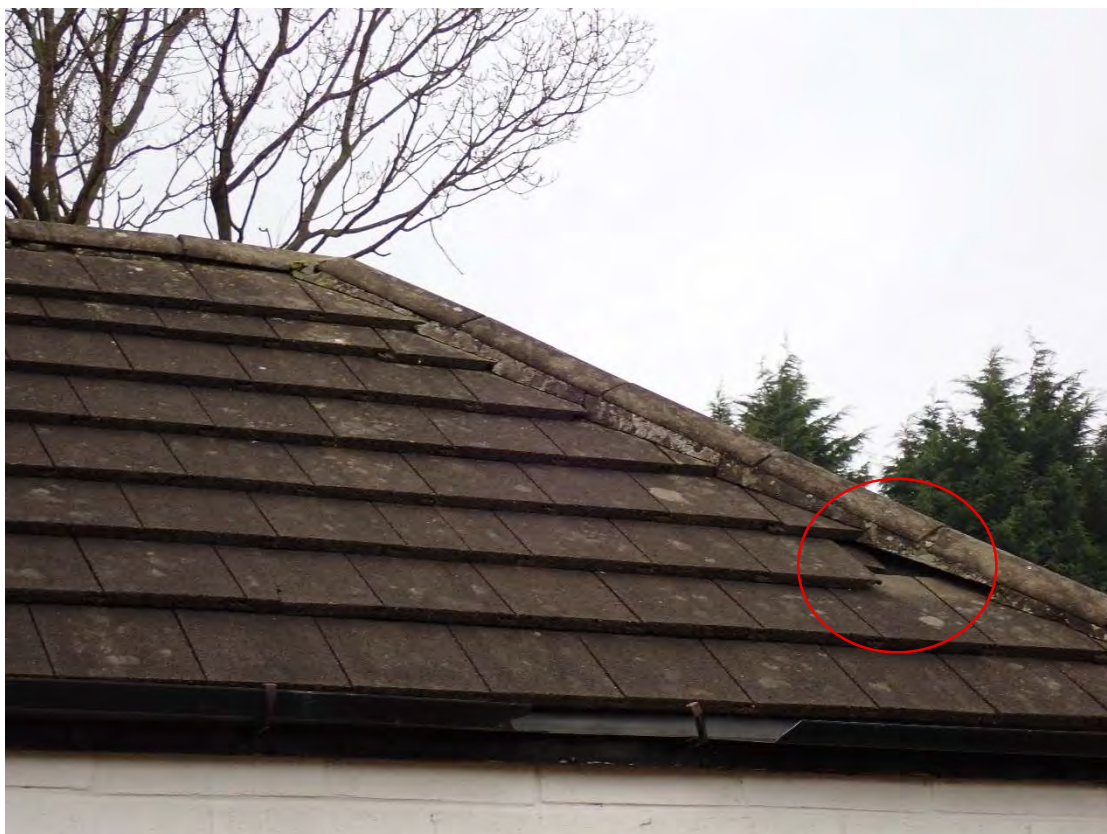
- Numerous raised and missing roof tiles
- Gaps in the verge pointing of the roof
- Raised lead flashing around dormers
- Deteriorated timber cladding with gaps creating crevices and also permitting internal access
- Deteriorated timber fascia and bargeboard with gaps

Photograph 4 – Missing roof tile on Building 1.

Although no bats were recorded roosting within Buildings 1 and 2 during the updated surveys, due to the known presence of a historic common pipistrelle day roost within Building 1 in 2020, there remains a residual risk that bats may use the building to roost in the future. As such, the works to Building 1 should proceed under a non-licensed method statement to protect bats in the event that they are present at the time of the works. The method statement will outline the mitigation and compensation measures required to safeguard protected species throughout the duration of the development.

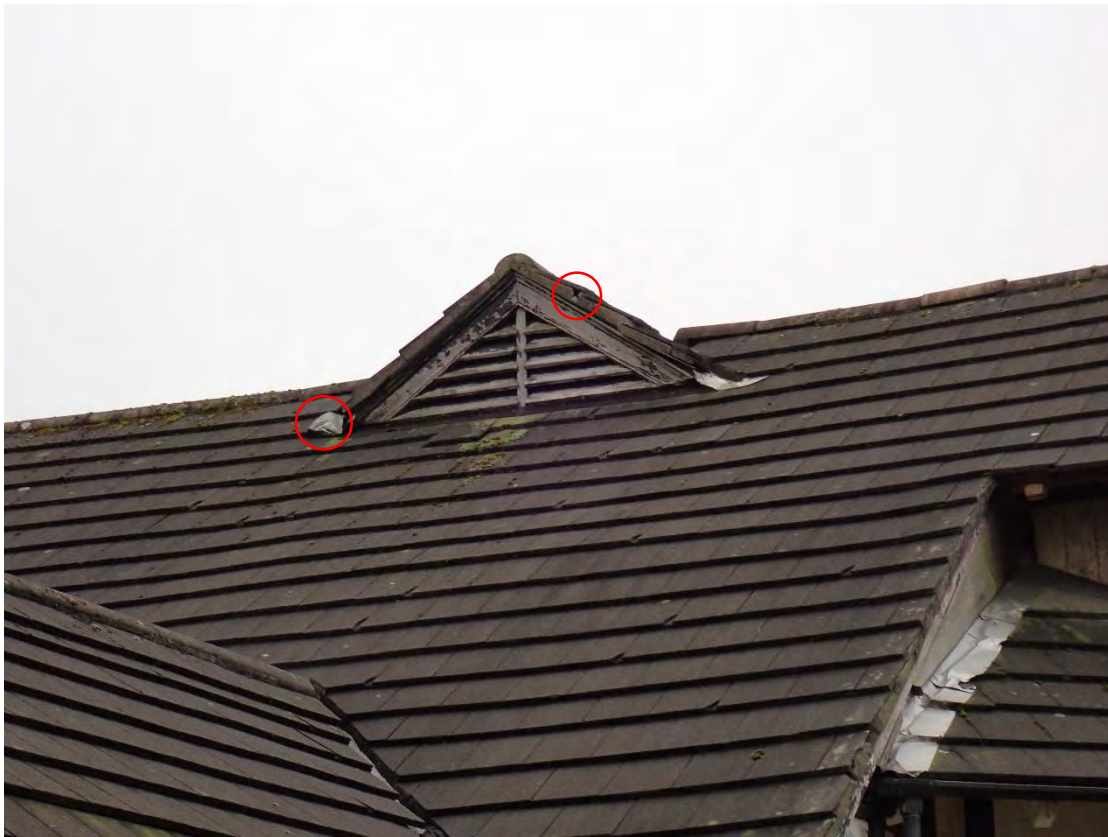
Photograph 5 – Gaps in the mortar of the end tiles and underneath the raised lead flashing on Building 1.

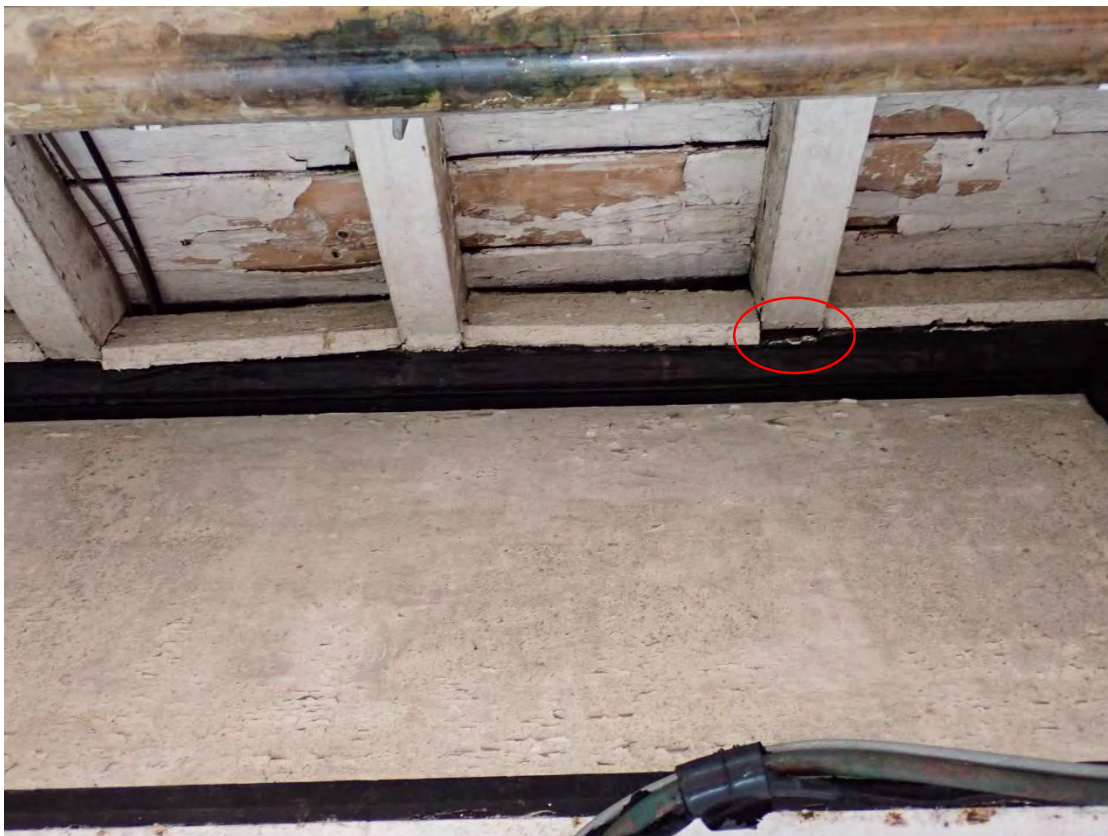
Photograph 6 – A gap in the overhanging porch where the timber connects to the wall plate.

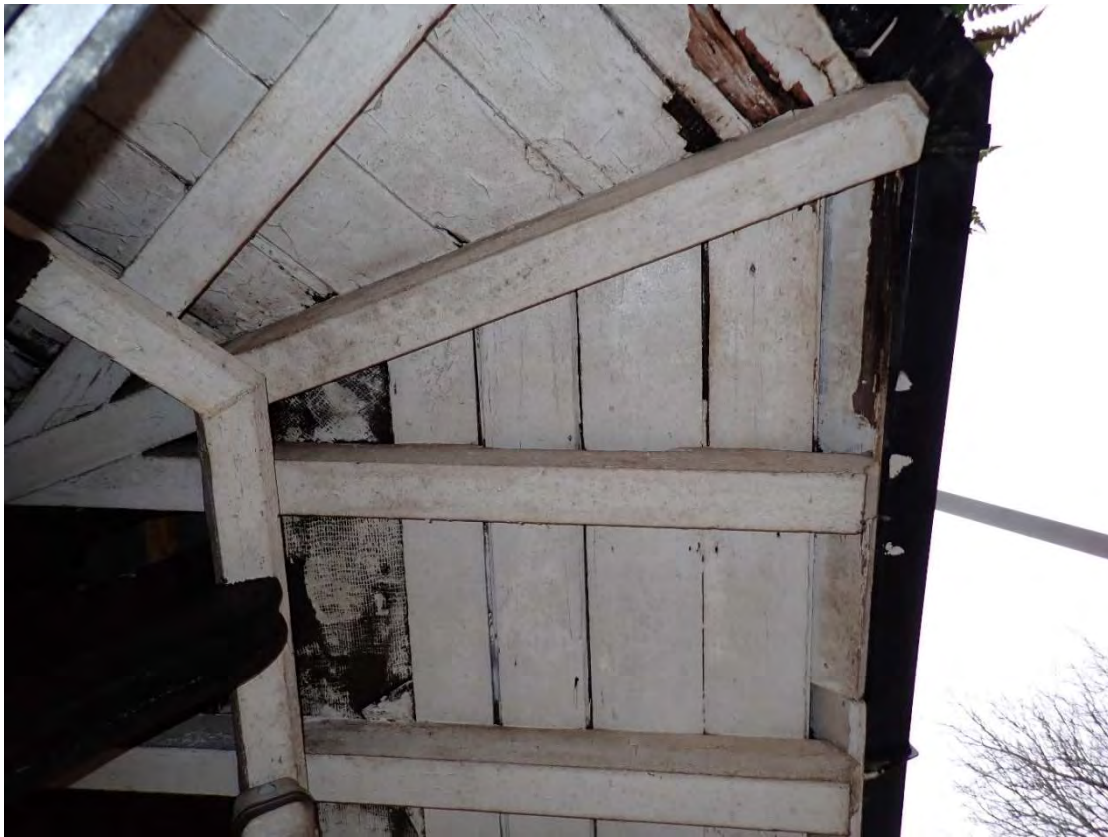
Additionally, there is a gap between the gutter pipe and the overhanging eaves on the southern aspect (photograph 7). This area is where a confirmed common pipistrelle day roost was observed during bats surveys in 2020 by Bowland Ecology. A historical birds' nest was identified on the north-eastern eaves.

Photograph 7 – Gaps between the bitumen felt and timber which creates a suitable crevice for bats.

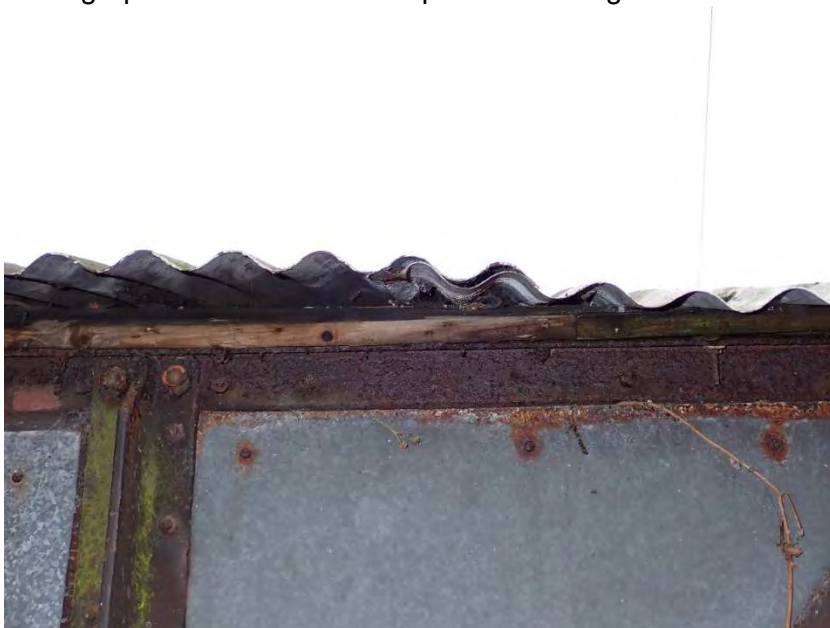
**Building 2** is a disused outbuilding: constructed from corrugated metal sheeting (timber frame), with a curved corrugated roof. The building is mostly tightly sealed, presenting limited opportunities for roosting bats. The only PRFs identified are small gaps between the corrugated roof and timber frame of the building; these lead to a cavity between internal timber cladding, thus presenting a suitable PRF for bats.

**Building 2** is internally lined with timber cladding; the external PRFs lead into a cavity between the roof and the cladding, providing a suitable opportunity for bats.

Photograph 10 – A gap between the timber cladding and corrugated roof on Building 2.

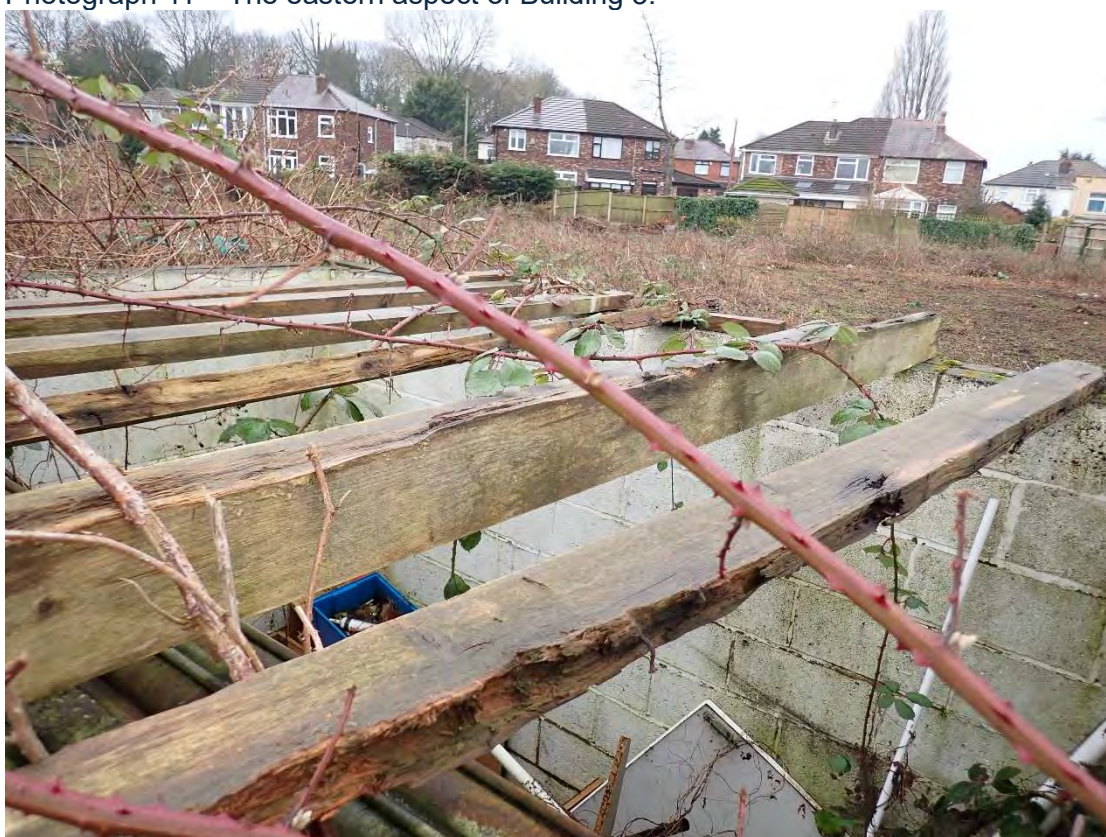
**Building 3** is also a disused outbuilding. The roof of the building is missing, but the timber rafters remain. The walls are constructed of breeze block which feature cavities between them; due to the exposed top of these blocks, it is assessed as unsuitable for use by bats. A gap is present in the brickwork above a roller shutter door on the south-western aspect, however, this is also exposed to poor weather and assessed as unsuitable. The building is surrounded by bramble on all sides apart from the western aspect, creating a cluttered environment. No bat droppings were found during the external building inspection.

**Building 3.** Although internal access was not provided at the time of the survey, the building has no roof, so the surveyors were able to view the interior using ladders. No suitable PRF's were identified. Furthermore, as the building has no roof, it is exposed to the elements, making it unsuitable for bats to roost.

Photograph 12 - Remaining timber rafters on Building 3, showing the absence of a roof.

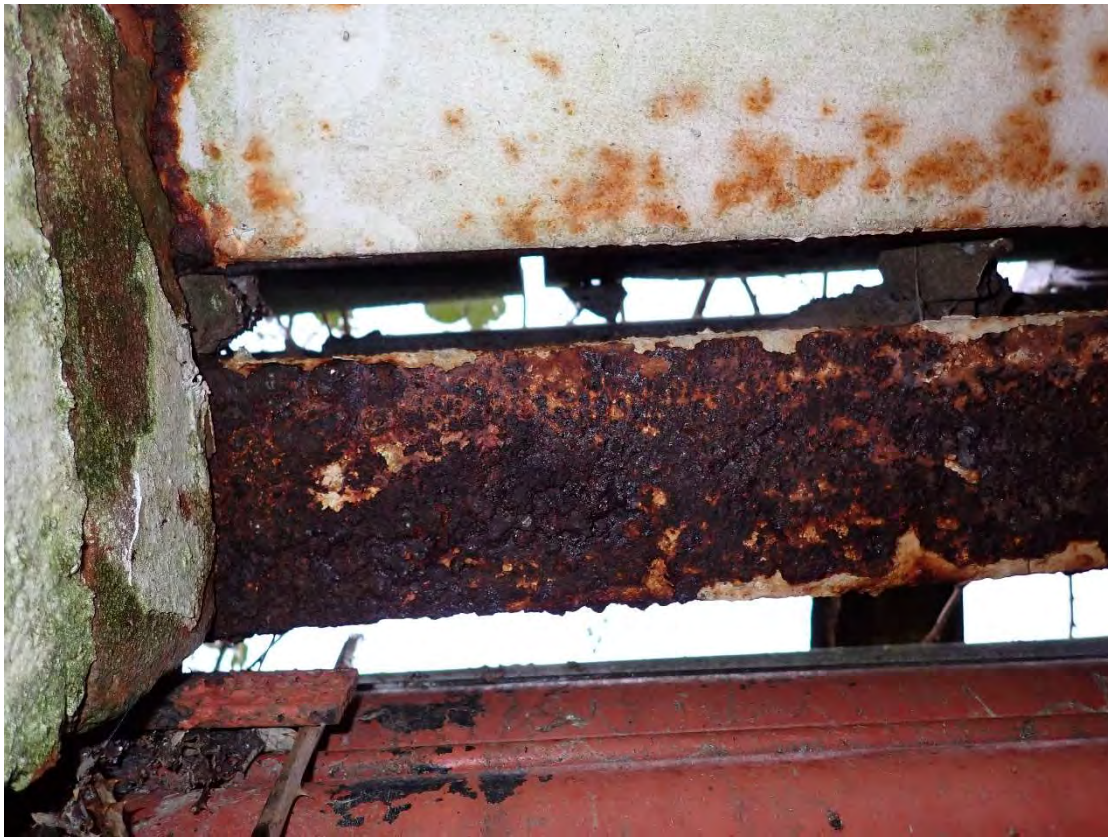
Photograph 13 – Gap above the roller-shutter door on Building 3.

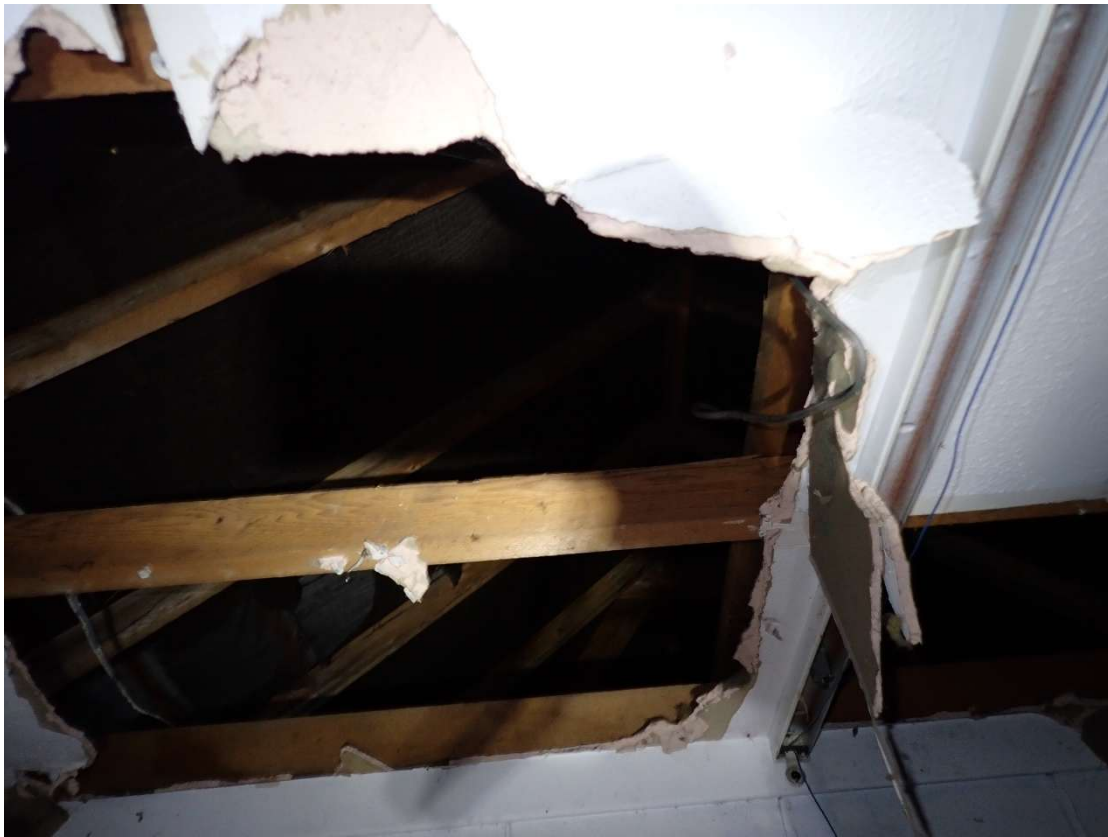
**Building 1** is in very poor condition internally too; both vandalism and water damage have rendered the building unsafe in some areas, and it is cold and draughty. There are five loft voids present within the building, which could not be fully inspected due to health and safety concerns, however they were viewed either from loft hatches or through holes in the ceiling. The loft spaces are constructed of timber rafters and purlins with bitumen felt lining, which appears to be torn in some areas throughout the inspected loft voids. Additionally, cobwebbed areas are visible throughout. There is some light ingress entering through the boarded-up window and the interior timber cladding, which showed significant damage.

Photograph 17 – Damaged ceiling within Building 1.
