## Huyton Cricket Club, Huyton

### Phase 1 Geo-Environmental Investigation Report

For: Breck Homes Ltd

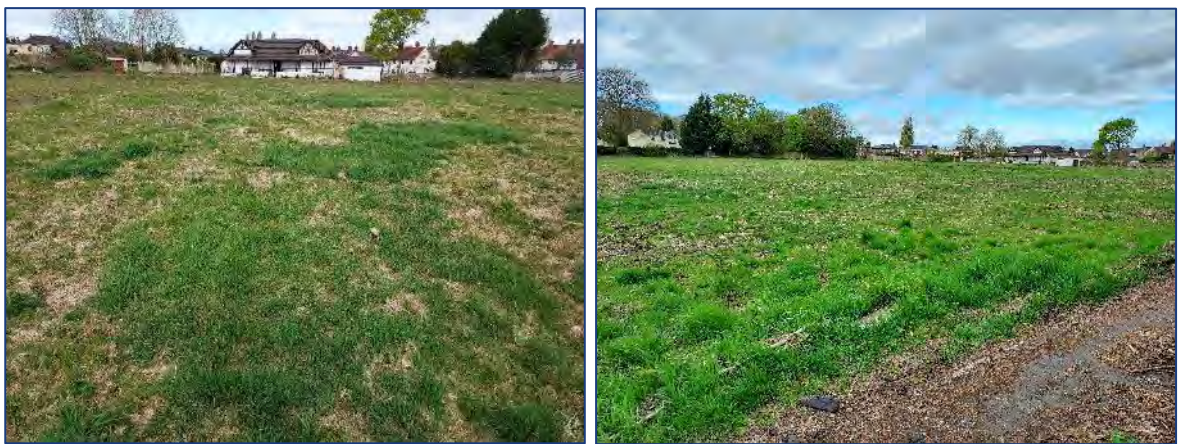
The site currently comprises a disused cricket club ground with a derelict pavilion building located in the north-western part of the site. The River Alt is located along the northern site boundary until the north-western site corner, where it appears to enter a culvert. The ground underfoot was noted to be grass across the majority of the site, with some areas of dense vegetation in the western site section and hardstanding in the northern site section.

*Figures 3 & 4: Photographs of the central site section and the existing pavilion (left) and the general site topography (right).*

The site is relatively flat, the topography was noted to gently fall from c. 34.00m AOD along the southern boundary to c. 31.50m AOD along the northern and north-western site boundary.

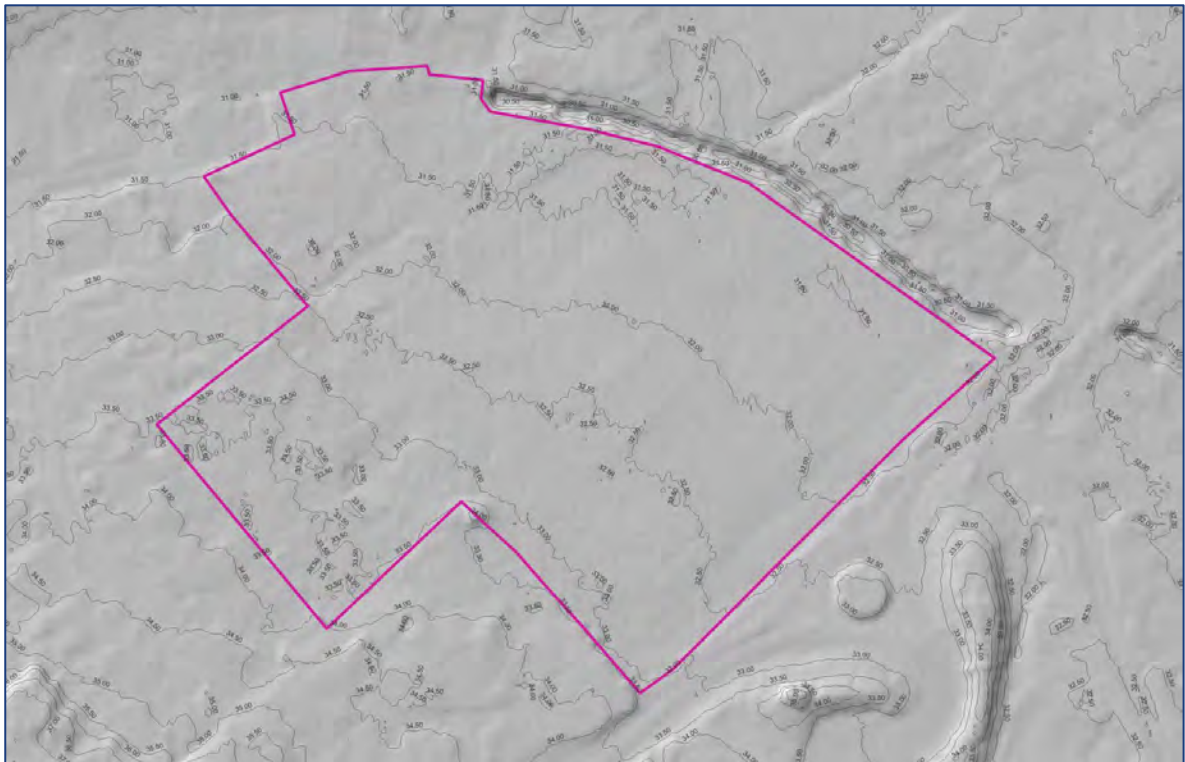
Figure 5: An extract of the LiDAR imagery of the site, showing the relatively flat nature of the site. The dip in topography to the north of the site boundary is consistent with the presence of the River Alt.

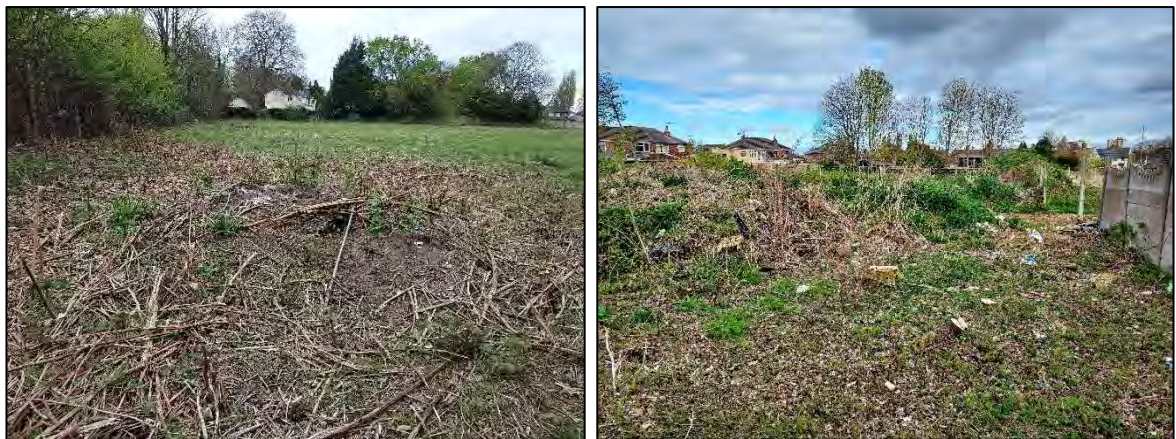
A suspected mound or stockpile, likely containing Made Ground materials including metals, plastics and timber, was recorded in the southern site section. A number of free-standing sheds or garages were recorded on site, suspected to have been utilised as equipment and / or machinery storage. Established trees were noted along the site boundaries as well as the north western site section. Dense vegetation was noted along site boundaries and in the south-eastern site section. Suspected Japanese Knotweed was also recorded in the eastern site section.

Figures 6 & 7: Established trees and suspected patch of Japanese Knotweed in the eastern site section (left) and suspected on-site stockpile in the southern site section (right).

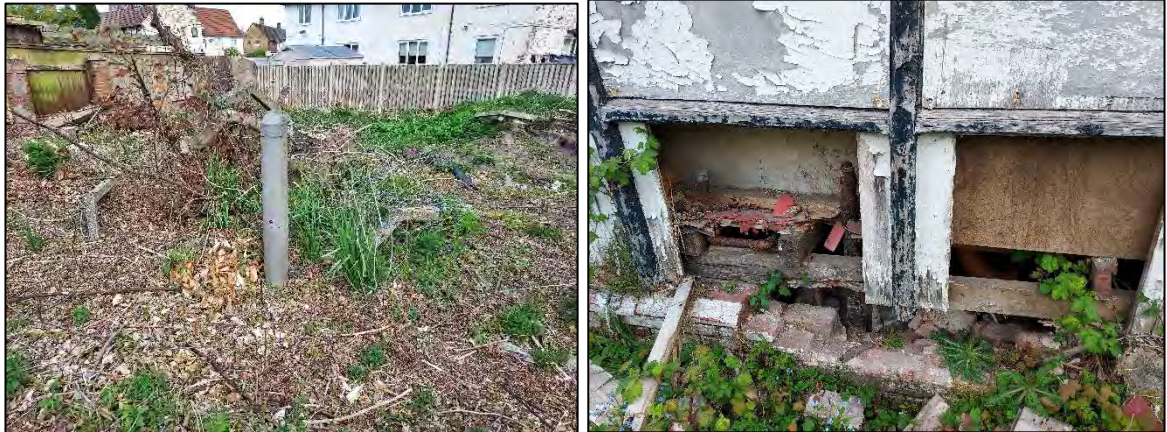
Disused lamp posts were recorded on site. Multiple cables were also noted on or in the vicinity of the on-site pavilion, indicating the presence of private services to the building. A suspected service entry point was recorded in the south-eastern site corner. Disused pipes were recorded on the sides of the free-standing sheds, indicating the presence of services that extend into the various on-site buildings.

*Figures 8 & 9: Evidence for a disused street light system (left) and on-site services into the buildings (right).*

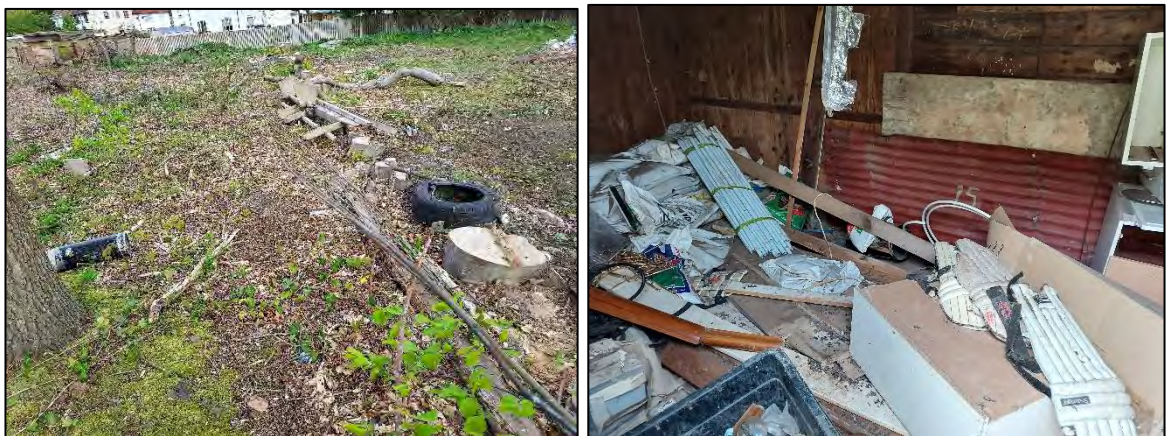
No evidence of contamination (i.e. spillages or leakages) were identified. Evidence of fly tipping was noted across the site, with metal and plastic canisters and bottles, metal sheets, wooden panels and tyres present in all areas of the site, as well as in the vicinity of the River Alt. No suspected asbestos containing materials were recorded during the walkover, though their presence in the interior of the pavilion cannot be discounted.

*Figures 10 and 11: Evidence for fly tipping in the south-western site section (left) and in one of the disused on-site free-standing sheds (right).*

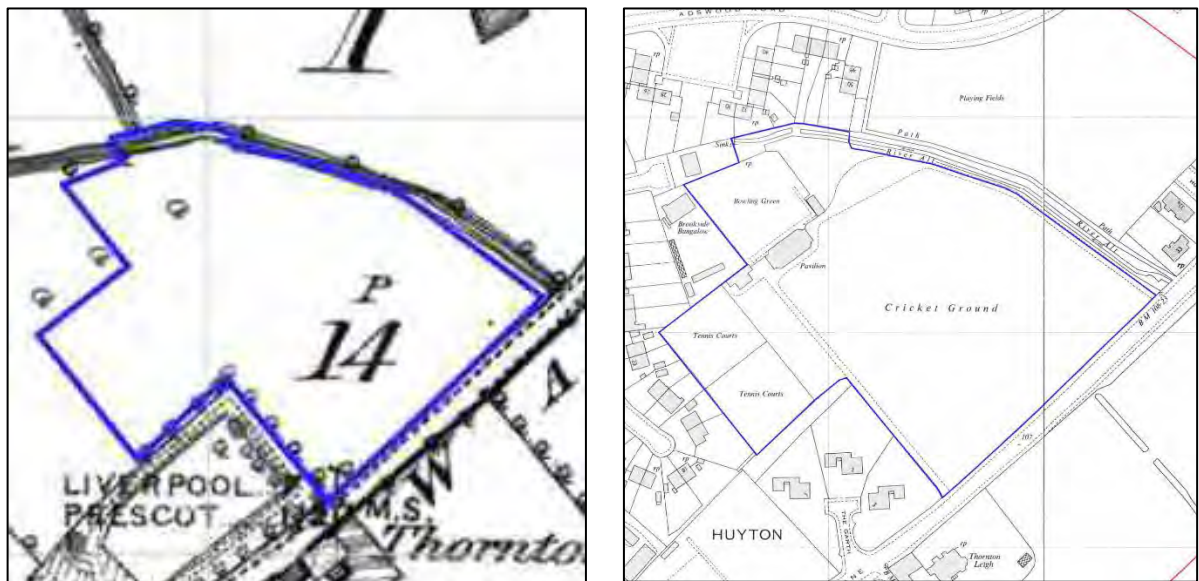
| Date | Site Feature |
|---|---|
| 1952 – 1976 | A slope is present in the northern site section, sloping towards the south-east. A bowling green is also recorded in the north-western site section, and 2 No. tennis courts are present in the southern site section. |
| 1976 - 2025 | The slope is no longer recorded. The eastern small building adjacent to the pavilion is no longer recorded by 1976. The 2 No. tennis courts are also no longer recorded since then. The site remains relatively unchanged until the present day. |

Figure 12: Extracts of the OS historical maps dated 1850 (left) and 1966 (right).

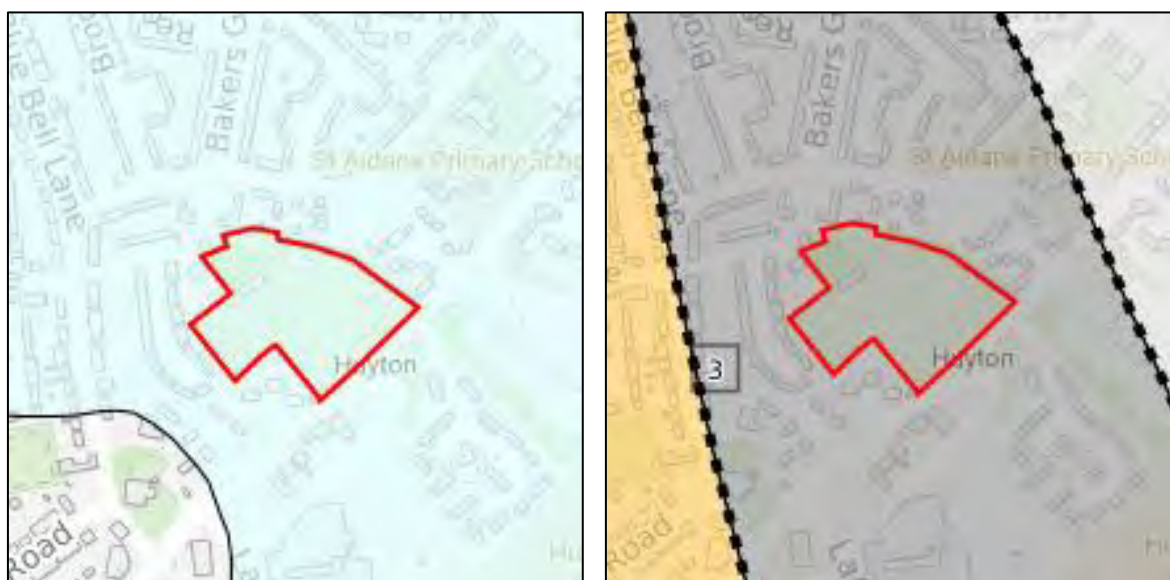
The BGS 1:50,000 drift and solid geological maps of the area (Sheet No. 97, dated 1977 and 1980, respectively) indicate that the site is underlain by superficial deposits comprising **Glacial Till** which typically comprises a heterogenous mixture of clays, sands and gravels. The site is underlain by bedrock of the **Pennine Middle Coal Measures Formation** comprising mudstone, siltstone and sandstone.

Figure 13: Extracts of the BGS 1:50,000 drift (left) and solid (right) geological maps. Light blue = Glacial Till, Dark grey and light grey = Pennine Middle Coal Measures Formation, Light grey = Chester Formation.

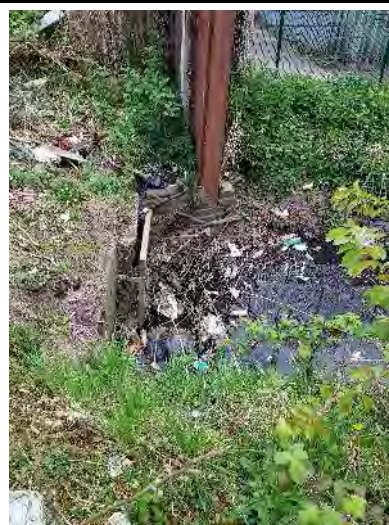
Figure 2 – The River Alt culvert along the northern site boundary, looking north.

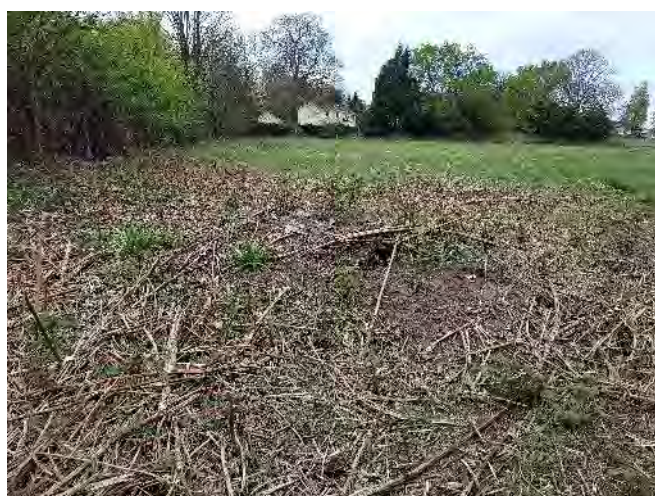
Figure 5 – The south-western site corner with suspected Japanese Knotweed, looking south-west.

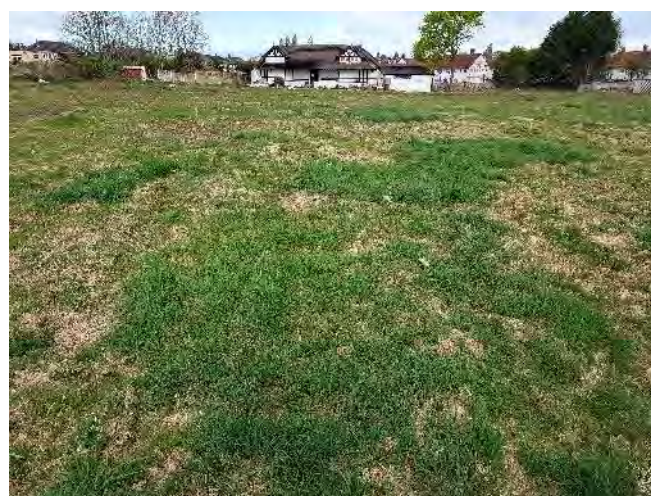
Figure 6 – The existing cricket club pavilion in the western site section, looking north-west.

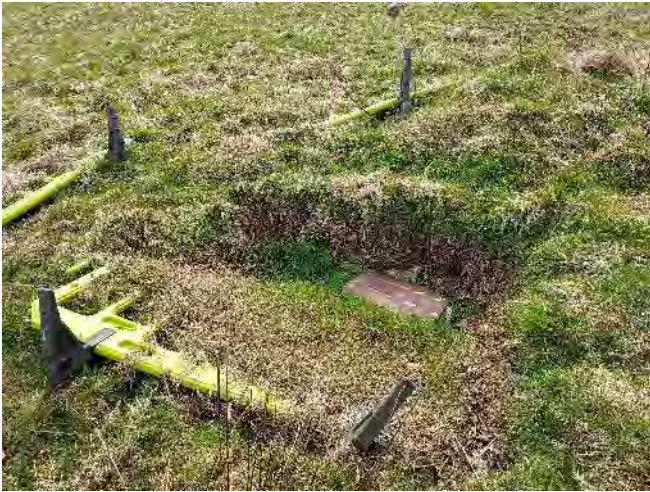
Figure 7 – An unknown on-site excavation in the southern site section, looking south.

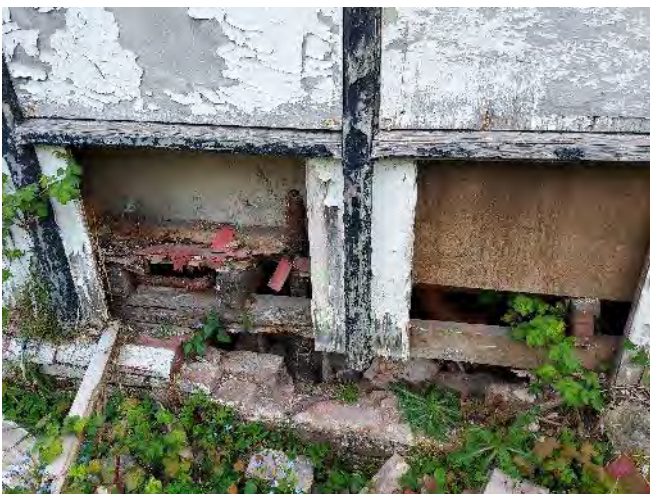
Figure 11 – Disused services into the cricket club building, looking north-east.

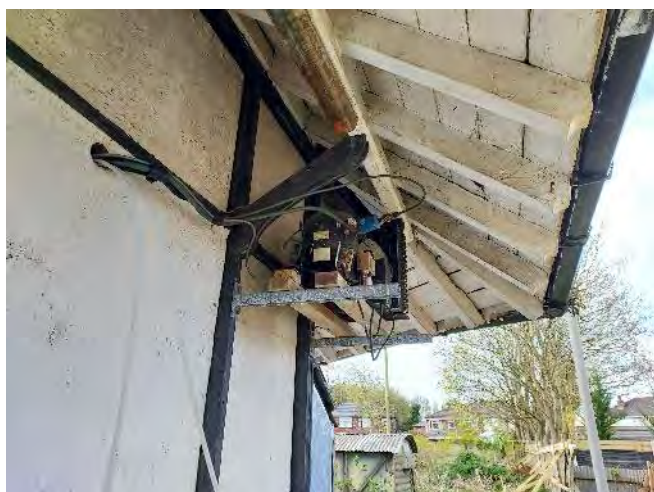
Figure 13 – Disused services within the former cricket club building, looking north-east.

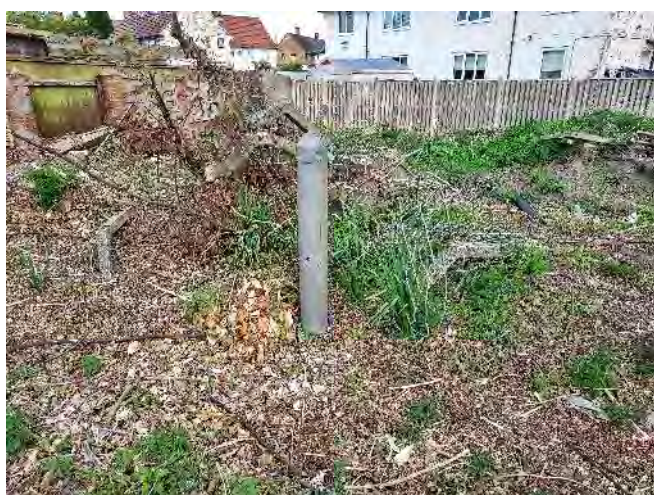
Figure 15 – Disused street light posts in the north-western site section, looking north-west.

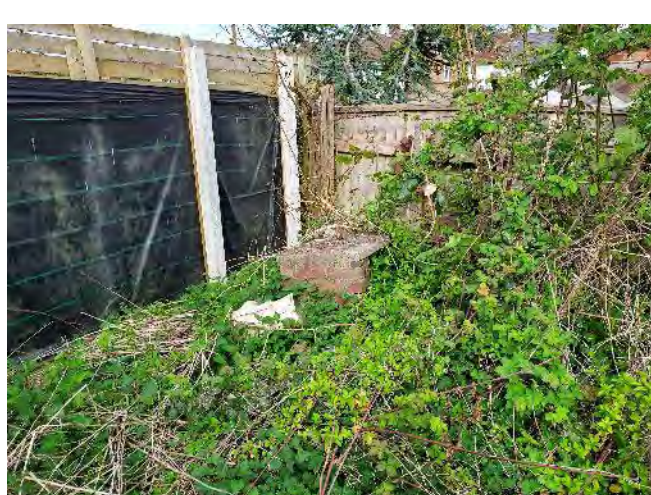
Figure 16 – A suspected service cupboard in the northern site section, looking north-east.
