HUYTON CRICKET CLUB,  
HUYTON LANE, HUYTON,  
KNOWSLEY, L36 7XH

### **GROUNDSURE COMBINED ENVIRO + GEO INSIGHT REPORT**

**DETAILED UXO  
RISK ASSESSMENT**

Project: Huyton Cricket Club, Knowsley

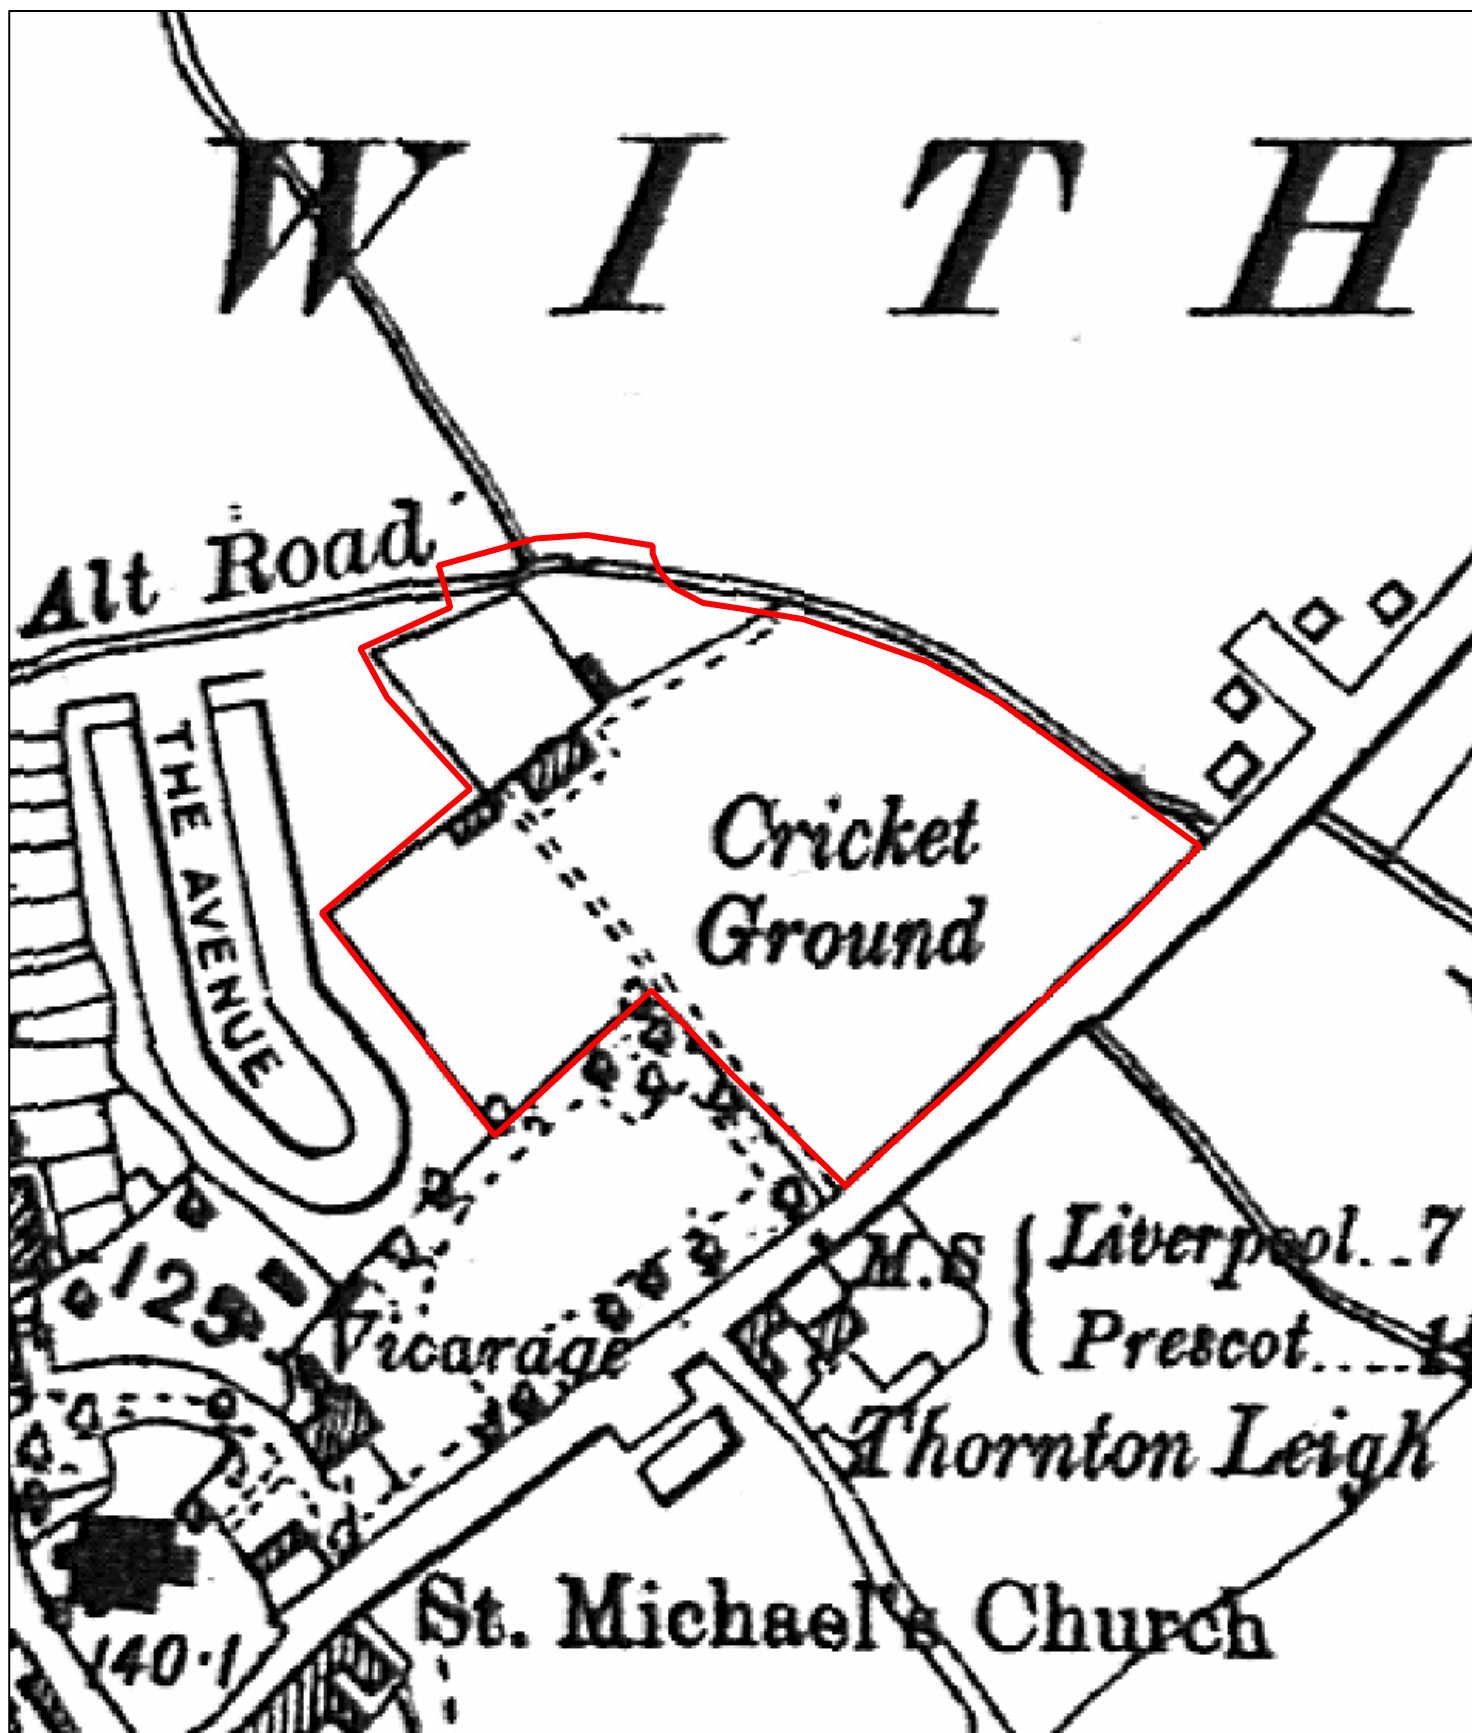
FIGURE: 3.1

Historical OS Mapping - 1938

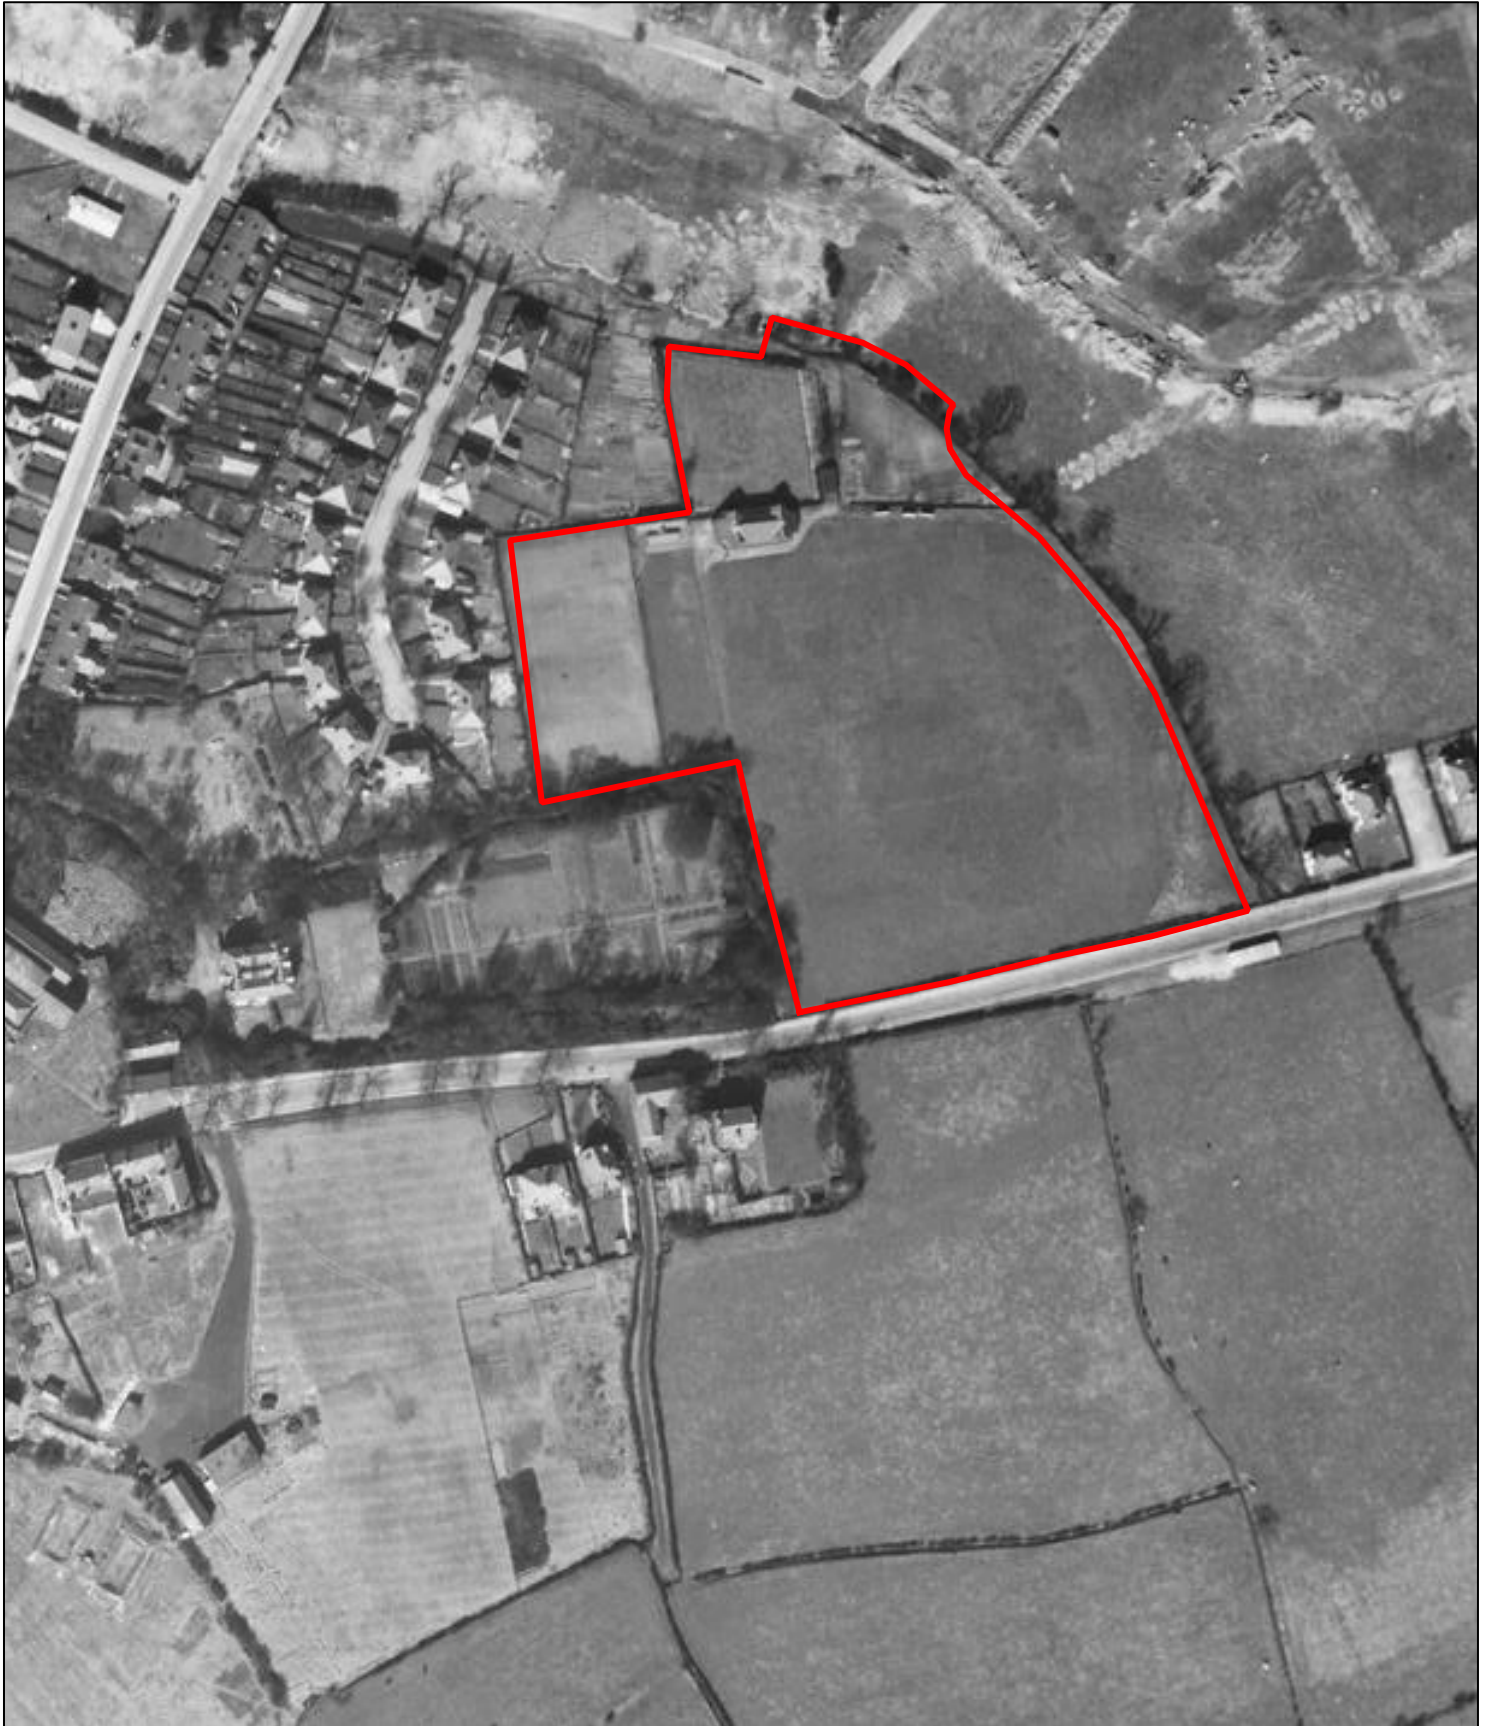
FIGURE: 4.1

Historical Aerial Photography – 26<sup>th</sup> March 1946
