Our Ref: BEK-23094-2

**Desk Based Coal Mining Risk Assessment – Land at Chapel St, Knowsley**

BEK Enviro (BEK) has been commissioned by 68K Red & Black Limited to carry out a Coal Mining Risk Assessment for a parcel of land located at Chapel St, Knowsley (hereafter referred to as 'the site') to assess the risks from subsidence associated with historical coal mining at and close to the site.

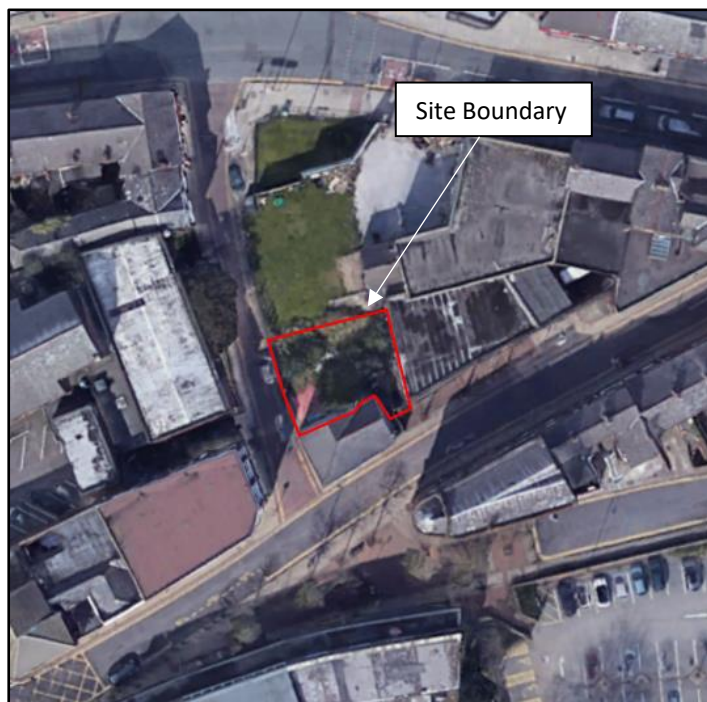
**Figure 1:** Aerial Image for the Site

The site is shown in Figure 1 below:

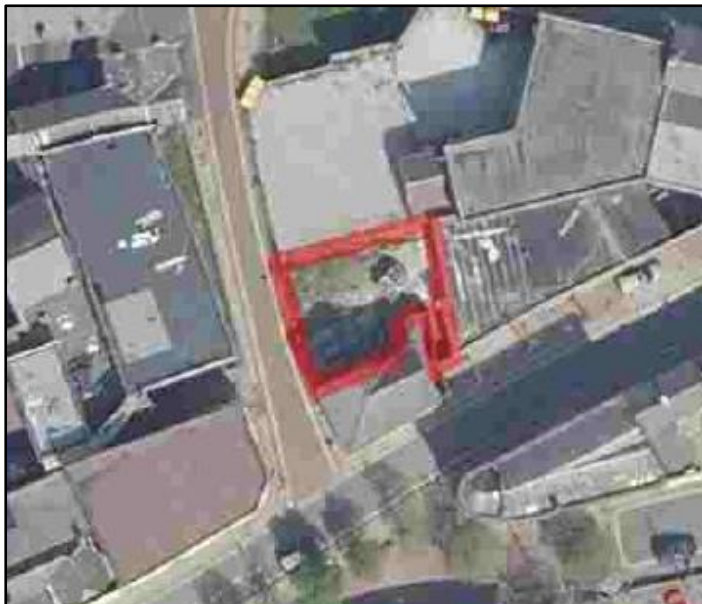
**Figure 1:** Aerial Image of the Site from 2019 (from Enviro+GeoInsight Report)

A review of Google earth satellite imagery indicated the building on site has been demolished and is no longer present from the 2005 onwards. The site remains unchanged until present. Figure 1 below is an aerial image taken of the site from 2019.

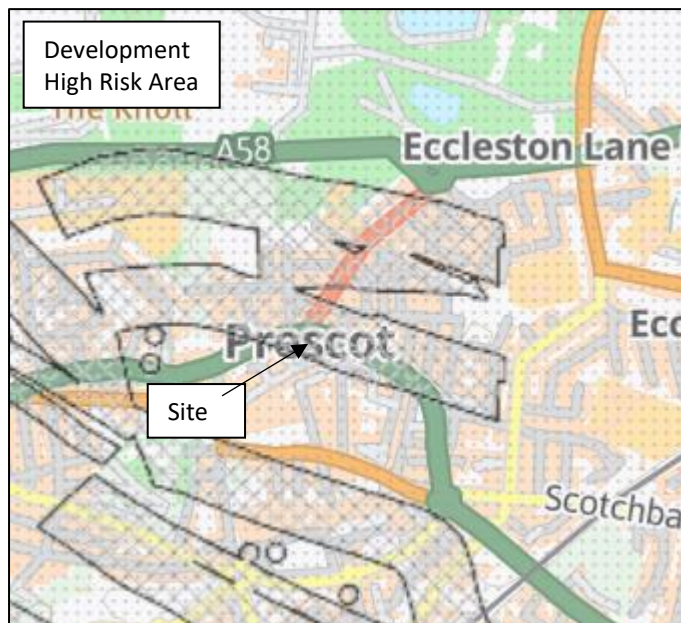
**Figure 2:** Development High Risk Area

The site is located in a probable shallow coal mining area. As such, the site is situated within a 'development high risk' area. (see Figure 3).

The Coal Authority interactive map indicates that the site is located in a Coal Mining consultation zone and entirely within a 'Development High Risk Area'. A coal seam outcrops to the north of the site, dipping beneath the site.

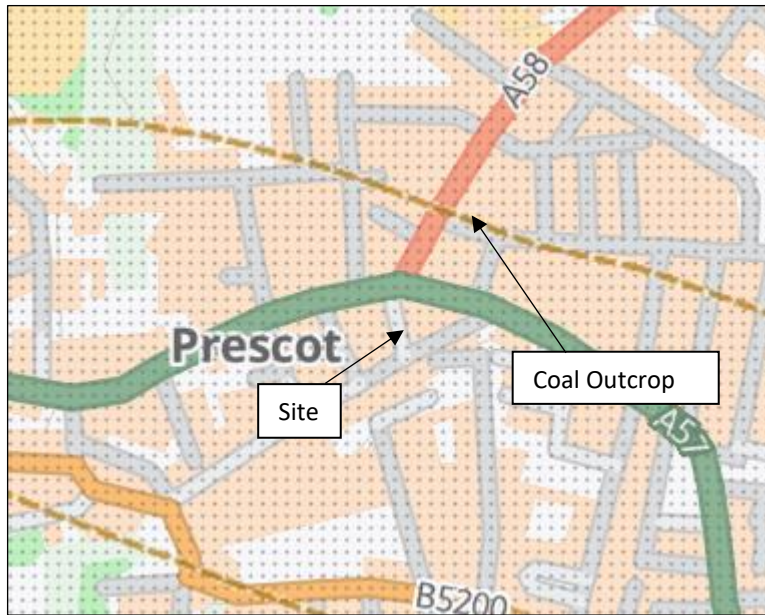
**Figure 3: Coal Outcrops**

The probable shallow coal mining area is associated with the with the potential working of the outcrop situated to the north of the site which appears to dip below the site (see Figure 4).

The key issue are associated with probable shallow coal mine workings along the coal outcrop that is situated to the north of the site and appears to dip below the site.
