## REMEDIATION AND ENABLING WORKS VALIDATION REPORT

**Parcel C**

**Former Prysmian Cable Works,  
Carr Lane,  
Prescot**

**E3P Report: 10-021-R12-Rev 1  
Issued: February 2017**

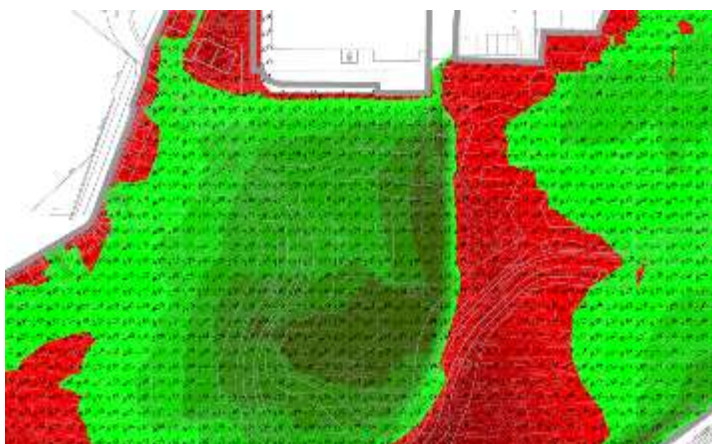
**Figure 3.1 – Extract of Cut / Fill Drawing**

The eastern sector (area shaded red) of Parcel C was generally subject large earthwork exercise that required the removal of between 2-3 meters of historically placed fill that formally comprised a large earth embankment that sub-divided the upper and lower plateau. Subsequent to the cut operation, a turn-over of 3.0m was instigated with subsequent replacement of re-engineered material. In the western sector the landform was upfilled by circa 3.0 - 4.0 at the south west boundary to facilitate the construction of the appropriate road grade (area shaded green).

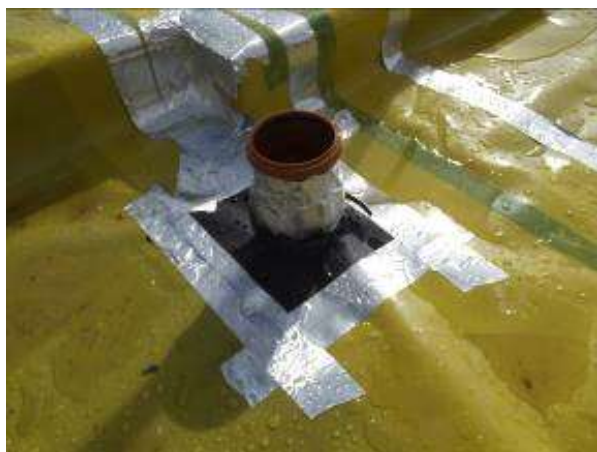
*Photograph 4: Check top hat is sealed to membrane and pipework. If the formed top hat is not tight to the pipework then also confirm presence of jubilee clip beneath butyl tape.*

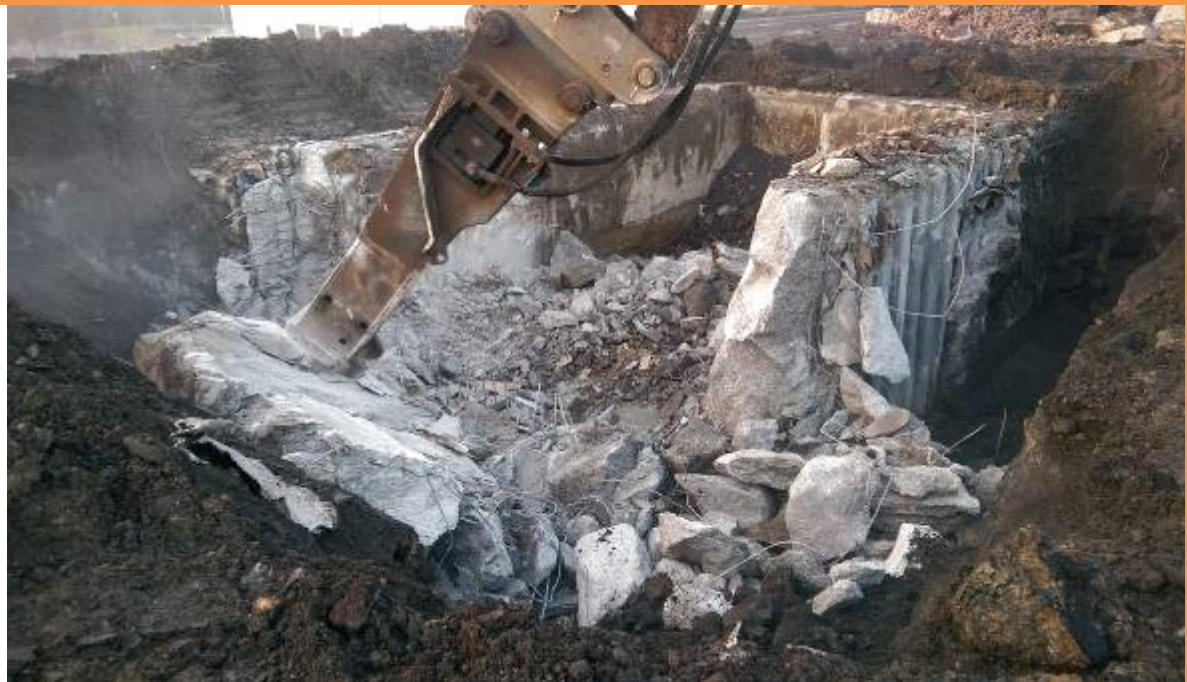
**PLATE 8 – LARGE UST BEING BROKEN TO AID IN THE REMOVAL OF THE TANK**

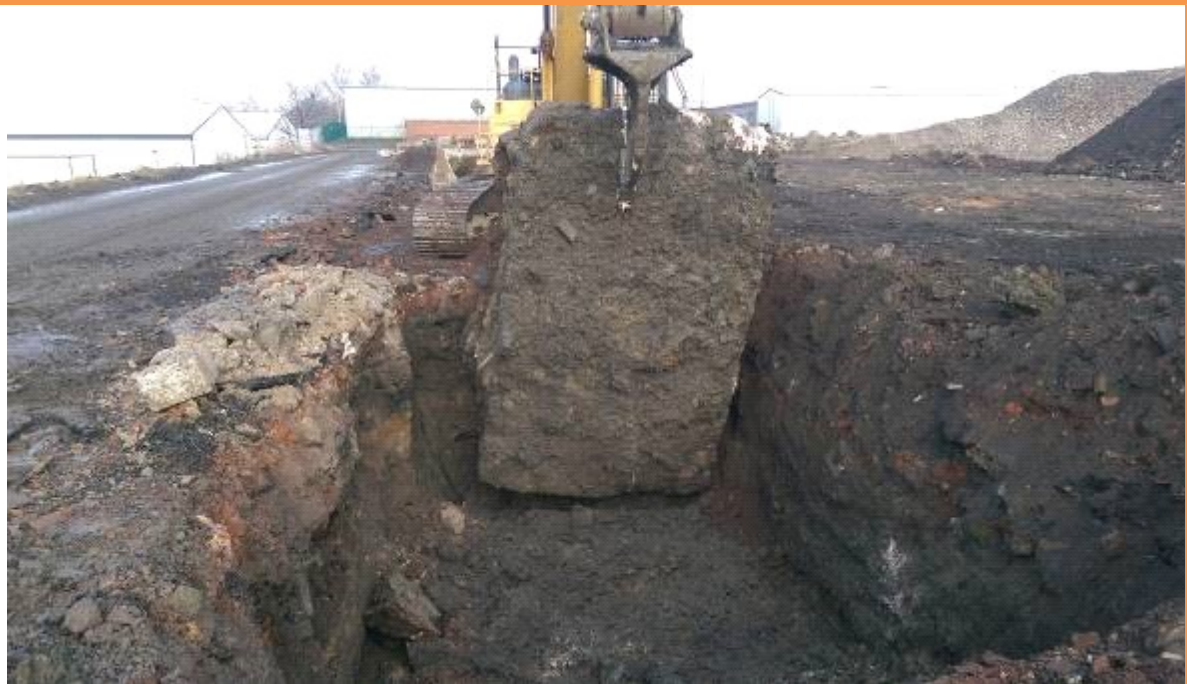
**PLATE 11 – SMALL RELIC FOUNDATIONS BEING REMOVED PRIOR TO  
TURNOVER**

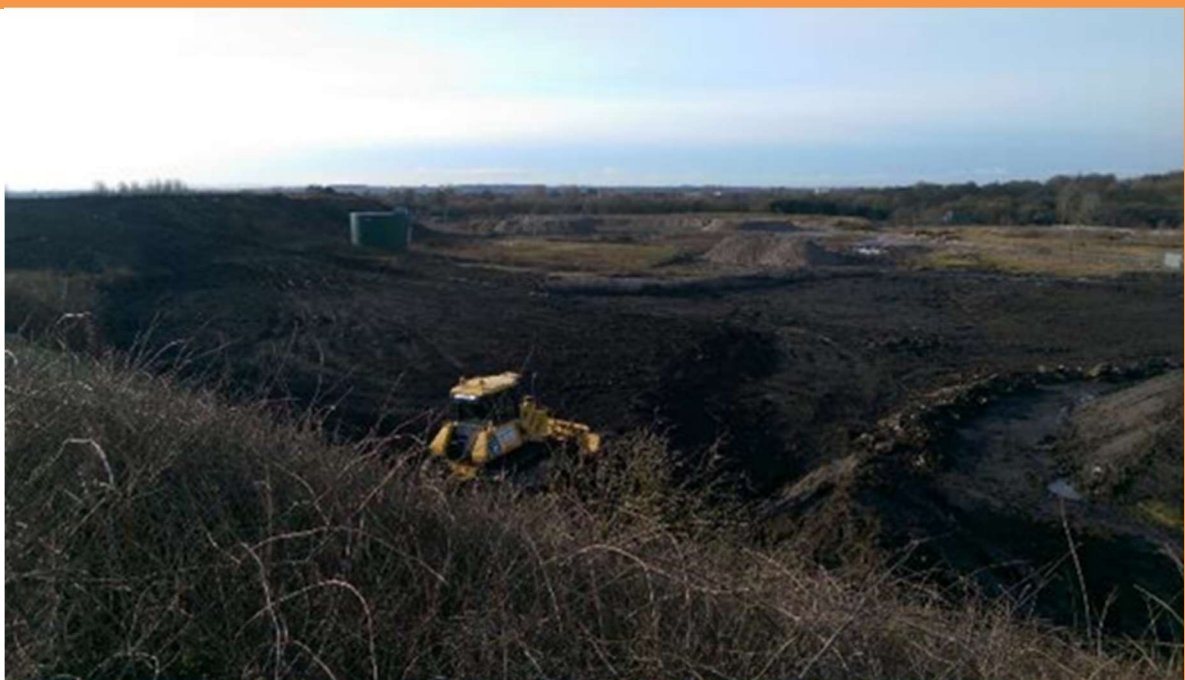
**PLATE 14 – VIEW WEST OF LOWER PARCEL C WITH TURNOVER OF >1.50BGL COMPLETED TO NATURAL STRATUM**

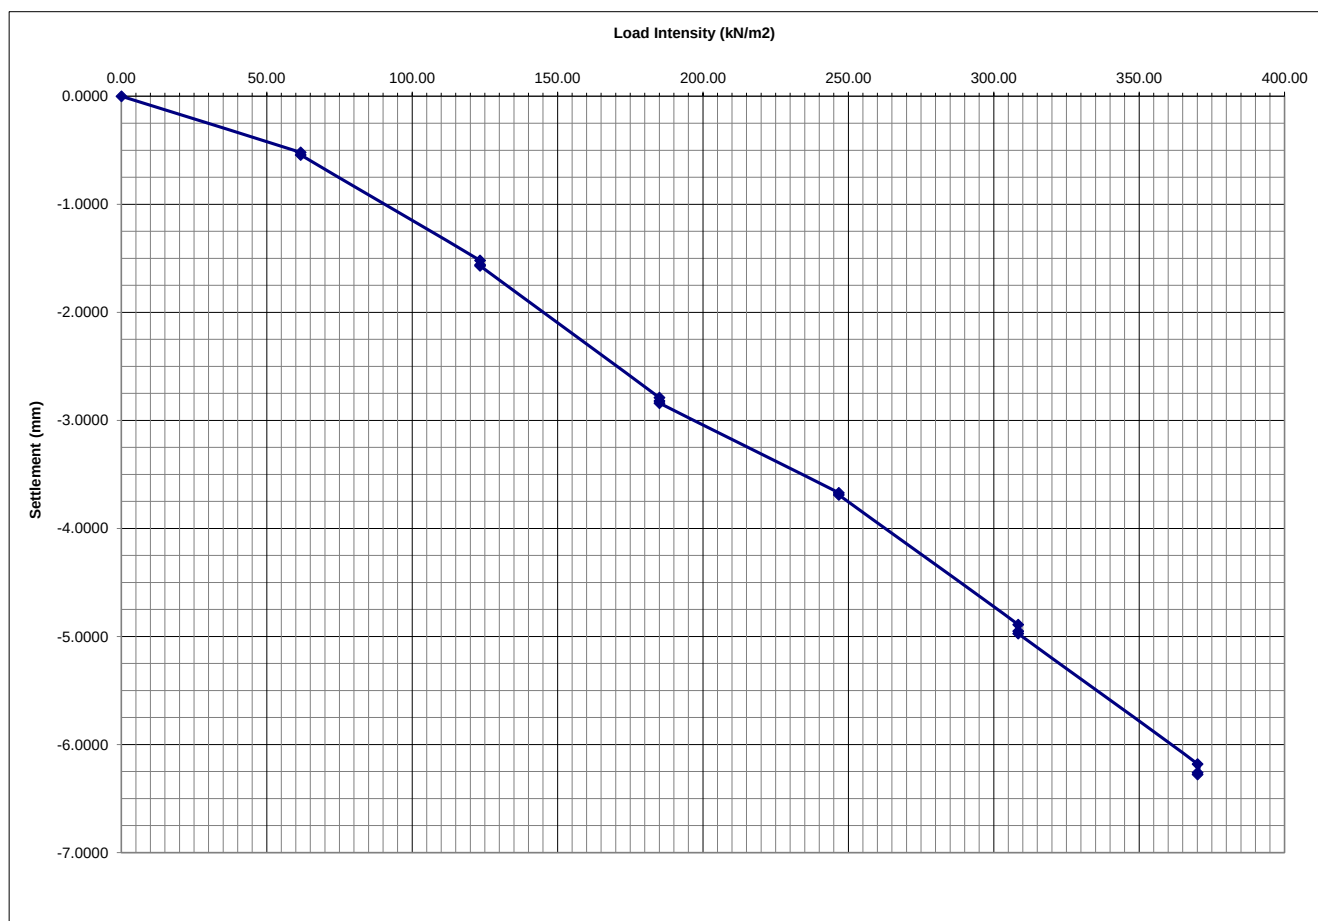
## Equivalent CBR Value of 10%

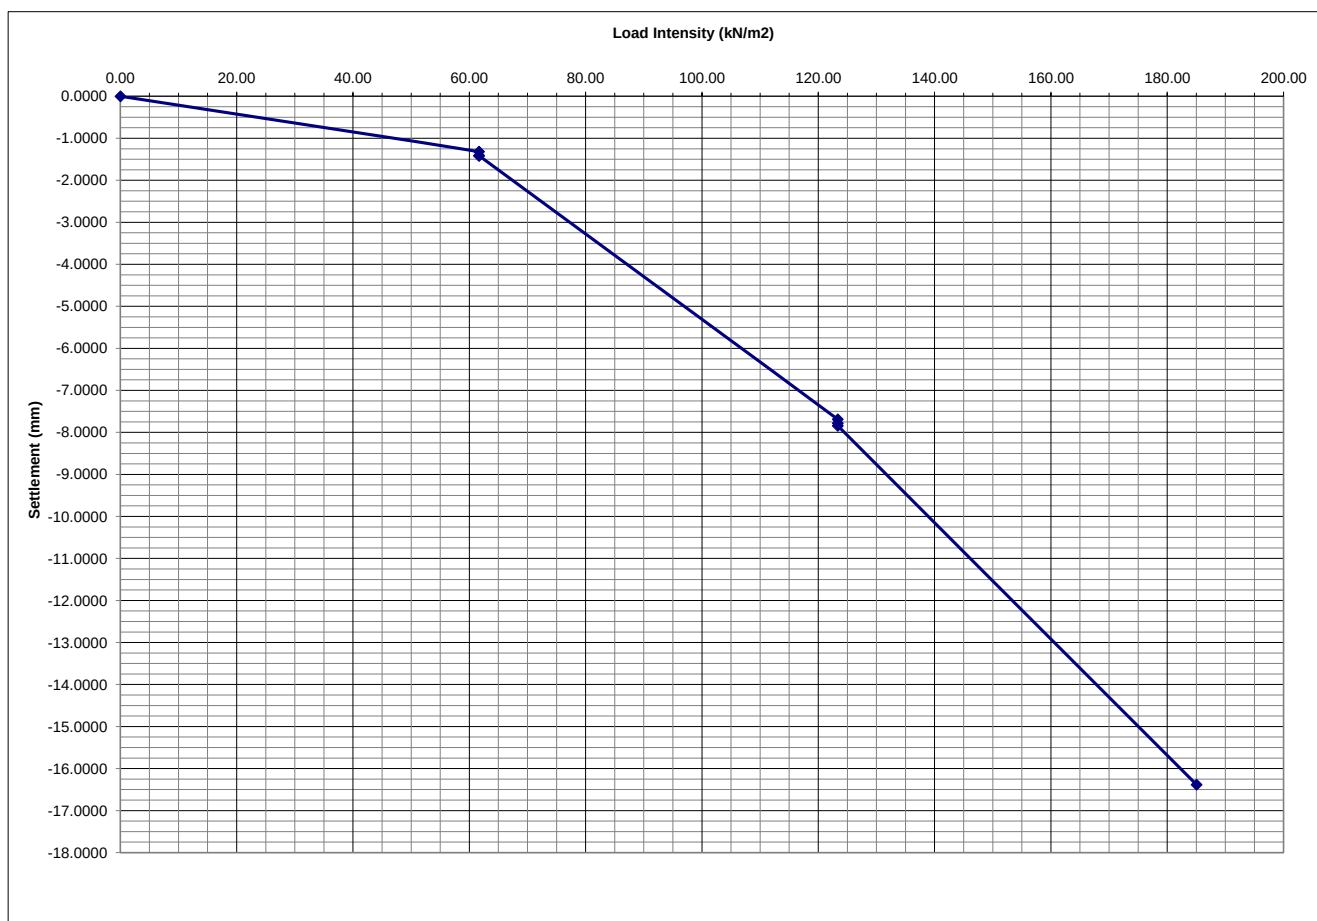
## Equivalent CBR Value of 3%

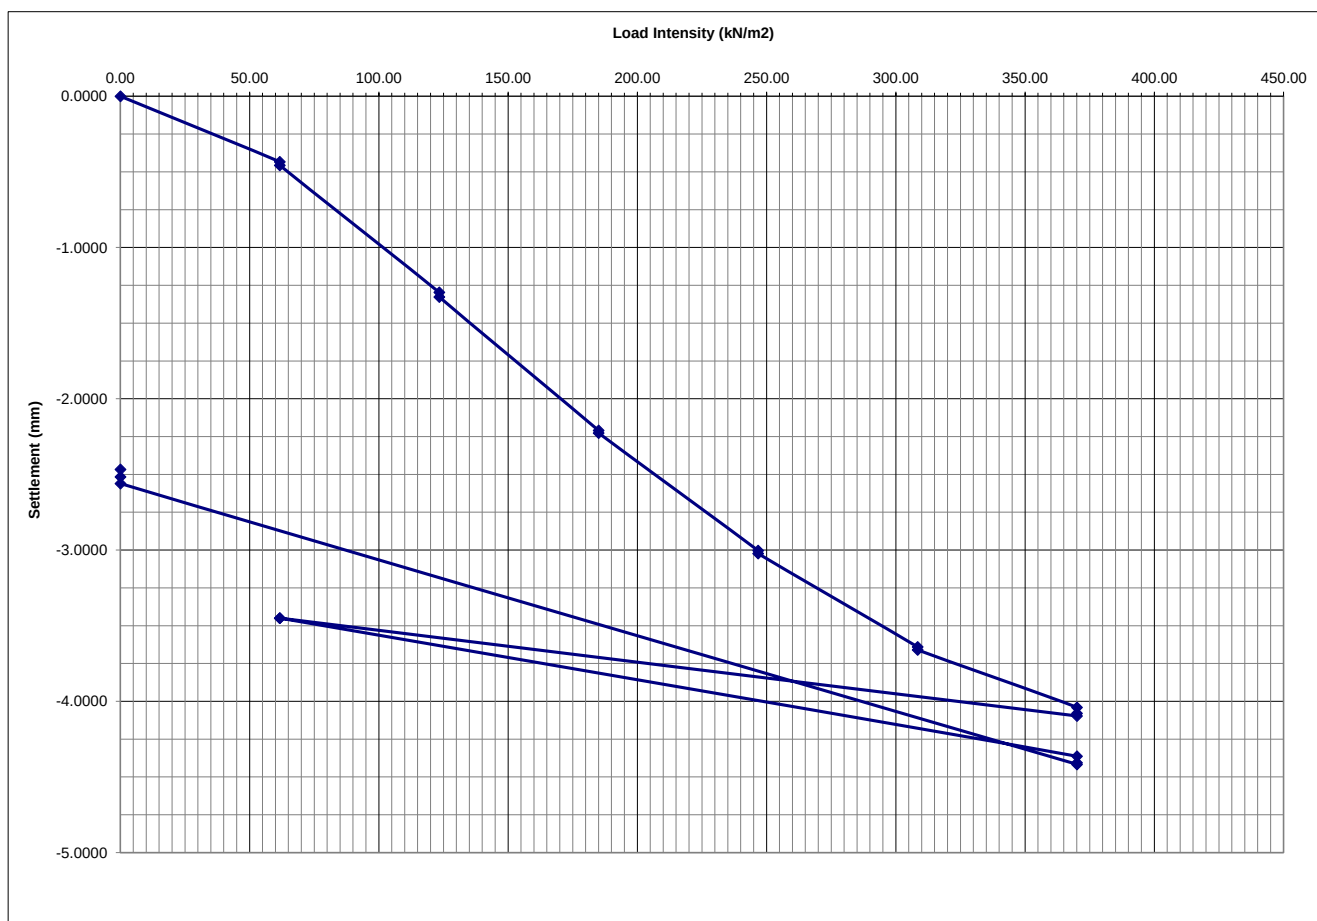
**Equivalent CBR Value of 13%**

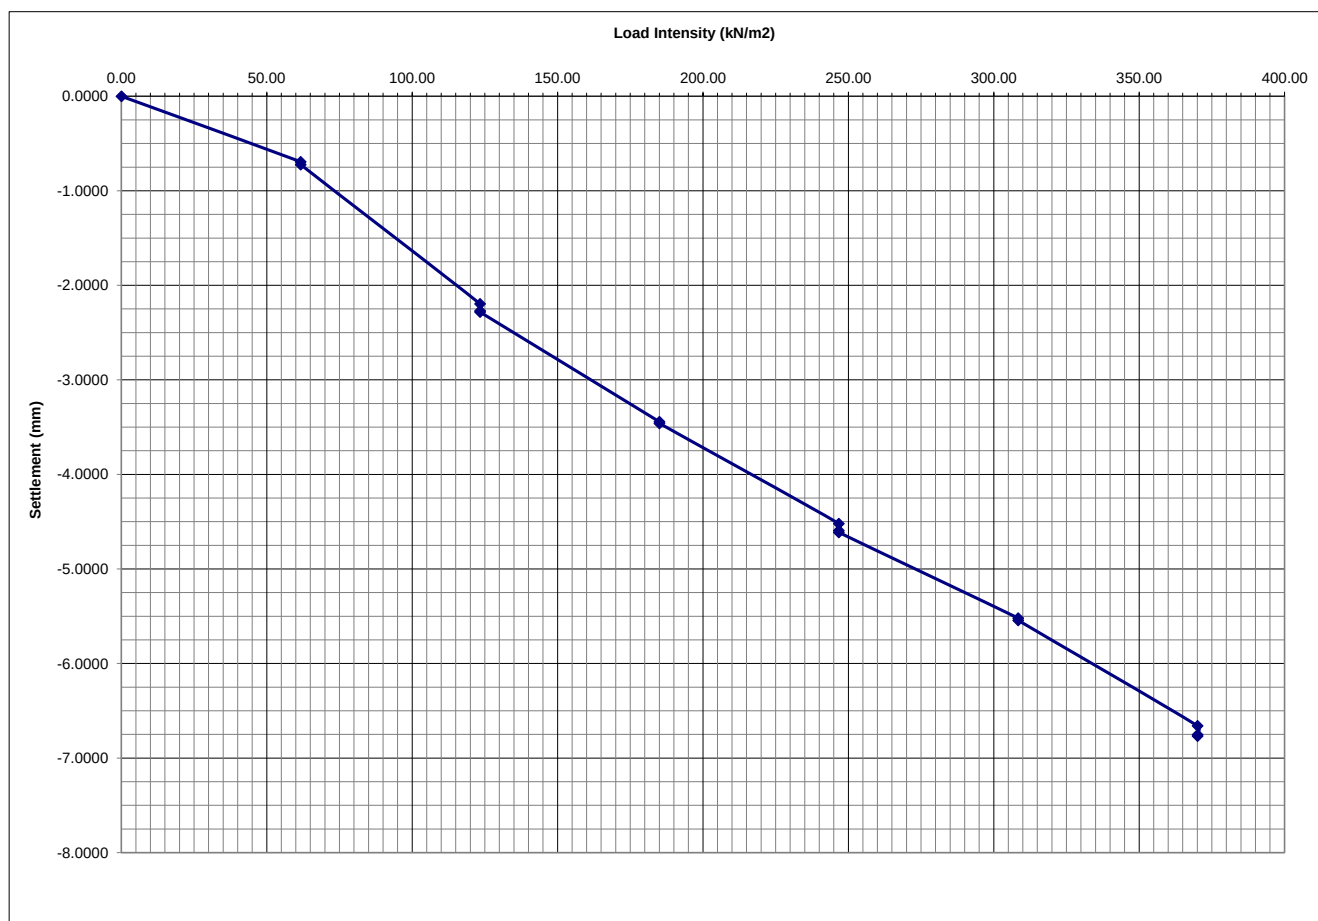
## Equivalent CBR Value of 7%

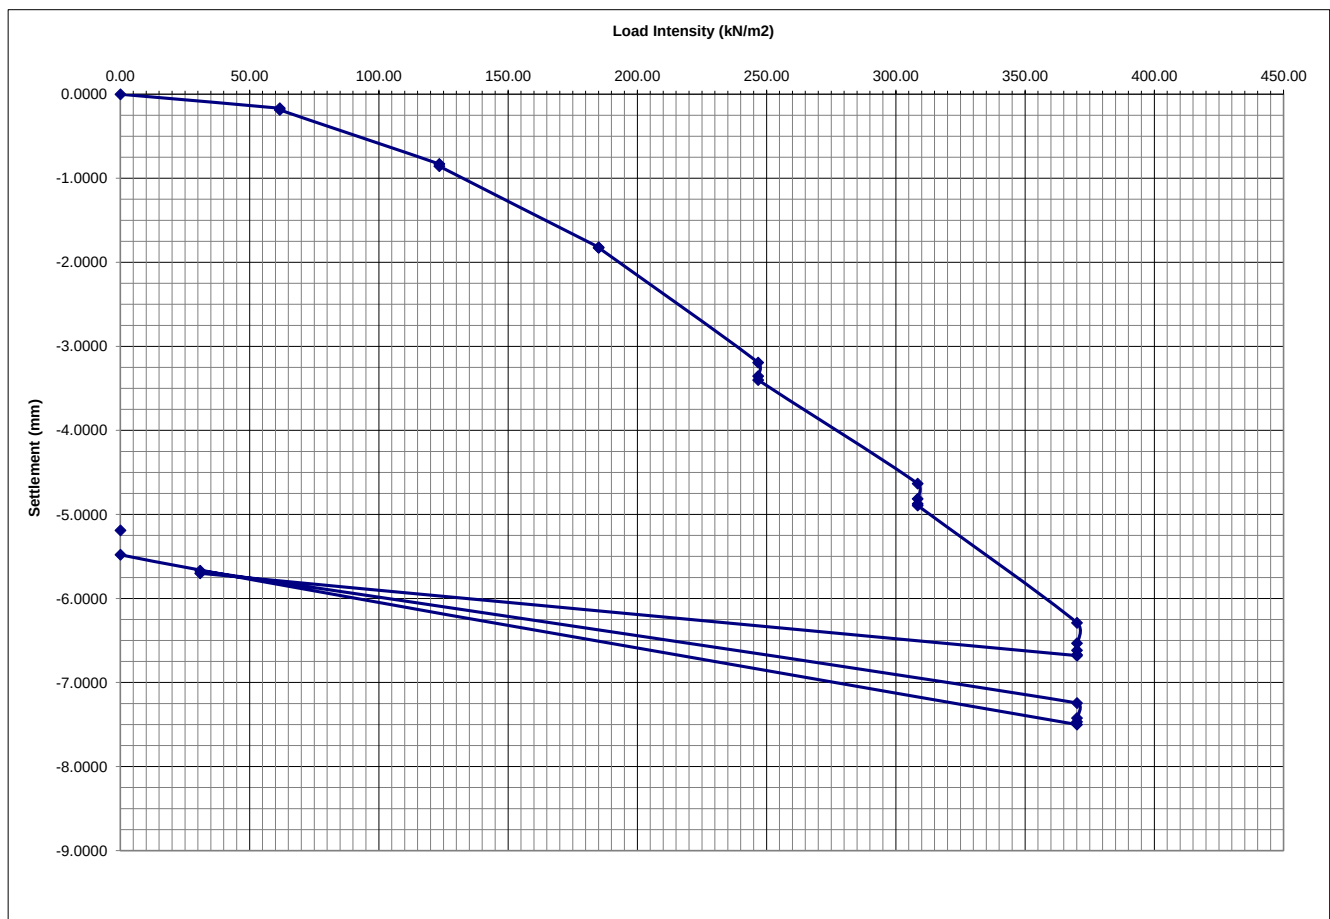
**Equivalent CBR Value of 17%**
