## Overarching Geo-Environmental Site Summary

Parcel C, Prescott Miller  
13-158-R1  
October 2020

# OVERARCHING GEO-ENVIRONMENTAL SITE SUMMARY

Parcel C  
Carr Lane  
Prescot  
L34 1JZ

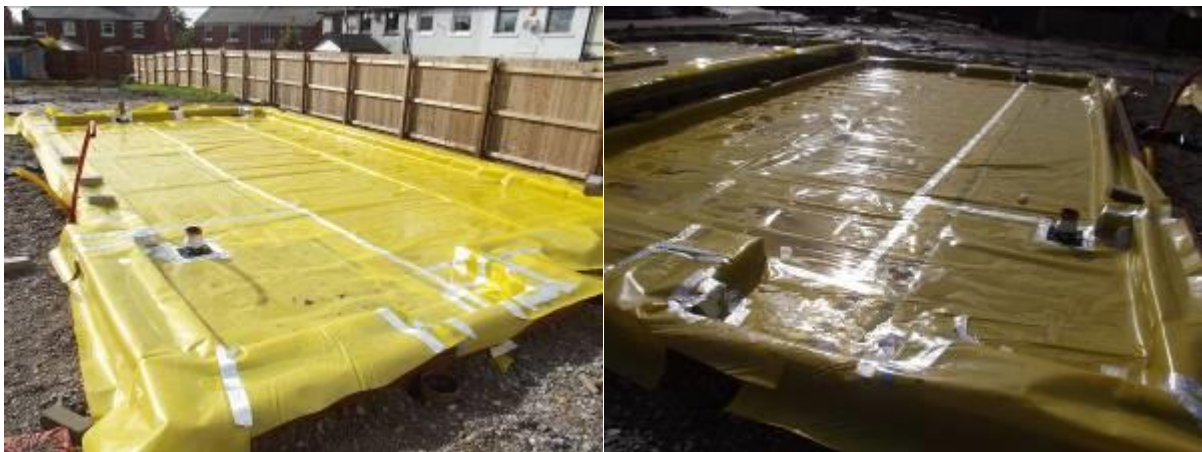
Examples of gas membrane verification (photographs include different membrane types for demonstrative purposes only – gas membranes are site specific):

*Photographs 1 and 2: Check general condition of membrane for punctures / tears etc*

| INSPECTION | METHOD |
|---|---|
| <b>General Condition</b> | The membrane is to be inspected to ensure there are no tears, punctures or rips. |

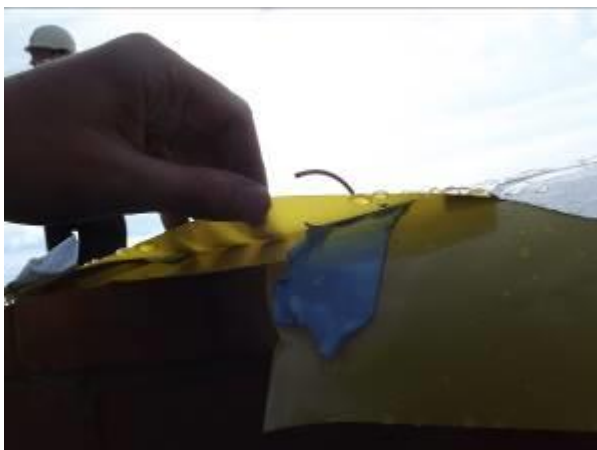
*Photograph 3: Confirm membrane product type and check joints between rolls of membrane to ensure 150mm overlap and presence of double sided butyl tape (by touch – may not be visible) and girth jointing tape.*

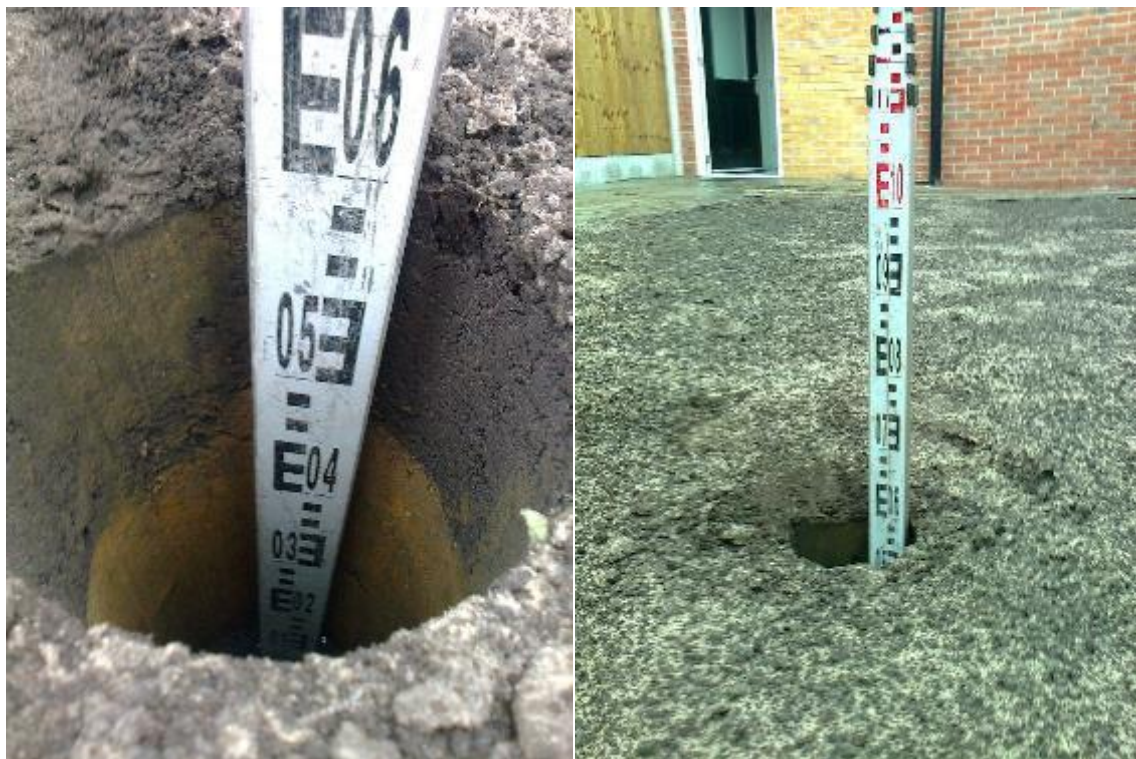
*Photographs 1 and 2: Examples of validation photographs demonstrating clean cover.*

| PROCEDURE | METHOD |
|---|---|
| <b>Validation Certificate</b> | As and when certified sub-soil and topsoil has been placed, inspected and photographed for each plot, a validation completion certificate will be prepared to include plot specific photographs and laboratory test certification. |

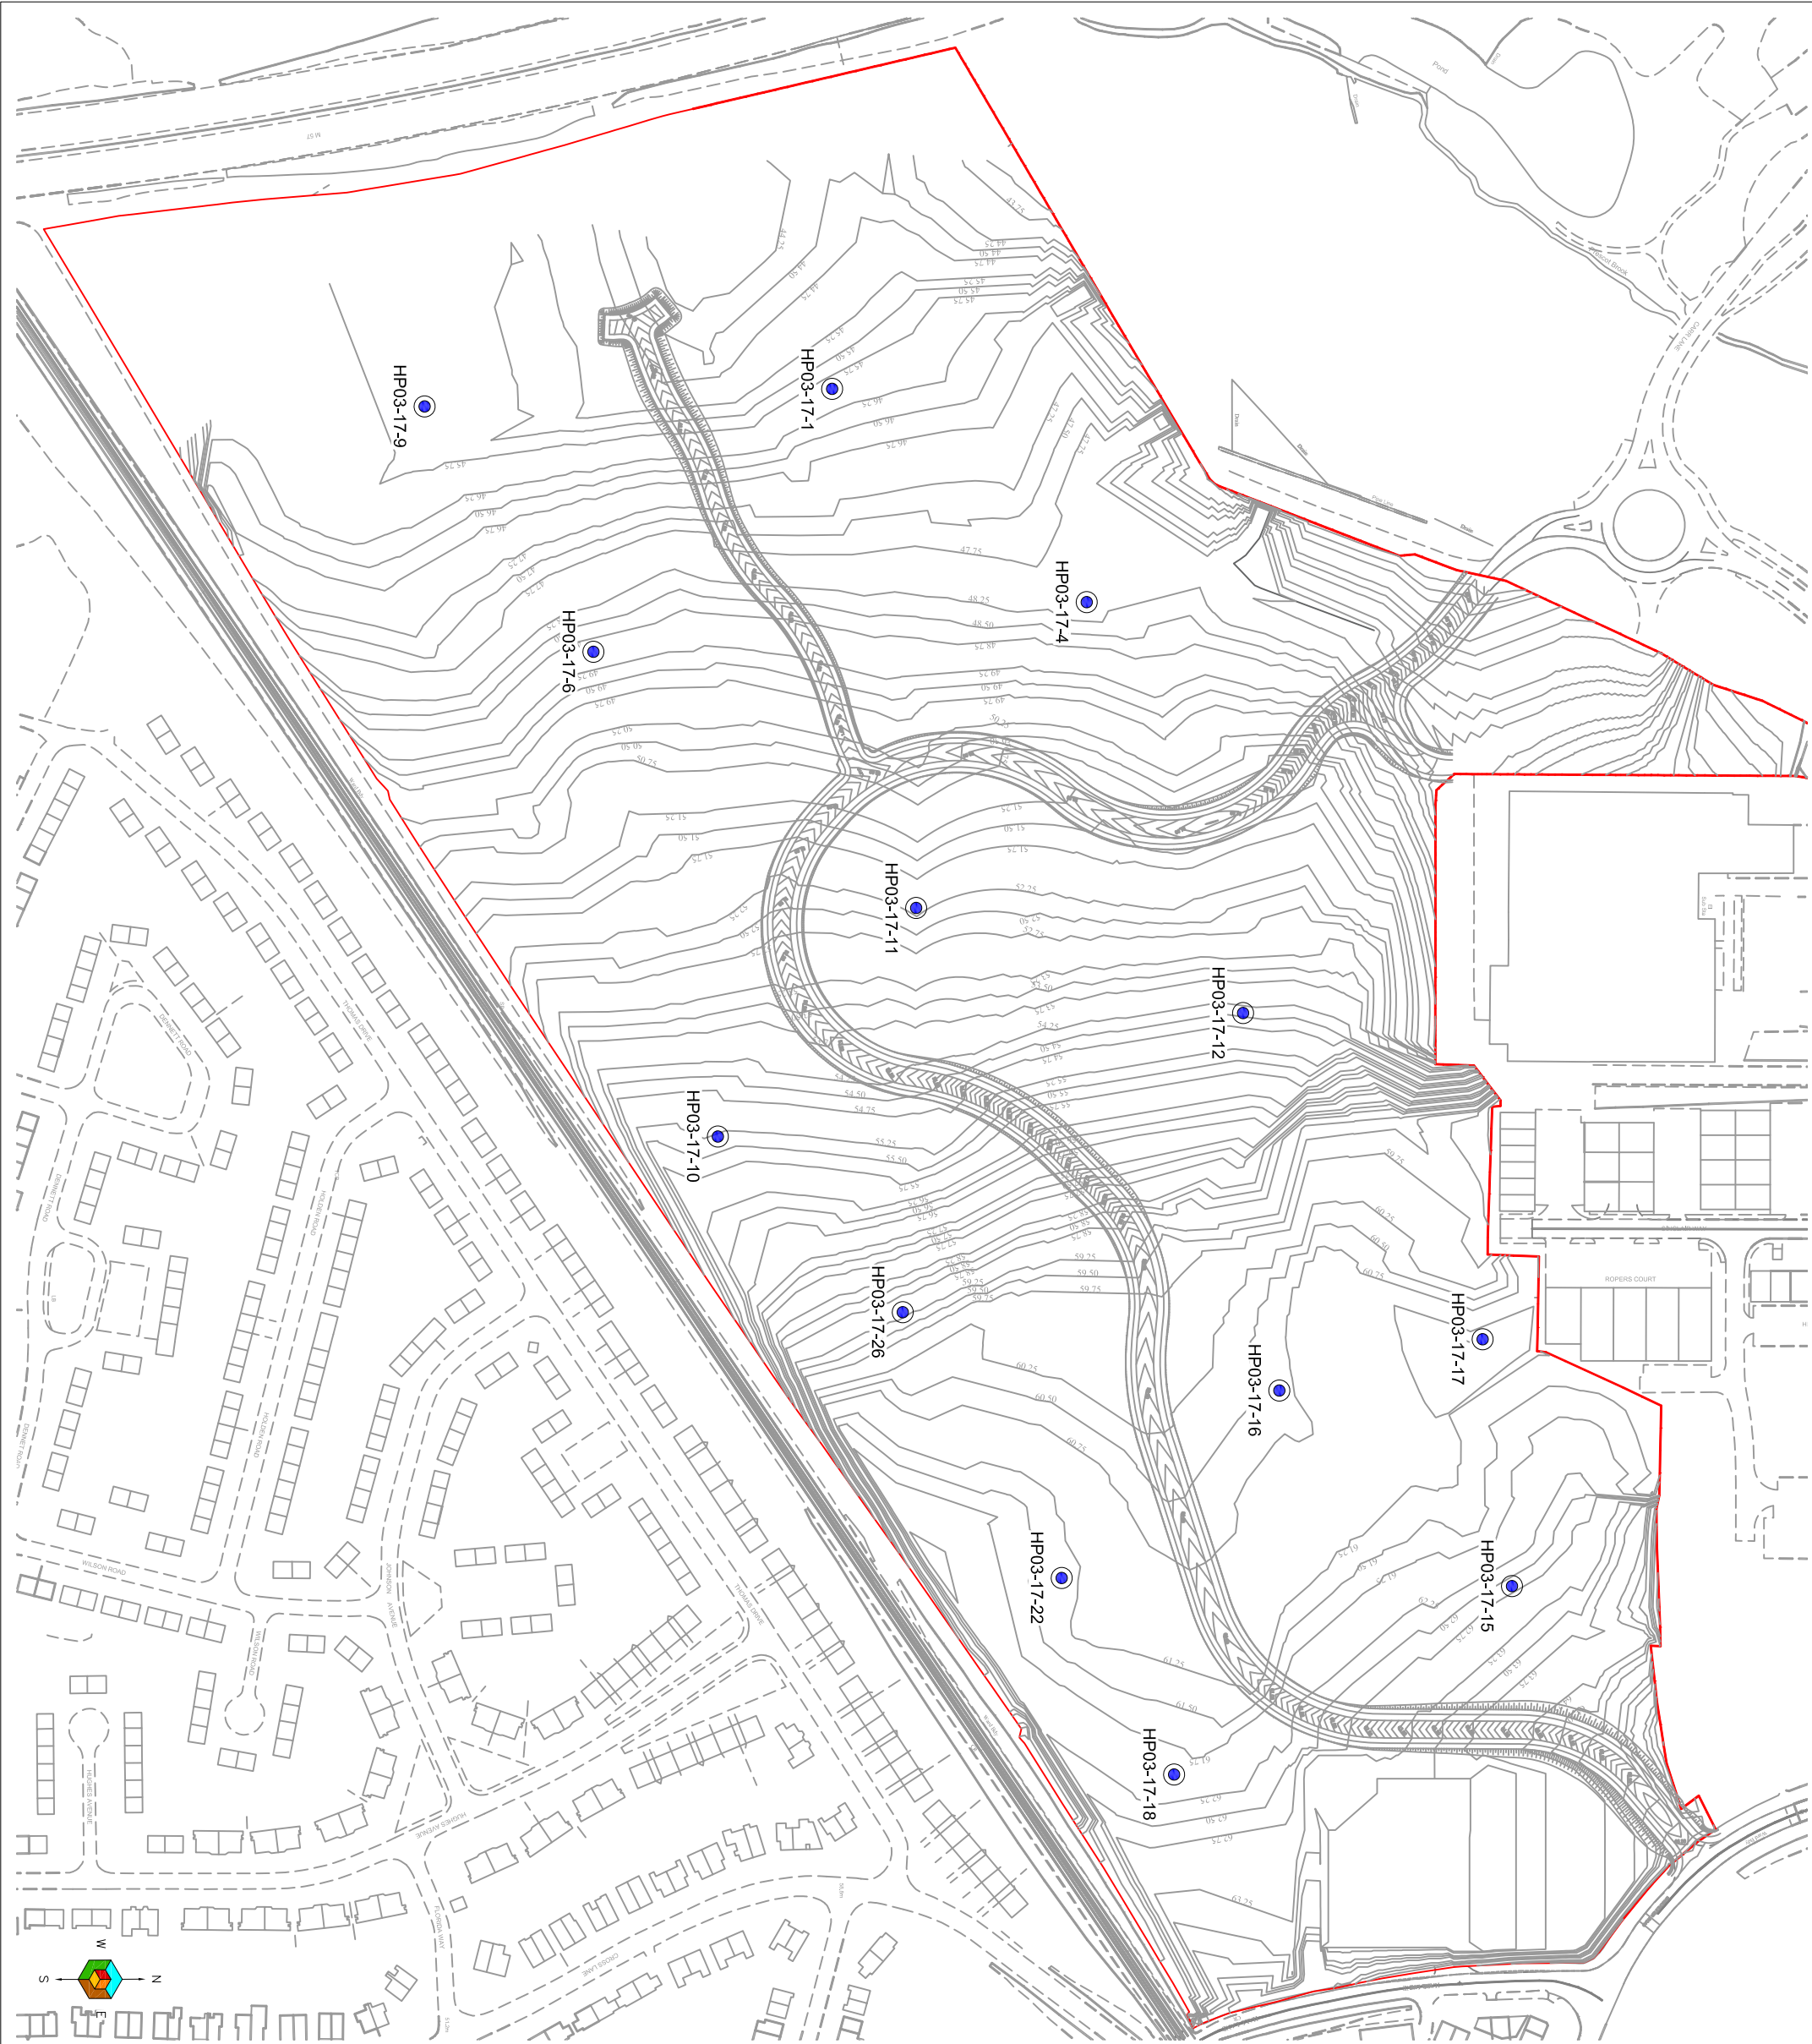
Location Symbols

HP03 Hand Pit to 0.00 - 0.40m to Sample Made Ground and Collect Sample for ASB Analysis
