**KNOWSLEY IMAGE BUSINESS PARK LTD**

**SITE 3, IMAGES BUSINESS PARK, KNOWSLEY**

**ARBORICULTURAL IMPACT ASSESSMENT  
TO BS 5837:2012**

**TREE SURVEY TO BS 5837:2012**

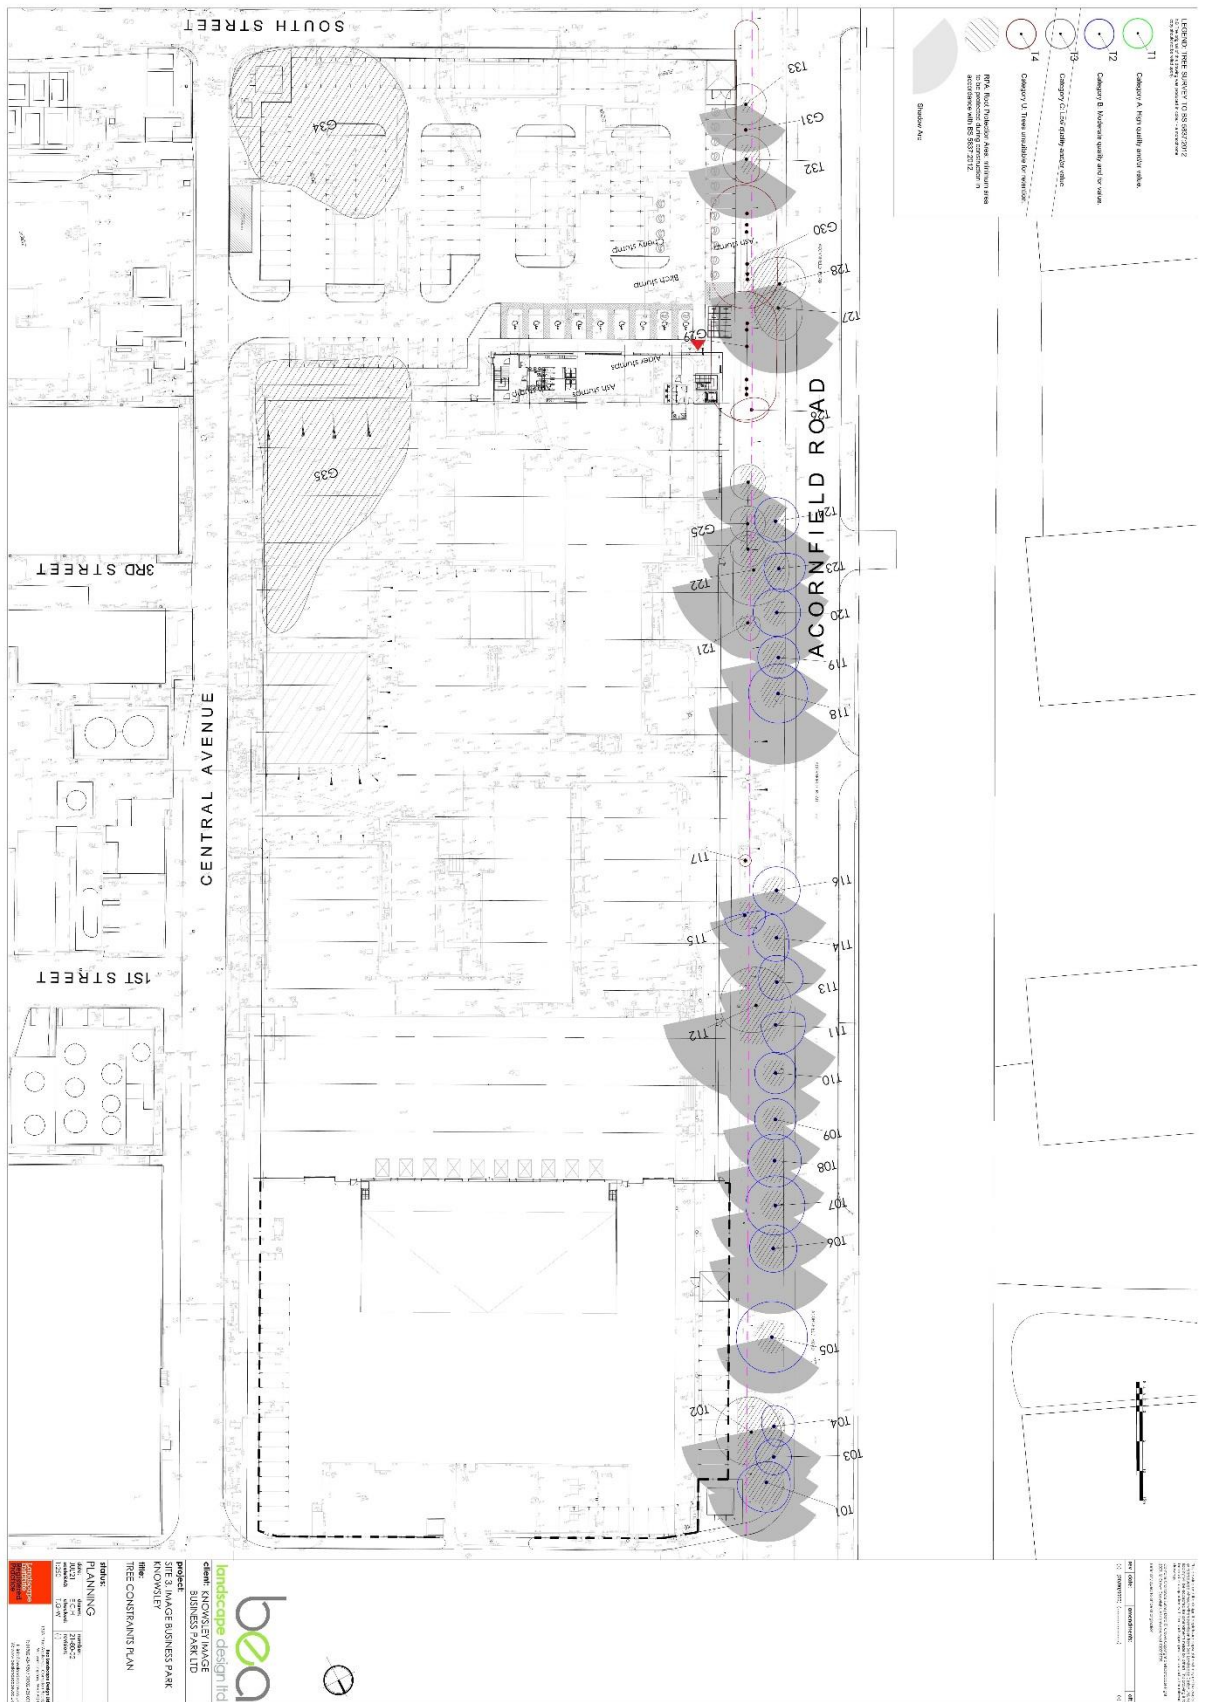
21-80-02 Tree Constraints Plan Overlay

- 3.1.0 A site layout has been prepared for the development area including for a 120,000 square foot light industrial unit with associated service yard, car parking and ancillary structures. In order to assess the impact of the development of the site and the existing trees the proposed site layout was superimposed into the Tree Constraints Plan as illustrated below.

- 3.1.1 The proposed development has been designed to retain the majority of the existing trees particularly those to the boundary that have good screening effects. However to accommodate the proposed development it will be necessary to remove a number of trees within the site in addition to those deemed unsuitable for retention within the tree survey.

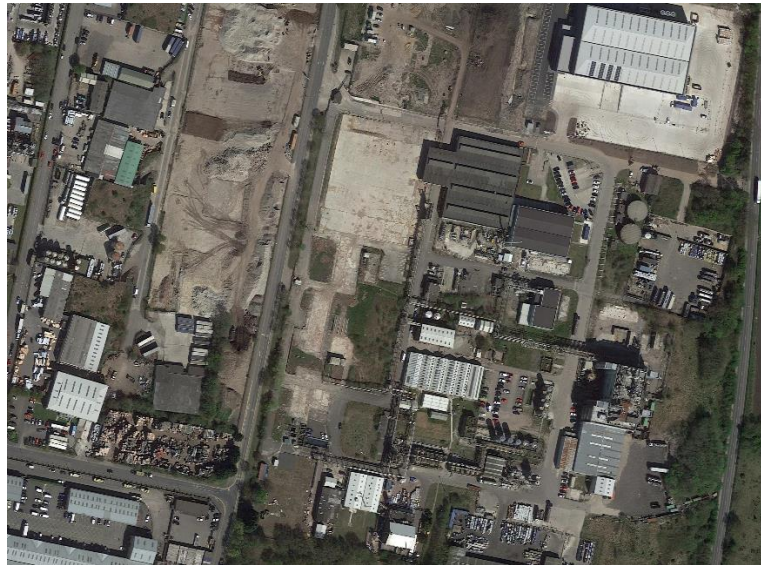
- 2.2 The area surveyed is currently occupied by the footings and foundations of the former industrial buildings and the verge between the site and Acornfield Road to the West (refer to Figure 02. Aerial Photograph below).
- 2.3 The topography of the site is relatively level with a gradual fall from North to South.

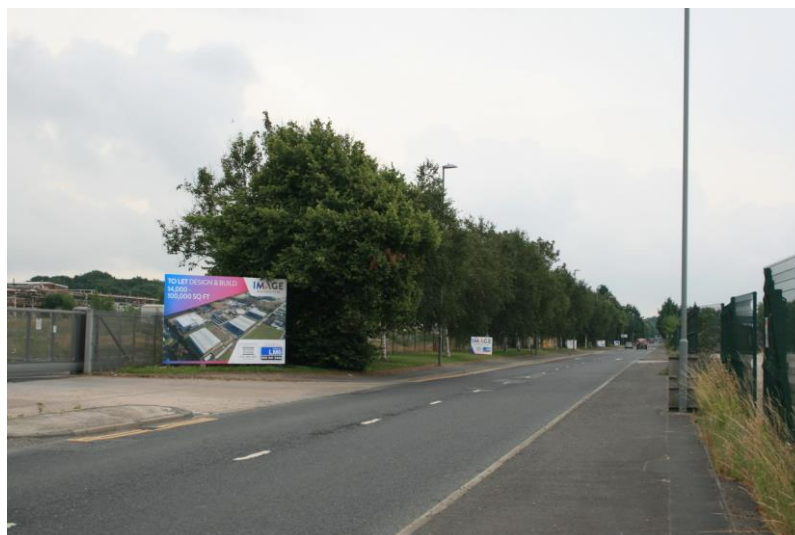
- 3.1 The majority of the trees surveyed (T01 to T14, T16, T18-T20, T23-T24, T27 & T28) are within the grass verge between Acornfield Road and the Western boundary of the site including a number of Himalayan Birch which form a distinctive arboricultural feature (refer to Figure 3 below) with occasional Single leaved ash & Lime and are considered to be of low to moderate quality and value.

Figure 3. View looking South towards T01 to T28

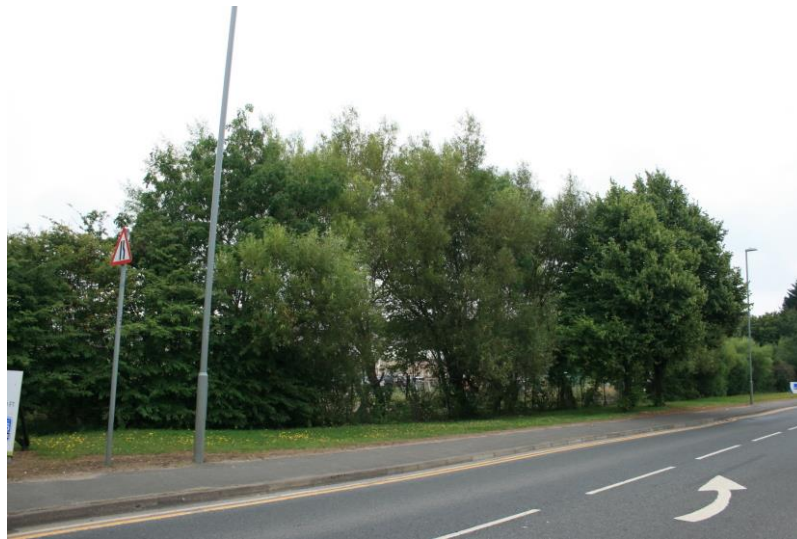
- 3.2 Between the Western site boundary fence and the edge of the internal road are a number of planted and self set trees (T15, T17, T21, G25, T26, G29, G30, G31, T32 & T33 including Rowan, Ash, Crack willow and Osier considered to be of moderate, low and U quality and value.

Figure 4. View looking South towards T26 to T33

- 6.1 The following trees are scheduled to be felled, or removed due to their poor condition, being dead or structurally dangerous and unsuitable for retention; T17, T26, G29, G30, G31.
- 6.2 The preliminary tree management works and tree removal are to be carried out by an Arboricultural Association accredited tree surgeon in accordance with BS 3998: 2010 ‘Tree Work - Recommendations’ with particular care to be taken where trees are in confined spaces or adjacent to highways.
- 6.3 The stumps of tree species that sucker from roots or stumps such as Alder, Ash, Beech, Birch, Cherry, Elm, Lime, Maple, Oak, Poplar, Rowan, Sycamore, Tree of heaven and Willow are to be treated on removal with glyphosate plugs i.e ‘Ecoplug Max Tree Stump Killer’ in accordance with the manufacturer’s instructions and specifications.

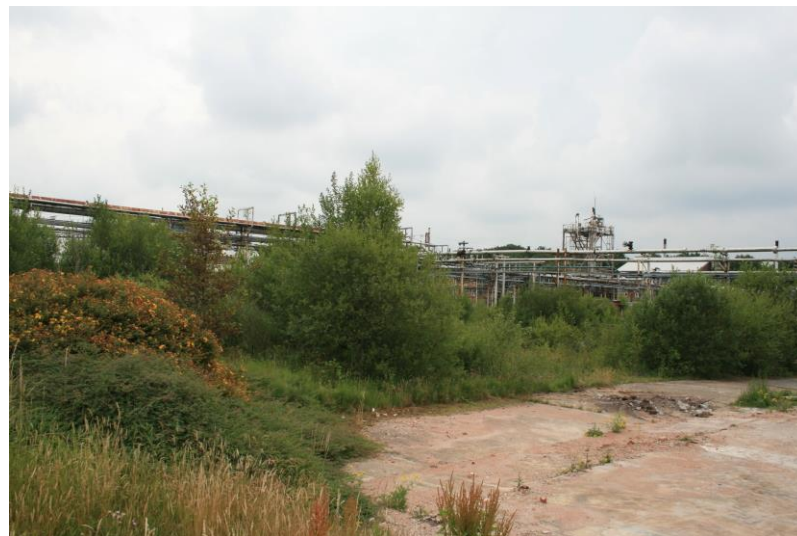
- 3.2 Within the site are a number of stumps of felled Ash and Alder with two areas of self set Birch, Ash, Goat willow and Buddleia saplings G34 & G35 of low quality and value.

Figure 5. View looking South towards G35
